Reach 7	City of Pasco
Reach Description: Columbia River from the upstream edge of Sacajawea State Park to Snake River just east of the Sacajawea State Park boat basin	
Shoreline Jurisdiction: 295 acres

Reach 8	City of Pasco
Reach Description: Snake River just upstream of confluence with Columbia River, extending from City UGA eastern boundary to near Sacajawea State Park	
Shoreline Jurisdiction: 260 acres

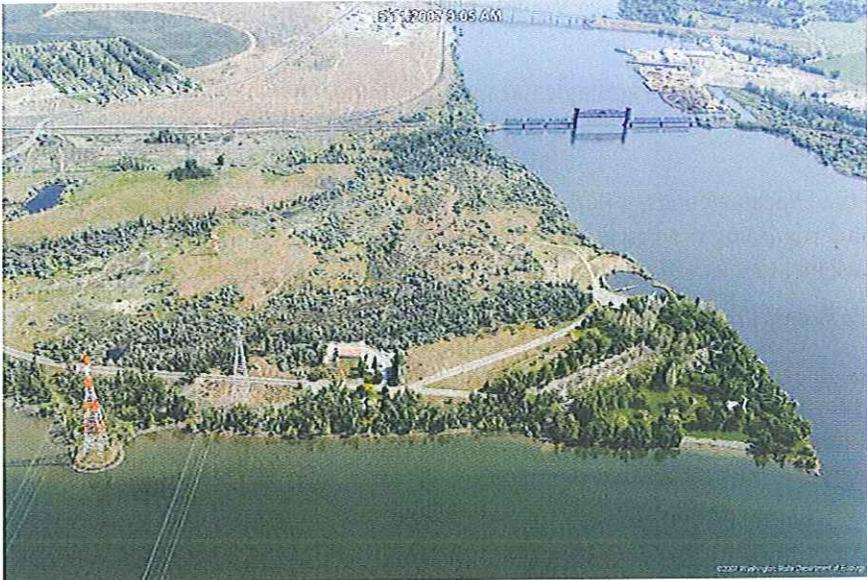
<p data-bbox="667 1075 1409 1102">Source: https://fortress.wa.gov/ecy/coastalatlantools/UICoastalAtlas/Tools/ShorePhotos.aspx</p>	
Subreaches; see Map 4: Not Applicable.	
CHARACTERISTICS	
Ownership: Reach 7 is owned by Washington State Parks and Recreation Commission.	
Land Use/Current SMP: Land use designation: <ul style="list-style-type: none"> • Current land use is Industrial and Open Space Nature • Zoning – Medium Industrial (I-2), and Heavy Industrial (I-3) Current SMP Environment Designation: Conservancy	
Existing Land Cover/Development: This reach primarily consists of riparian vegetation in the Sacajawea State Park. There is also a boat launch, dock, a beach, and utility poles within this reach.

Geomorphic Character: Description: Reach 7 consists of a topographic low area at the confluence of the Columbia River and Snake River. The shoreline throughout the reach consists of alluvium with relatively low banks throughout Sacajawea State Park.

Reach 7	City of Pasco
<p data-bbox="212 338 846 369">Recreational use: Upland trails, water access, boat use.</p> <p data-bbox="212 384 1365 453">Potential Restoration Opportunities: Consider incorporating more riparian buffer plantings near the boat launch area at northeast side of subreach. Replace non-native species with native alternatives.</p> <p data-bbox="212 468 1300 537">Potential Protection Opportunities: Preserve existing riparian and shrub-steppe habitat. Provide stormwater controls consistent with Eastern Washington Stormwater Manual.</p>

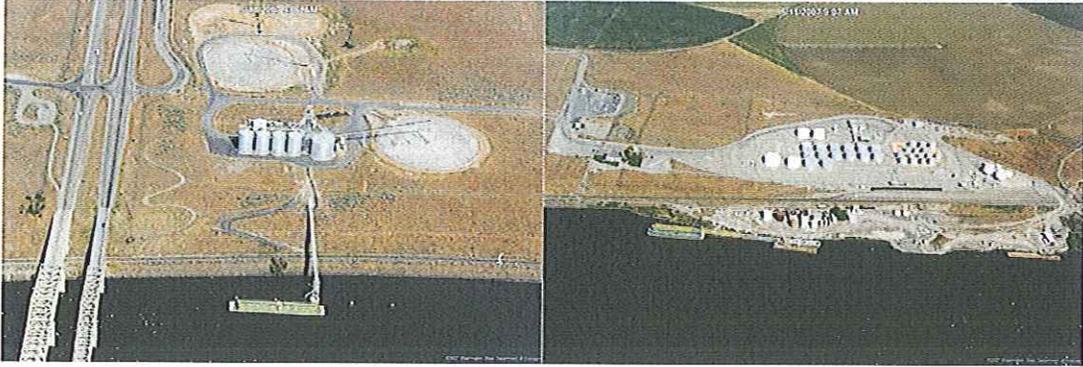
Source: https://fortress.wa.gov/ecy/coastalatlantlas/UICoastalAtlas/Tools/ShorePhotos.aspx	
Subreaches; see Map 4:	
SR 8a: Begins at Sacajawea Sate Park to the edge of industrial developments	
SR 8b: Extends 0.5 mile to the north ending at the US 12 bridge	
CHARACTERISTICS	
Ownership: SR 8a is owned by Washington State Parks and Recreation Commission and federal government. SR 8b is mostly private with a small amount (less than 10%) of federal ownership.	
Land Use/Current SMP:	
Land use designation:	
<ul style="list-style-type: none"> • Current land uses are Industrial and Open Space Nature • Zoning – Light Industrial (I-1), Medium Industrial (I-2), and Heavy Industrial (I-3) 	
Current SMP Environment Designation: Urban

Existing Land Cover/Development:	
SR 8a is mostly unimproved natural land with riparian vegetation. SR 8a includes a rail crossing. SR 8b includes State Route 12 crossing, a fuel storage tank, and barge facilities.	
Geomorphic Character:	
Description: The shoreline in this reach consists mostly of outburst flood deposits. The reach consists of low bank areas near the confluence with the Columbia River. Lake Wallula levels fluctuate with downstream dam management practices.	
Hardened Banks: Approximately 7,200 linear feet of artificial hardened banks exist along the Columbia River (left bank) within all the subreaches.

Reach 8	City of Pasco
ECOLOGICAL FUNCTIONS ANALYSIS	
SR 8a	
Level of Existing Function: Partially Functioning	
Stressors:	
Upland development: Non-native riparian species (Russian-olive), railroad corridor and railroad bridge.	
Potential Restoration Opportunities: Replace non-native species with native alternative.	
Potential Protection Opportunities: Provide stormwater controls consistent with Eastern Washington Stormwater Manual.	
SR 8b	
Level of Existing Function: Impaired	
Stressors:	
Upland development: Railroad corridor along shoreline, industrial structures and Port development and vessel use, very limited riparian buffers and non-native Russian-olive species where riparian buffer exists, US 12 bridge.	
Recreational use: Informal roads and possibly off-road vehicle recreation use within upland areas.	
Potential Restoration Opportunities: Incorporate riparian buffers where absent. Replace non-native species with native alternatives.

Potential Protection Opportunities: Protect intact shrub-steppe habitat from degradation by limiting recreation use. Provide stormwater controls consistent with Eastern Washington Stormwater Manual.
