Clallam County SMP: No Net Loss Update

Spring 2012 Shoreline
Planners Meeting

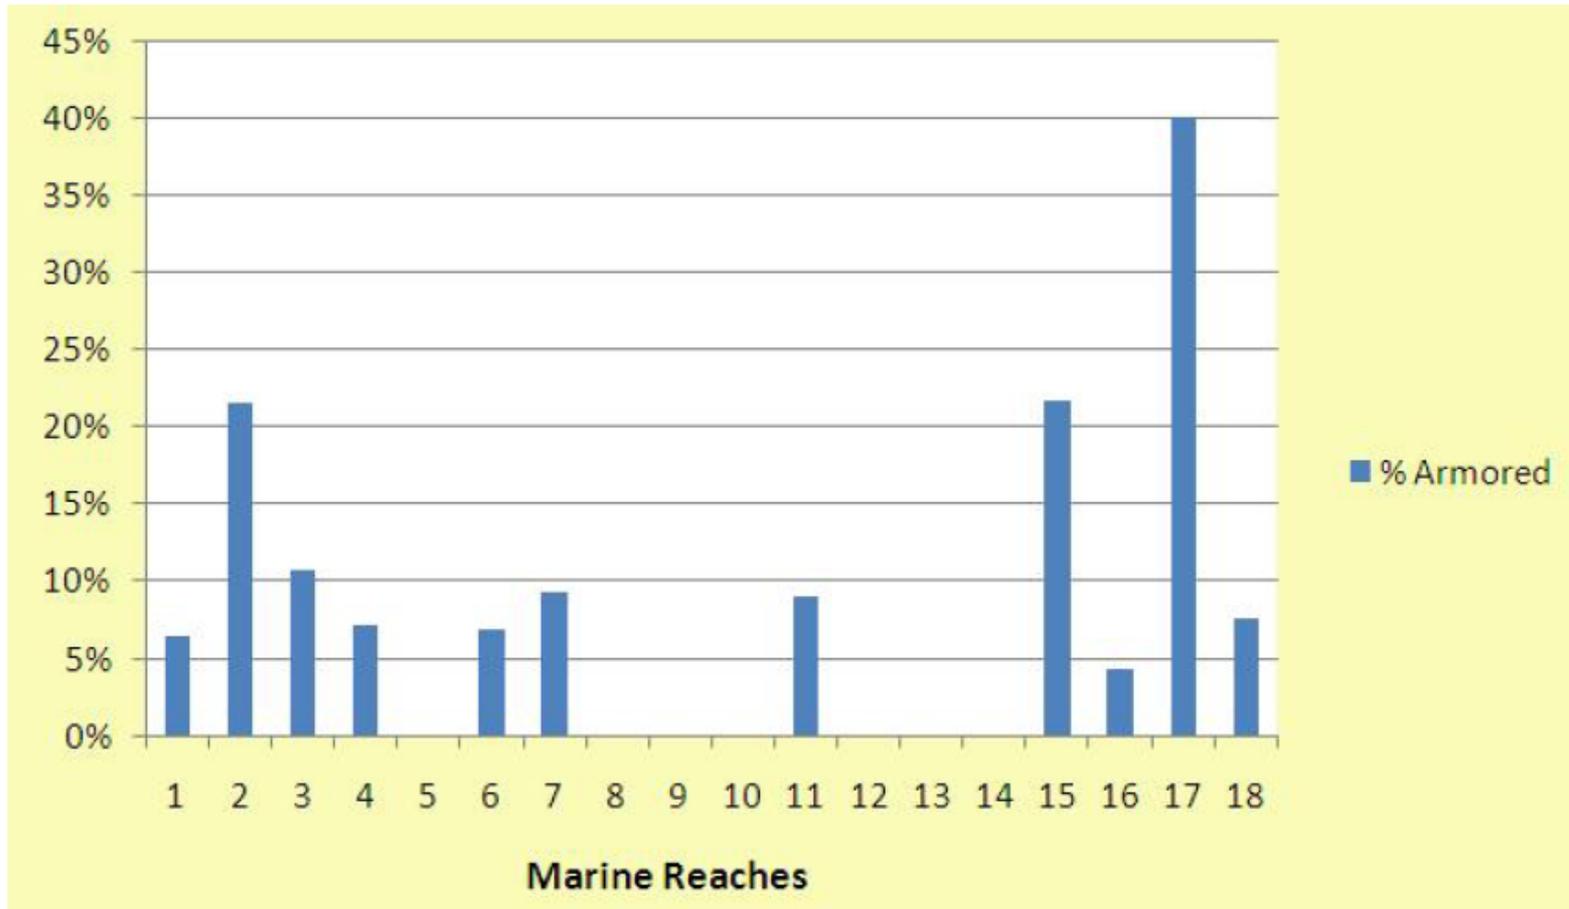
Figure 3-9. Percent of each reach with hard armoring along the Strait of Juan de Fuca in Clallam County (data from point PSNERP 2009, Battelle 2008)

Modified shoreline
Feeder bluff with
armoring
Armoring (non feeder
bluff)
OW structures
OW structures in
sediment transport
zones

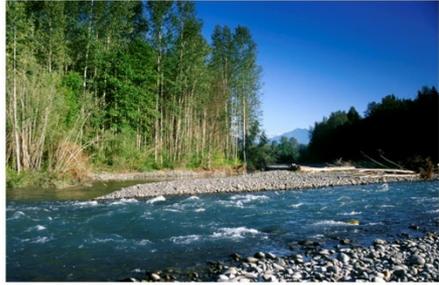
Achieving No Net Loss Using Salmon Restoration Projects

Higher
↑
Ecosystem Function
Lower

No Net Loss

2012 Baseline of
Ecosystem Functions

Development Impacts
with mitigation

Salmon Restoration Projects

Development Impacts
without mitigation

Mitigation

Time (years)
