**Terrace Mitigation Bank
Mitigation Banking Instrument**

Vancouver, Washington

1 **MITIGATION BANKING INSTRUMENT**
2 **Terrace Mitigation Bank**

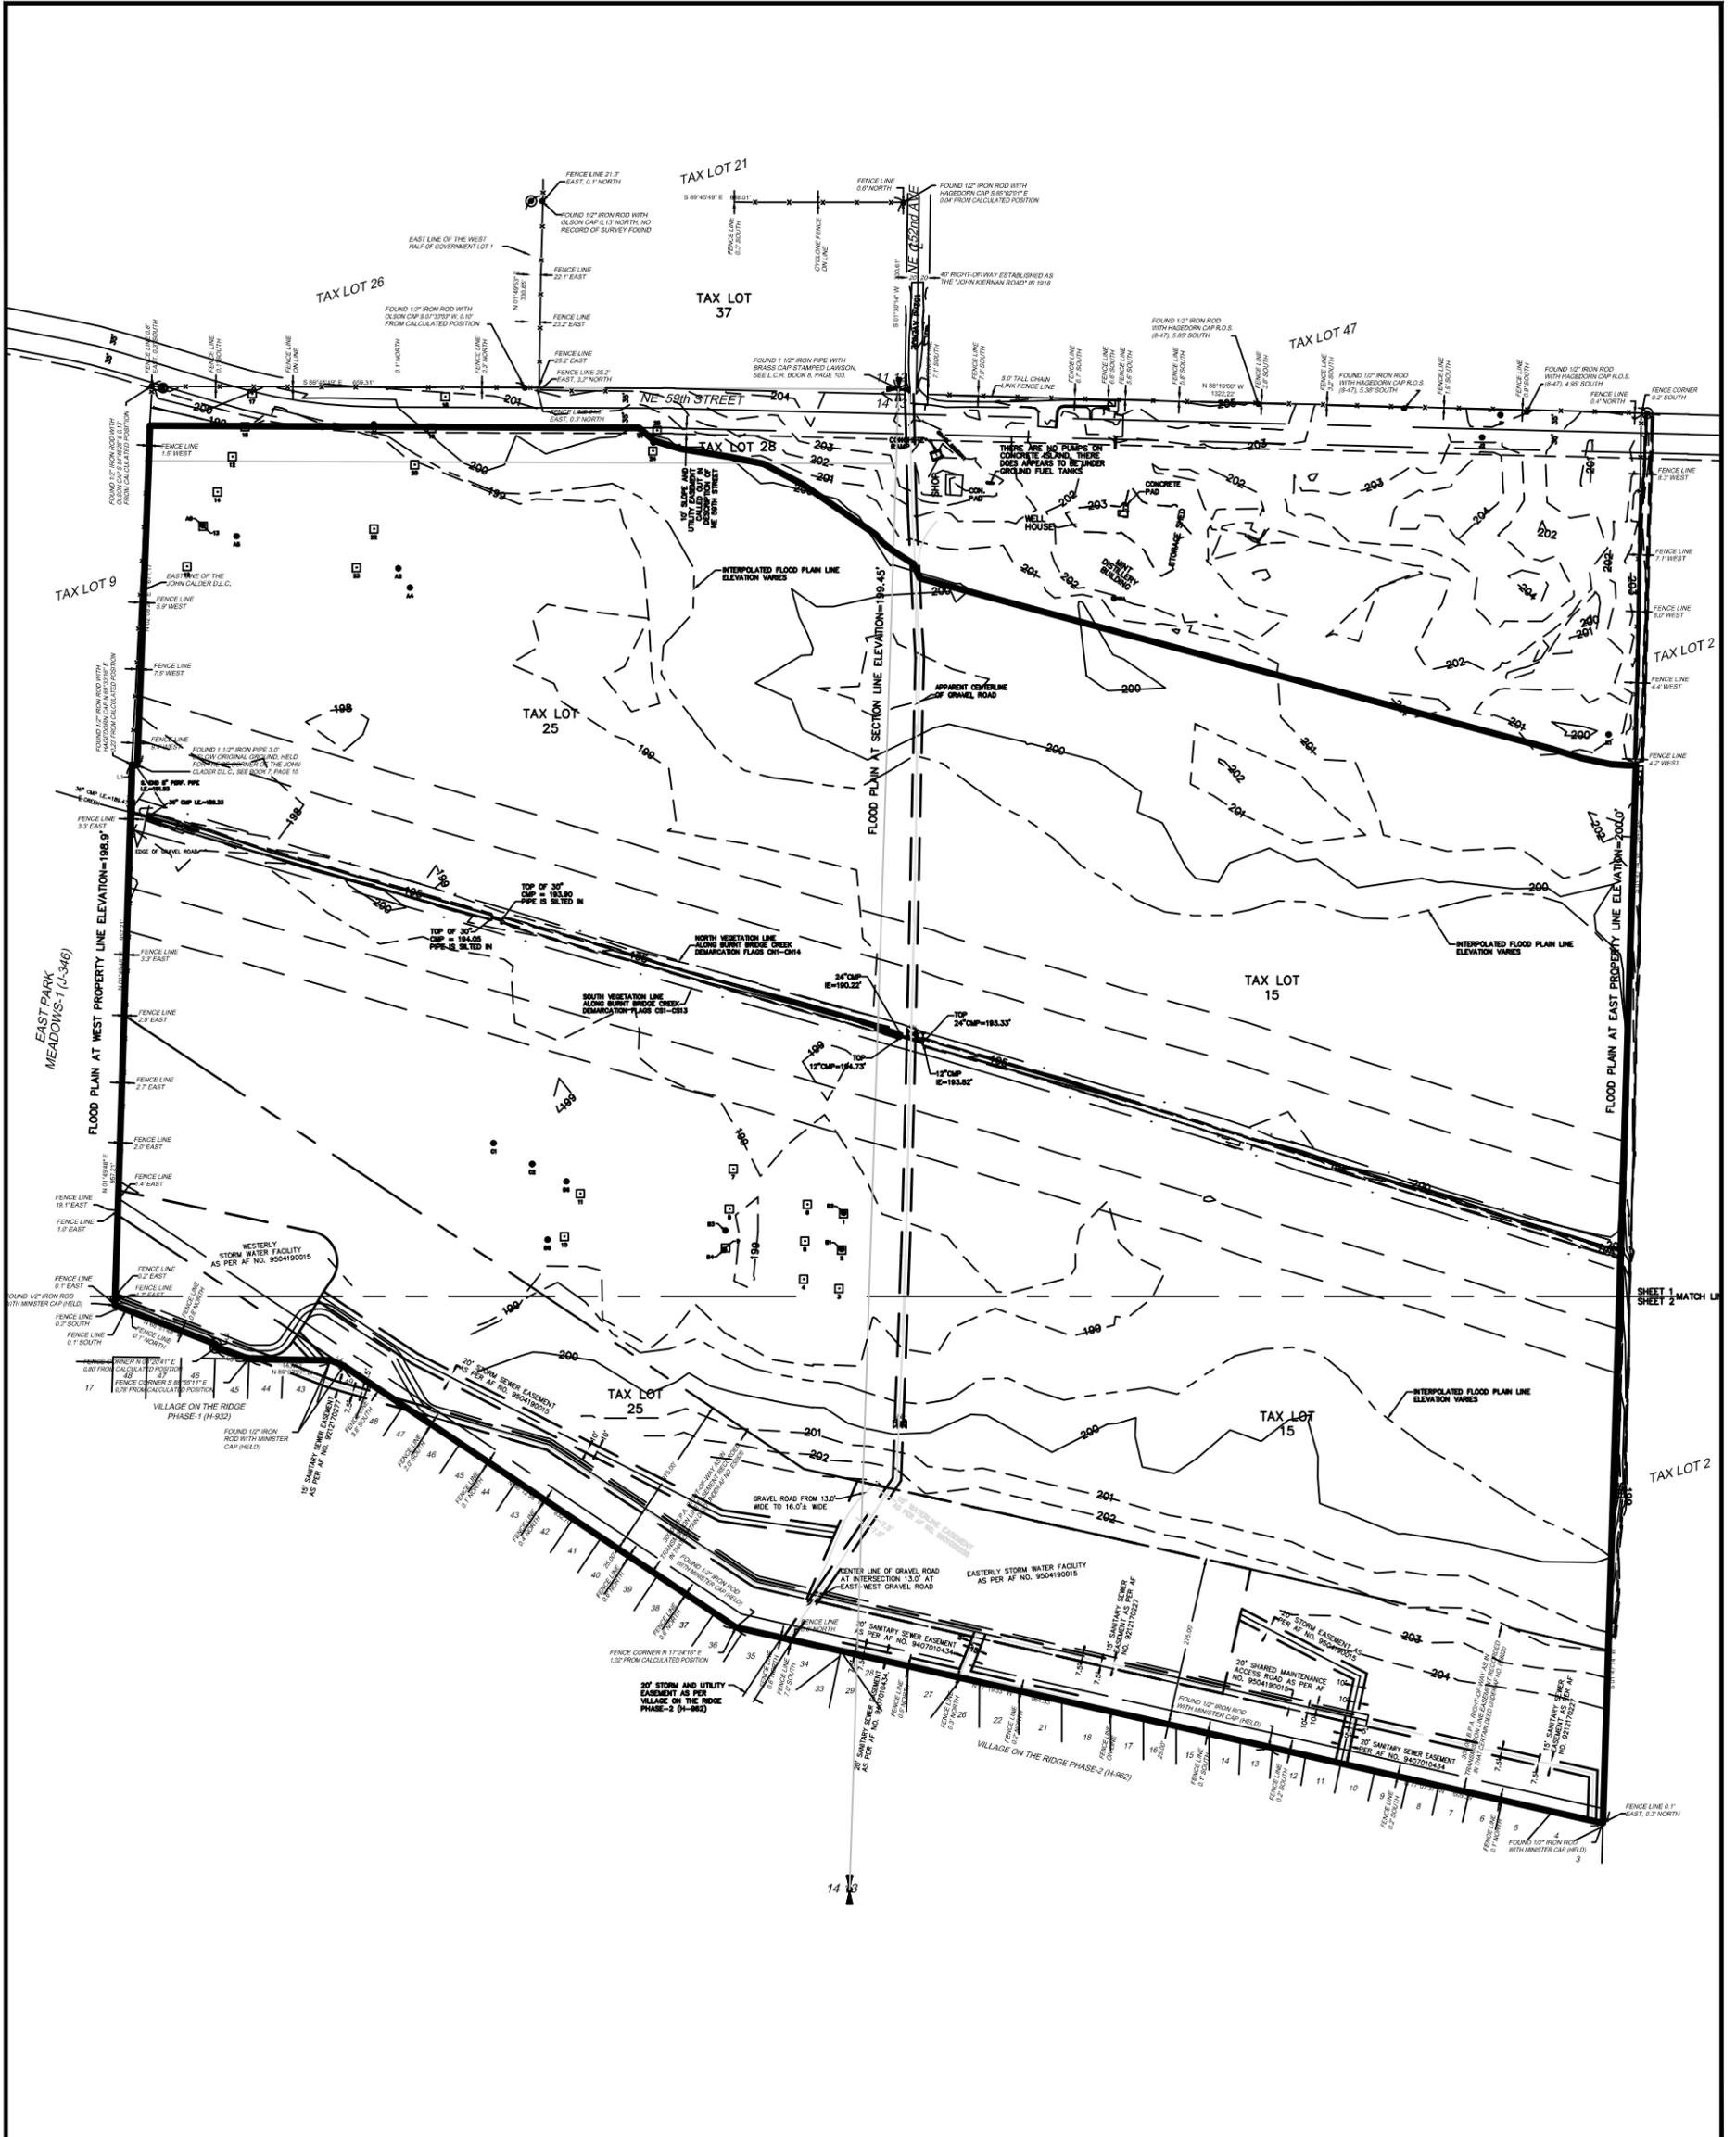
Figure A-2
SITE SURVEY
Terrace Wetland Mitigation Bank
Rotschy, Inc.
City of Vancouver, Clark County, Washington
Section 13 & 14, Township 2N, Range 2E, W.M.

Site Boundary/Bank Boundary (113.04 ac.)

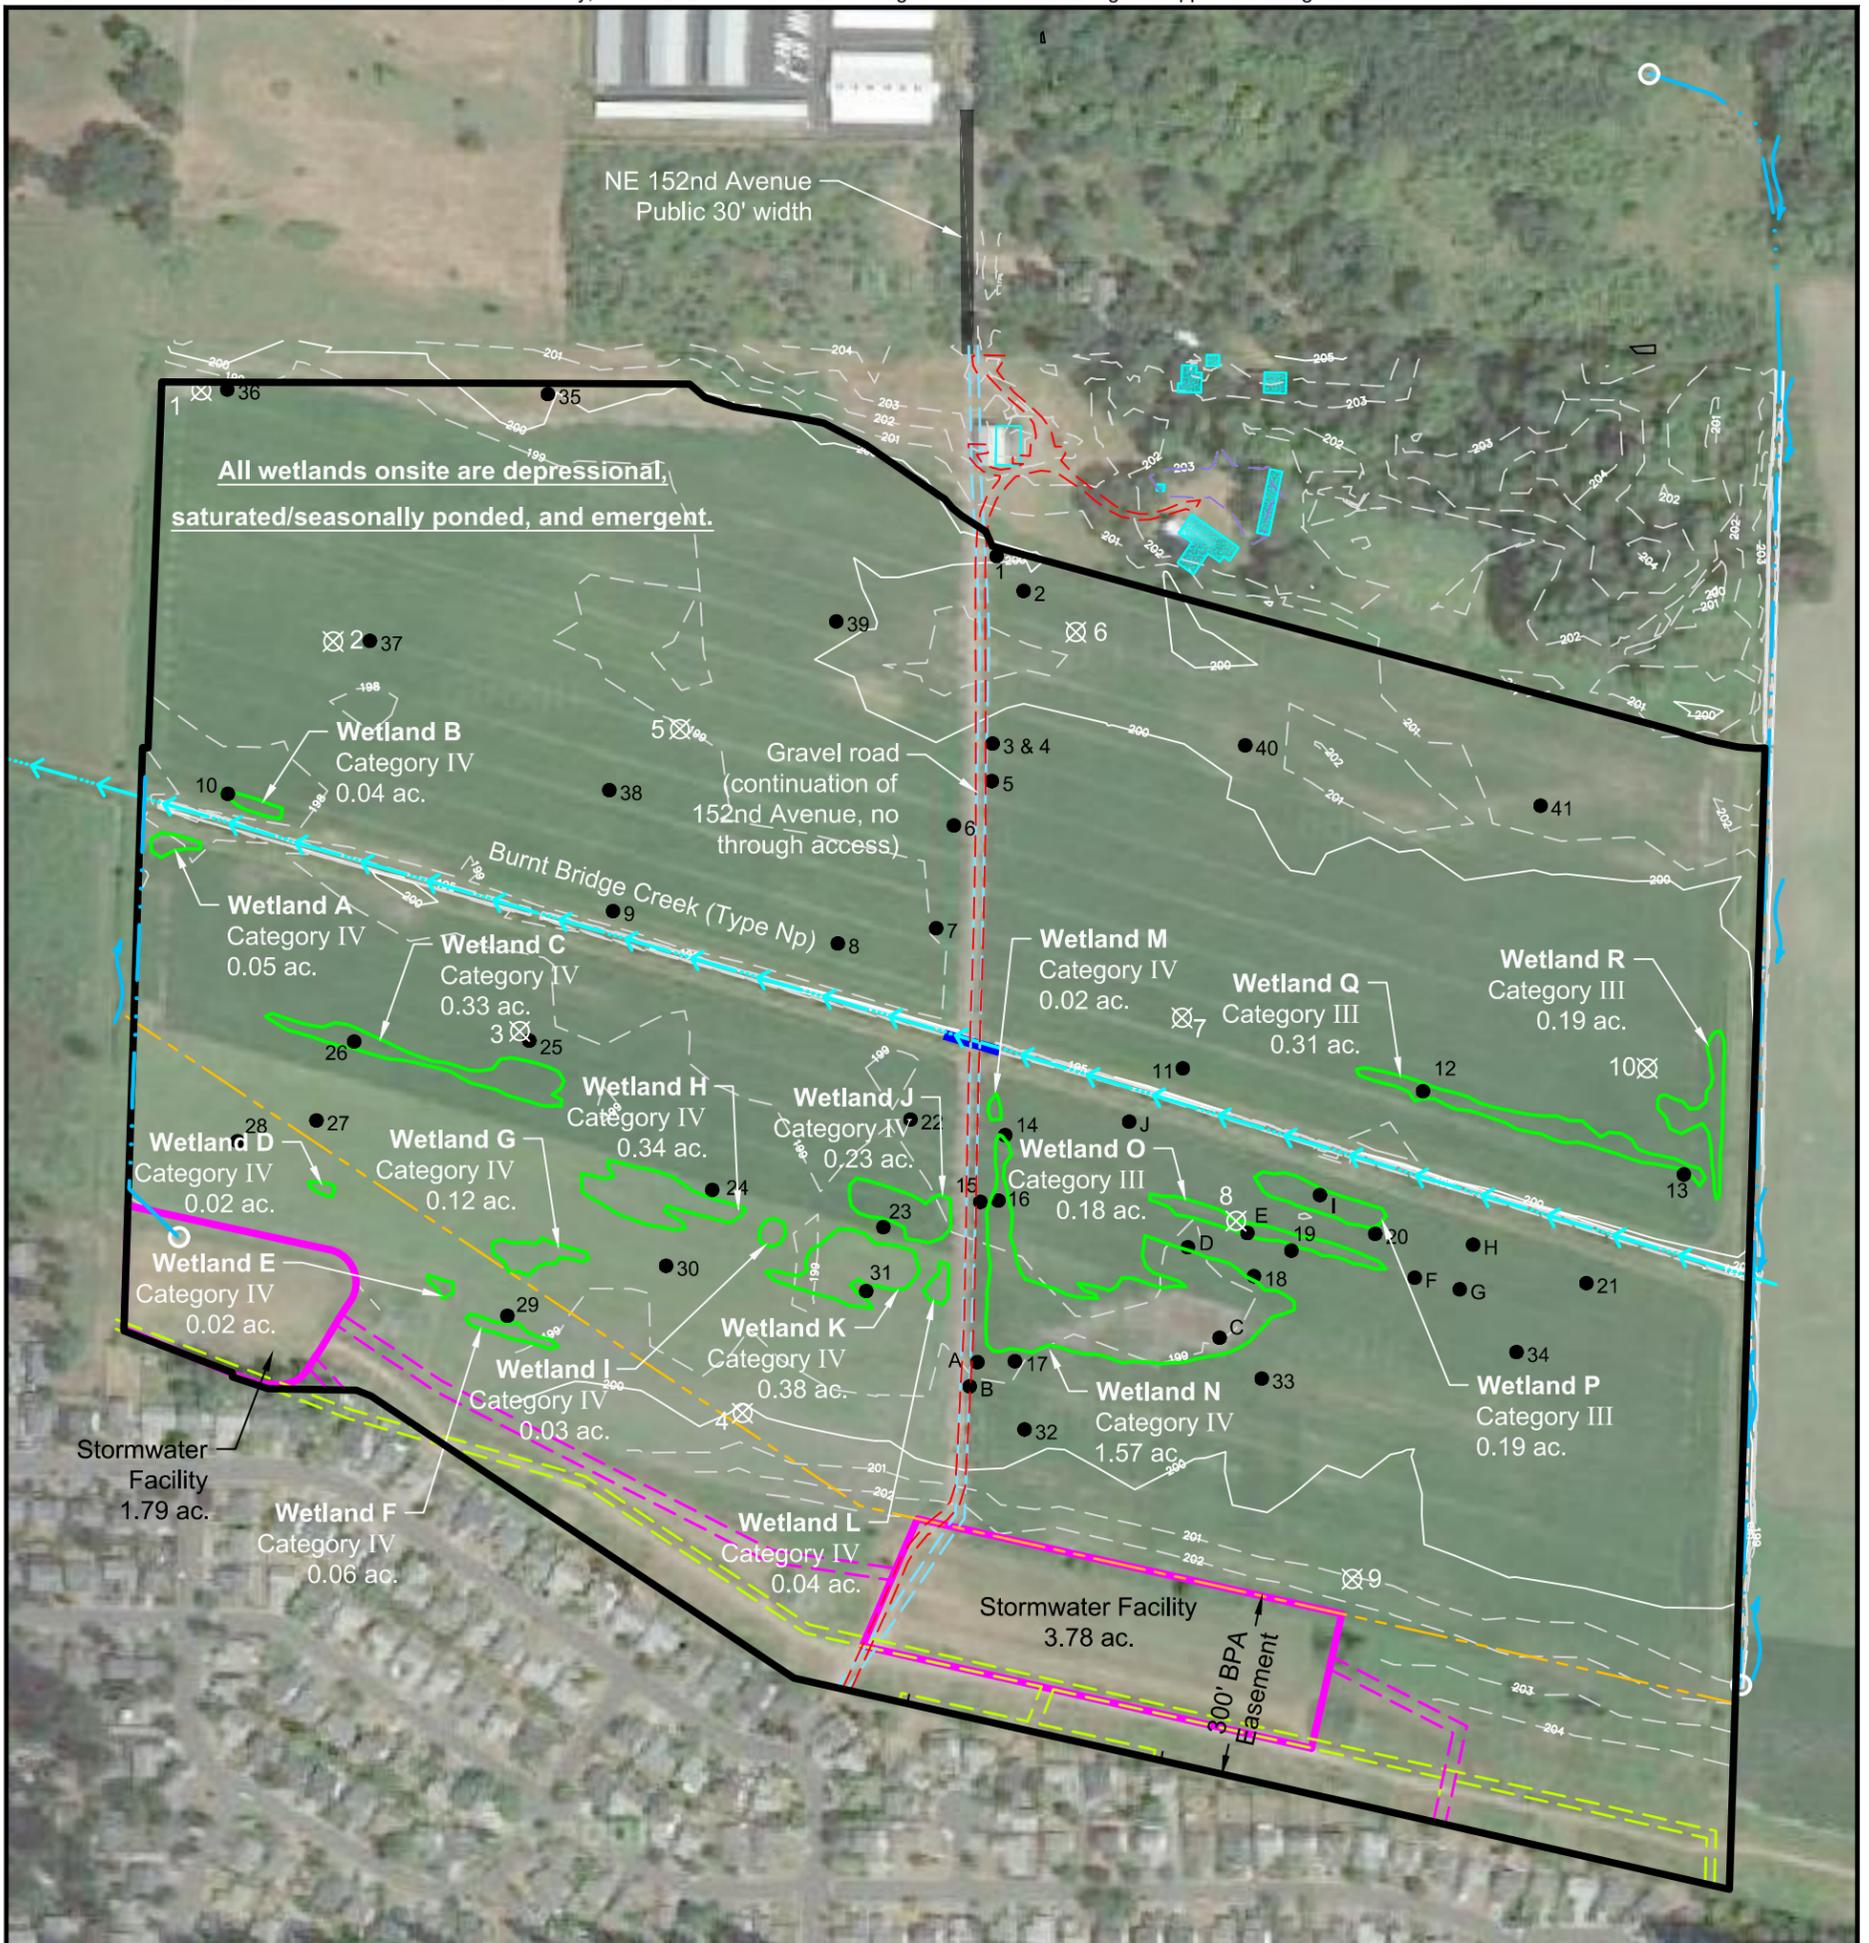
Figure A-3a
 EXISTING CONDITIONS
 Terrace Wetland Mitigation Bank
 Rotschy, Inc.
 City of Vancouver, Clark County, Washington
 Section 13 & 14, Township 2N, Range 2E, W.M.

- Site Boundary/Bank Boundary (113.04 ac.)
- Stream
- Ditch
- Ditch Point of Origin
- Existing Wetland Boundary
- BPA Powerline Easement
- Existing Gravel Road (0.70 ac. onsite²)
- Existing Structure
- Culvert Location
- Test Plot Location
- Monitoring Well Location
- 20' Storm Sewer Easement
- 20' Sanitary Sewer Easement
- 15' Water Line Easement
- Stormwater Facility

37 The Bank site contains several easements, which are further described in Table 1. These
38 easements include a 15-foot wide waterline easement which runs north to south within the
39 footprint of the gravel road (an extension of NE 152nd Avenue) until it reaches the Bonneville
40 Power Administration (BPA) easement, where it shifts to the west and runs adjacent to the road.
41 The remaining easements are located within the 300-foot BPA easement in the southern portion
42 of the Bank site, and consist of two stormwater facilities, and several other utility easements
43 (storm sewer and sanitary sewer). The easements are not considered part of the credit generating
44 areas within the overall Bank Site. A breakdown of the overall bank acreage in relation to the
45 specific easement areas is illustrated on **Figure A-3a, Existing Conditions** and on Table 1
46 below.

14
15 The existing Bank site includes approximately 2,750 linear feet of Burnt Bridge Creek, which
16 originates at the east property boundary and flows east to west and 4.12 acres of Category III and
17 IV wetlands (**Figure A-3a**).

A 15-foot wide waterline easement runs north to south within the footprint of the gravel road (an extension of NE 152nd Avenue) through the middle of the site, until it reaches the BPA easement, where it shifts to the west and runs adjacent to the road. A 300-foot Bonneville Power Administration (BPA) easement, two stormwater facilities, and several other utility easements (storm sewer and sanitary sewer) are located in the southern portion of the site (**Figure A-3a, Existing Conditions**). Bank use within the BPA easement is subject to a *Land Use Agreement*, which was signed and made effective on November 19, 2015. The overall Bank property size is approximately 113.04 acres, which consists of the habitat types and easement areas listed in Table A-1 and **Figure A-3a**.

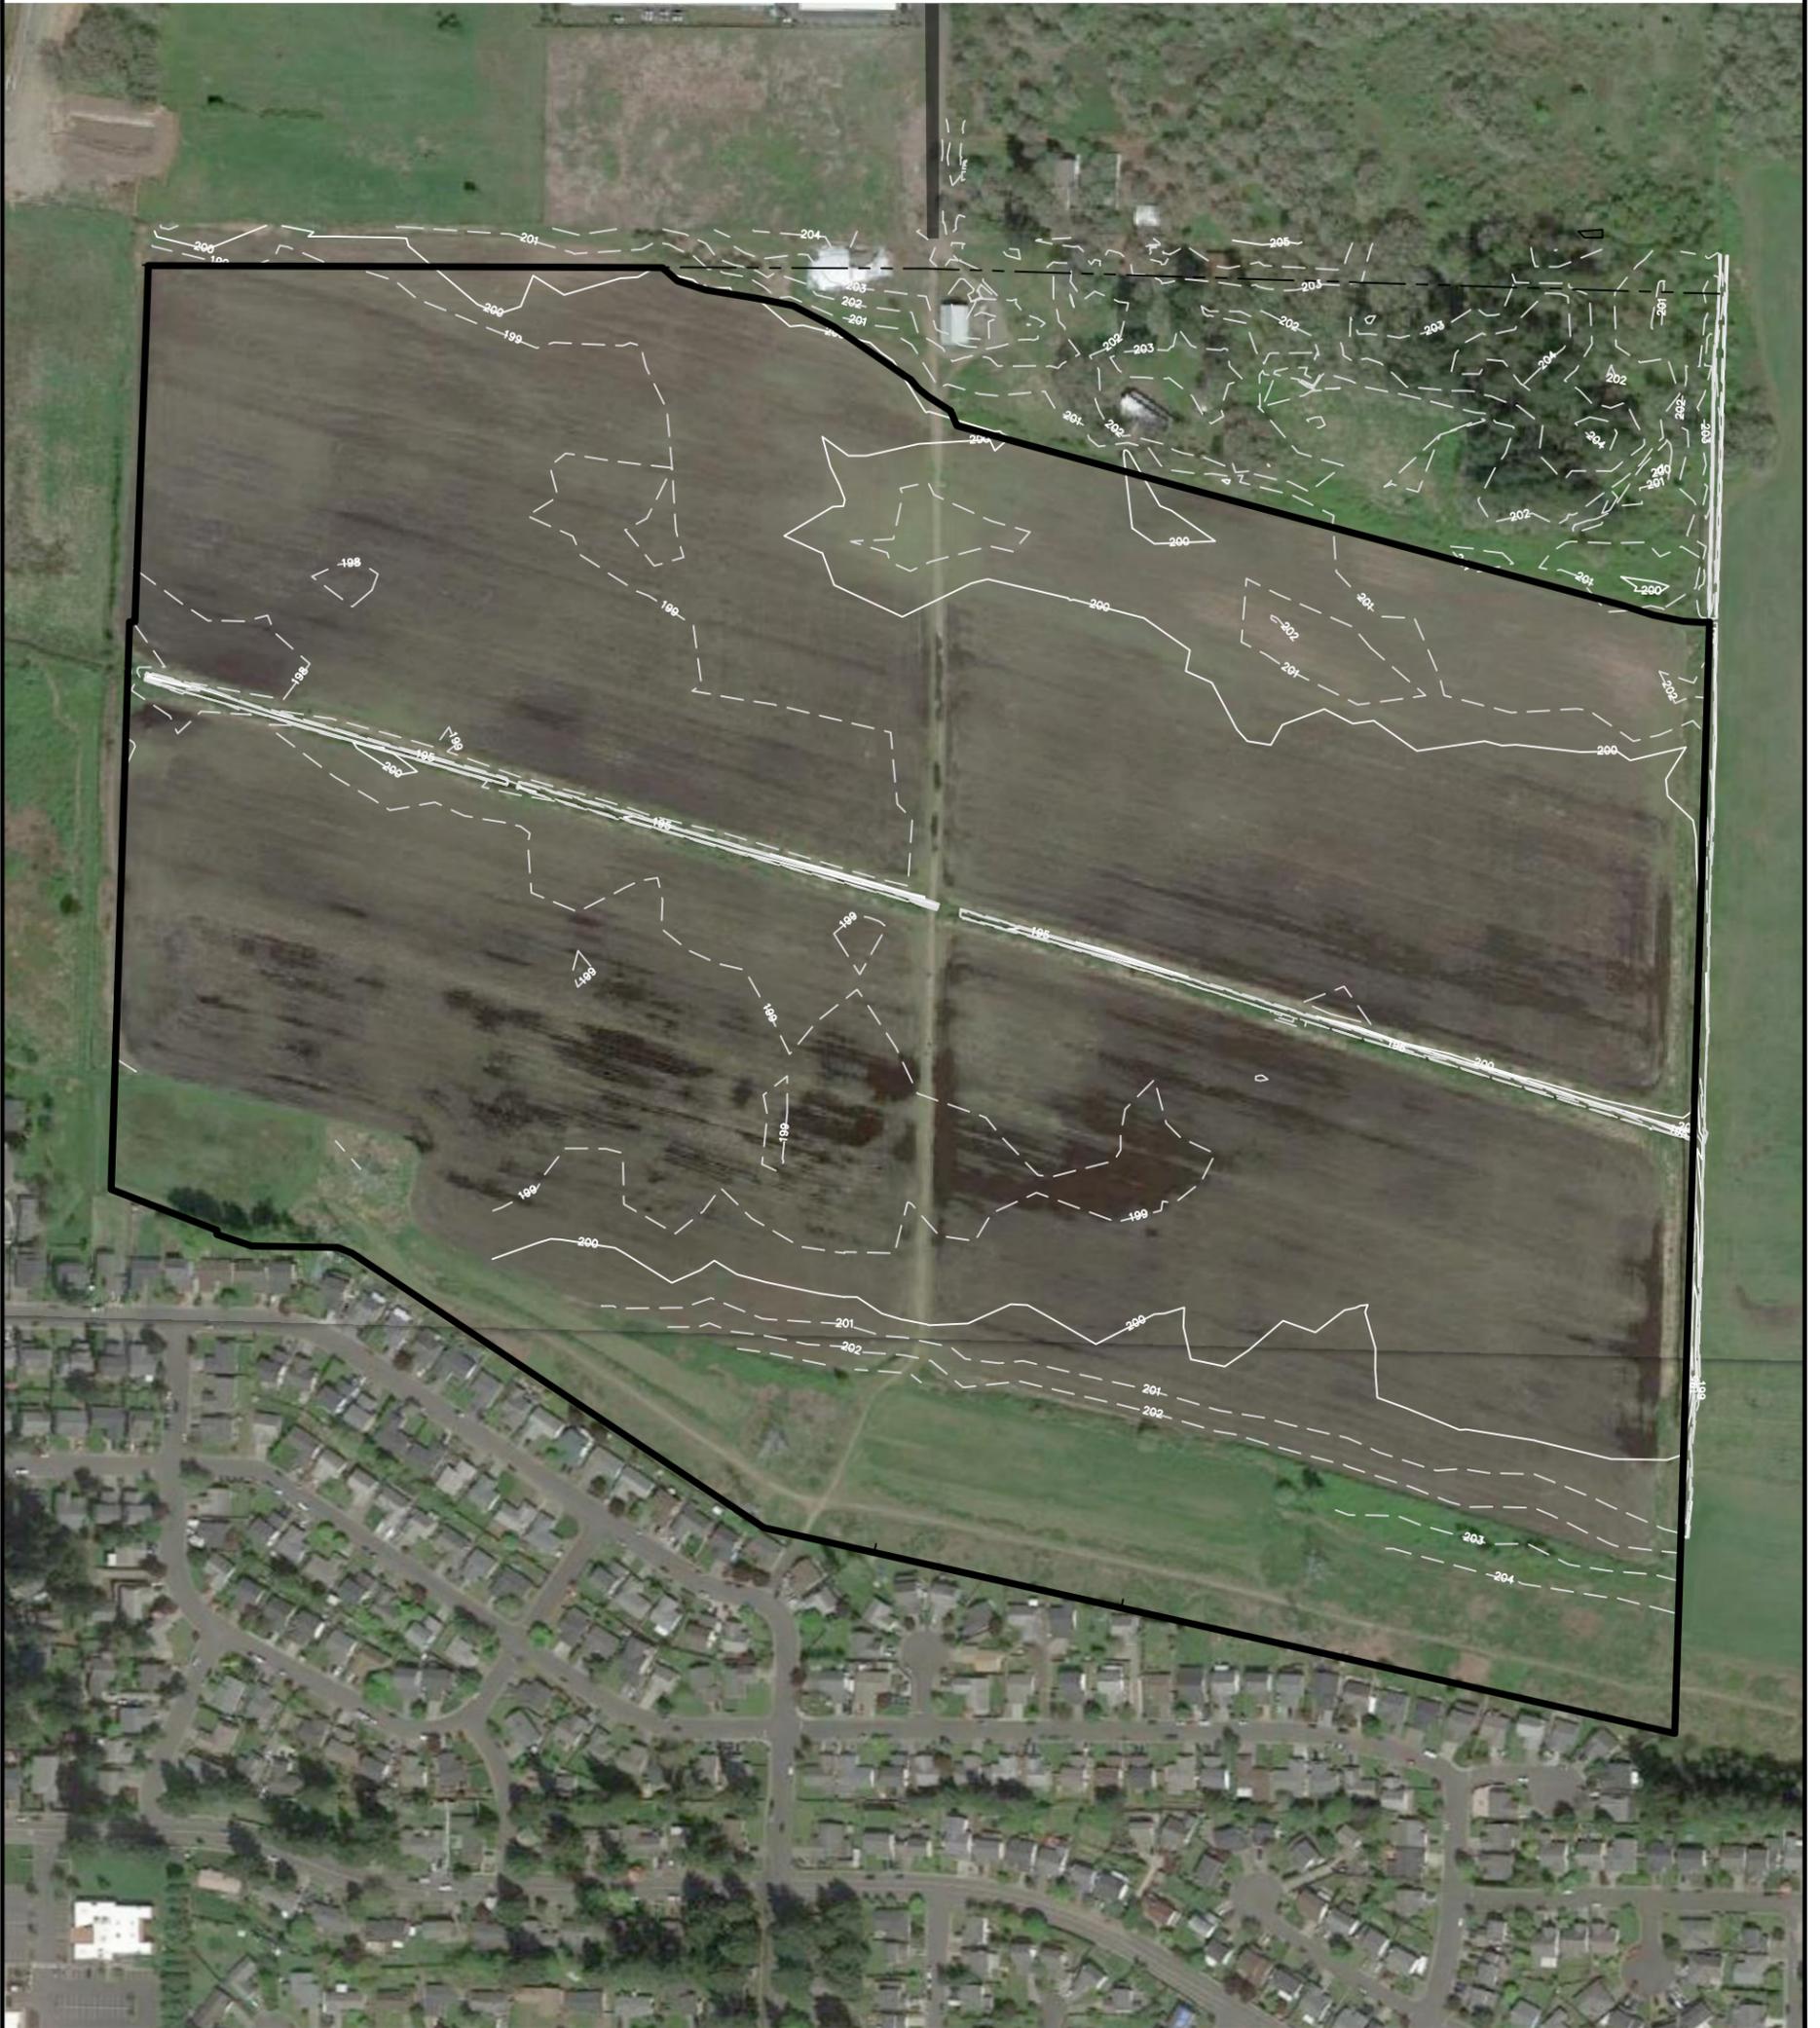
Figure A-4
SITE TOPOGRAPHY
Terrace Wetland Mitigation Bank
Rotschy, Inc.
City of Vancouver, Clark County, Washington
Section 13 & 14, Township 2N, Range 2E, W.M.

SITE TOPOGRAPHY FOR TERRACE MITIGATION BANK

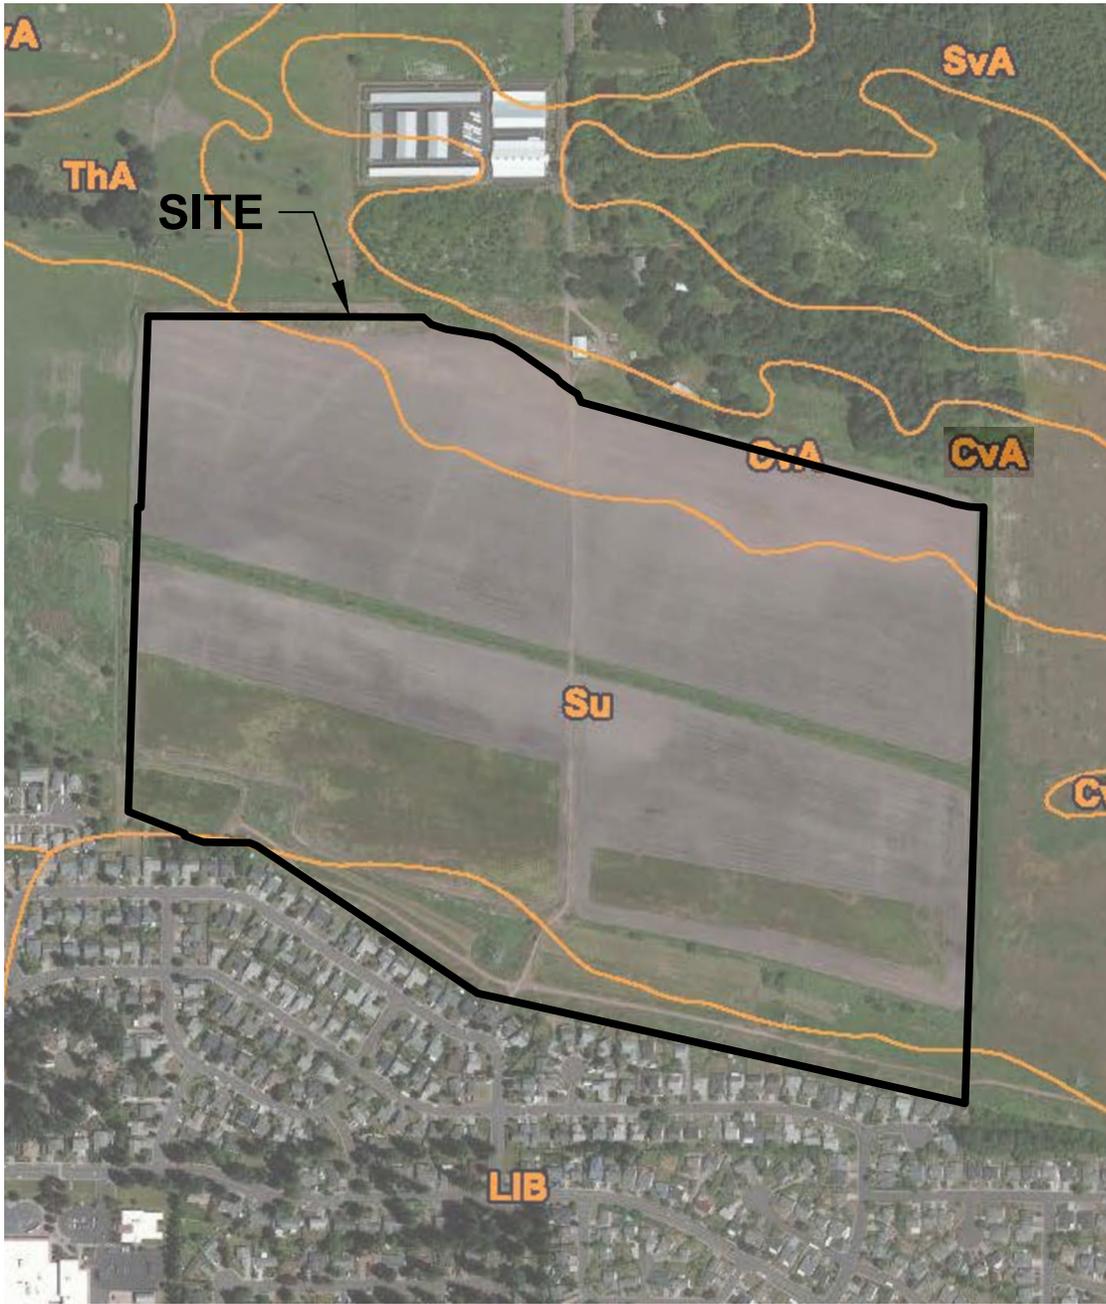
Figure A-5
SOIL SURVEY MAP
 Terrace Mitigation Bank
 Rotschy, Inc.
 City of Vancouver, Clark County, Washington
 Section 11, 12, 13, & 14, Township 2N, Range 2E, W.M.

- CvA** Cove silty clay loam, 0 to 3 percent slopes. Hydric.
- LIB** Lauren very gravelly loam, 0 to 8 percent slopes. Not hydric.
- Su** Semiahmoo muck, shallow variant. Hydric.
- SvA** Sifton gravelly loam, 0 to 3 percent slopes.

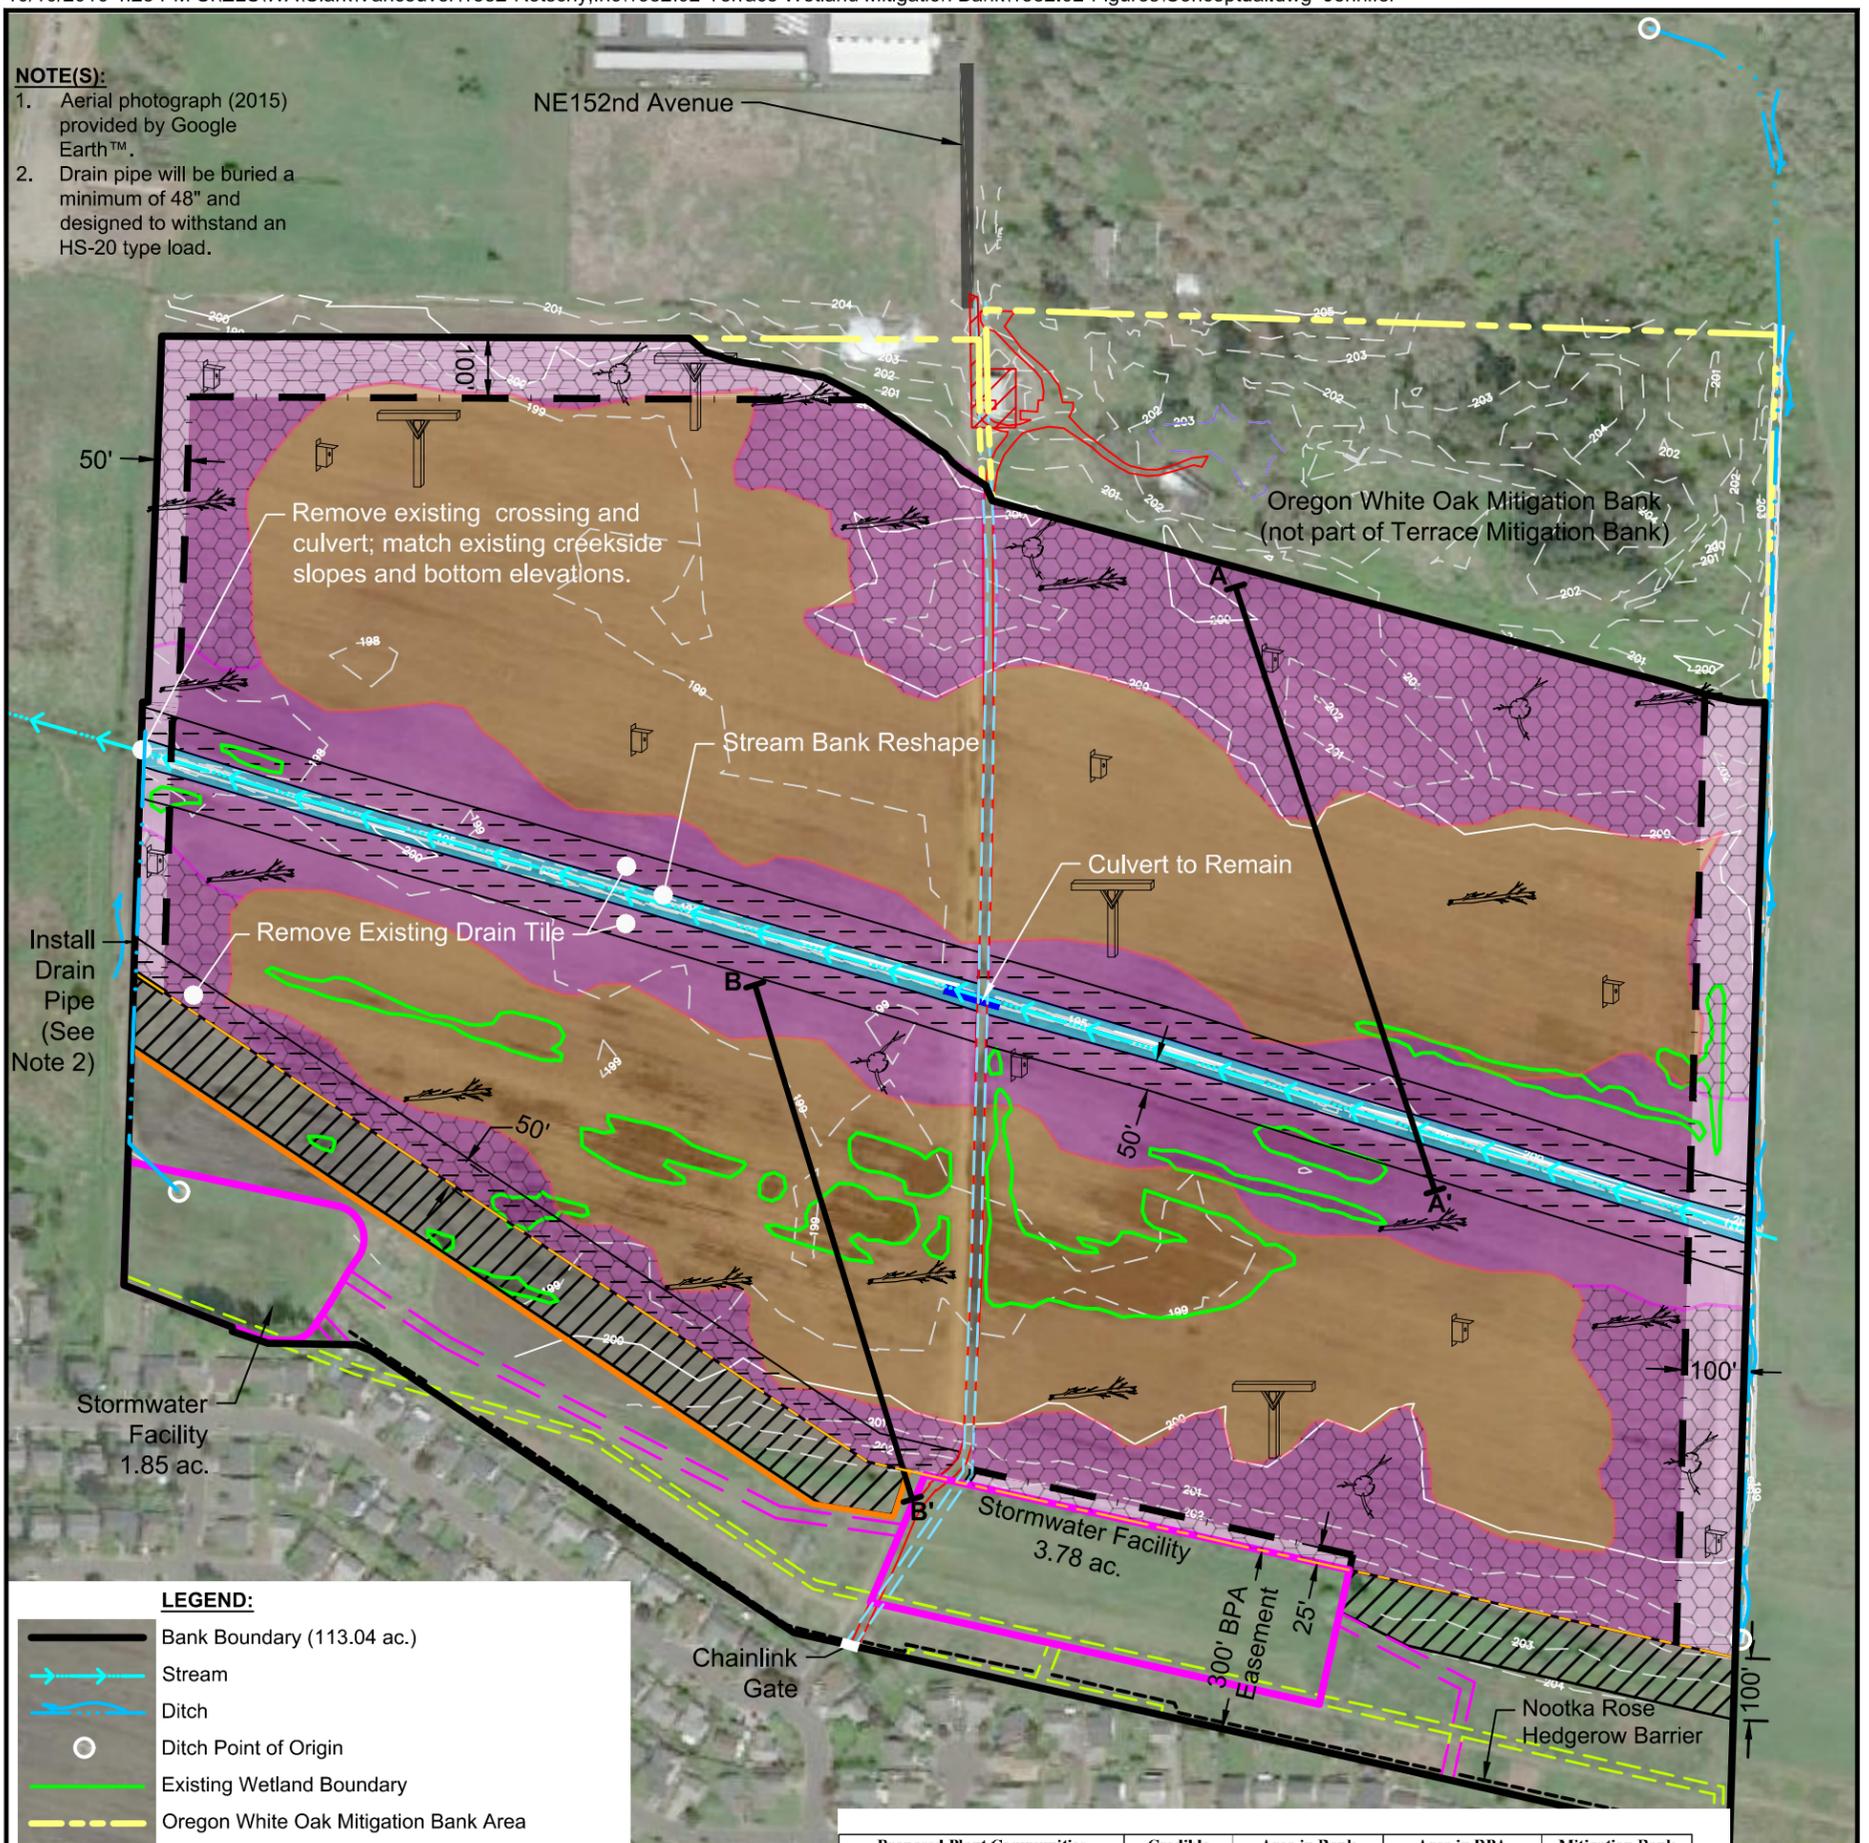
Figure B-1
BANK SITE DESIGN
 Terrace Mitigation Bank
 Rotschy, Inc.
 City of Vancouver, Clark County, Washington
 Section 11, 12, 13, & 14, Township 2N, Range 2E, W.M.

1. Aerial photograph (2015) provided by Google Earth™.
2. Drain pipe will be buried a minimum of 48" and designed to withstand an HS-20 type load.

- Bank Boundary (113.04 ac.)
- Stream
- Ditch
- Ditch Point of Origin
- Existing Wetland Boundary
- Oregon White Oak Mitigation Bank Area
- BPA Powerline Easement
- Existing Gravel Road
- Culvert Location
- Mitigation Bank Buffer (7.28 ac.)
- Staging Area
- Drain Tile Removal Area
- BPA Easement Drainage Pipe
- 20' Storm Sewer Easement
- 20' Sanitary Sewer Easement
- 15' Water Line Easement
- Stormwater Facility

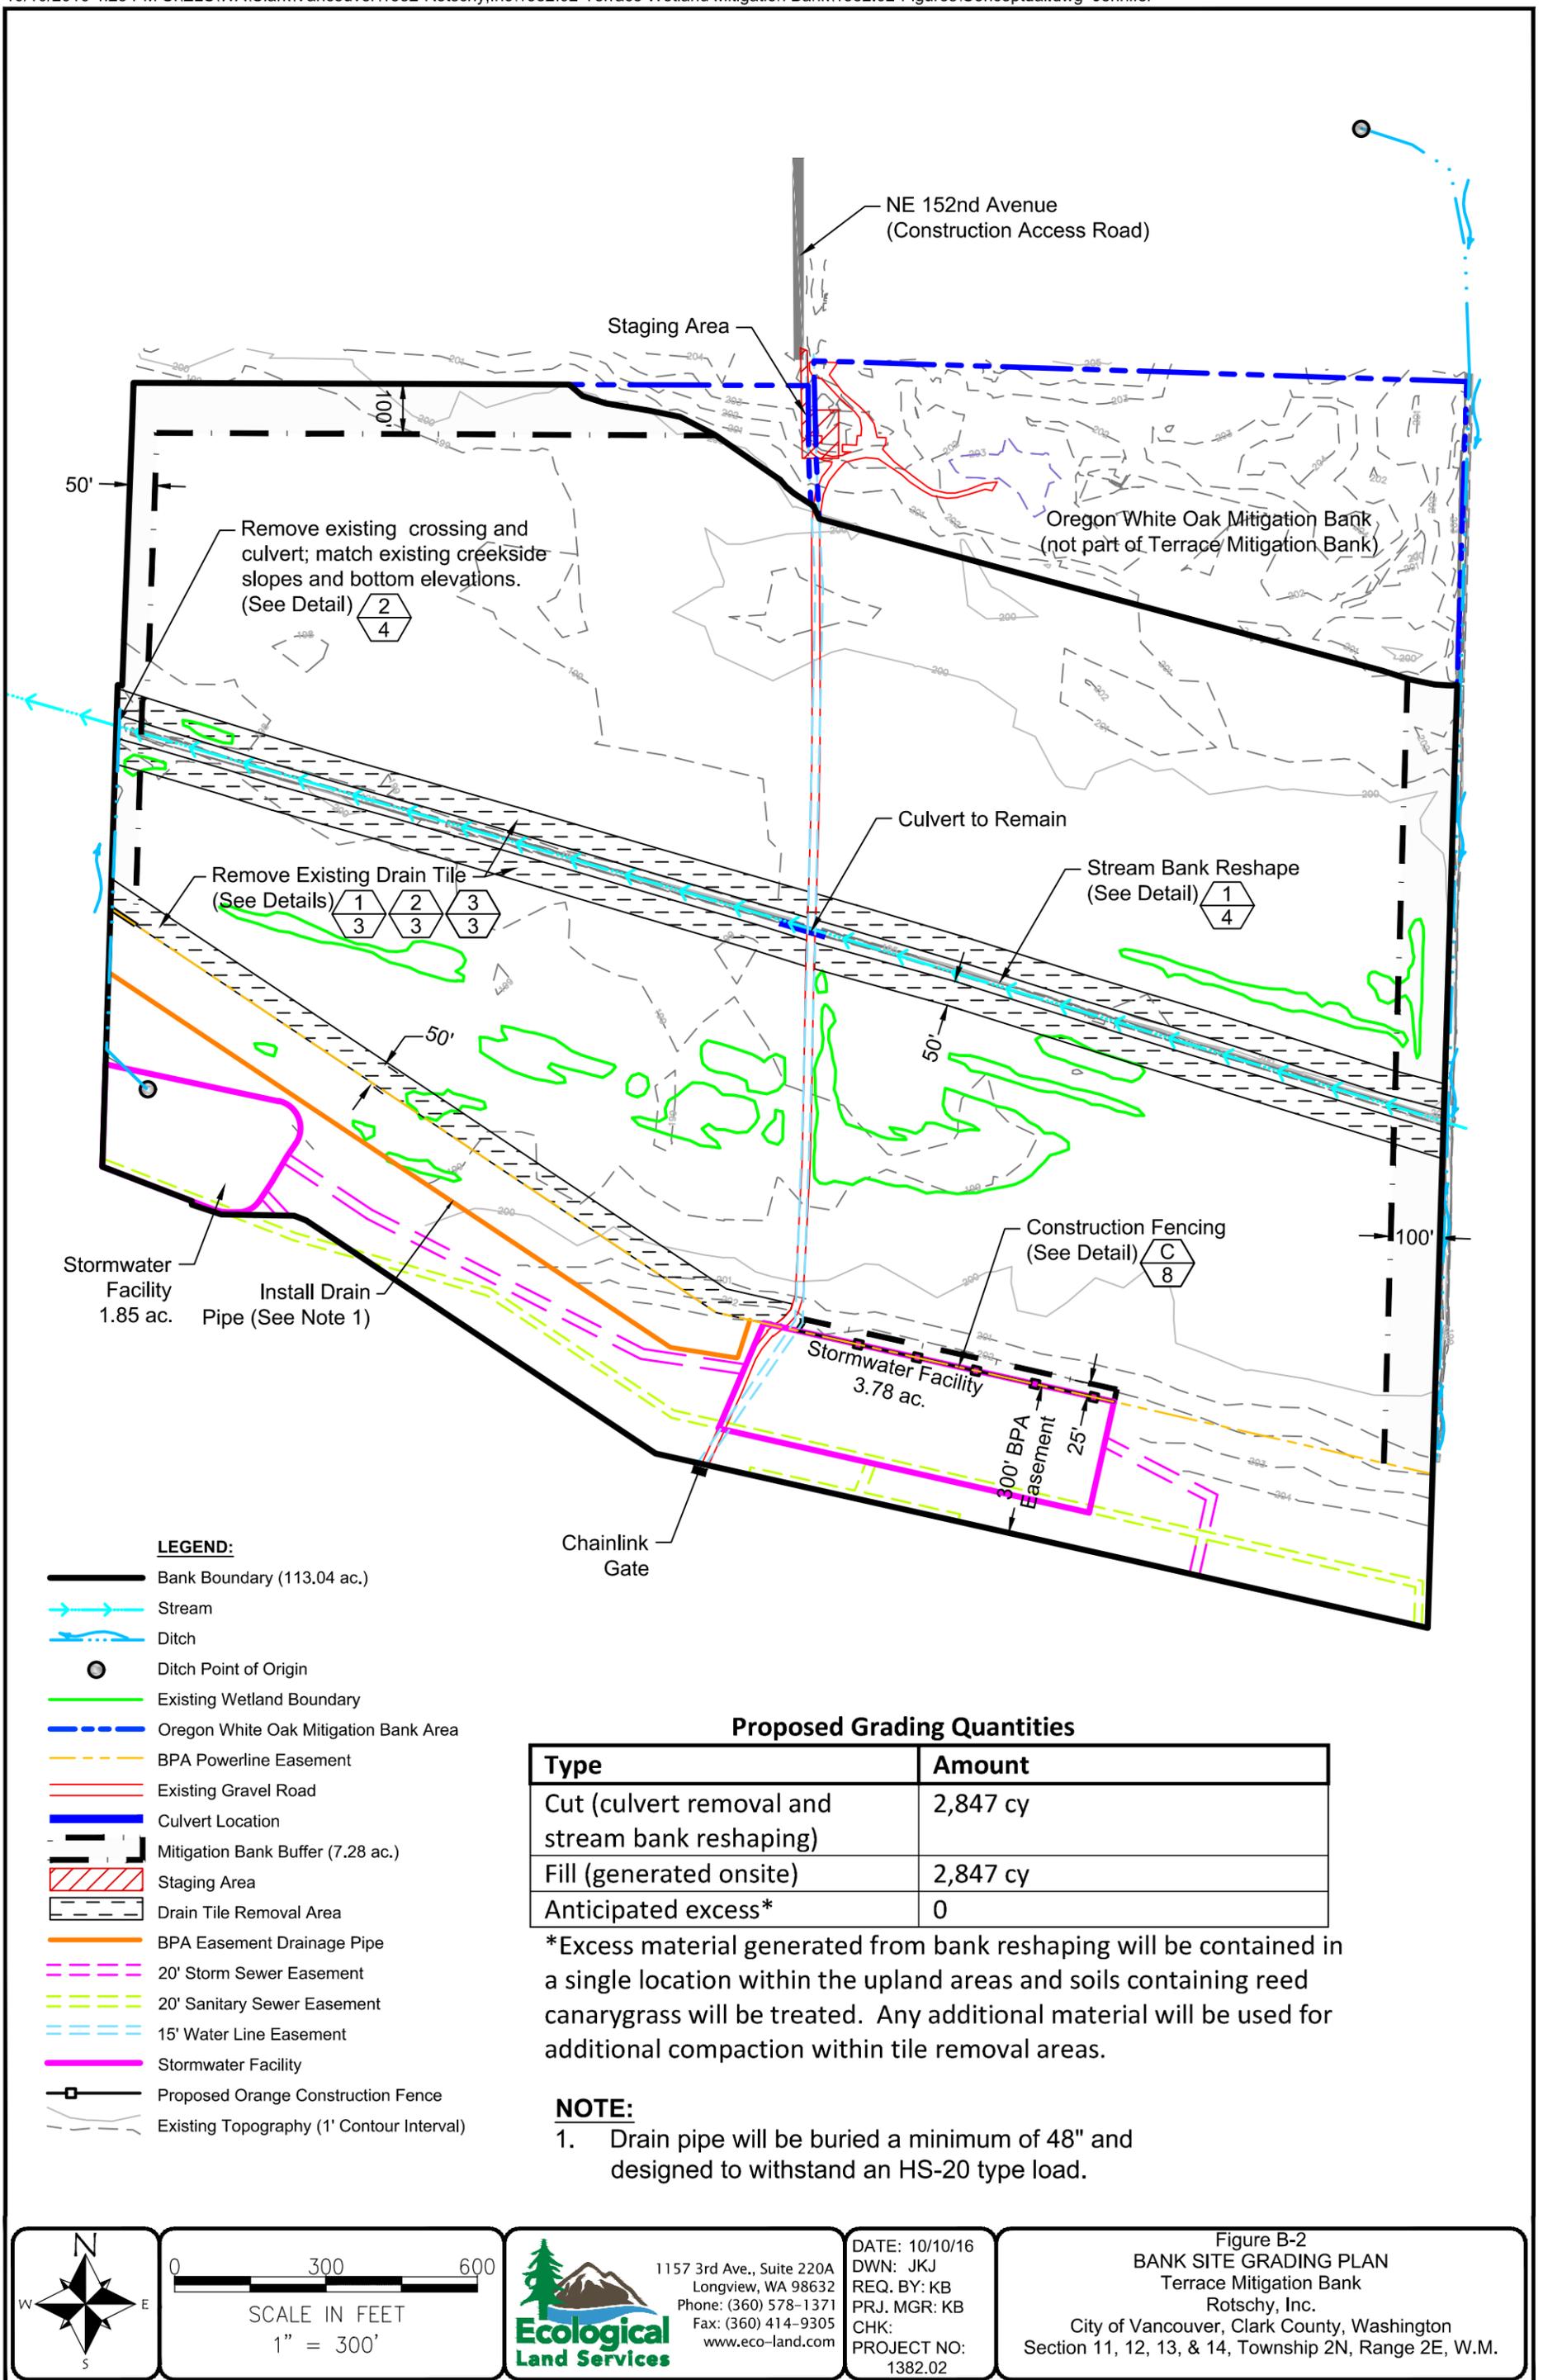
Figure B-2
 BANK SITE GRADING PLAN
 Terrace Mitigation Bank
 Rotschy, Inc.
 City of Vancouver, Clark County, Washington
 Section 11, 12, 13, & 14, Township 2N, Range 2E, W.M.

- Bank Boundary (113.04 ac.)
- Stream
- Ditch
- Ditch Point of Origin
- Existing Wetland Boundary
- Oregon White Oak Mitigation Bank Area
- BPA Powerline Easement
- Existing Gravel Road
- Culvert Location
- Mitigation Bank Buffer (7.28 ac.)
- Staging Area
- Drain Tile Removal Area
- BPA Easement Drainage Pipe
- 20' Storm Sewer Easement
- 20' Sanitary Sewer Easement
- 15' Water Line Easement
- Stormwater Facility
- Proposed Orange Construction Fence
- Existing Topography (1' Contour Interval)

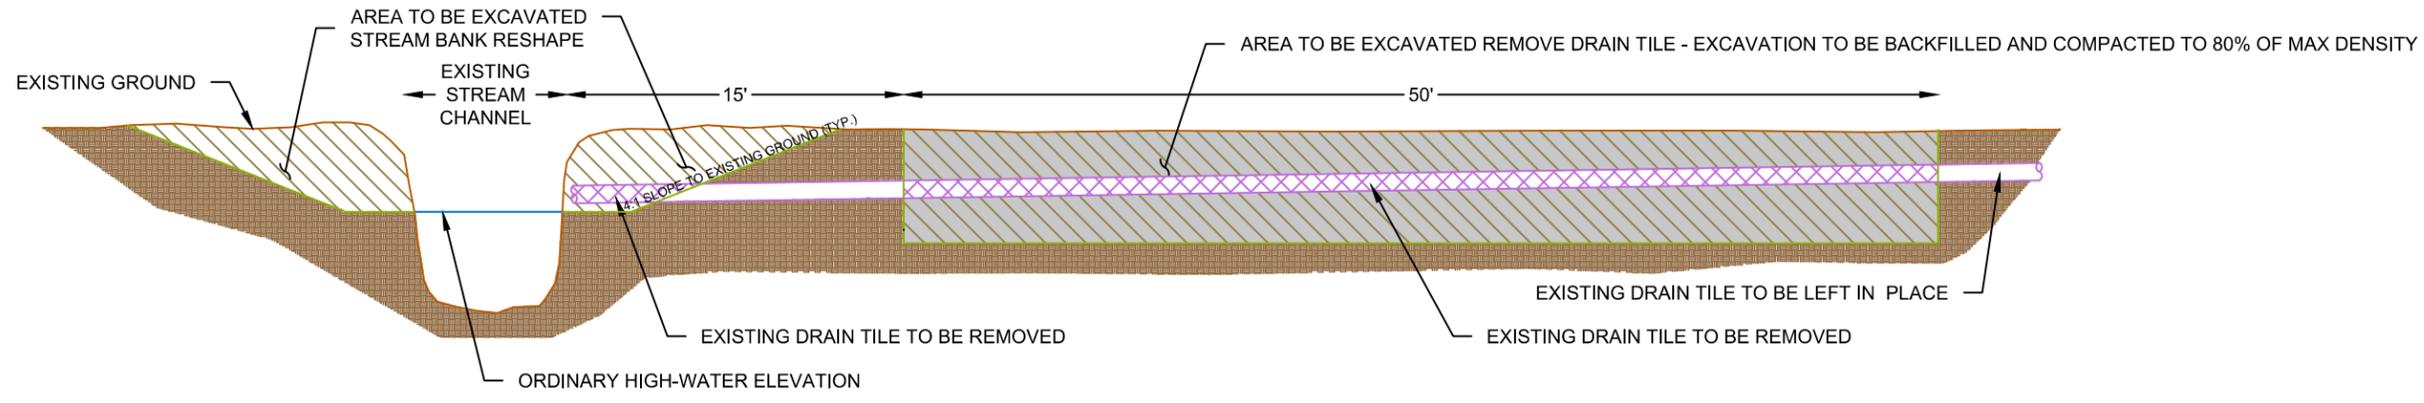
DRAIN TILE REMOVAL
DETAIL AND CROSS SECTION
(DRAIN TILE LOCATED AT SAME ELEVATION AS STREAM BANK EXCAVATION)
TYPICAL 1/3
NTS

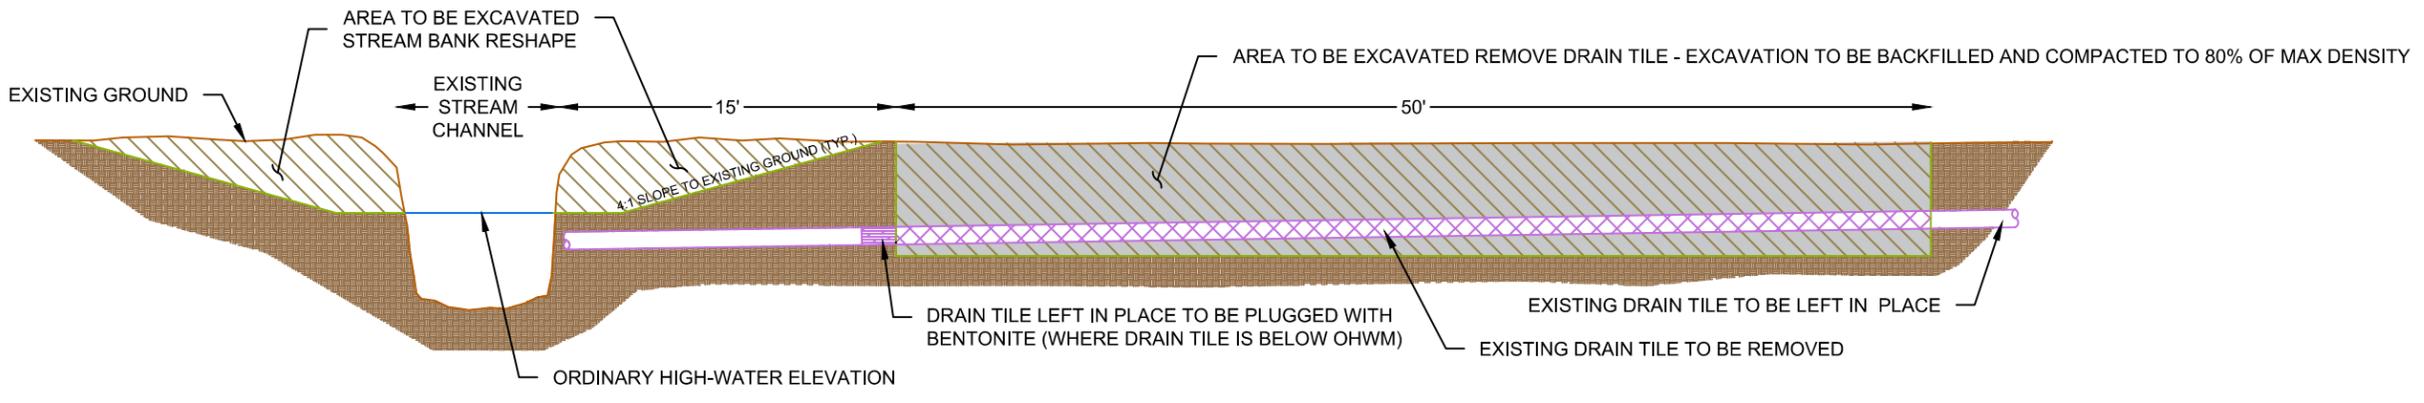
DRAIN TILE REMOVAL
DETAIL AND CROSS SECTION
(DRAIN TILES LOCATED AT ELEVATIONS LOWER THAN STREAM BANK EXCAVATION)
TYPICAL 2/3
NTS
