**Terrace Mitigation Bank
Mitigation Banking Instrument**

Vancouver, Washington

1 **MITIGATION BANKING INSTRUMENT**
2 **Terrace Mitigation Bank**

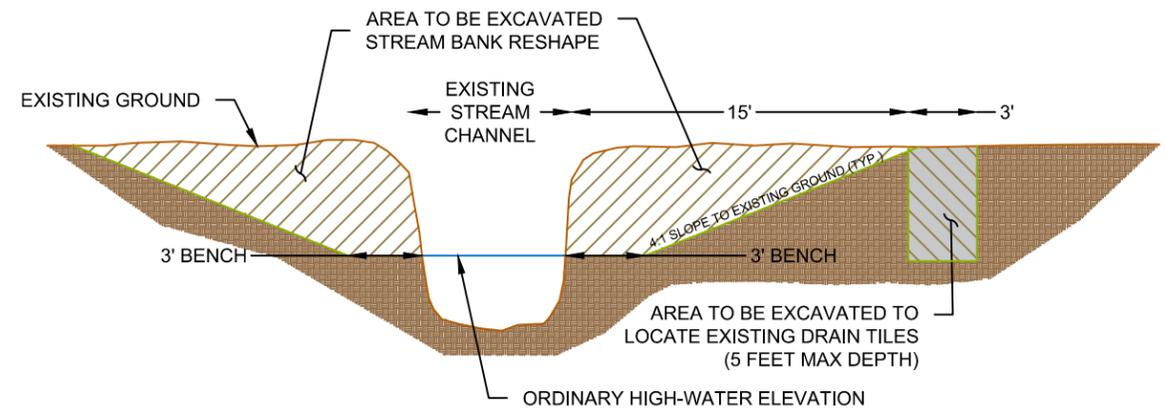
EXCAVATION TO LOCATE DRAIN TILE DETAIL
TYPICAL 3/3
NTS

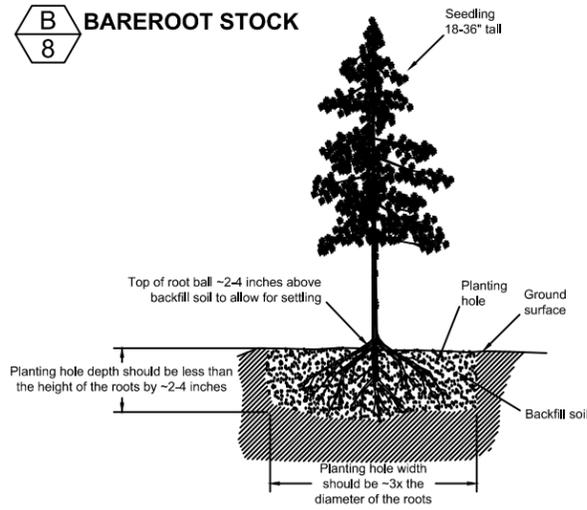
Figure B-8
TYPICALS
Terrace Mitigation Bank
Rotschy, Inc.
City of Vancouver, Clark County, Washington
Section 11, 12, 13, & 14, Township 2N, Range 2E, W.M.

- NOTES:**
1. Use a shovel to slice into the loose soil; gently compact the soil and do not step on the backfill.
 2. Water heavily after transplanting.
 3. Do not add soil amendments or fertilizers in the planting hole.

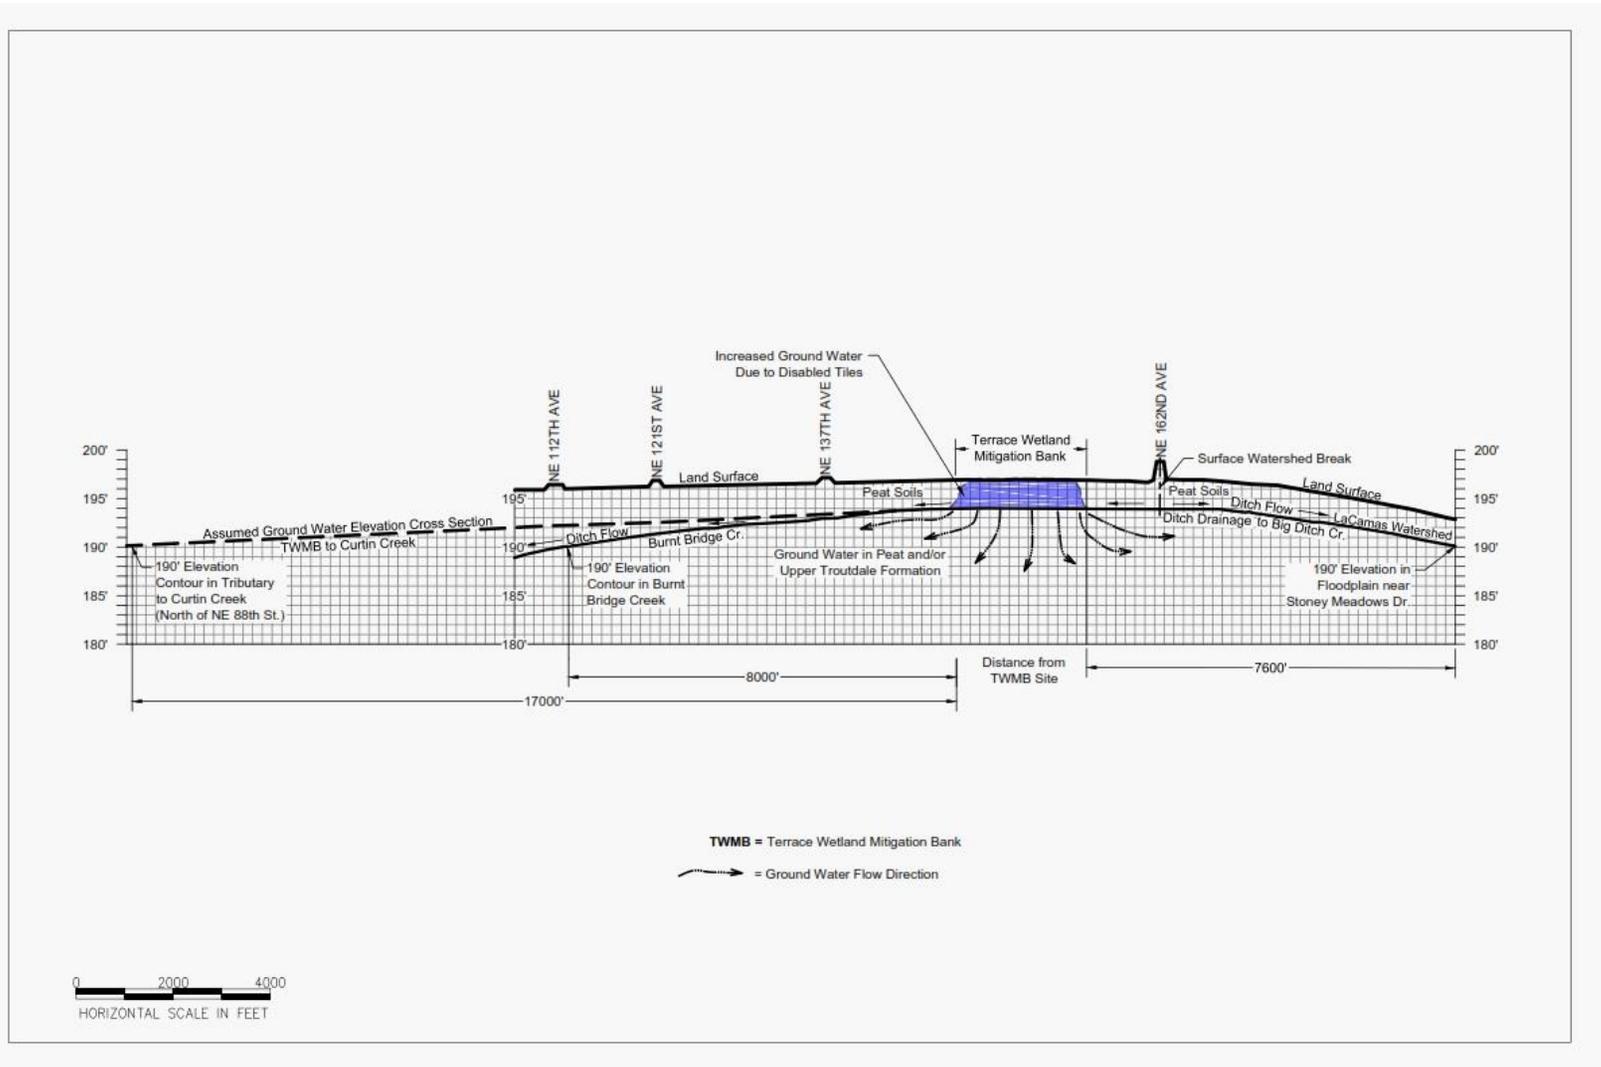
Exhibit E-1. Groundwater cross section.

The other watershed benefiting from increased groundwater elevations at the Bank is the Curtin Creek drainage within Salmon Creek Watershed. A review of groundwater expressing as surface water can be found northwest of the Bank within the Salmon Creek Watershed, from the Curtin Creek tributary, extending 17,000 feet horizontally to a wetland at 190 feet elevation north of NE 88th Street and west of 79th Court. While this location is nearly twice the distance from the Bank to the same elevation westerly on Burnt Bridge Creek, the 190-foot elevation on both Curtin Creek and Burnt Bridge Creek are roughly aligned on a southeast to northwest axis. The Troutdale formation slopes southwesterly such that the Bank site is positioned higher on the Troutdale formation slope than Curtin Creek, suggesting groundwater can trend in a west and northwesterly direction from the Bank toward both Curtin Creek and Burnt Bridge Creek (Exhibit E-1).

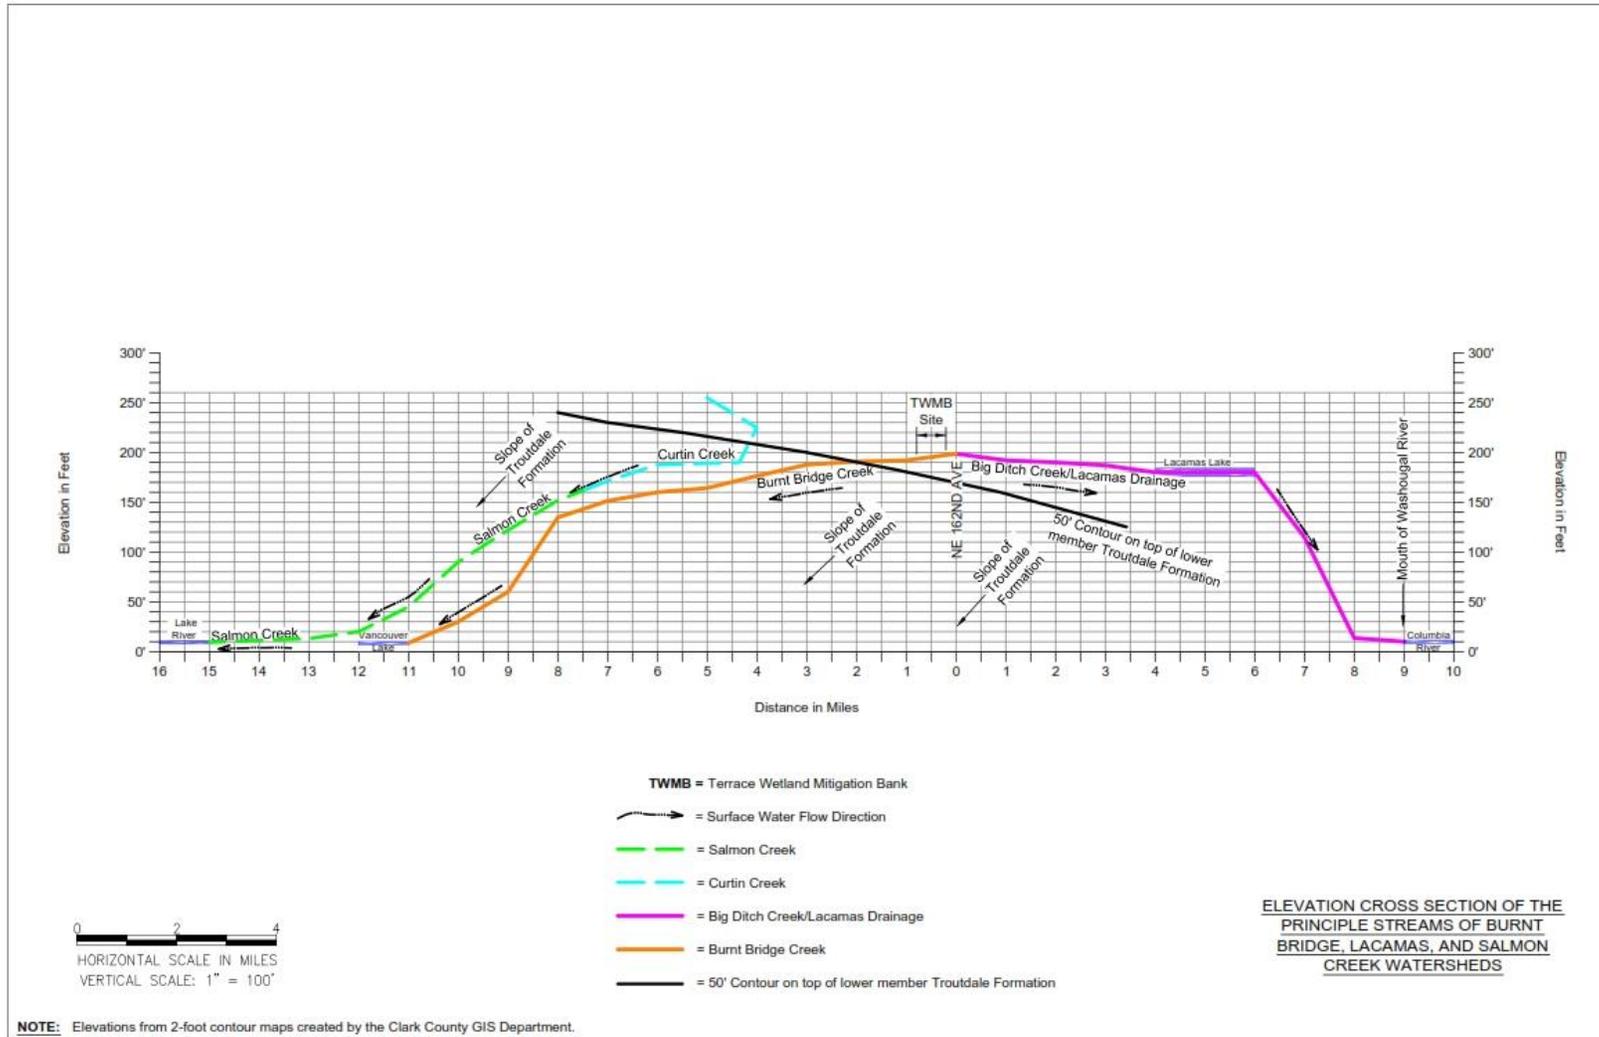
Exhibit E-2. Watershed streams cross section.

Exhibit E-2 displays a cross-sectional comparison of elevations of the primary drainages in the Burnt Bridge Creek, Lacamas, and Salmon Creek Watersheds. As discussed above, the proposed Bank can provide increased water storage, which based on the interconnectivity of wetlands, groundwater, and stream flows provide a hydrological benefit to all watersheds within the service area, by increasing natural storage in groundwater and wetlands.

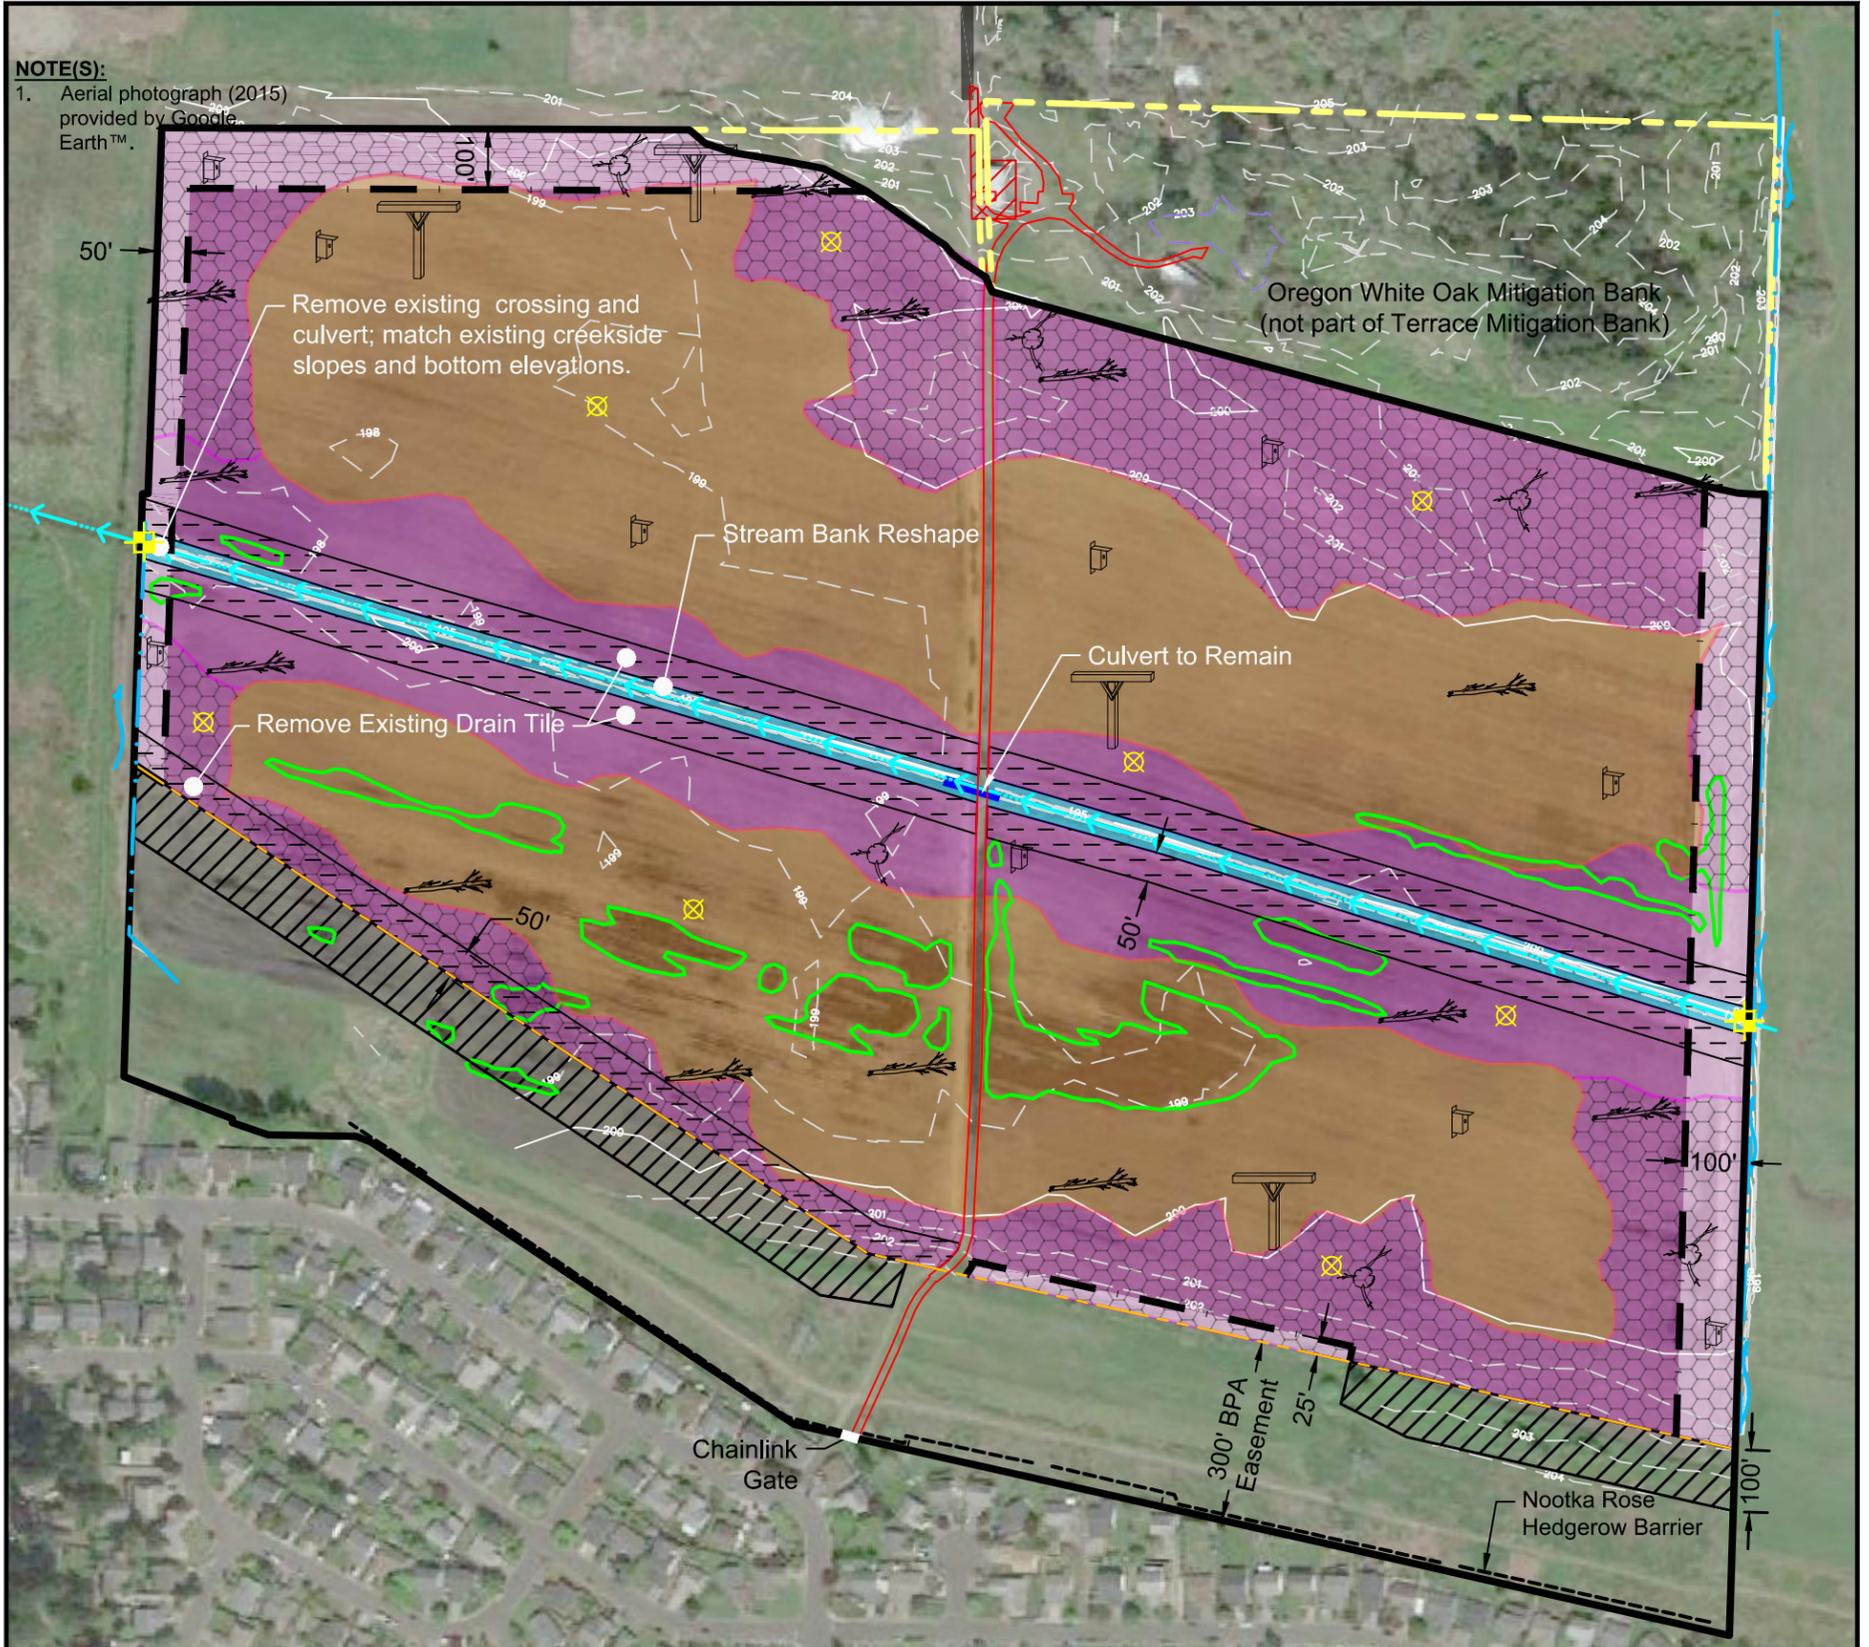
- LEGEND:**
- Bank Boundary (113.04 ac.)
 - Stream
 - Ditch
 - Existing Wetland Boundary
 - Oregon White Oak Mitigation Bank Area
 - BPA Powerline Easement
 - Existing Gravel Road
 - Culvert Location
 - Mitigation Bank Buffer (7.28 ac.)
 - Staging Area
 - Drain Tile Removal Area

- Proposed Habitat Features**
- Standard Bird Nest Box (10)
 - Snags (6)
 - Perch Poles (4)
 - Horizontal Logs (14)

- Vegetation Monitoring**
- Proposed Location of Hydrology Dataloggers
 - Proposed Location of Stream Temperature Dataloggers

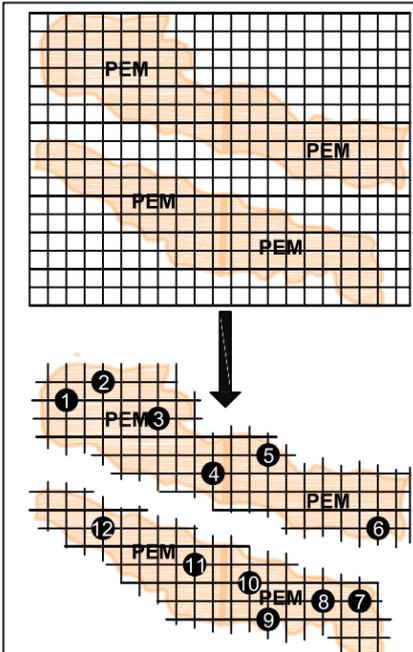
Stratified Random Sampling Approach

1. Vegetation stratum defined (PEM, PFO/PSS, SS, hedgerow)
2. Grid pattern lines for each stratum established through AutoCAD.
3. All grid pattern line intersections assigned numbers within a vegetation stratum, those falling outside stratum discarded.
4. An adequate number of monitoring points chosen by random number generator for each stratum.
5. Coordinates for each monitoring plot determined using AutoCAD Civil 3D.
6. Coordinates uploaded to GPS and located in the field.
