MITIGATION BANKING INSTRUMENT

Chehalis Basin Mitigation Bank, Hanaford Valley Site

C. Project Description: Whereas, the Sponsor has expressed intent to restore, rehabilitate, create, and/or enhance approximately 176.97 acres divided into a north unit, northeast unit, south unit, and west unit of aquatic and associated upland habitat in accordance with the provisions of this Instrument, and shall then maintain the Bank in accordance with the provisions of this Instrument. Table 1 summarizes project actions, acreage, and credit generation. The Bank will utilize ratios consistent with WAC 173-700 to determine credit generation. The Bank is projected to, among other purposes, to provide habitats as shown in the table that follows and as detailed in Appendix A and Appendix B. Mitigation actions and associated acreages are described in Appendix D and shown on figure D-1.

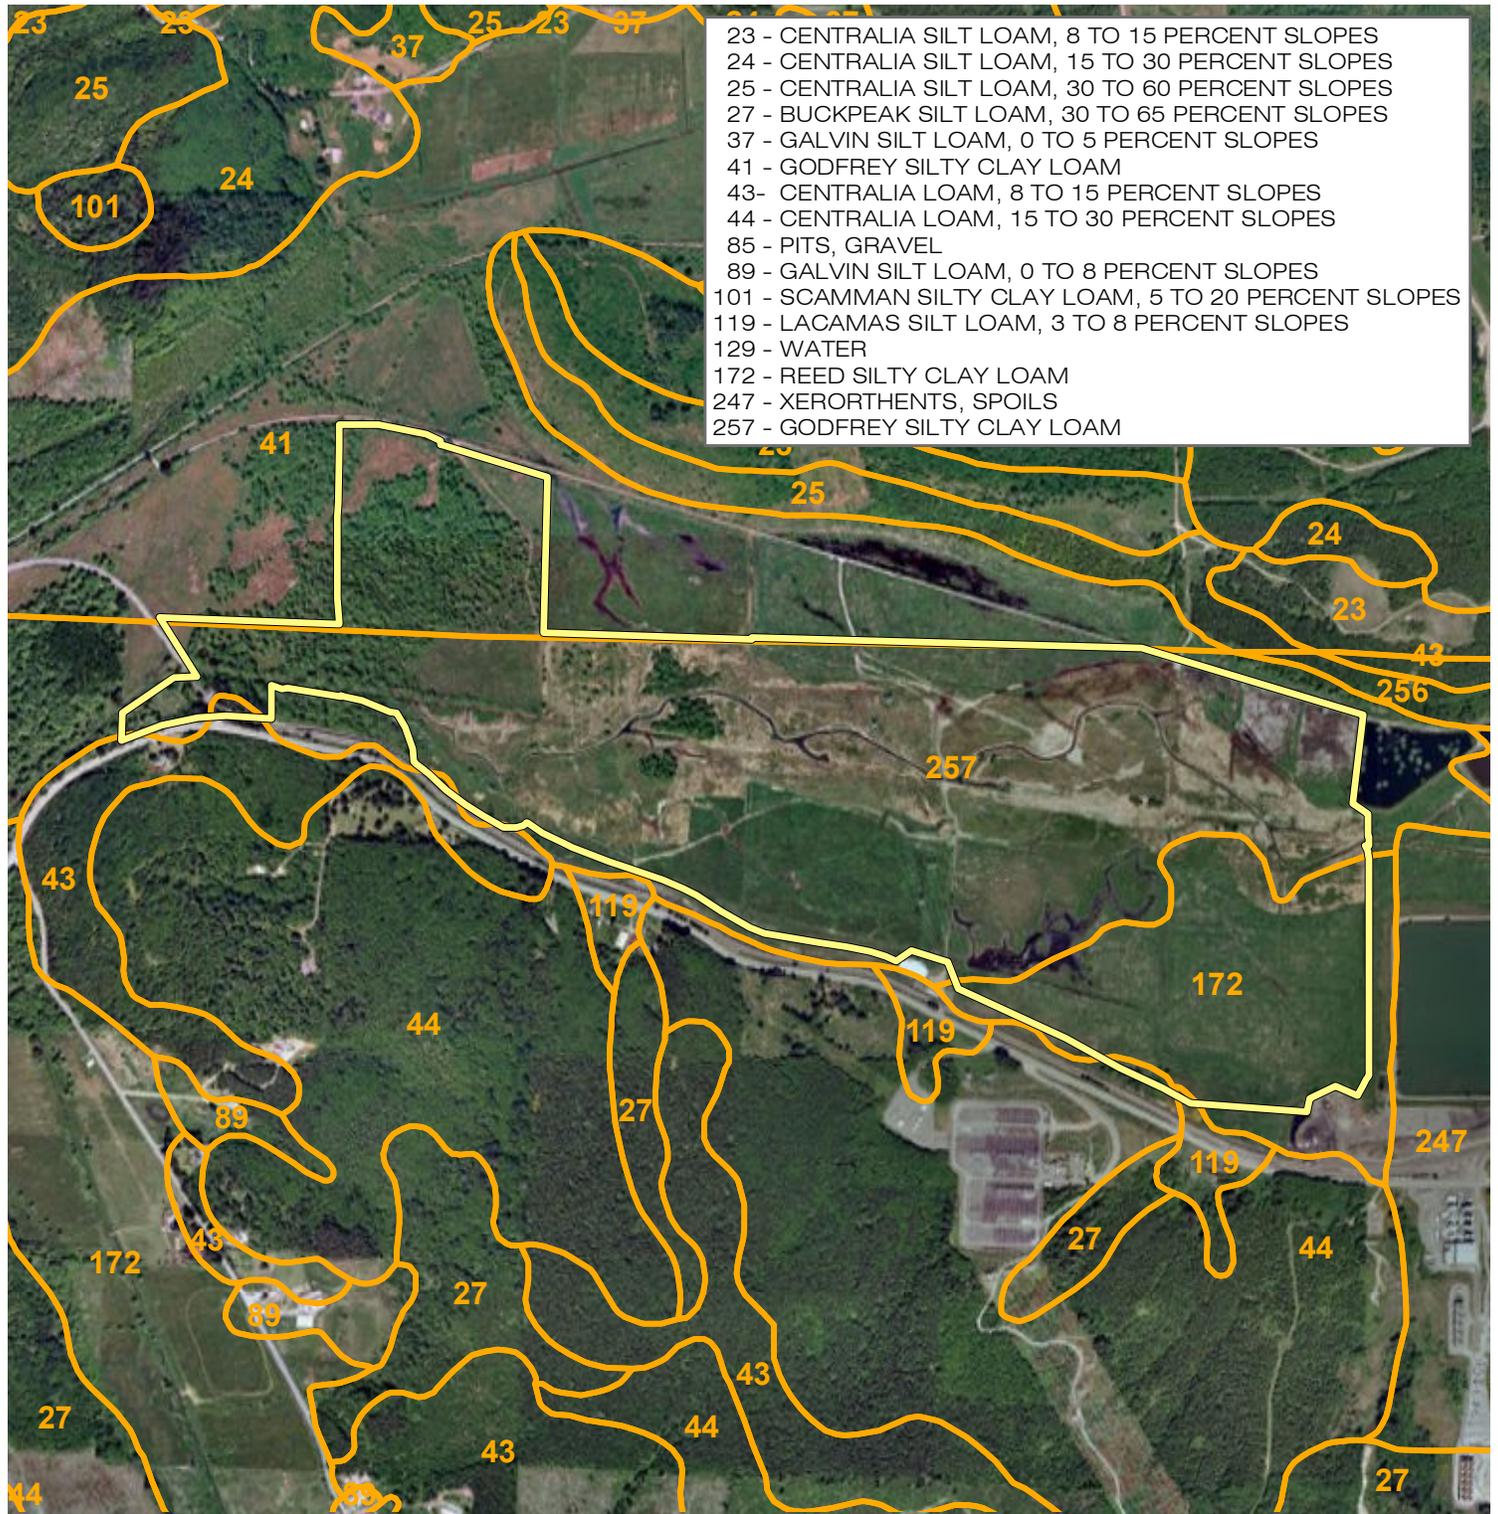
- 23 - CENTRALIA SILT LOAM, 8 TO 15 PERCENT SLOPES
- 24 - CENTRALIA SILT LOAM, 15 TO 30 PERCENT SLOPES
- 25 - CENTRALIA SILT LOAM, 30 TO 60 PERCENT SLOPES
- 27 - BUCKPEAK SILT LOAM, 30 TO 65 PERCENT SLOPES
- 37 - GALVIN SILT LOAM, 0 TO 5 PERCENT SLOPES
- 41 - GODFREY SILTY CLAY LOAM
- 43- CENTRALIA LOAM, 8 TO 15 PERCENT SLOPES
- 44 - CENTRALIA LOAM, 15 TO 30 PERCENT SLOPES
- 85 - PITS, GRAVEL
- 89 - GALVIN SILT LOAM, 0 TO 8 PERCENT SLOPES
- 101 - SCAMMAN SILTY CLAY LOAM, 5 TO 20 PERCENT SLOPES
- 119 - LACAMAS SILT LOAM, 3 TO 8 PERCENT SLOPES
- 129 - WATER
- 172 - REED SILTY CLAY LOAM
- 247 - XERORTHENTS, SPOILS
- 257 - GODFREY SILTY CLAY LOAM

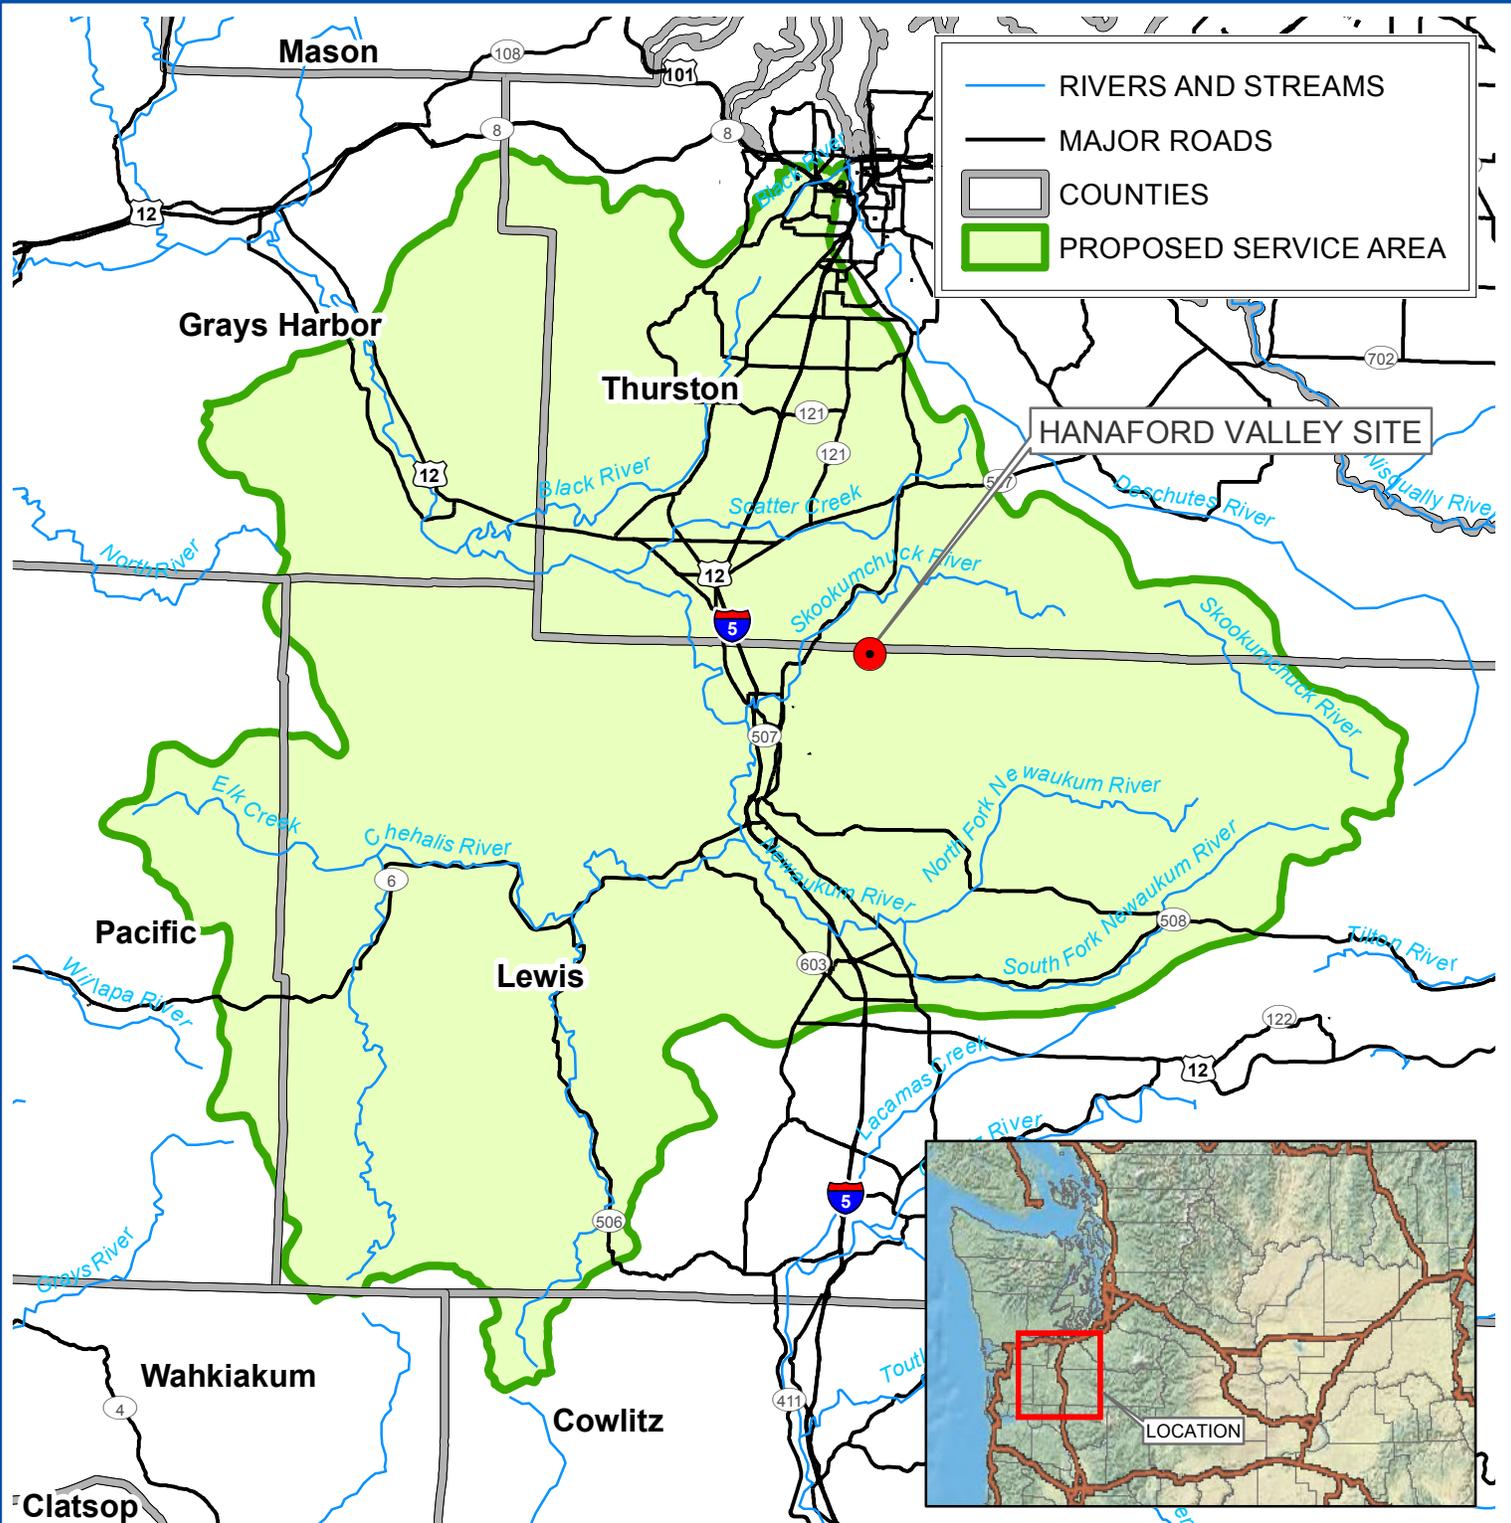
Figure E-1 Chehalis Basin Mitigation Bank Service Area Map

- RIVERS AND STREAMS
- MAJOR ROADS
- COUNTIES
- PROPOSED SERVICE AREA
