**Washington State
Department of Transportation**

MOSES LAKE WETLAND MITIGATION BANK INSTRUMENT

February 21, 2003

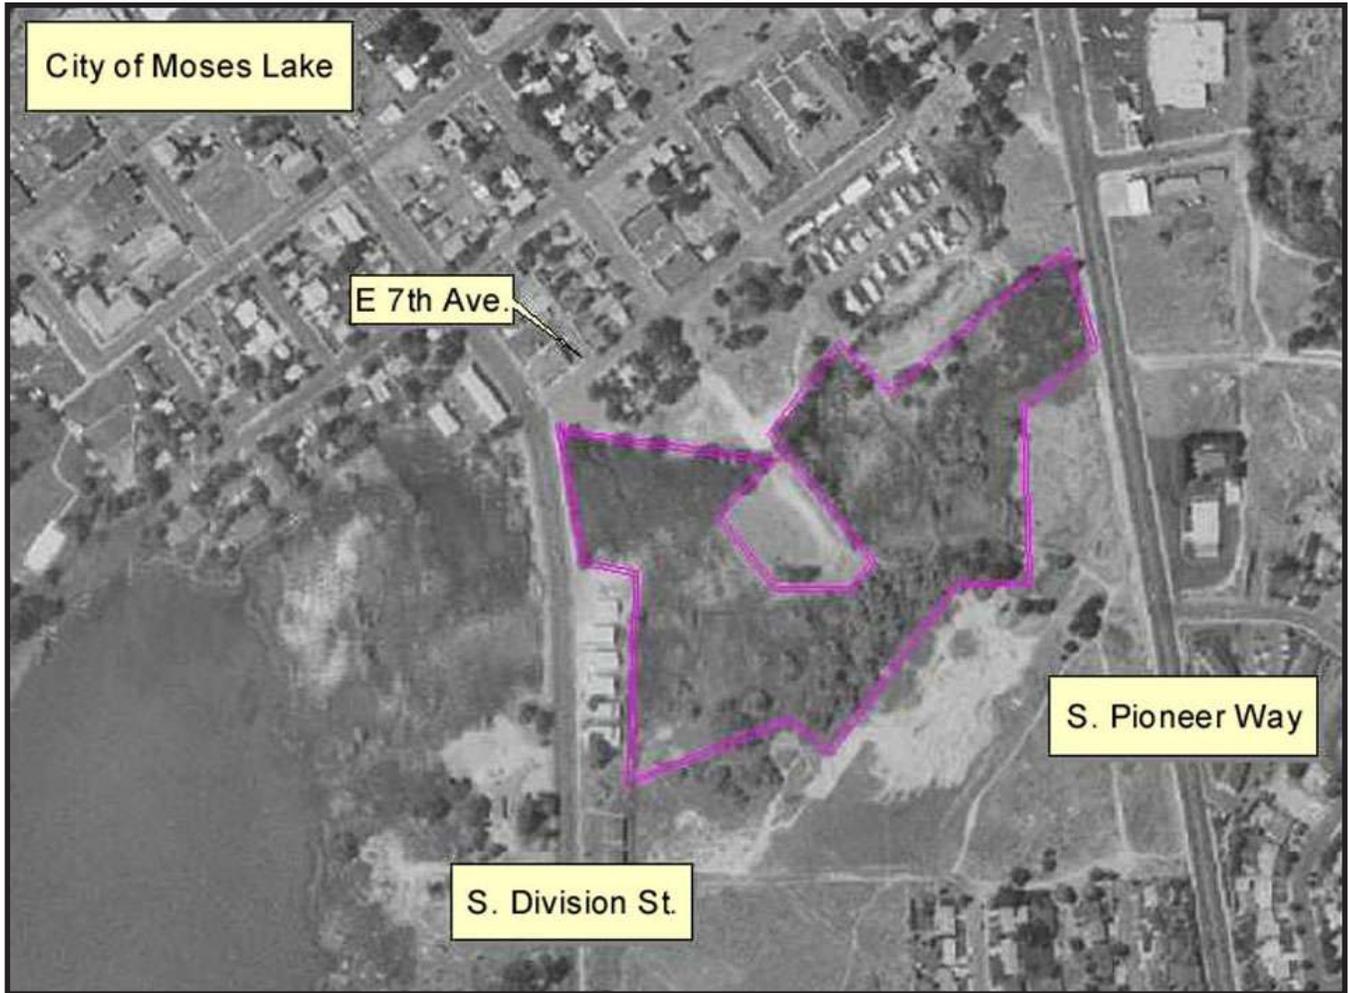
Moses Lake Wetland Mitigation Bank Site

— Bank Site Property Boundary

The Moses Lake Bank Site is located within the corporate limits of the City of Moses Lake. The site is adjacent to the Pelican Horn arm of Moses Lake in Grant County, Washington. The project is located primarily in the SE $\frac{1}{4}$, NW $\frac{1}{4}$, of Section 23, T 19 N, R28E, with small areas extending into portions of the S $\frac{1}{2}$, NE $\frac{1}{4}$ and the E $\frac{1}{2}$, SW $\frac{1}{4}$, and NW $\frac{1}{4}$ of Section 23 (Figure 1 on page 1-2).
