**Final Prospectus**  
for the  
**Long Beach**  
**Wetland Mitigation Bank**  
in  
**Pacific County, Washington**

Ecological Land Services, Inc.  
1157 3<sup>rd</sup> Avenue, Suite 220  
Longview, Washington 98632  
360-578-1371  
ELS Project Number 1645.01

February 19, 2009

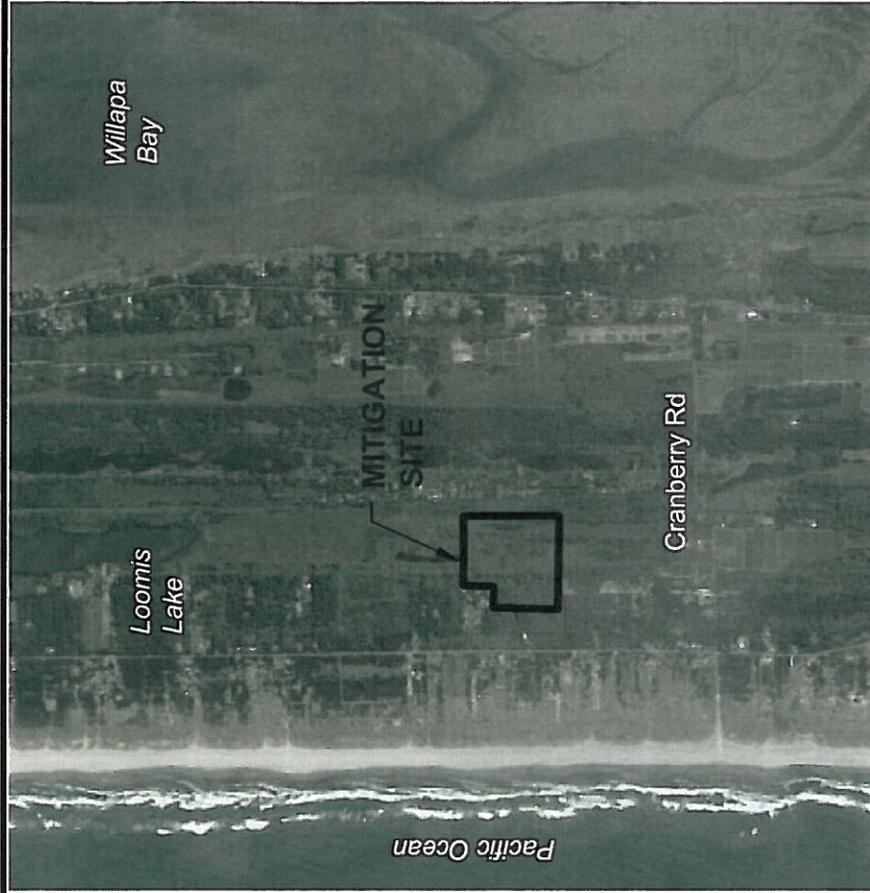
Figure 5  
 1943 AND 2006 AERIAL PHOTOGRAPHS  
 Proposal for Long Beach Wetland Mitigation Bank  
 LBMB, LLC  
 Pacific County, Washington  
 Section 28, Township 11N, Range 11W, W.M.

1943 Aerial

2006 Aerial

The proposed 72.95-acre mitigation-bank is located on two parcels and meets all the criteria listed above. It is part of a mature interdunal wetland and will be used to mitigate impacts to interdunal wetlands on the Long Beach peninsula. This site has the potential for timber harvest of mature onsite trees and has the potential for conversion to residential development or cranberry farming (it is zoned Agricultural). If the property was re-zoned for a residential use with a 5-acre minimum, up to 16 homes could be constructed along the western boundary of the site where there is a mosaic of uplands and wetlands and an existing gravel access road that abuts the western side of the parcel. Residential areas could impact the wetland by increasing impervious surfaces, pesticide use, septic-tank effluent, increased noise and light, and increased presence of humans, pets, and livestock. Figure 5 shows aerial photographs from 1943 and 2007 that show residential growth in the area.

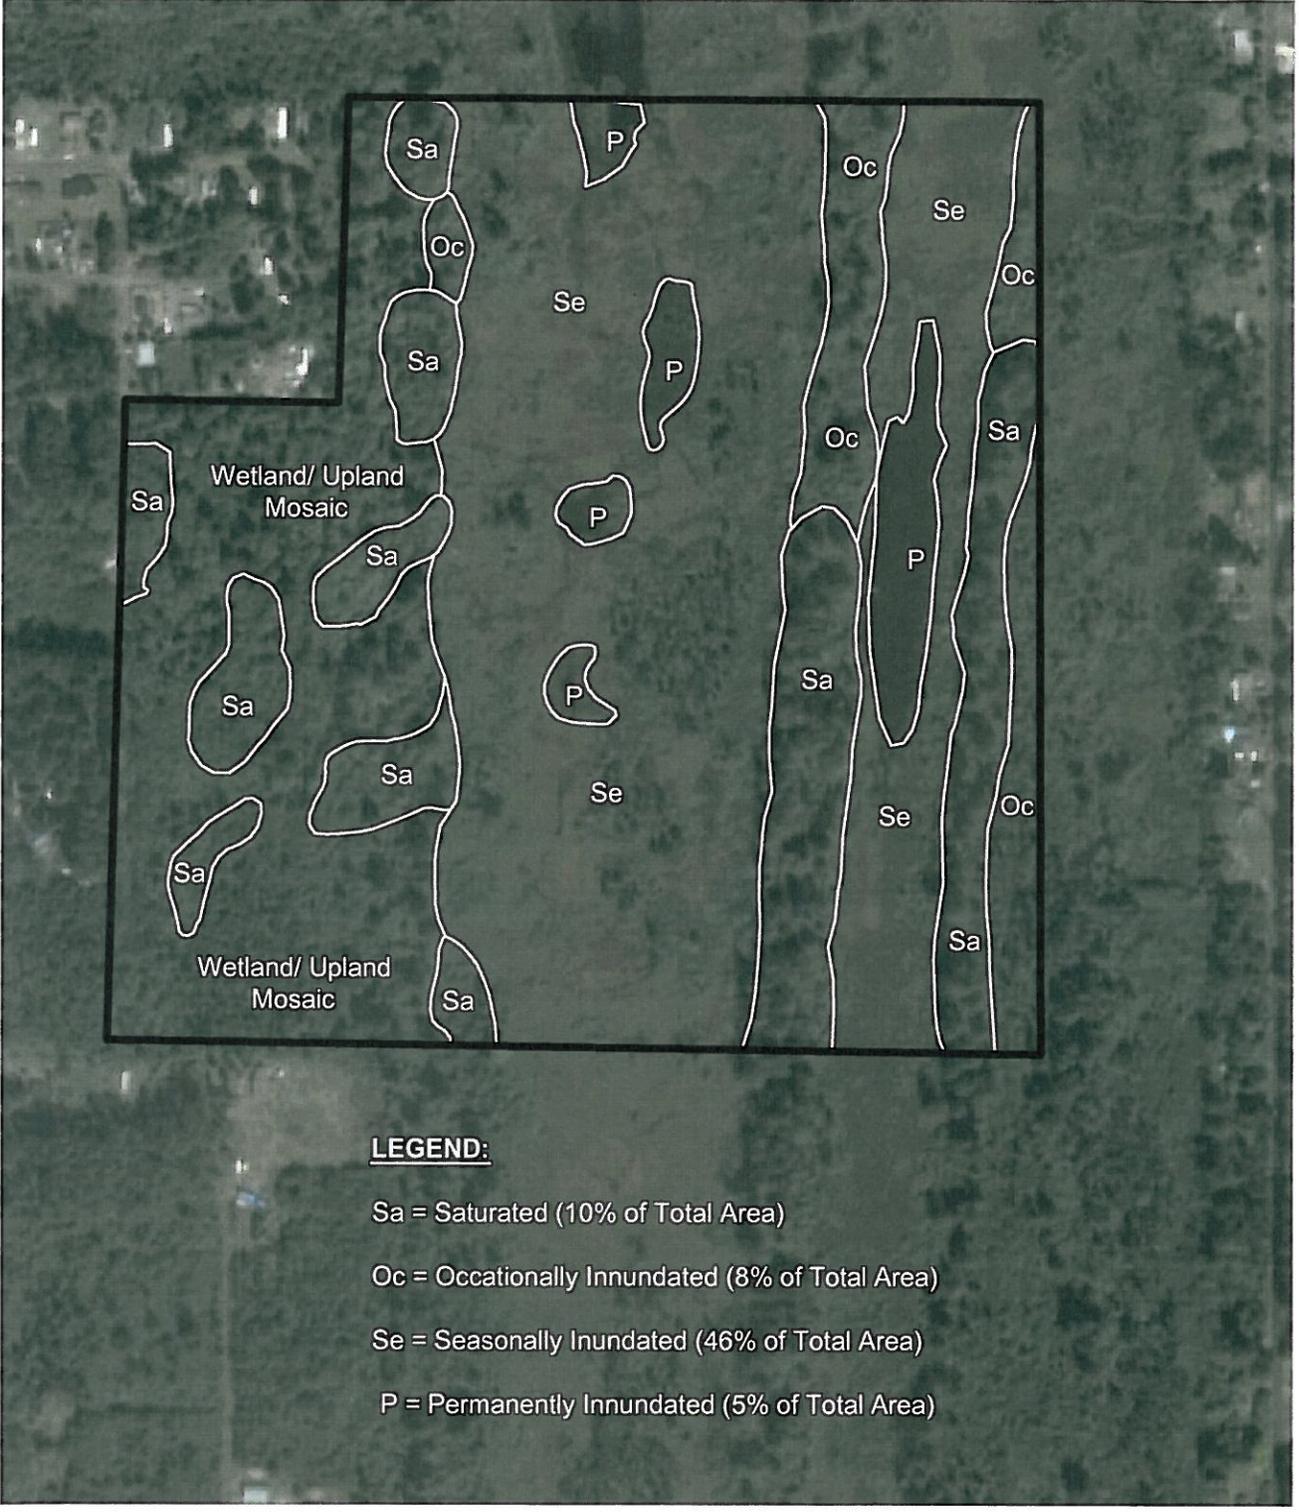
Figure 7  
**ESTIMATED HYDROPERIODS**  
 Proposal for Long Beach Wetland Mitigation Bank  
 LBMB, LLC  
 Pacific County, Washington  
 Section 28, Township 11N, Range 11W, W.M.

- Sa = Saturated (10% of Total Area)
- Oc = Occasionally Inundated (8% of Total Area)
- Se = Seasonally Inundated (46% of Total Area)
- P = Permanently Inundated (5% of Total Area)

The primary hydrologic source for the large wetland swale is a shallow groundwater table. The 2007 aerial photograph in Figure 7 shows the wide range of hydroperiods provided by this area of the wetland. The wetland system has permanent, seasonal, and occasional inundation and some areas that are only saturated. Based on recent aerial photographs, the NWI map, USGS topography maps, and local knowledge, we estimate the following percentages of hydroperiods within the proposed mitigation bank: 5 percent permanent inundation, 46 percent seasonal inundation, 8 percent occasional inundation, 10 percent saturated, and 31 percent upland.

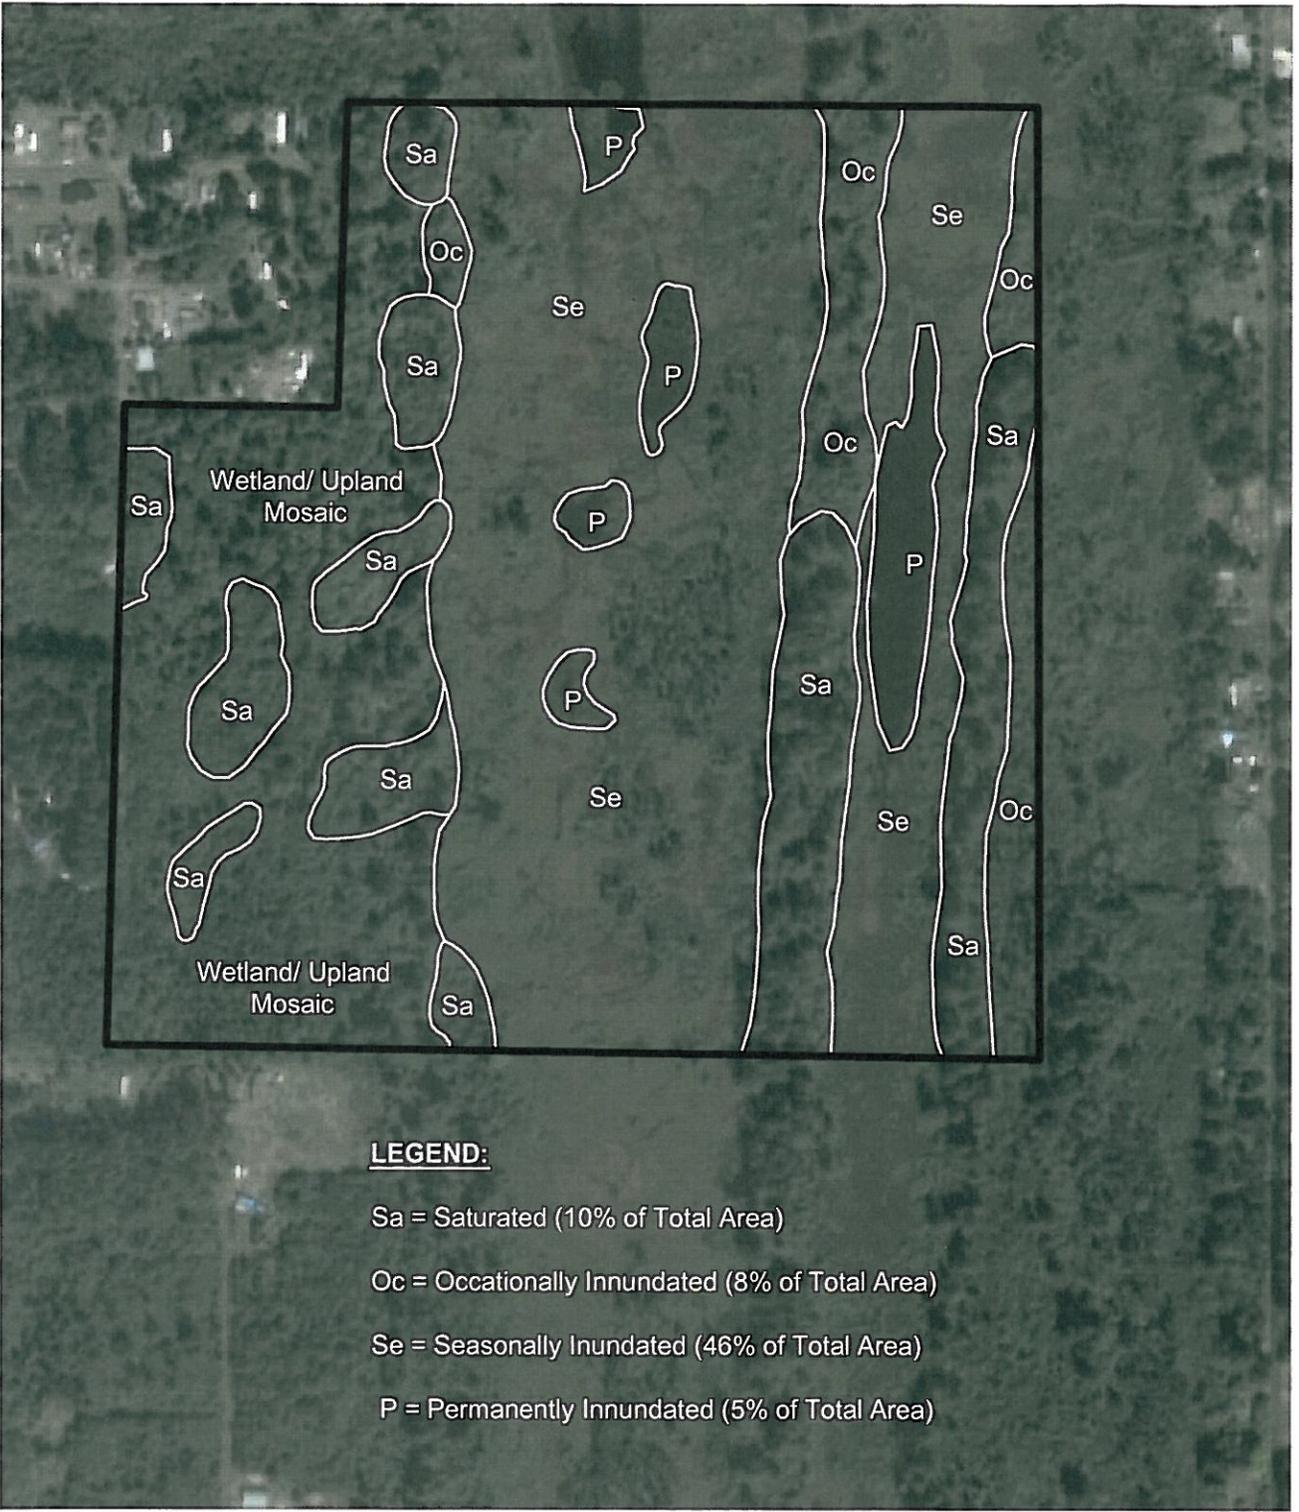
**Figure 7**  
**ESTIMATED HYDROPERIODS**  
Proposal for Long Beach Wetland Mitigation Bank  
LBMB, LLC  
Pacific County, Washington  
Section 28, Township 11N, Range 11W, W.M.

- Sa = Saturated (10% of Total Area)
- Oc = Occasionally Inundated (8% of Total Area)
- Se = Seasonally Inundated (46% of Total Area)
- P = Permanently Inundated (5% of Total Area)

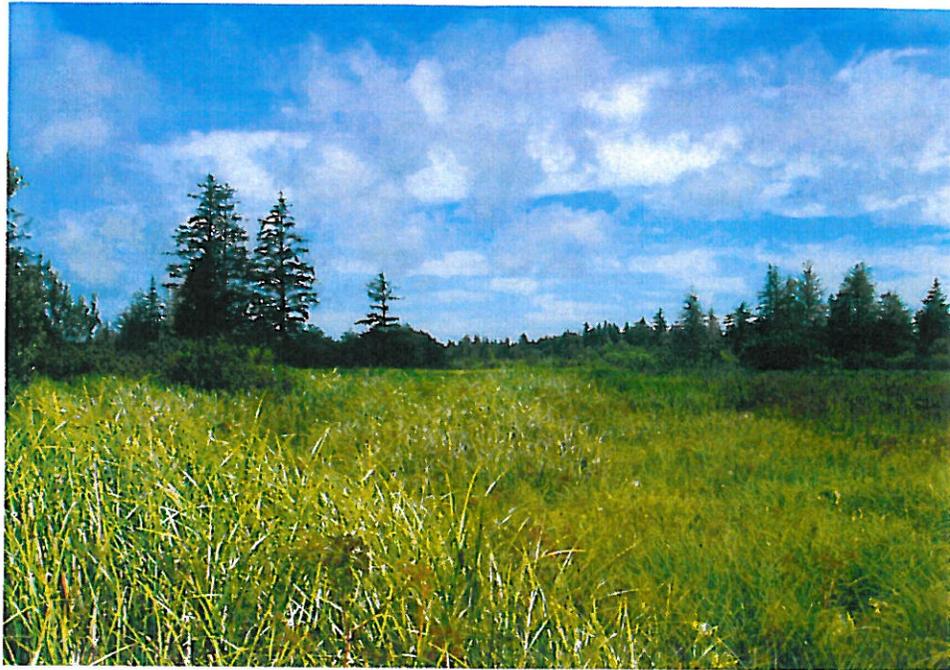
Photo 1.  
Looking north at proposed Long Beach Mitigation Bank wetland.

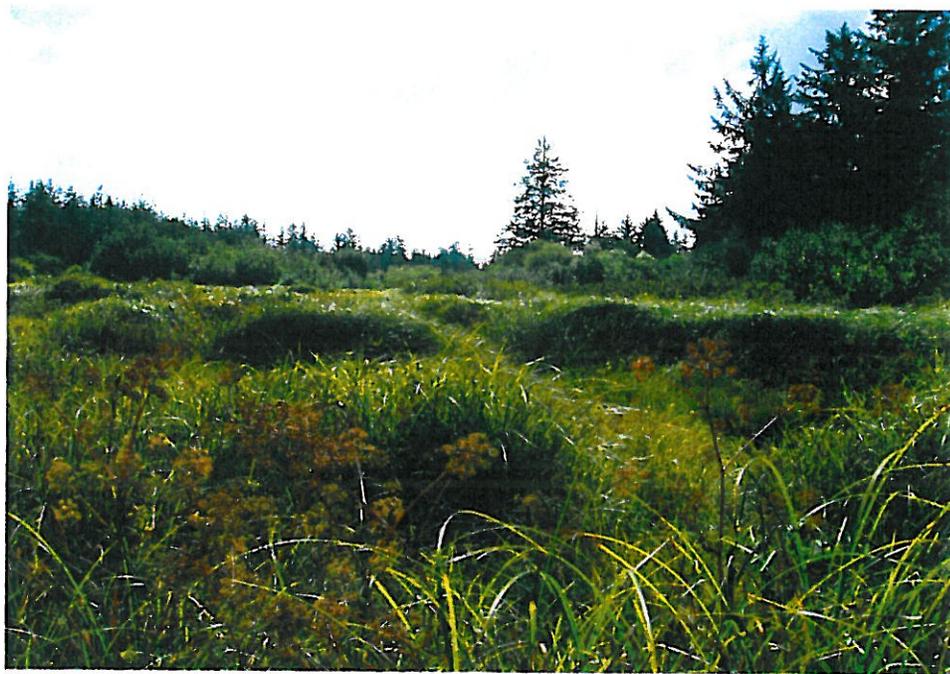
Photo 2.  
Emergent, scrub-shrub, and forested areas of the wetland.  
View is to the southeast.

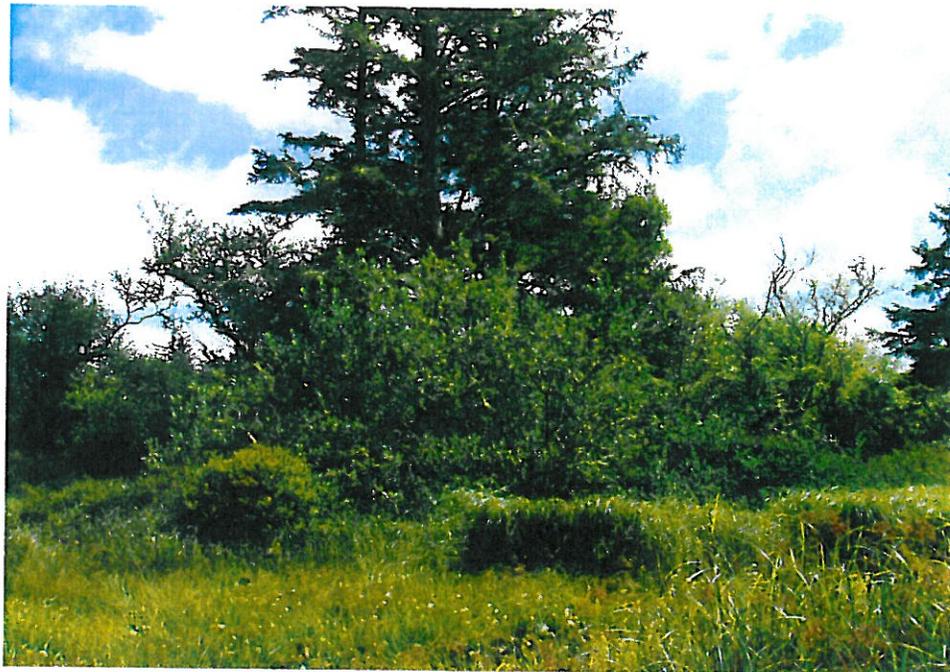
Photo 3.  
Upland habitat island.

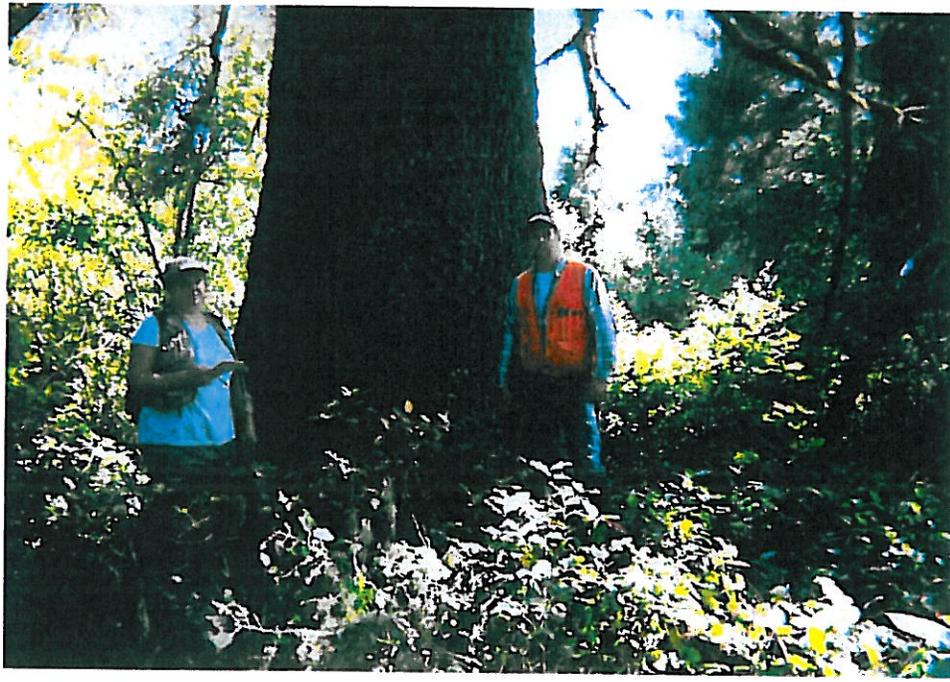
Photo 4.  
Example of mature spruce trees present in the wetland/upland mosaic in the western portion of the proposed mitigation bank.

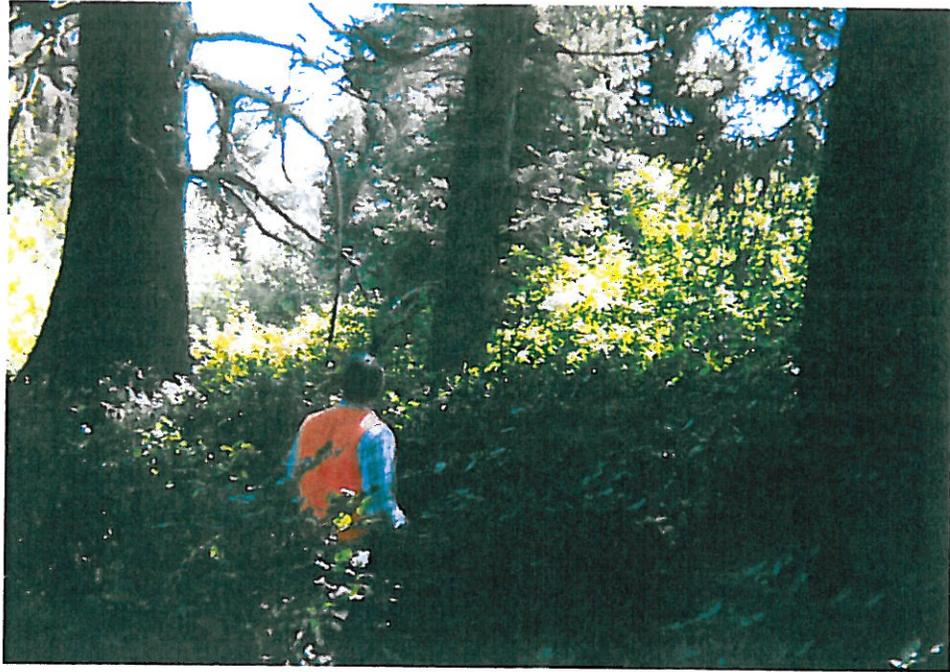
Photo 5.  
Typical habitat in wetland/upland mosaic.

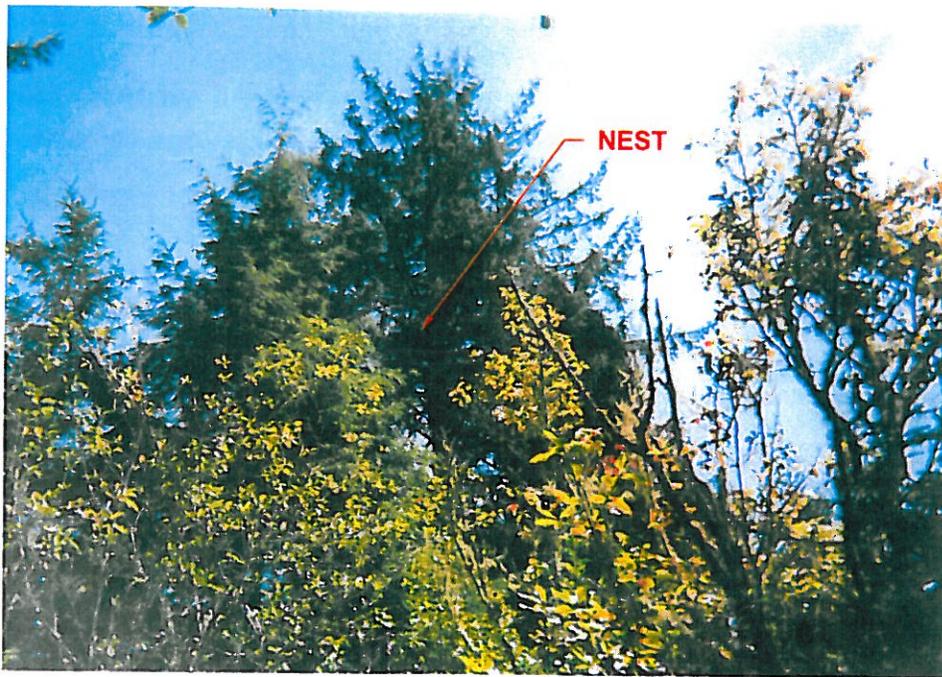
Photo 6.  
Location of large bird-of-prey nest in western portion of the site.

On August 15, 2007, ELS observed signs of the following species: black bear (scat and evidence of digging); beaver (dam in wetland); moles (soil mounds); chipmunk (cone-seeds eaten); banana slug (observed specimen); swallowtail butterfly (observed specimen); osprey (heard calls); Steller's jay (heard calls); grouse (observed specimen); golden or bald eagle (observed very large bird in flight without the markings of mature or juvenile bald eagles - bones and feathers were found at the base of a tree with a large nest).

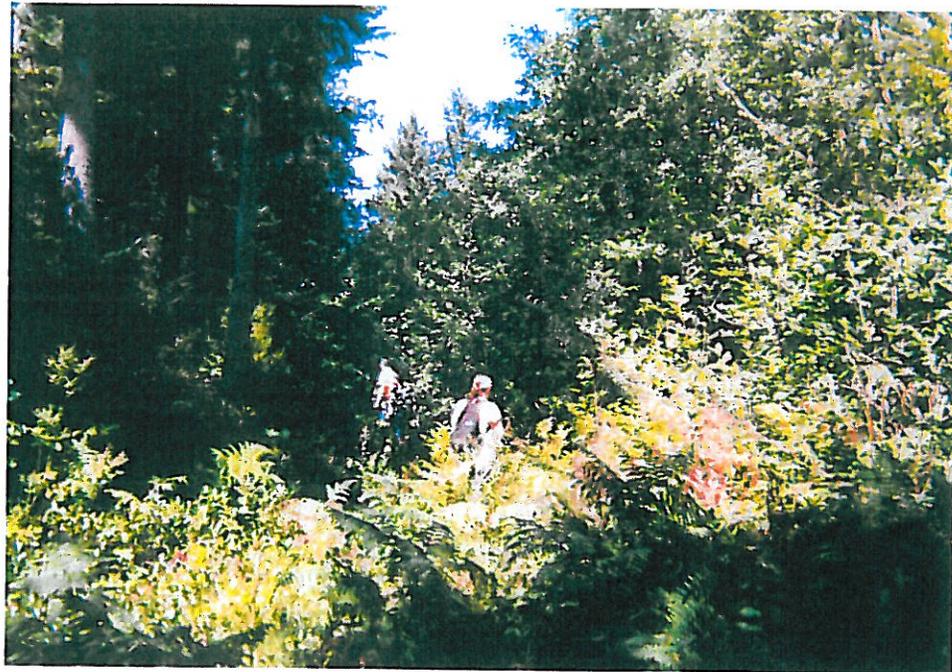
Photo 7.  
Open areas totaling over 7.2 acres can be enhanced with native trees and shrubs.

The onsite wetland is in a relatively natural state and does not need extensive restoration. There is opportunity for 7.2 acres of enhancement in the wetland/upland mosaic area (see Figure 3). The site has been logged in the last 15 years, but there are still large, mature trees onsite too large for most mills to process (see Photoplates); however, there are also many smaller trees within the mosaic area that are ready for harvesting. Timber values in this area increase 3 to 4 percent each year.

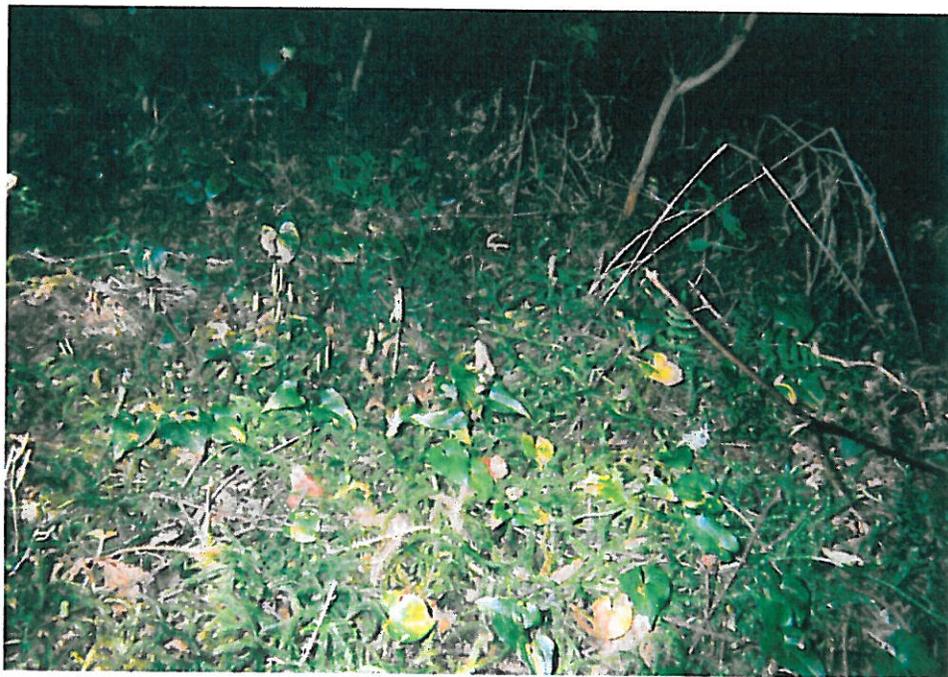
Photo 8.  
Forested carpet in upland areas includes false lily-of-the-valley (*Maianthemum dilatatum*) and clubmoss (*Lycopodium clavatum*).

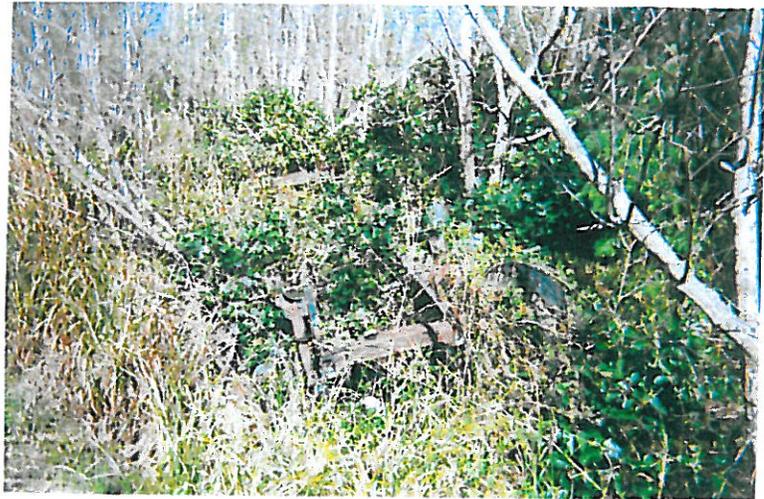
Photo 9.  
Example of garbage along the western portion of the property that will be removed.

extends from the residential area south along the western boundary. There has been illegal garbage dumping along the gravel road that includes appliances, televisions, camper tops, and vehicle bodies.

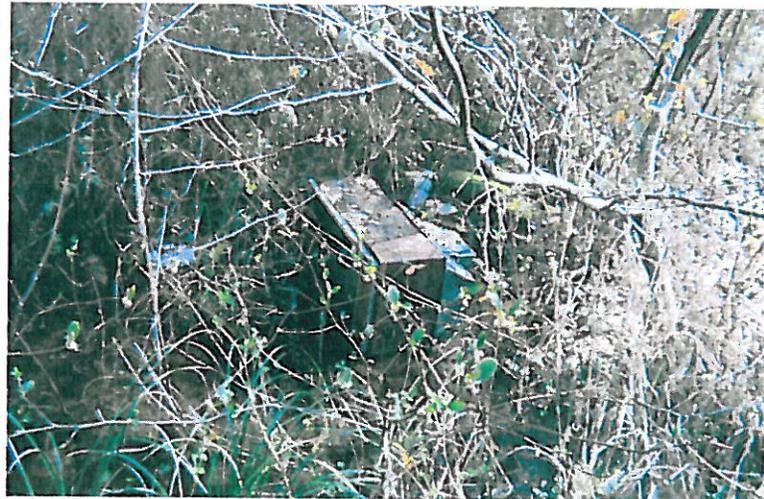
Photo 10.  
Example of garbage along the western portion of the property that will be removed.

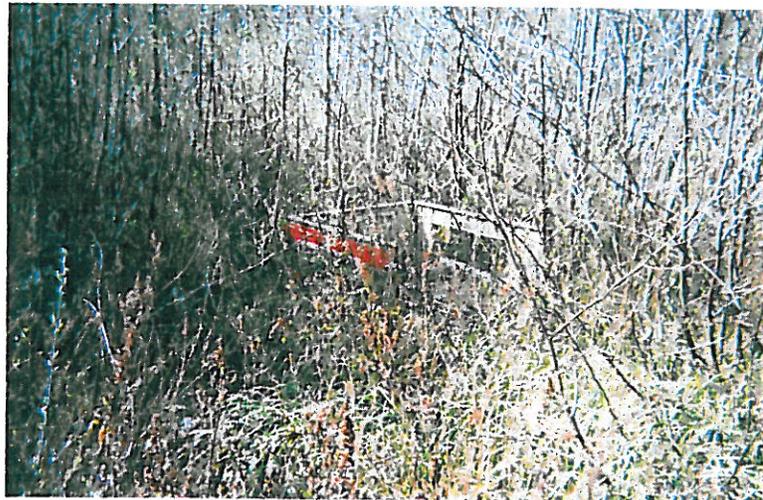
Photo 11.  
Example of garbage along the western portion of the property that will be removed.

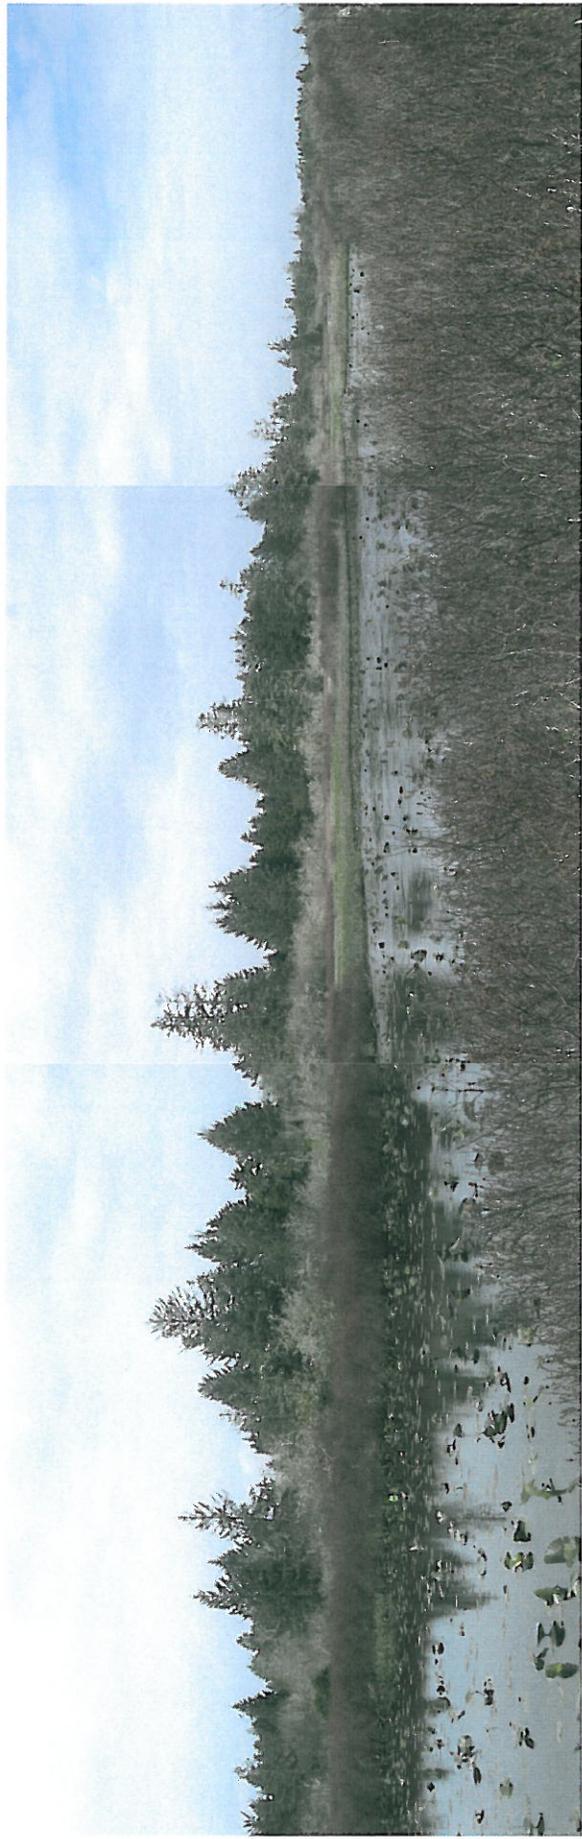
**Photo 12**

Panoramic view to the southwest of forested, shrub, and emergent bog wetland in background and aquatic bed wetland in foreground.

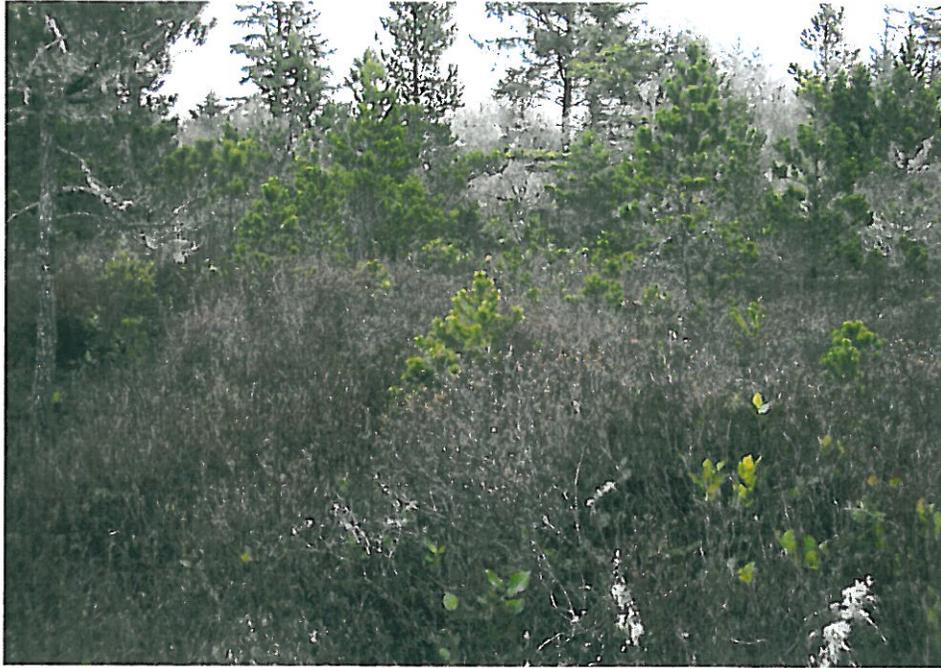
**Photo 13**

Scrub-shrub sphagnum bog wetland habitat. Species include bog cranberry, bog Labrador tea, and bog laurel. Tree species occurring on hummocks adjacent to bogs include shore pine, Sitka spruce, and western hemlock.

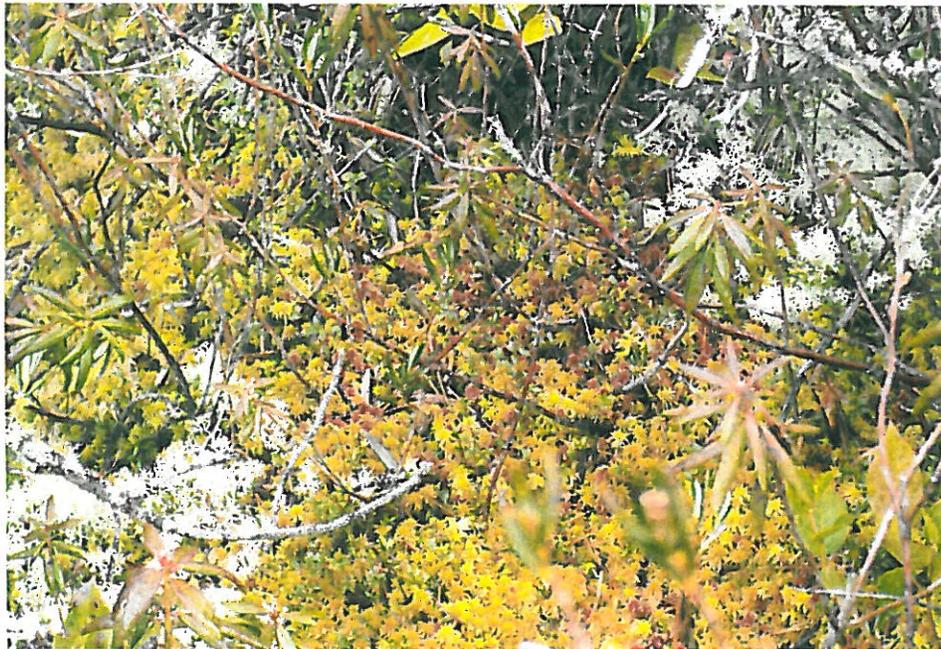
**Photo 14**

Sphagnum mosses and coastal reindeer lichen in bog wetland area.
