Incident Report: Davy Crockett Emergency Response

Updated: February 8, 2011

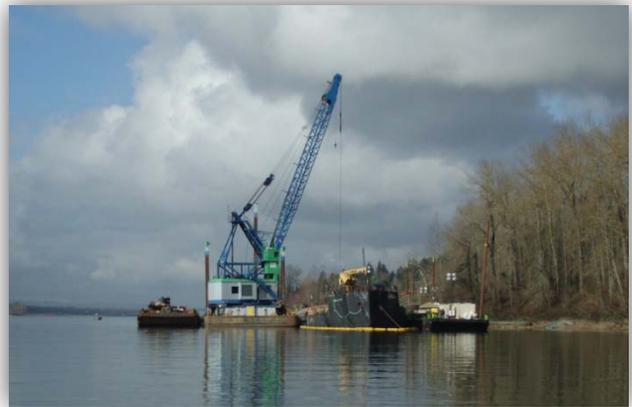
- Debris removal continues (large metal pieces that are part junk that had been in the vessel and pieces cut by the divers to facilitate removal). Divers can only stay in the water for 3 hours due to exposure challenges presented by having to wear hazmat diving suits.
- Skimming operations continues in the machinery space. Very little sheen is present but the source of the oil that surfaces in this area is still unknown.
- Oiled sorbents and smaller pieces of oily debris is being placed in plastic-lined large dumpsters on the deck barge.
