Incident Report: Davy Crockett Emergency Response

Update as of July 30, 2011

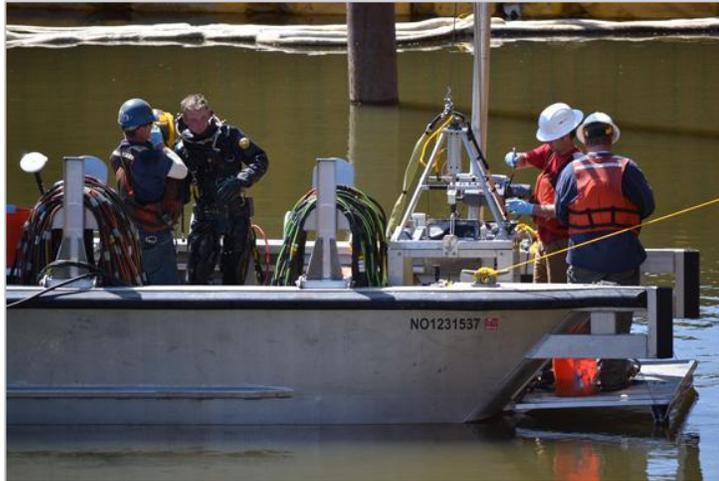
An environmental specialist at the bow of the Valkyrie prepares a sediment sample that was collected with the help of a diver at the Davy Crockett work site. (7/27/11)

Water quality samples upstream, downstream and inside the cofferdam are being collected on a periodic basis in order to evaluate the effectiveness of work activities to minimize water pollution. After the Davy Crockett is removed, sediment samples will be collected inside the cofferdam to determine if sediment cleanup is needed before the cofferdam is removed.
