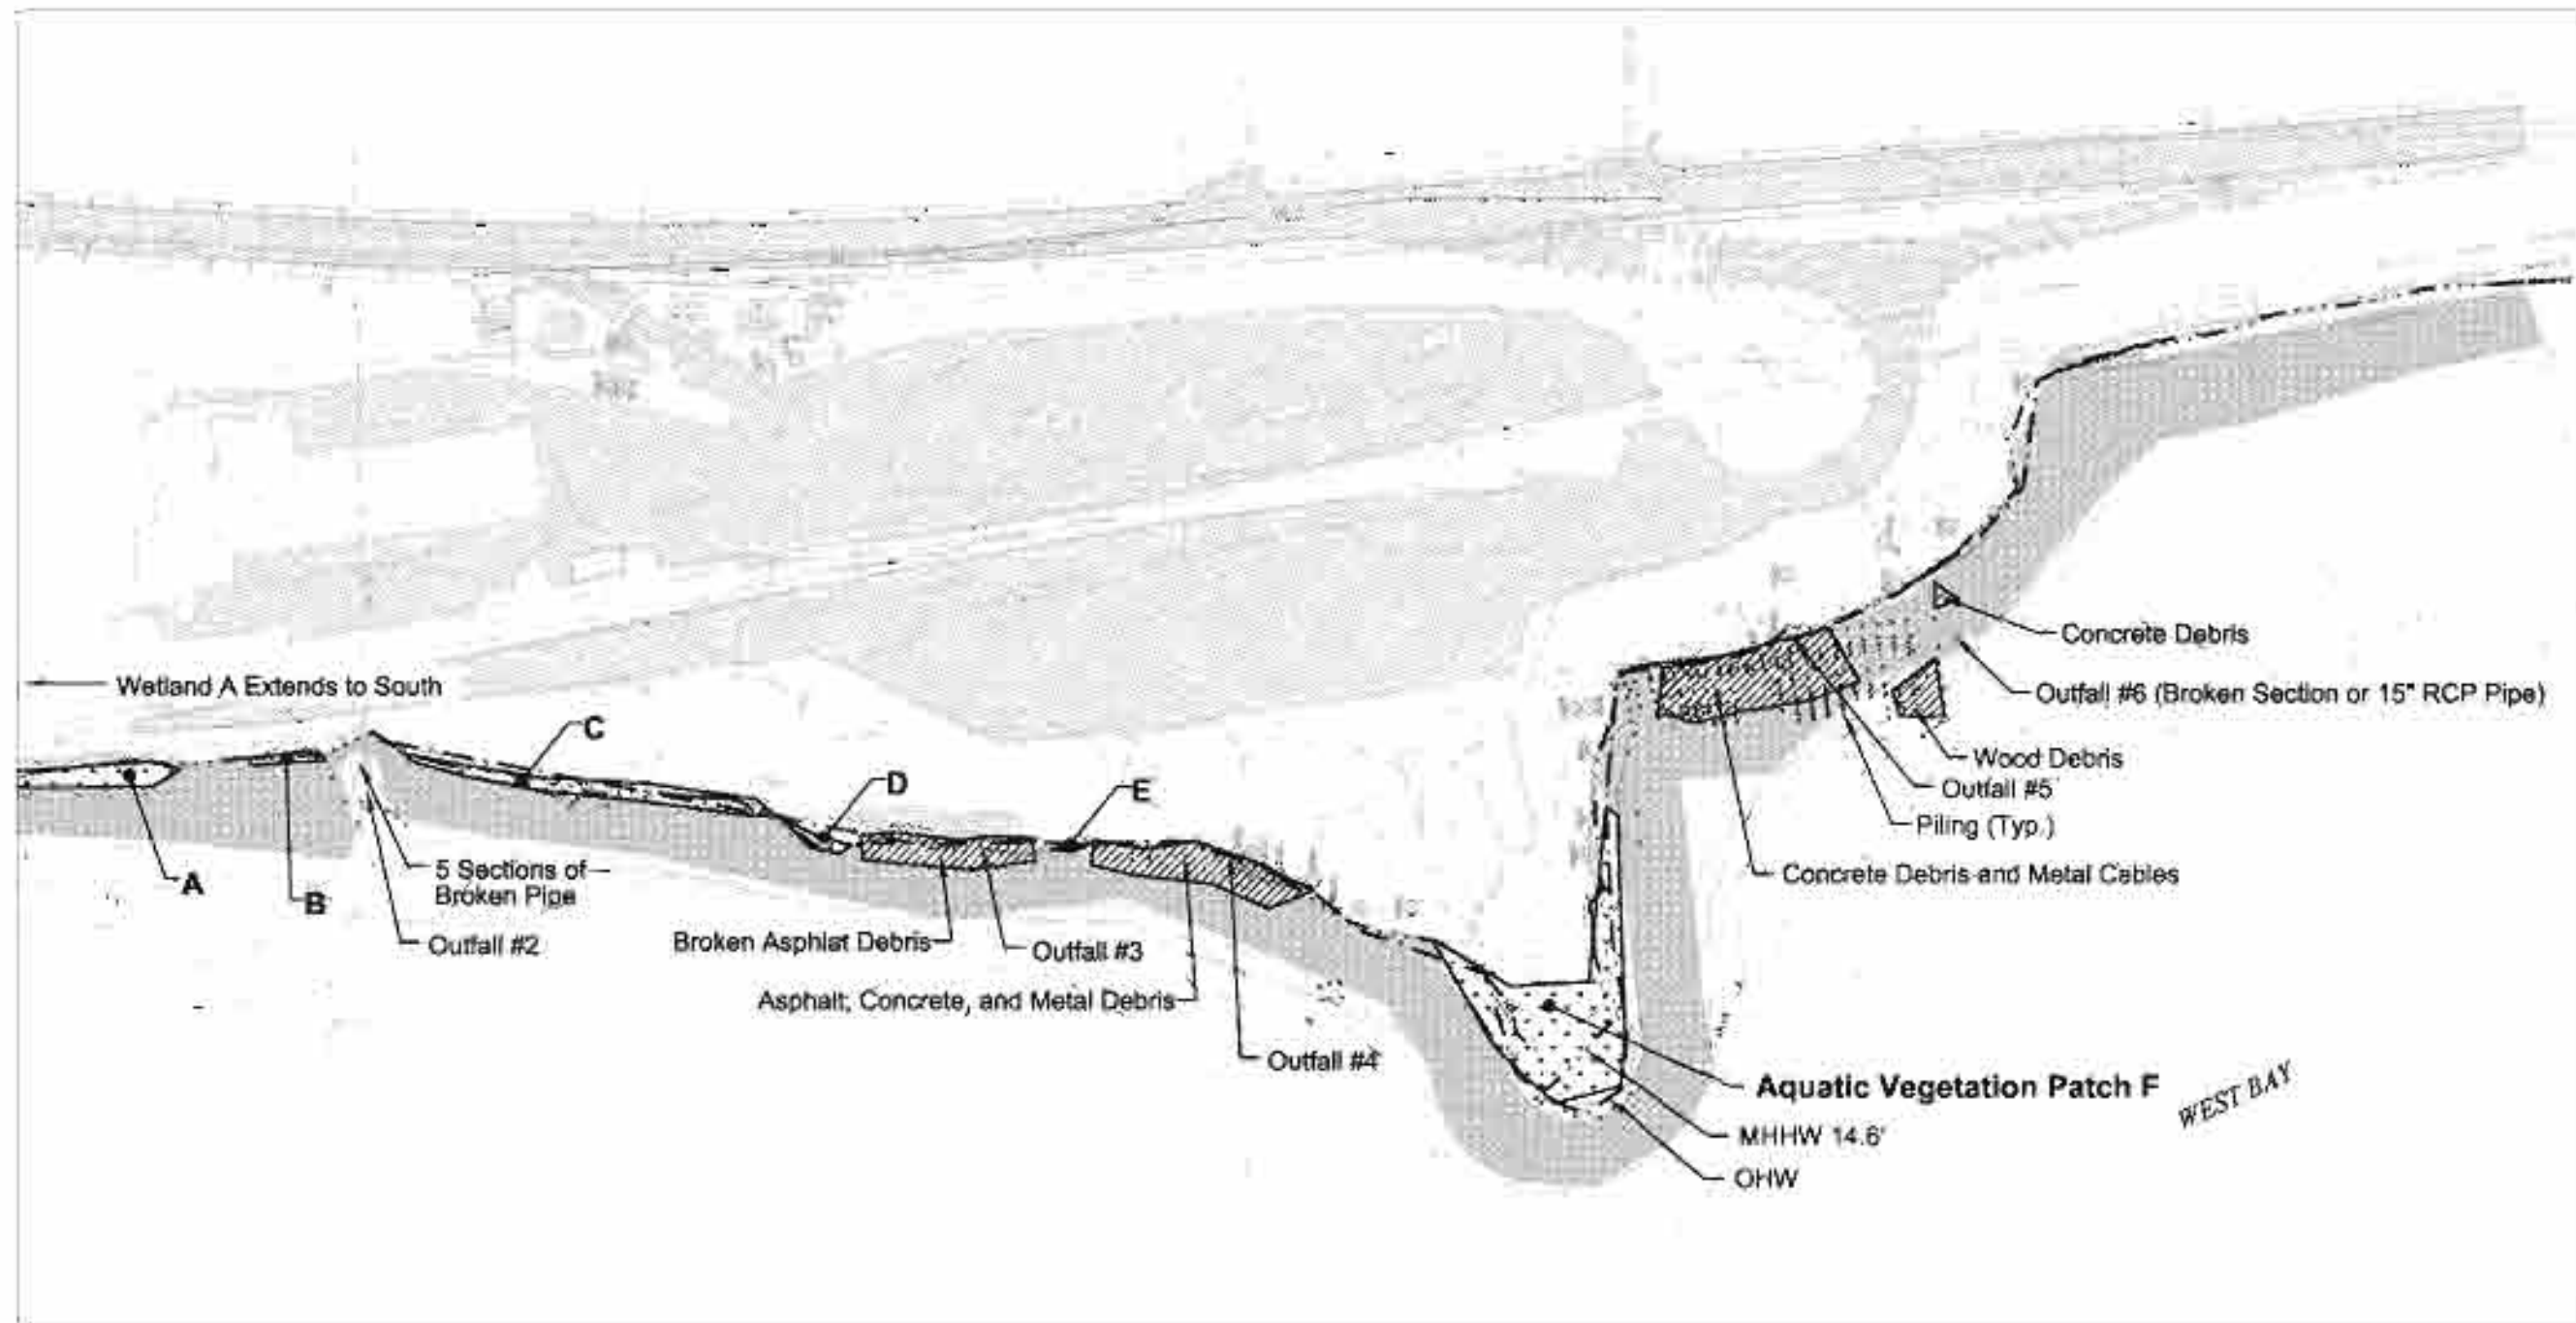
Jul 02, 2007 1:51pm c:\dev\p001\KCI\Udbs\070324-West Bay Park\07032401\07032401-000.dwg FIG. 3

Six drainage outfalls were observed during the investigation, identified as Outfalls 1, 2, 3, 4, 5, and 6. Two of the drainage channels are piped (2 and 6), and four are naturally flowing from beneath the ground (seeps) and emerge below the OHW line of Puget Sound. The outfall locations are shown on Figure 3.

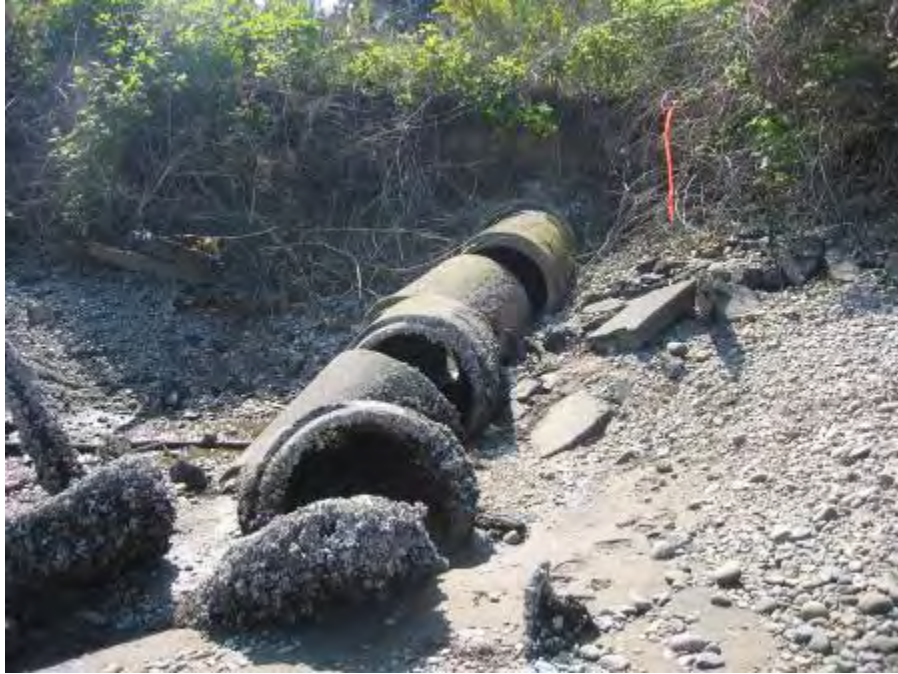
Photograph 1. Outfall 2

All six outfalls were actively flowing during the site visit. Outfalls 1 and 2 had defined scour channels in the upper intertidal area of the beach. Outfall 2 flows from a broken culvert (see Photograph 1) and is the terminus of Garfield Creek. Garfield Creek flows through open channel in a wooded ravine west of West Bay Drive NW. It is culverted below West Bay Drive NW and the Property. The flows of Outfalls 3, 4, and 5 consisted of seeps with sheet flow patterns with no discernable scouring (see Photograph 2). Outfall 6 flows from a broken culvert that is exposed in the upper intertidal area about 50 feet below the OHW line and is therefore beneath water during much of the tidal cycles. Outfalls 1, 3, 4, and 5 are seeps with no exposed pipes or culverts identifying the source of the flows.

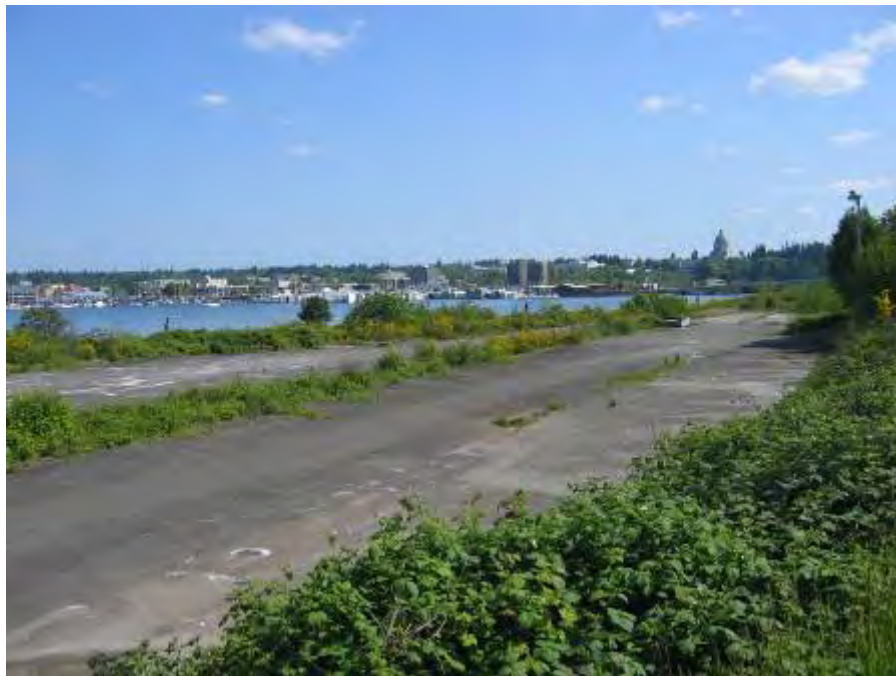
Photograph 3. Upland Vegetation

Dominant tree species include ornamental cherry (*Prunus* sp.) and the non-native species Black locust (*Robinia pseudoacacia*). Additional tree species observed include the native species big-leaf maple (*Acer macrophyllum*), red alder (*Alnus rubra*), and Pacific madrona (*Arbutus menziesii*). Trees on the Property are relatively young with no mature trees observed.

Shrub species communities are dominated by the non-native invasive plant species Himalayan blackberry (*Rubus armeniacus*), Scot's broom (*Cytisus scoparius*), and Japanese knotweed (*Polygonum cuspidatum*), with twinberry (*Lonicera involucrate*) also occurring.

Grass and herbaceous plant species within the Property include a variety of native and non-native species that are common in Thurston County and western Washington. Dominant grass and herbaceous species include common velvet-grass (*Holcus lanatus*), Canadian thistle (*Cirsium arvense*), tall fescue (*Festuca arundinacea*), and common dandelion (*Taraxacum officinale*). The non-native invasive species English ivy (*Hedra helix*) was frequently observed as a dominant ground cover and growing up the trunks of trees.
