Appendix B Photographs

Appendix B-1
Historical Aerial Photograph Review

Historical Aerial Photograph Review

Lower Duwamish Waterway RM 1.7–2.0 East (Slip 2 to Slip 3)

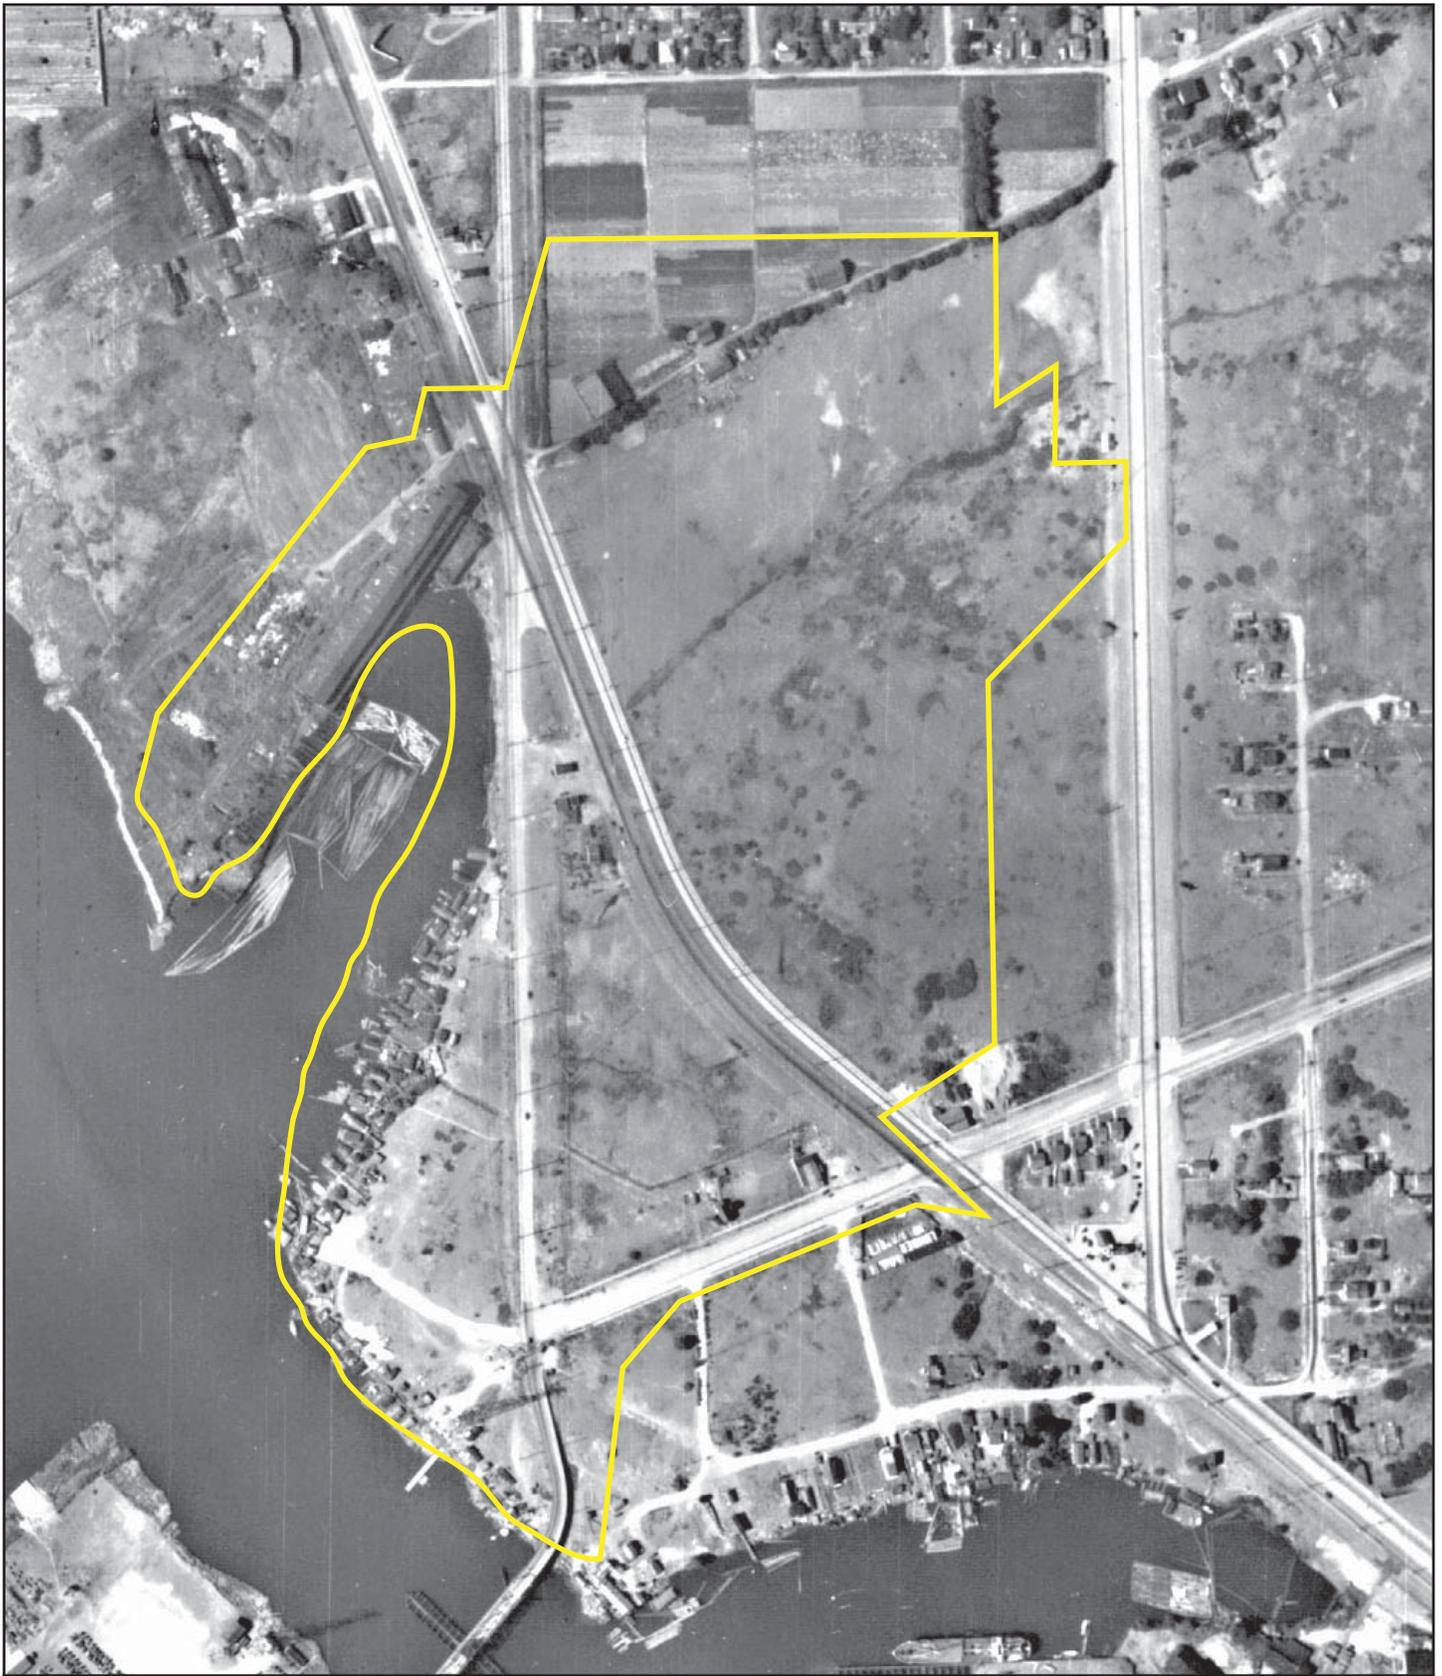
Figure B-1. RM 1.7-2.0 East (Slip 2 to Slip 3): 1936

Slip 2 is already well defined with clear shoreline definition. Timber rafts are stored on the north side and numerous small docks and above-water structures, possibly used to house small boats, are located along the south side of the slip. 1st Ave S is relatively close to the east side of Slip 2. There is either the early development or decaying remains of a structure resembling a pier along the north side of the slip.

Glacier NW is virtually undeveloped and consists of possible grassland and/or floodplain. A long narrow building of unknown use or identity is located adjacent to the northeast side of Slip 1 and has a smaller adjacent building. East Marginal Way runs north and south through the middle of parcel 4505 fairly close to the east side of Slip 2.

The Duwamish Marine Center property is also relatively undeveloped. Several roads are located on the property. The only structural development is in the northwest area where the aforementioned overwater buildings are located. Several small docks appear to extend a short way out into the LDW. A feature resembling an open ditch appears to run from the Upland Properties area under 1st Ave S and likely connects to Slip 2. This is in the same general location as the 2021 Gilmore James Bldg. outfall.

The **Upland Properties** appear to consist of mostly farmland or undeveloped grassland. East Marginal Way bisects this area but there is no other road development within this

specific location. Several small buildings, possibly residential in nature, are located near the northern and southern edges.

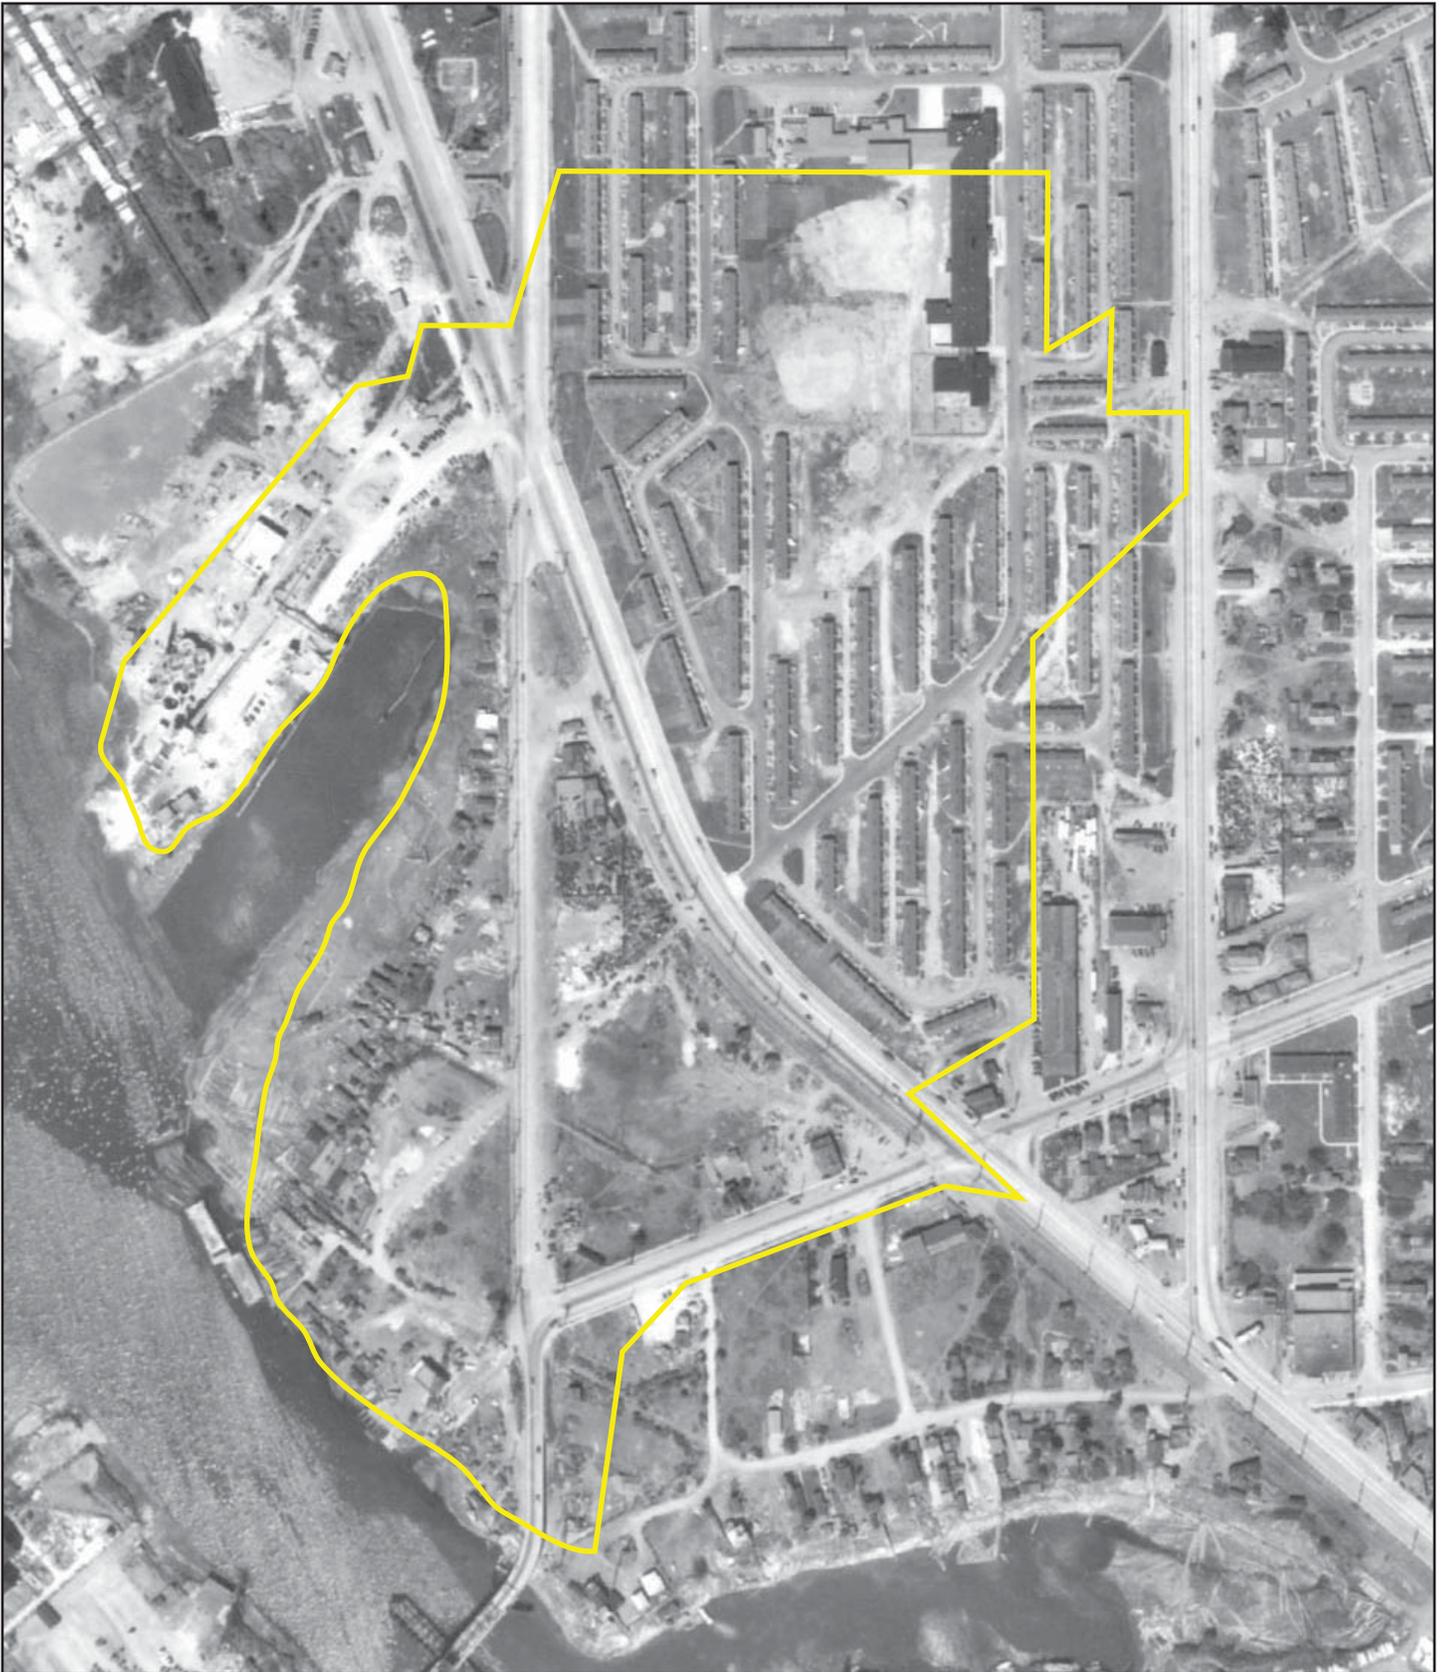
Figure B-2. RM 1.7-2.0 East (Slip 2 to Slip 3): 1946

Slip 2 underwent significant changes due to the apparent filling and subsequent reduction in size of approximately one third of the original open surface-water area. There appears to be a small dock or log boom present along the north and east sides of the slip.

Glacier NW appears to be in the early stages of development. Several buildings underwent construction including cylindrical silos on the northwest side of the property. The long narrow building adjacent to Slip 2 has been removed and replaced by an access road.

The Duwamish Marine Center gained a considerable amount of property as a result of the filling process, which took place within Slip 2. Several additional buildings are located along the west and south sides of the area. It appears that the structural remains of a wharf remain on the northwest side. Two barges are docked on the east side of the LDW along the west side of the Duwamish Marine Center. The ditch-like feature can still be observed; however, the discharge into Slip 2 is obscured by the fill material.

The **Upland Property** area underwent the most drastic change due to the development of the 901-unit Duwamish Bend housing project and associated school buildings. Developed streets and alleyways are in place. The area to the southwest remains fairly undeveloped with just the addition of a few buildings in the north.

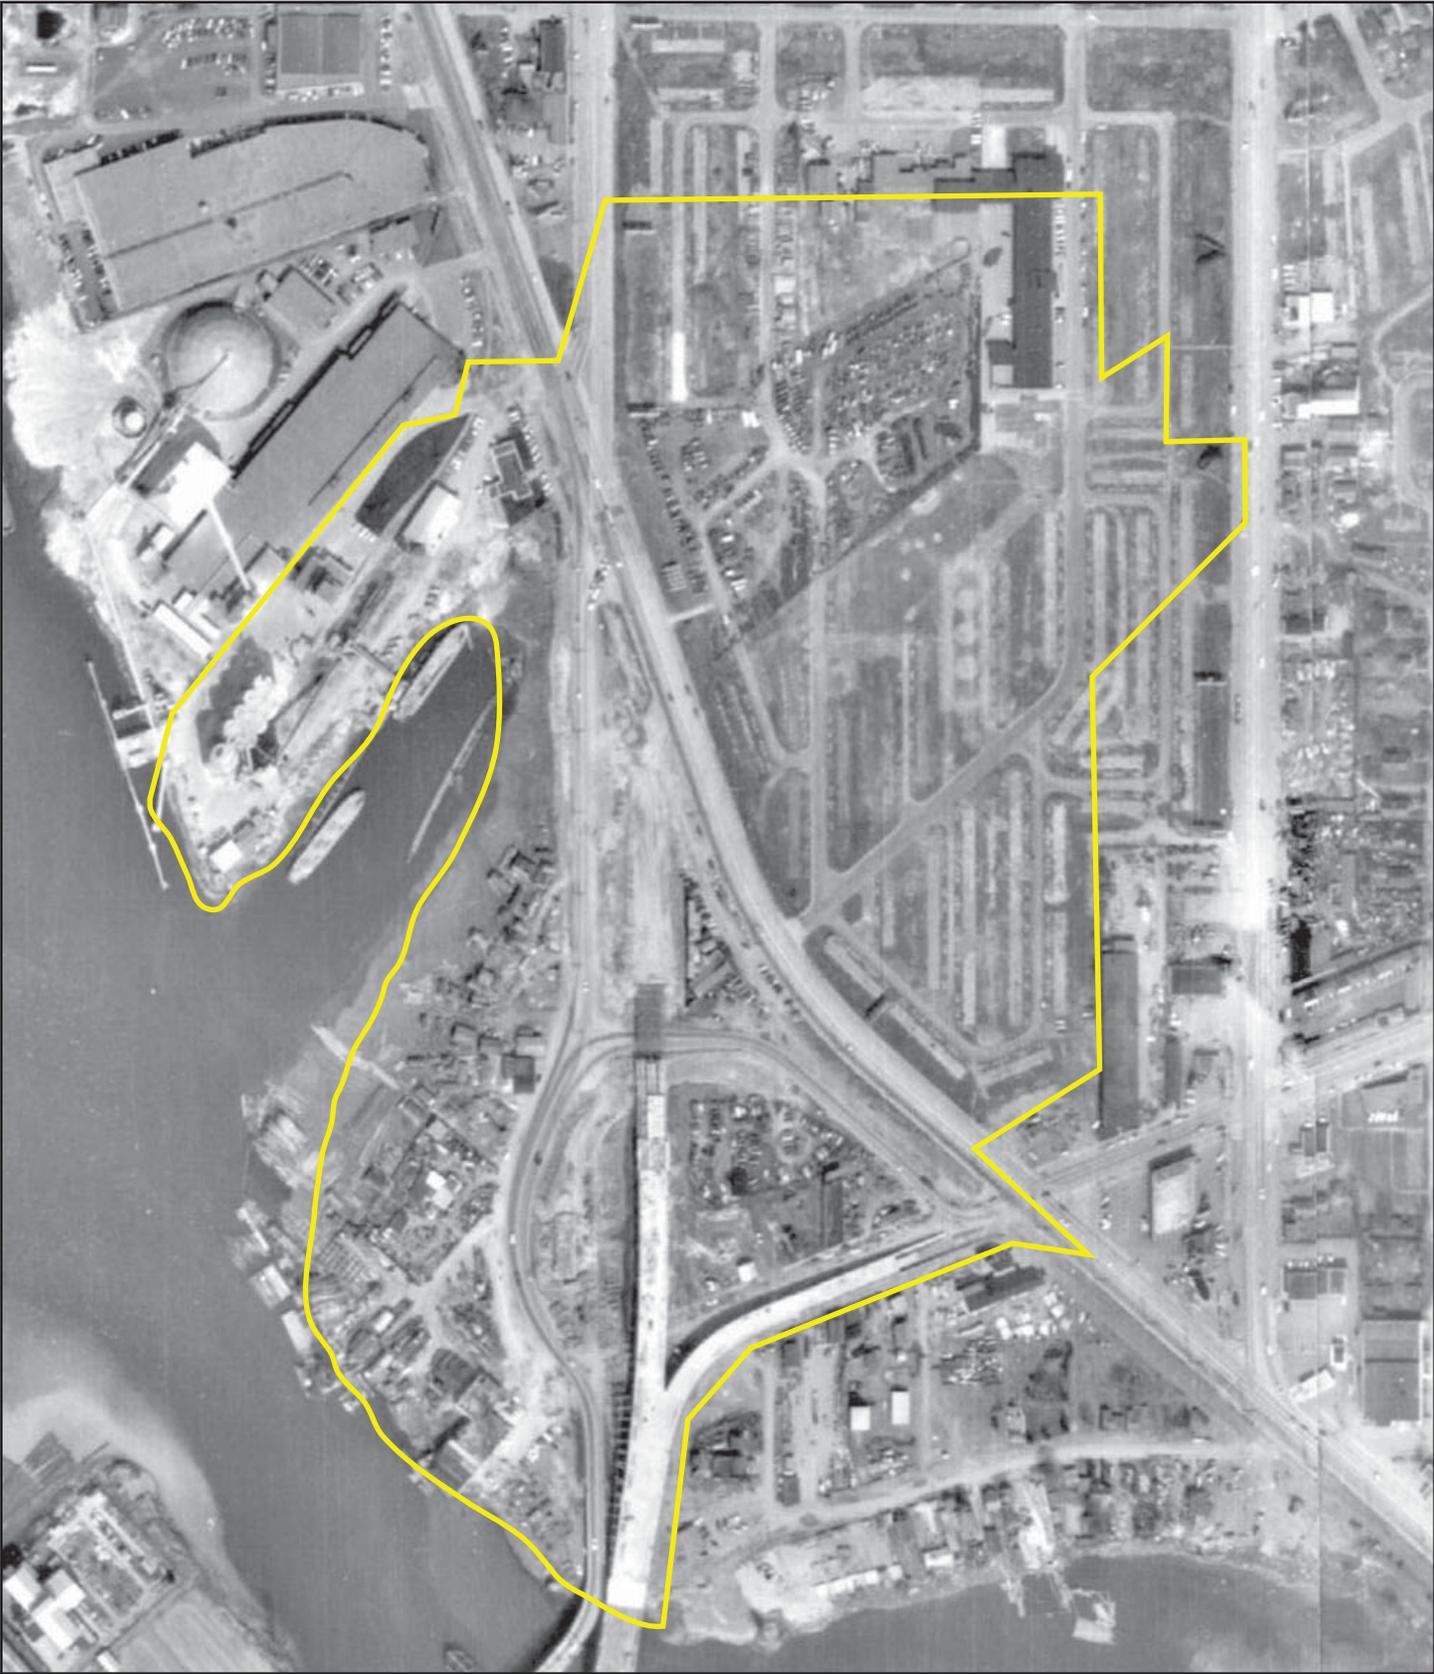
Figure B-3. RM 1.7-2.0 East (Slip 2 to Slip 3): 1956

Slip 2 has two long docks paralleling the north and south sides. The primary purpose of the north dock appears to be for ship mooring. The function of the south dock is unknown. The south side of the slip remains mostly mudflats from when the slip shape was reconfigured and filled.

Glacier NW underwent the development and construction of various small buildings and roads, which is similar to the modern-day configuration. A dock which extends into the east side of the LDW is present.

The Duwamish Marine Center has increased development of small buildings. Most notably is the early stages of rerouting of the 1st Ave Bridge, which moves the roadway to the east. The ditch-like feature appears to have been filled or covered and is no longer present on the landscape. However, there is discoloration in the water of Slip 2 near where the 2021 Gilmore James Bldg. outfall is located. This may indicate water oxygenation from churning water associated with an outflow of some type.

The **Upland Properties** underwent the demolition of the Duwamish Bend housing project; only the footprints of buildings remain visible. Two exceptions include a large building located towards the north of the area and another long narrow building to the

south. The property between East Marginal Way and where the new 1st Ave Bridge currently is located appears to be under development for road use.

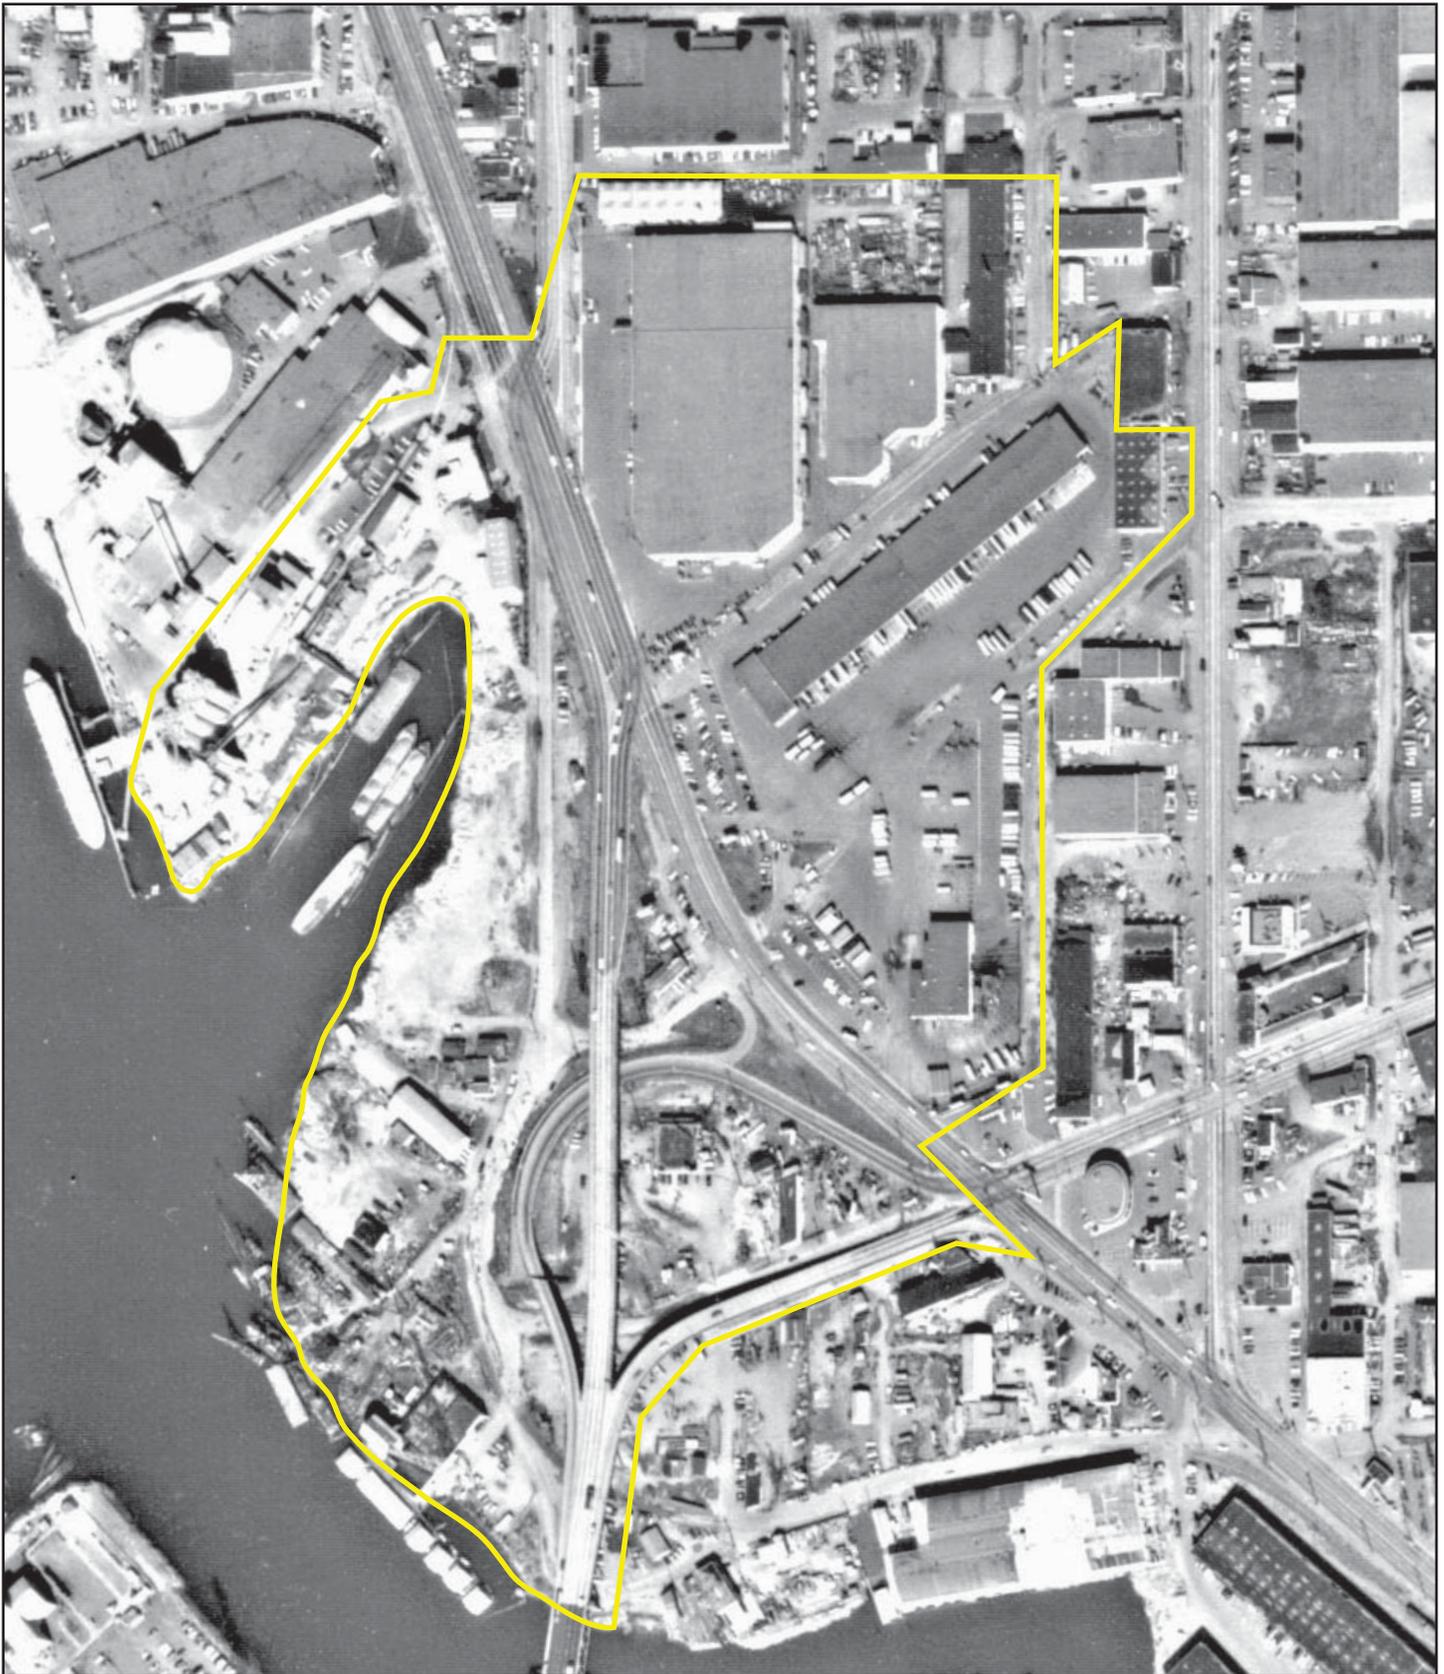
Figure B-4. RM 1.7-2.0 East (Slip 2 to Slip 3): 1969

Slip 2 remains generally the same shape with some increased definition along the southern shoreline, which shifts from mudflats to usable developable land. Boat moorage appears to be the primary function of the slip.

The **Glacier NW** parcel 9075 located to the north remains virtually unchanged. However, the usable space for parcel 4505 increased due to the relocation of East Marginal Way farther to the east. No buildings or other infrastructure is present on this parcel.

The Duwamish Marine Center has more overwater structures on the south end and various larger buildings have been constructed within the area.

The **Upland Properties** underwent substantial redevelopment, which included many large buildings and warehouses. The two buildings from the Duwamish Bend housing project still remain but now appear dwarfed in comparison.

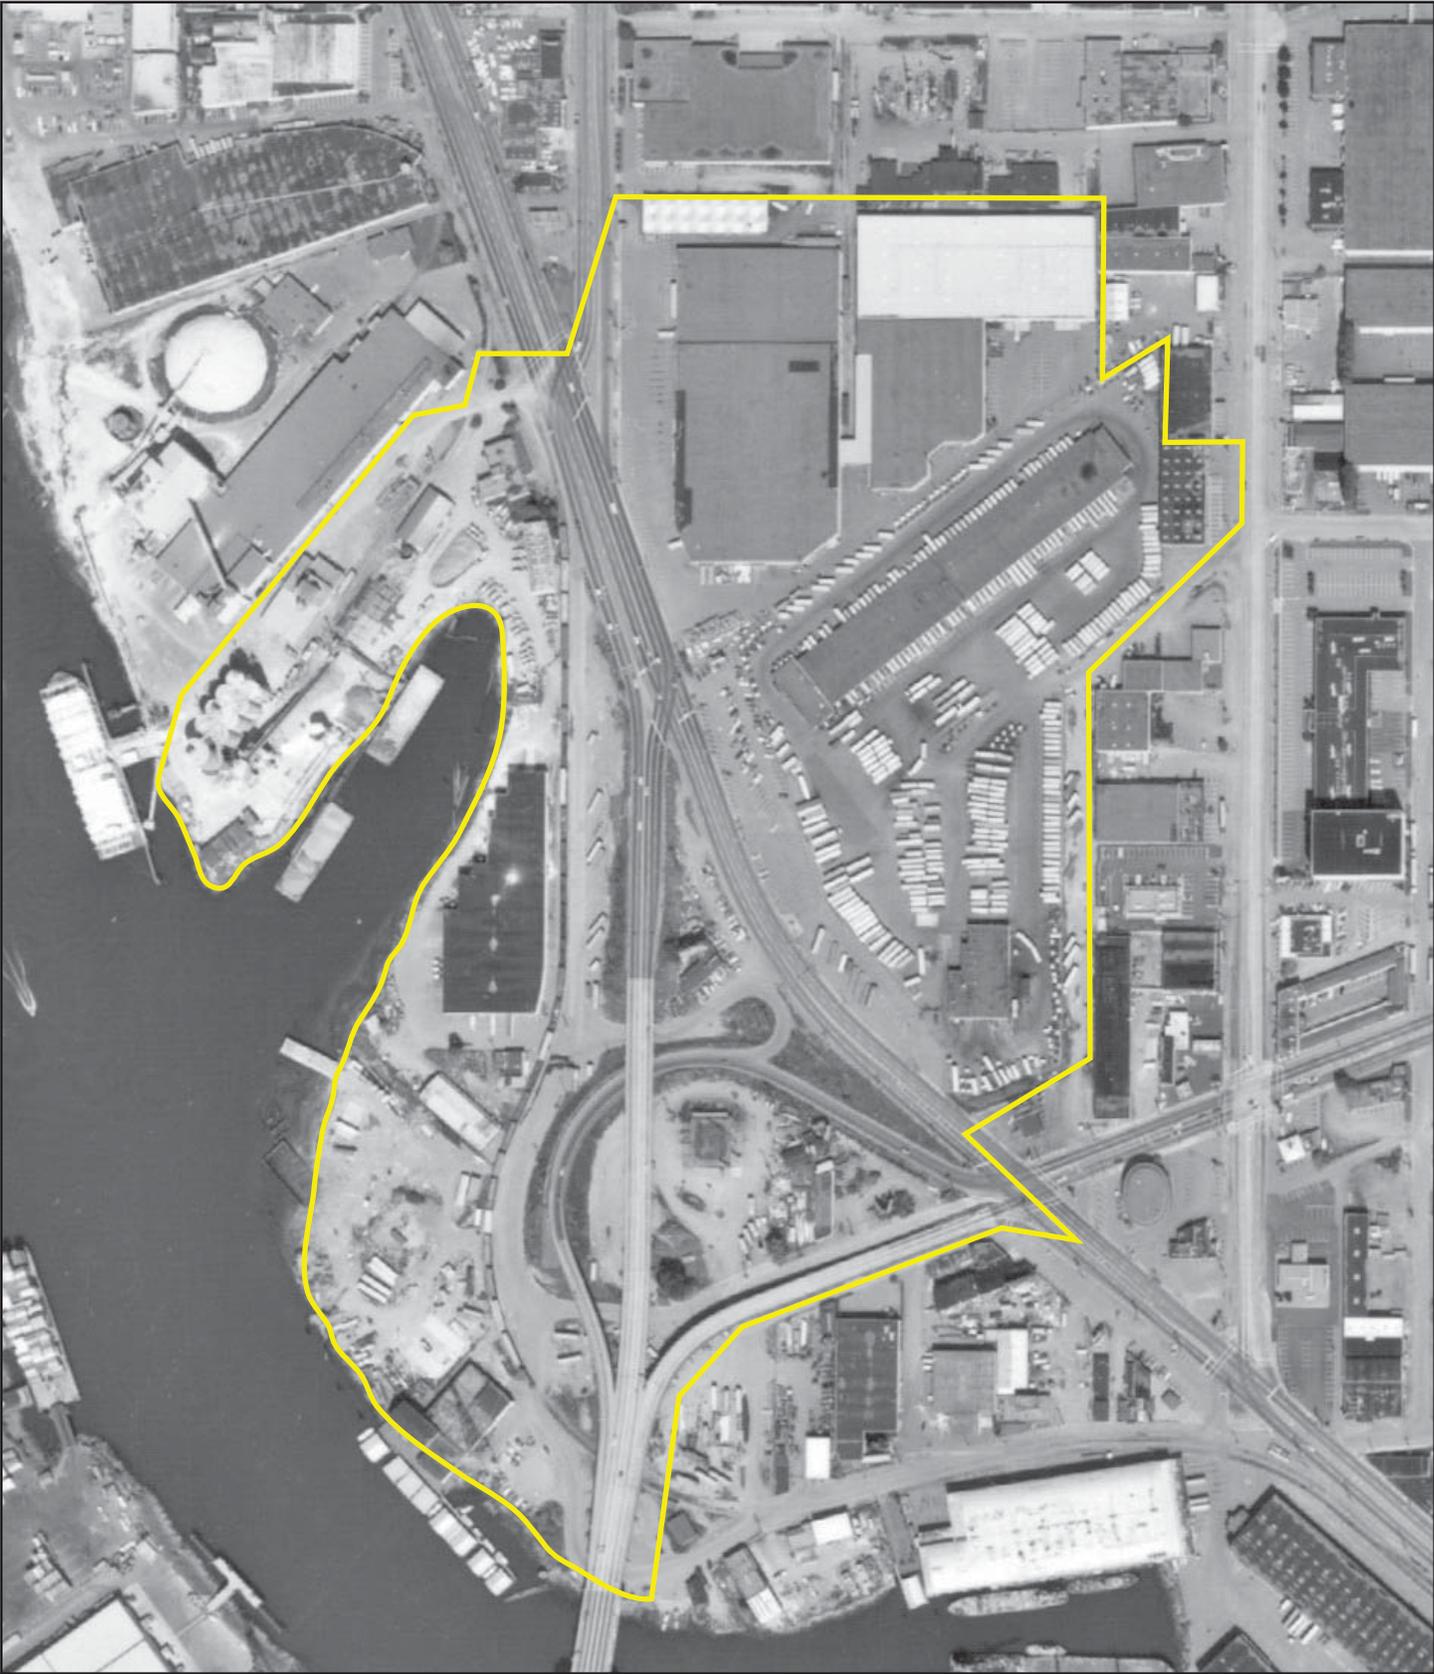
Figure B-5. RM 1.7-2.0 East (Slip 2 to Slip 3): 1980

Slip 2 underwent the removal of the southern dock. Two large barges were moored on the north side of the slip. A small pier located on the south side of the slip near the mouth was also constructed.

Glacier NW parcel 9075 remains unchanged whereas parcel 4505 underwent the construction of a large warehouse-type building that covers most of the parcel.

The Duwamish Marine Center area had numerous small buildings and structures removed.

The **Upland Properties** underwent no obvious changes or development.

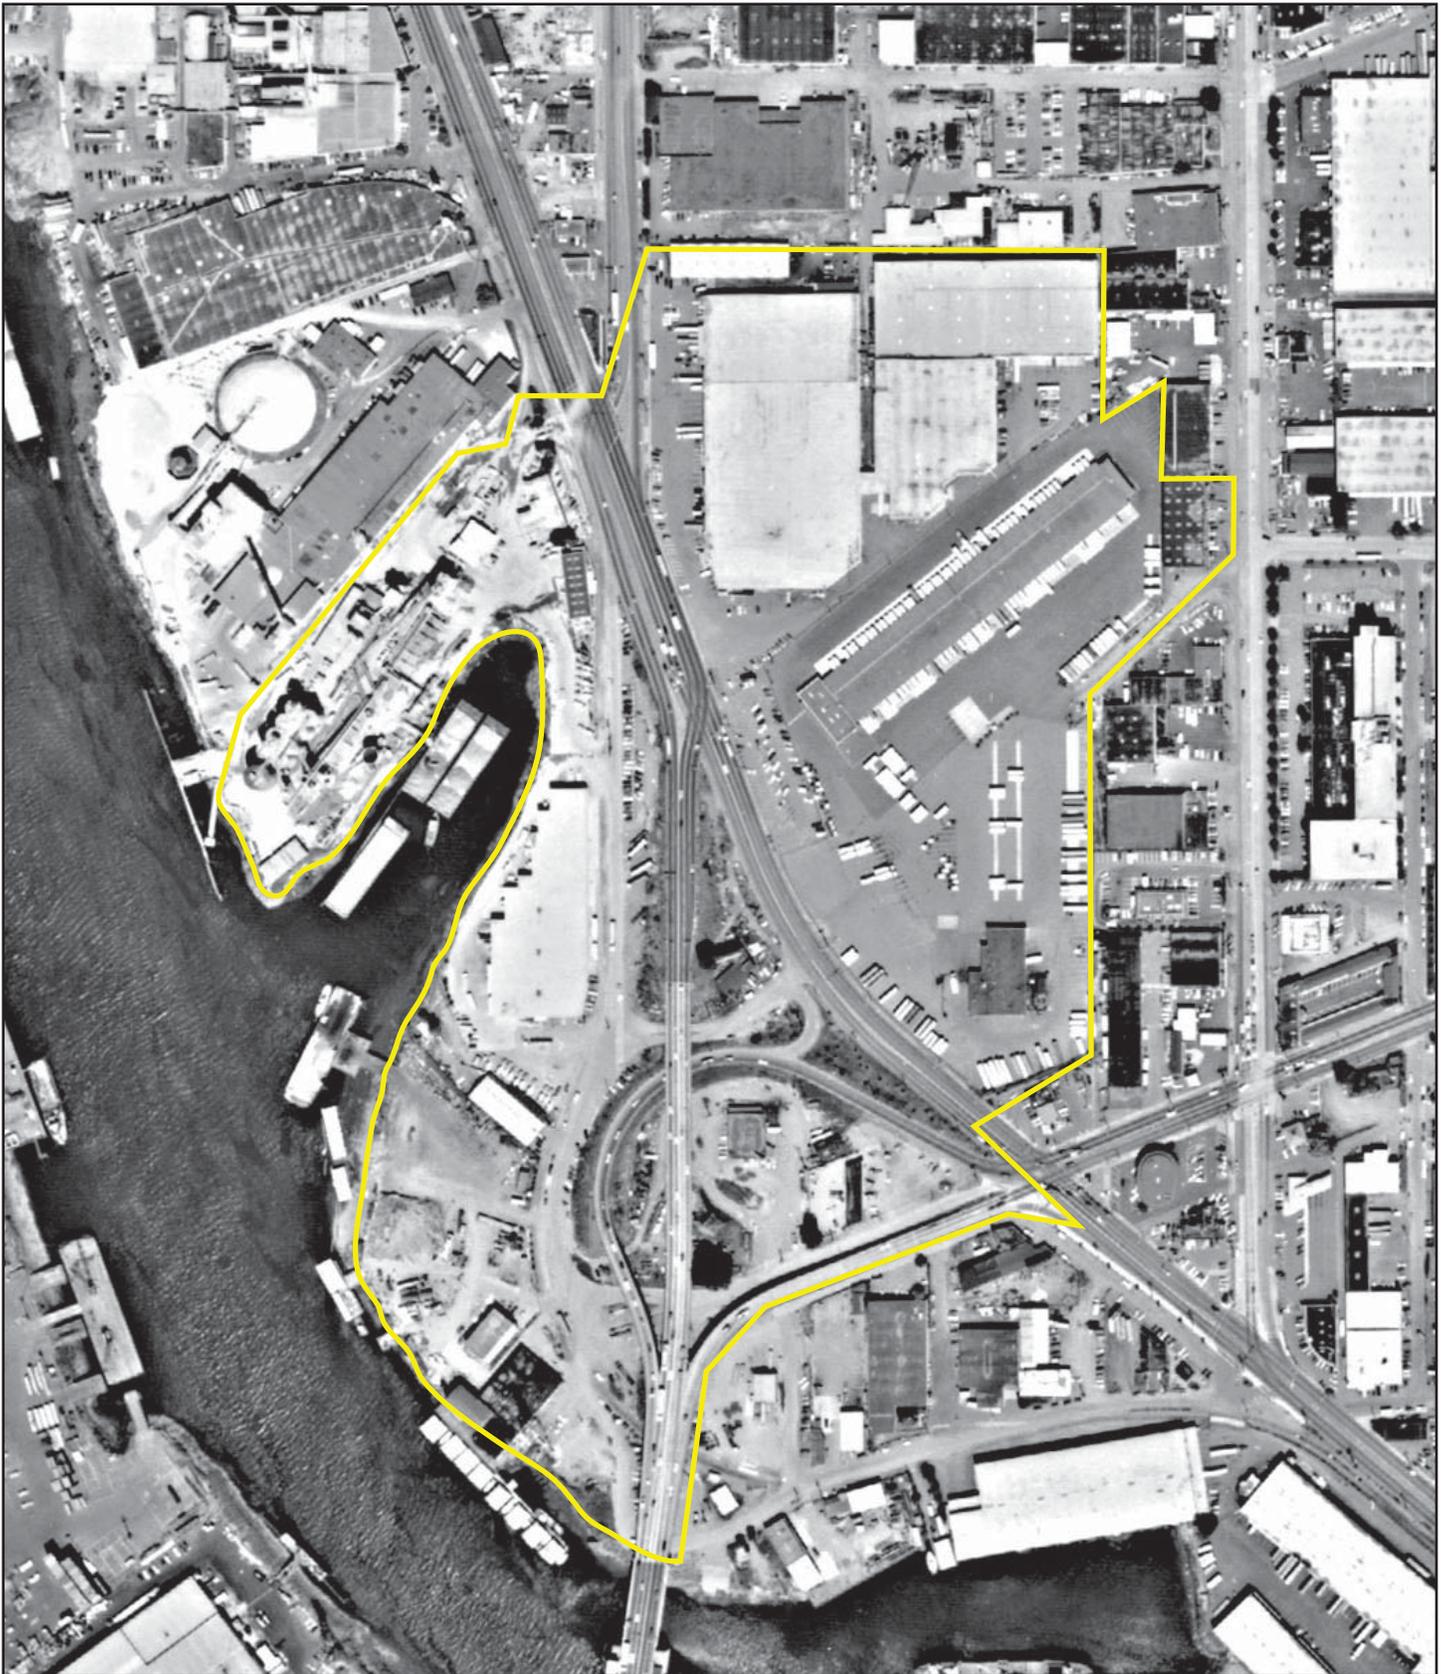
Figure B-6. RM 1.7-2.0 East (Slip 2 to Slip 3): 1990

Slip 2 continues to accommodate large barge moorage along the north side. The pier located on the south side underwent the addition of a wharf at the end, which facilitated large barge moorage.

Glacier NW appears relatively unchanged with the exception of removing a small building located on the south side of parcel 9075.

The Duwamish Marine Center had an additional wharf constructed just outside the mouth of Slip 2 on the east side of the LDW. An additional building was built on the southern end of the area.

The **Upland Properties** appear unchanged.

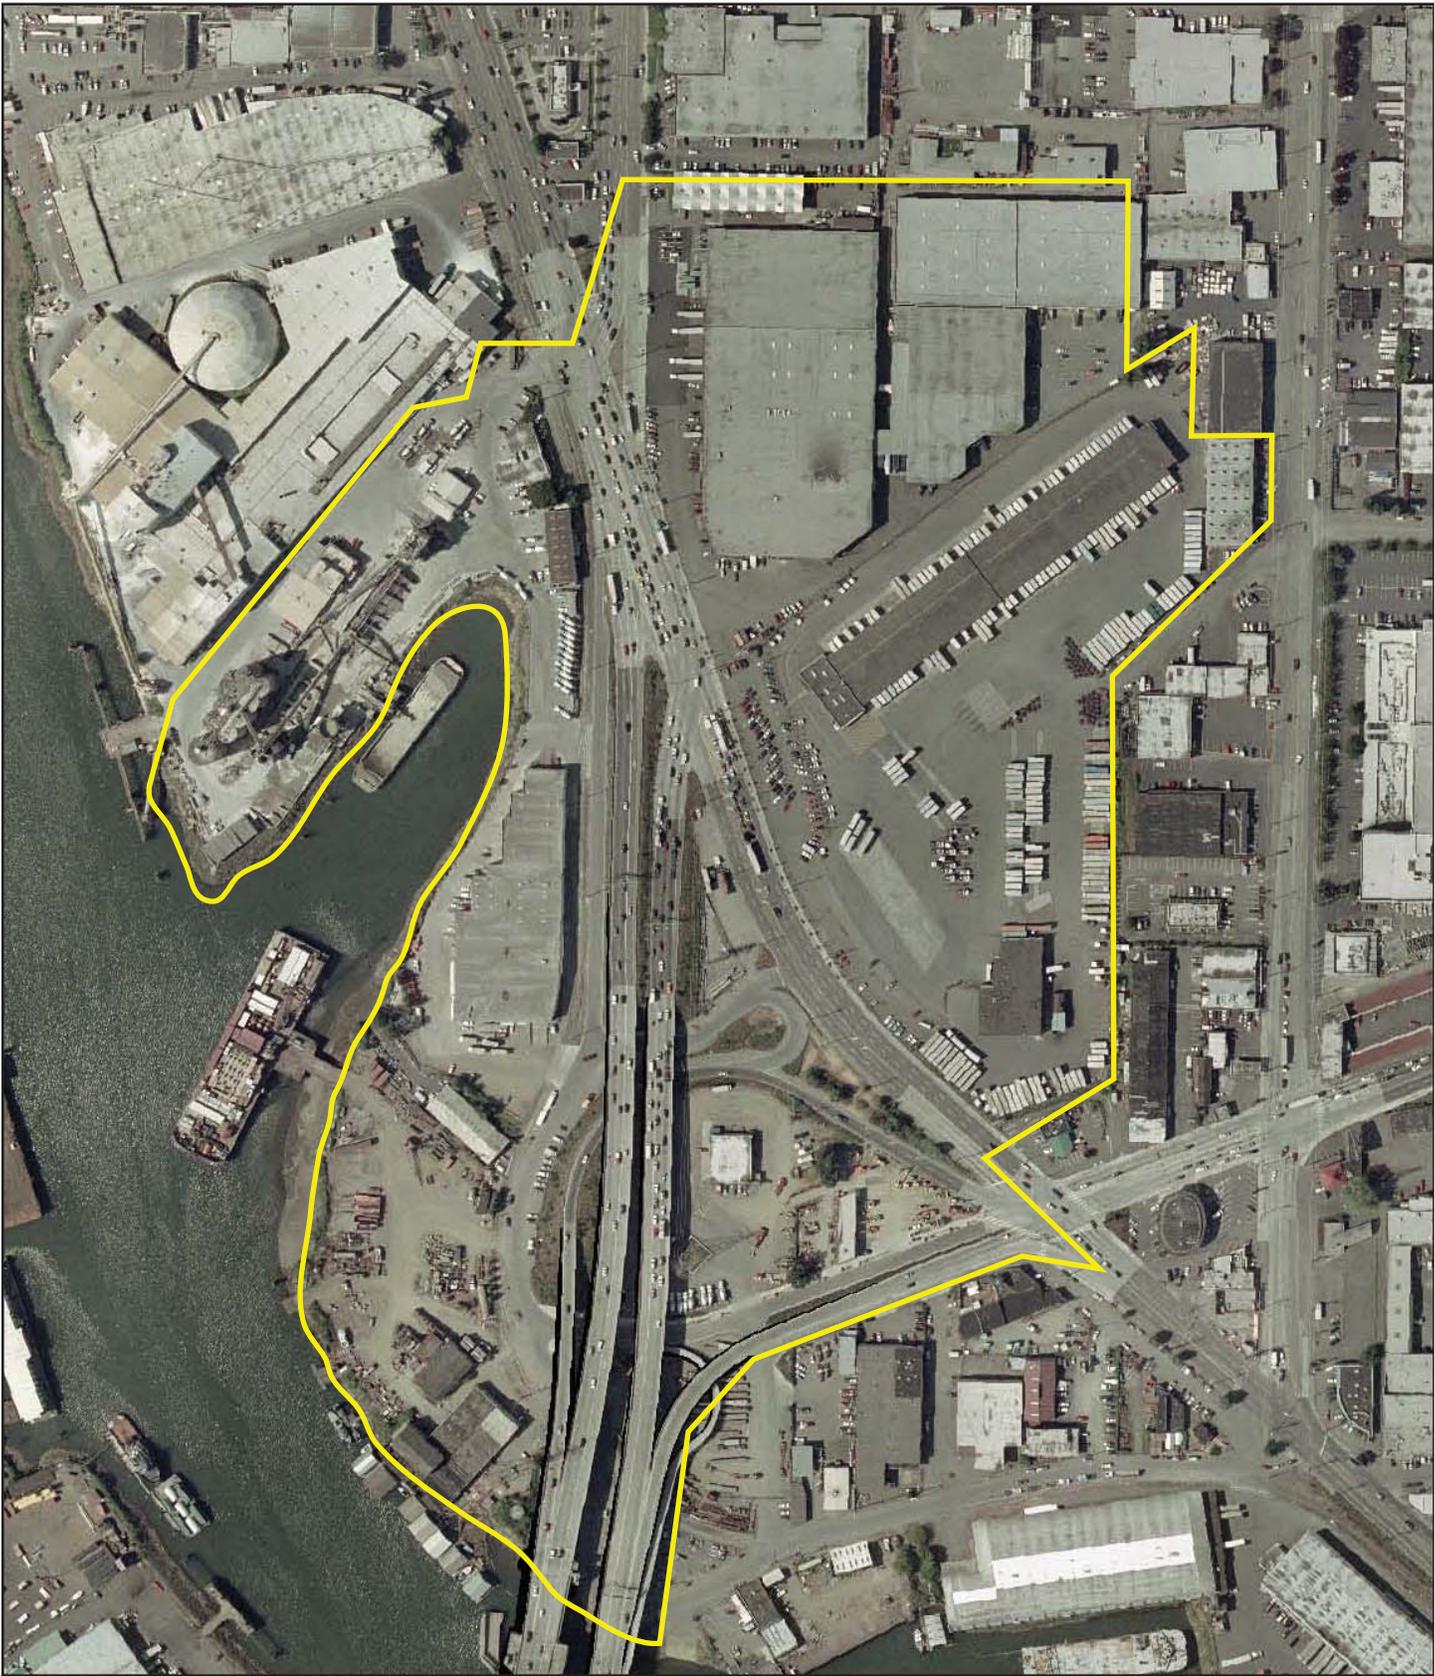
Figure B-8. RM 1.7-2.0 East (Slip 2 to Slip 3): 2002

No significant changes were visible to **Slip 2**.

Glacier NW continues to have undergone little to no change and is very similar to modern day design.

The Duwamish Marine Center appears to have undergone no observable changes.

The **Upland Properties** also appear to have had relatively little changes made with regard to development. Site reconnaissance indicates that the large rectangular building located on parcel 4646 was demolished and removed sometime between 2002, when this photo was taken, and April 2008.
