Appendix B. Historical Aerial Photograph Review

A historical aerial photo review was conducted to document changes in site use and layout at T-108 over time. Photos from 1936 (King County 2008), 1946 (Aerial Photo Publishers), 1953 (Photographer unknown), 1961 (Pacific Aerial Surveys), 1970 (WDNR), 1981 (WDNR), 1990 (Metro Aerial 1991), and 1995 (WDNR) were available. The parcel boundaries for both the Eastern and Western Parcels of T-108 and the outline of the present-day shoreline are overlaid on the aerial photographs for reference. In addition to the aerial photos collected for this investigation, photos from 1976 and 1977 showing the central and western portions of the property were also available from an existing report by King County (King County et al. 2005).

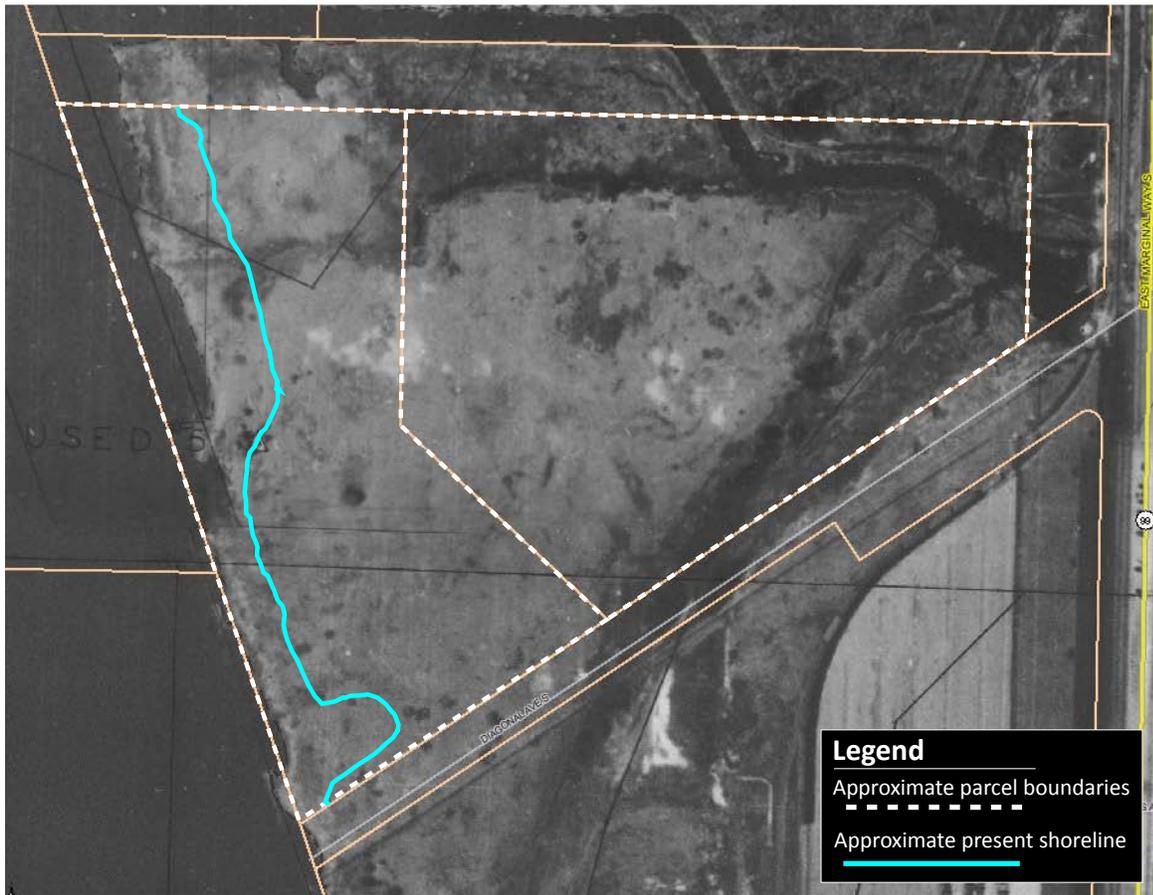
1936 aerial photograph (King County 2008)

The 1936 aerial photograph shows the property undeveloped with a tidal channel located on the eastern and northern portions of the Eastern Parcel. The shoreline extends further into the LDW than the present-day shoreline. By 1946, the Diagonal Way STP had been developed. Two large, round clarifiers are visible in the photograph, with two smaller round digesters to the west, and three or four rectangular-shaped sludge-drying beds to the west of the digesters. A control house is located to the east of the clarifiers. The STP outfall is visible approximately midway along the property shoreline, and lumber is being stored offshore within the LDW.

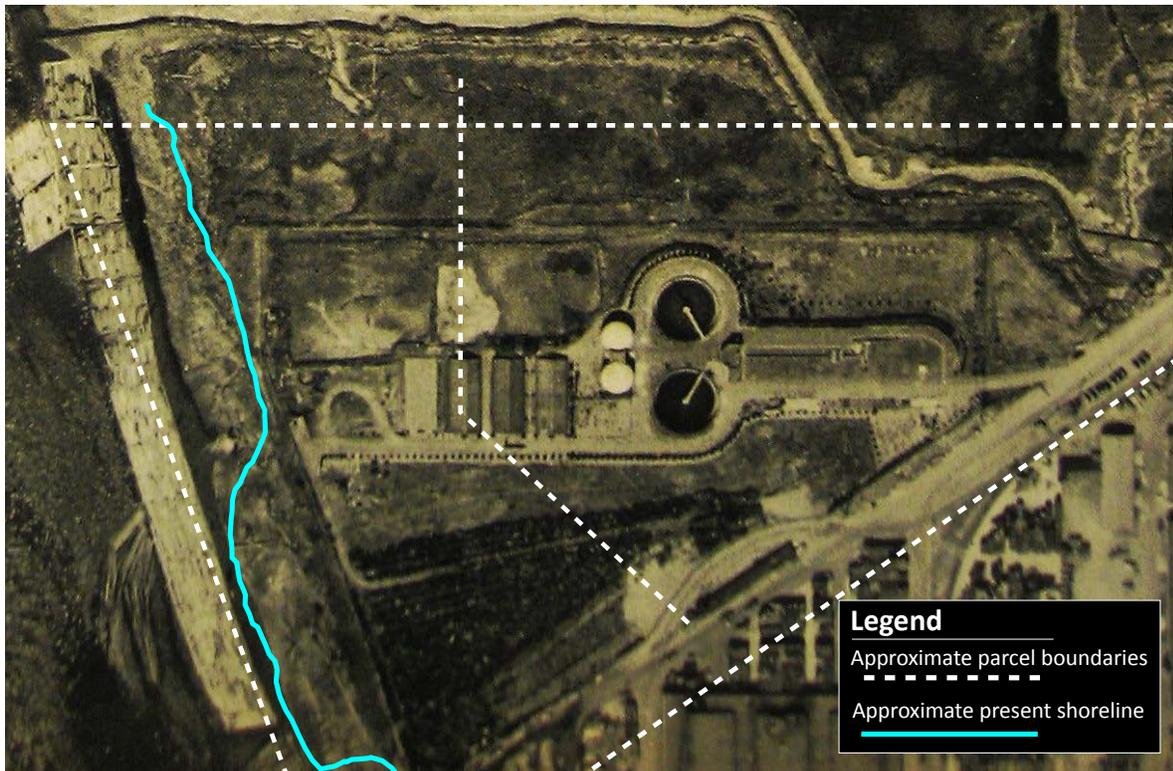
1946 aerial photograph (Aerial Photo Publishers 1946)

A report by King County indicated that the tidal channel on the north end of the property received untreated sewage from a small sewer system located to the northeast of the Diagonal Way STP (King County et al. 2005). What appears to be a small structure is visible along the eastern boundary of the Eastern Parcel in the aerial photograph from 1946. This may represent the small sewer system, however this could not be confirmed during the course of this investigation.

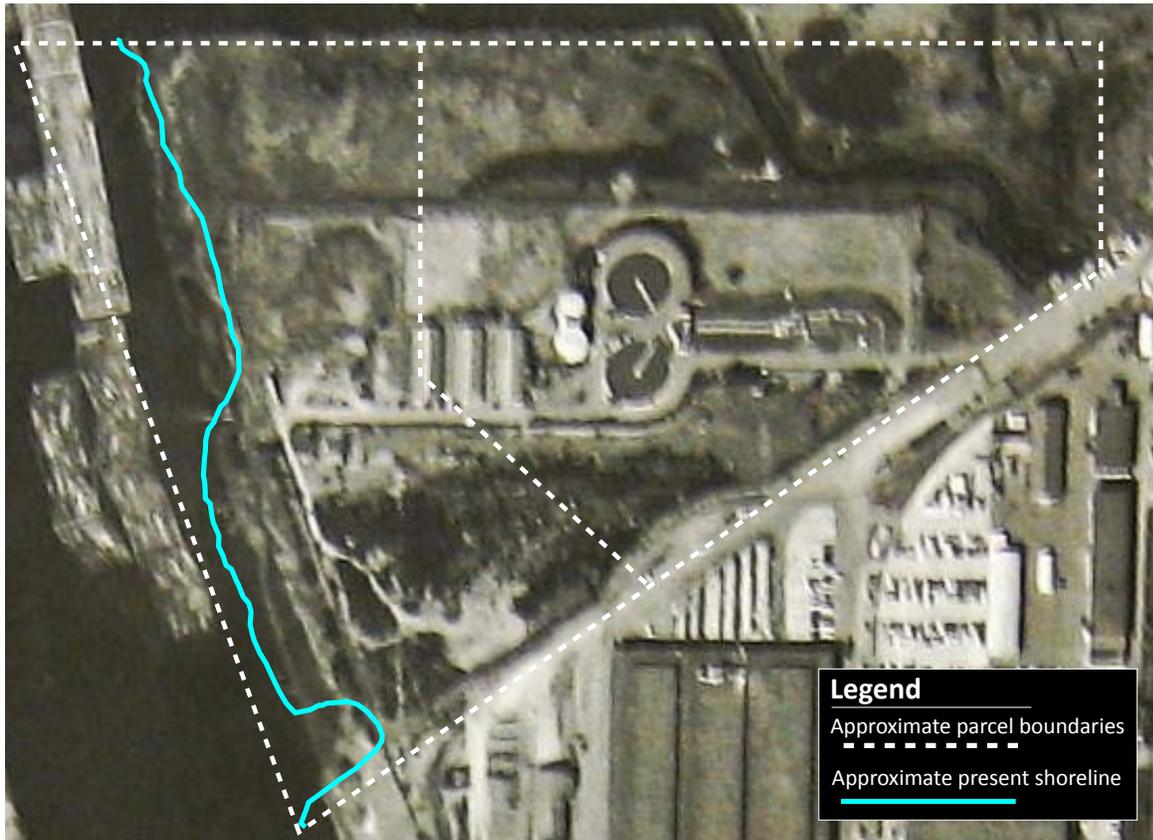
1953 aerial photograph (Source not reported)

The site layout observed in the 1953 photograph appears similar to the 1946 layout. In the 1961 photo, a large sludge pond is visible to the west of the clarifiers and digesters; additional sludge ponds may be present to the north of the treatment plant. A large parking lot has been installed on the southern portion of the property.

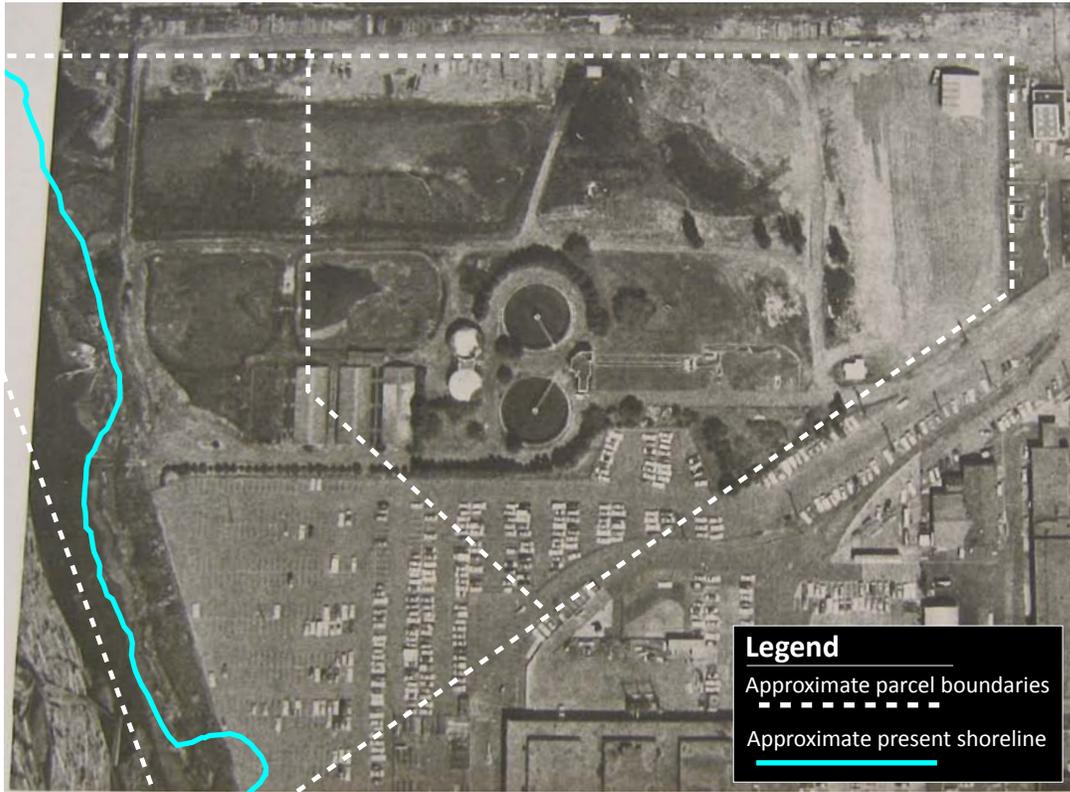
1970 aerial photograph (Washington Department of Natural Resources 1970)

In the aerial photograph from 1970, an additional structure has been added to the northeast corner of the Eastern Parcel. According to a historical map by the Kroll Map Co. contained in a historical report of site conditions conducted for Chevron by TAMS (1992), this may have been a pump house. Other changes from 1961 apparent on the 1970 photograph include filling of the tidal channel, clearing and grading on the northern and eastern portions of the site, and a reduction in the size of the open sludge pond located to the west of the clarifiers and digesters.

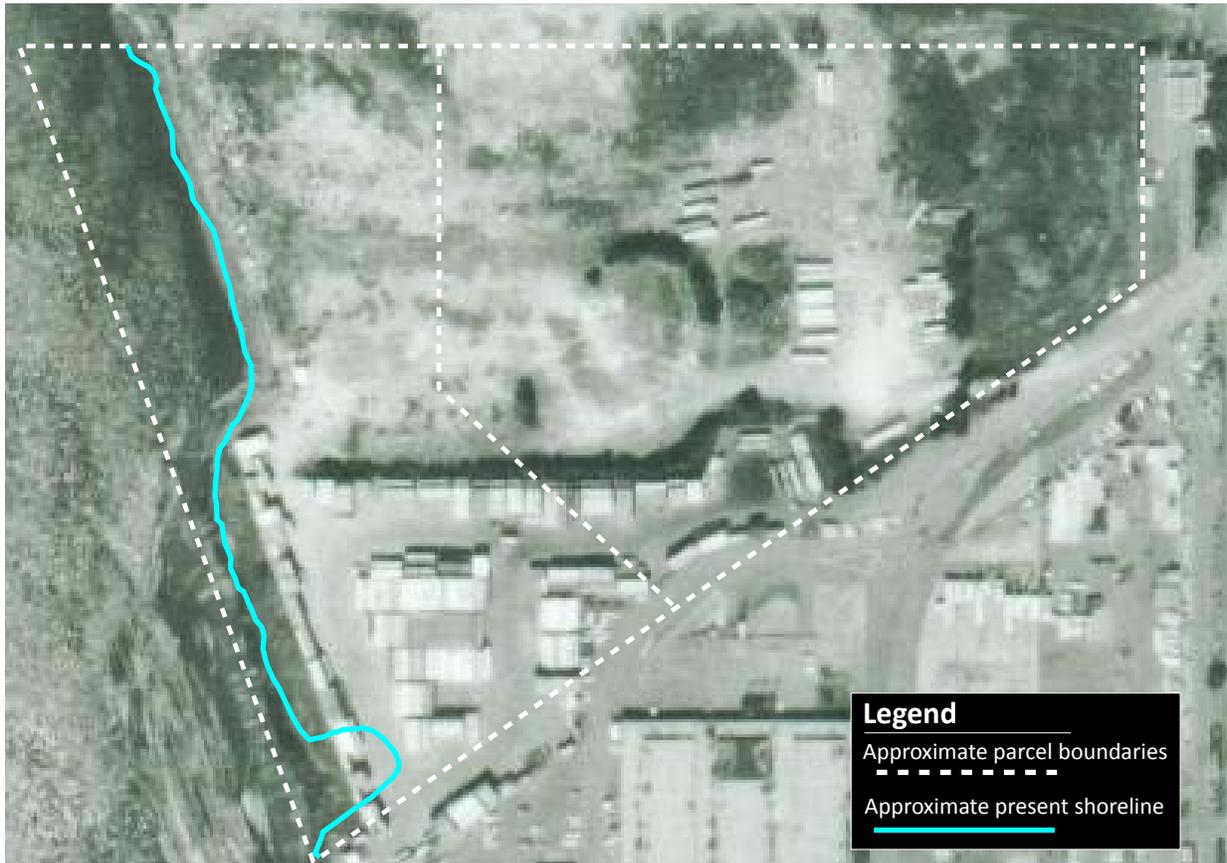
1981 aerial photograph (Washington Department of Natural Resources 1981)

In the 1981 aerial photograph, the STP has been removed and the shoreline along the northern portion of the property has been dredged. It appears that the paved parking area on the southern portion of the property and an area in the center of

the Eastern Parcel are being used to store shipping containers or similar large objects.

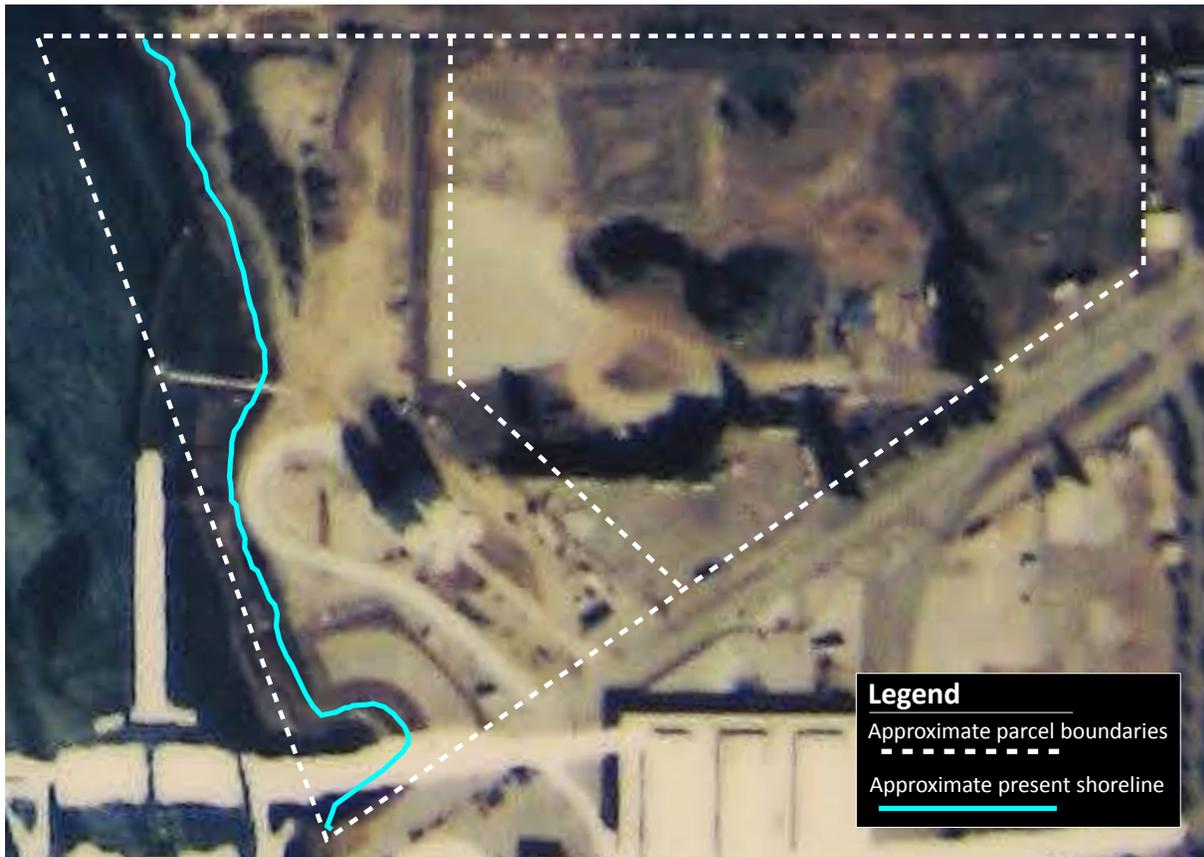
1990 aerial photograph (Metro Aerial 1991)

The Lafarge facility is apparent on the Western Parcel of the property in the aerial photograph from 1990. The pipeline dock, cement silos, and truck turn-around area are all distinguishable. The Eastern Parcel appears to be primarily vacant except for a few equipment storage areas visible on the central and southern portions of the parcel. The shape of the mitigation area on the southern portion of the shoreline is also apparent, and lumber is no longer being stored offshore of the property.

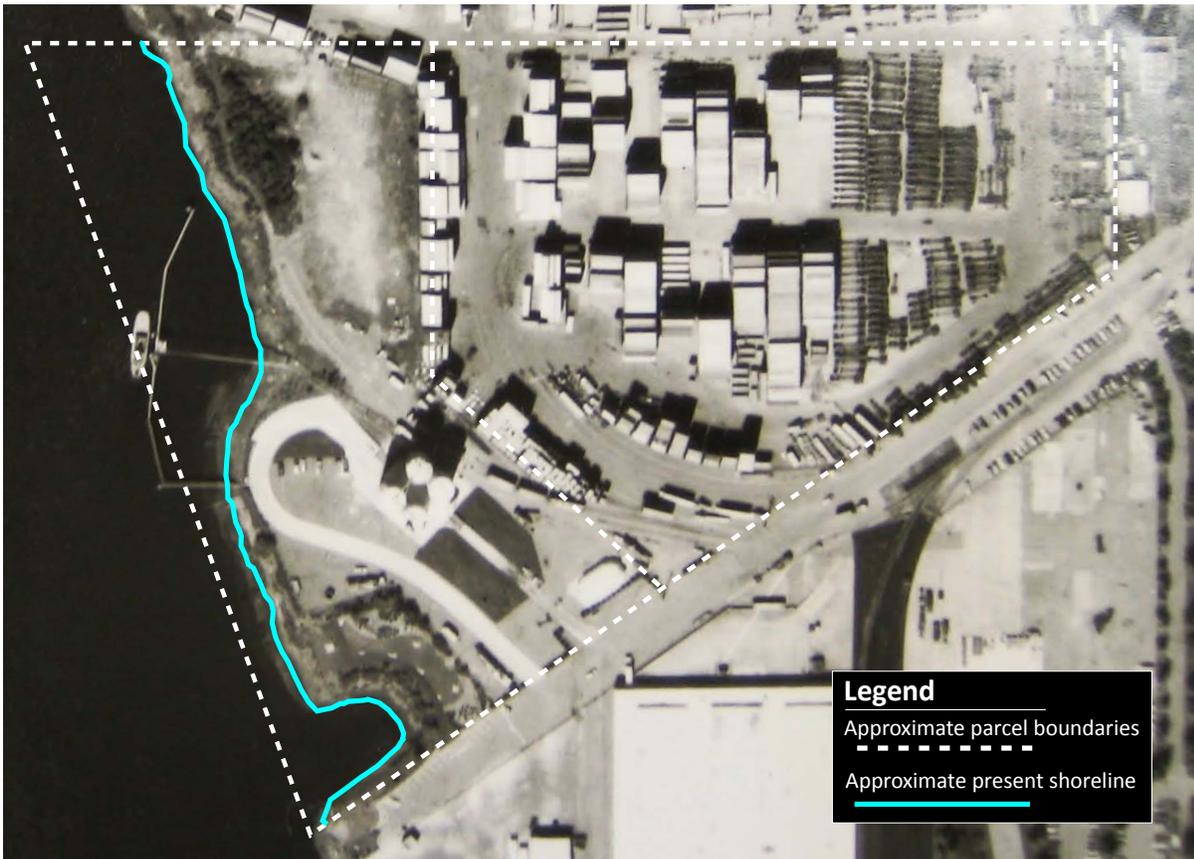
1995 aerial photograph (Washington Department of Natural Resources 1995)

In the 1995 aerial photograph, the T-108 container terminal is visible on the Eastern Parcel of the property, while the Lafarge facility remains on the Western Parcel. The mitigation area appears to be more fully developed than in the 1990 photo as vegetation is now visible.

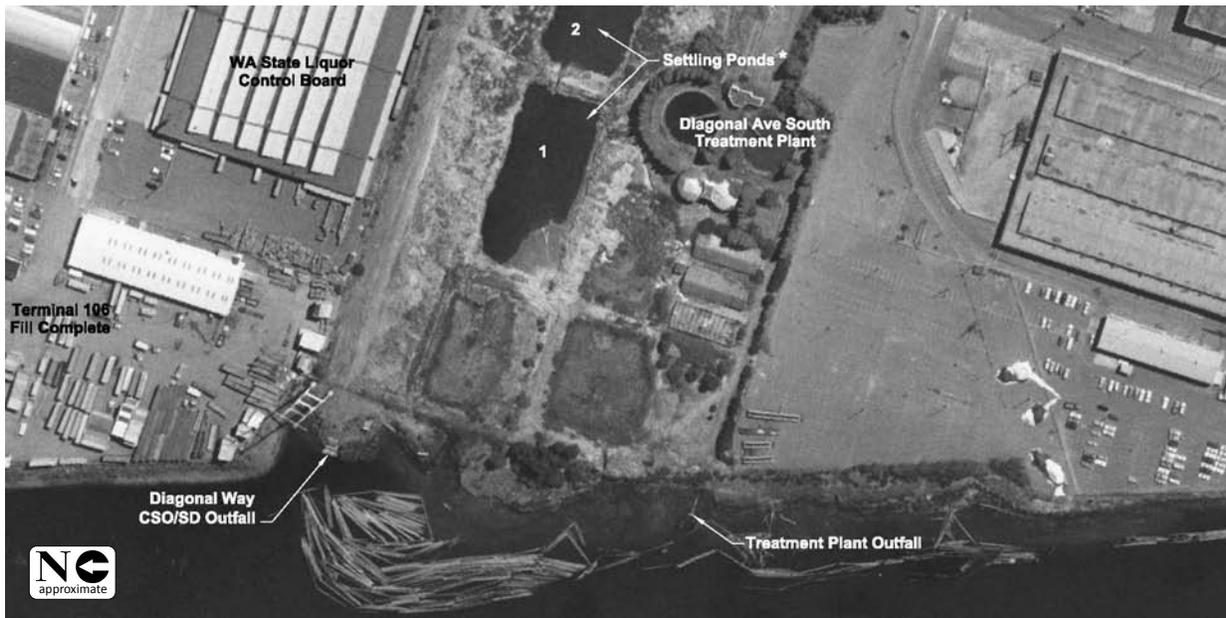
The aerial photographs with coverage of the western portion of the property acquired from the Duwamish/Diagonal CSO/SD Cleanup Study Report (King County et al. 2005) provides information on site conditions at T-108 in the mid-1970s. It was during this time period that the Diagonal Way STP was decommissioned, and also that two pits were excavated on the property to store and treat PCB-contaminated sediment dredged from the LDW. Based on these photographs, it is known that the sediment pits were present on the property in 1976 but had been filled by 1977. The Diagonal Way STP appears to have been decommissioned either in the latter half of 1976 or in 1977. The newly-dredged shoreline along the northern portion of the property is also clearly visible in the 1977 photograph. Overall, the historical aerial photographs reviewed during this investigation support the accounts of the property history reviewed in other reports and records.

1976 aerial photograph showing settling holding pits (KCDNR et al. 2005; photograph provided by US Army Corps of Engineers, Seattle District, dated July 28, 1976)

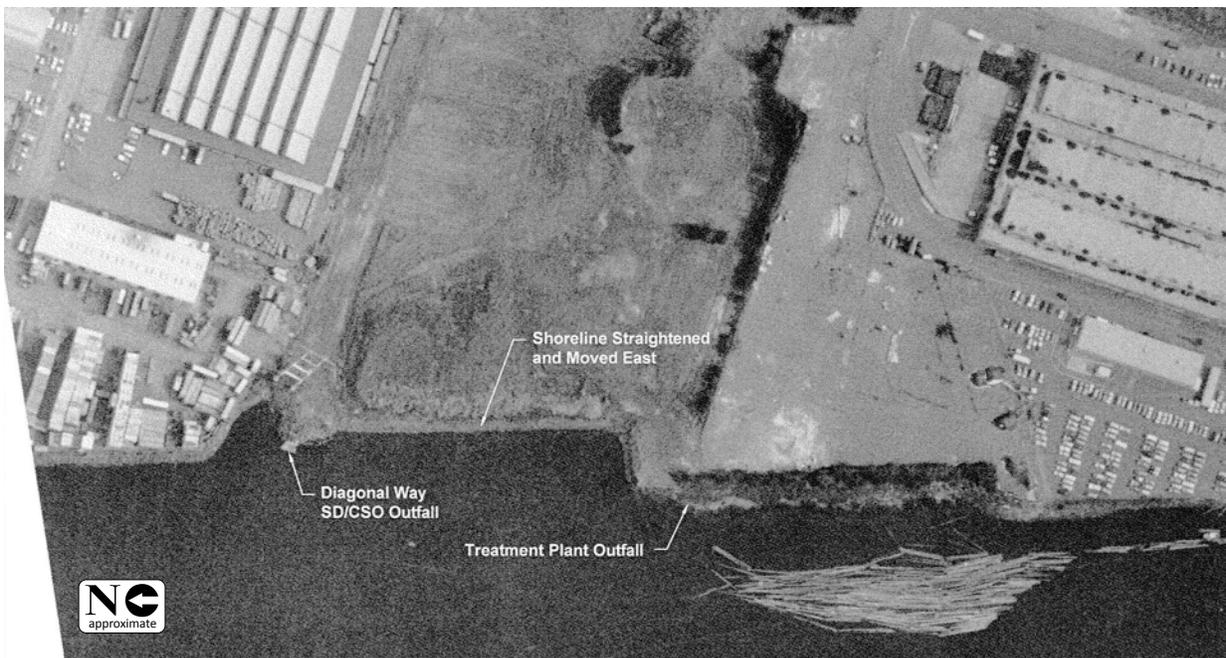
1977 aerial photograph showing settling holding pits filled (KCDNR et al. 2005; photograph provided by US Army Corps of Engineers, Seattle District, dated October 4, 1977)
