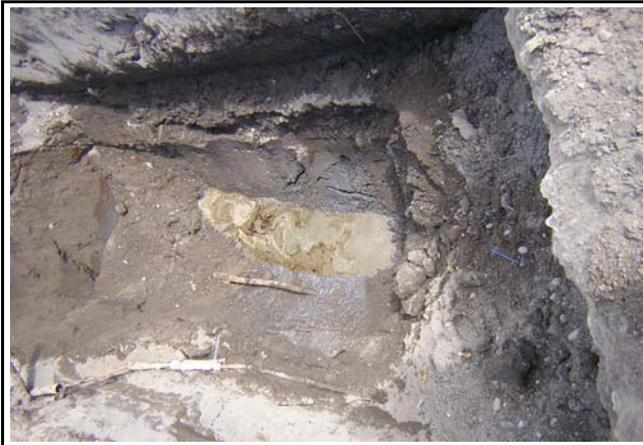
Photo 7. Bottom of Bunker C tank excavation after tank removed. Small amount of product visible on water surface.

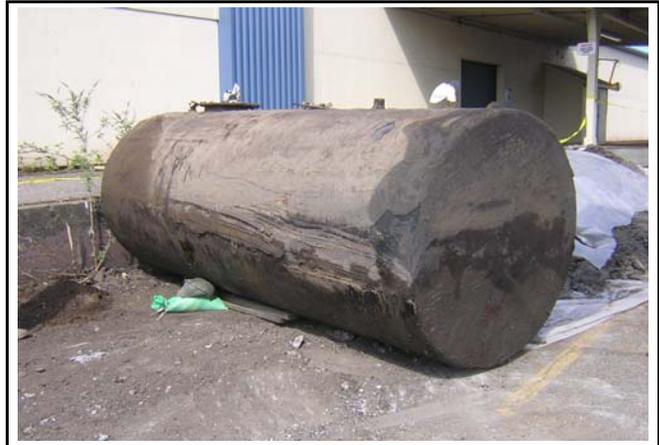
Photo 8. Bunker C tank after removal.

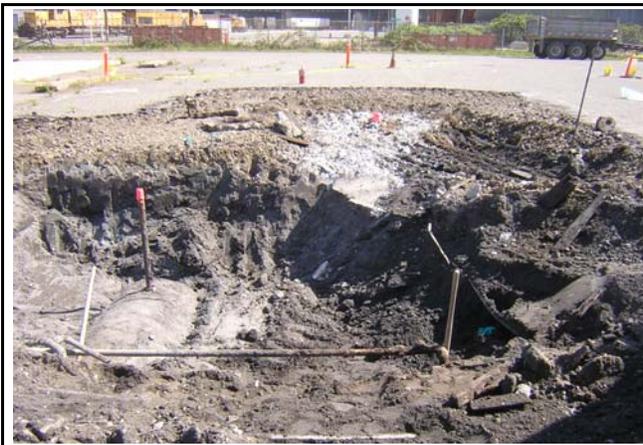
Photo 9. Diesel tank (left) and gasoline tank (right) after being uncovered.

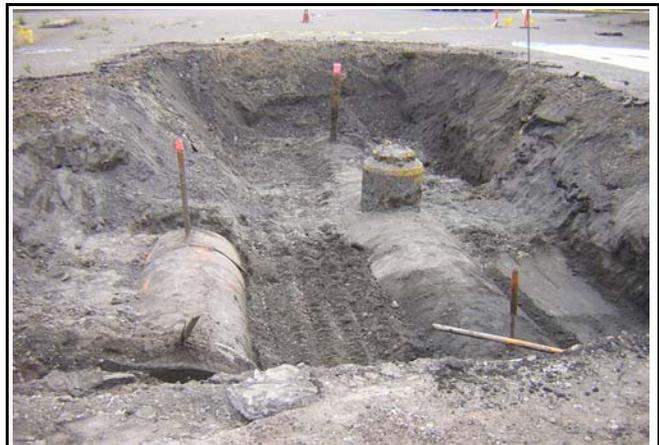
Photo 10. Diesel and gasoline tanks uncovered.

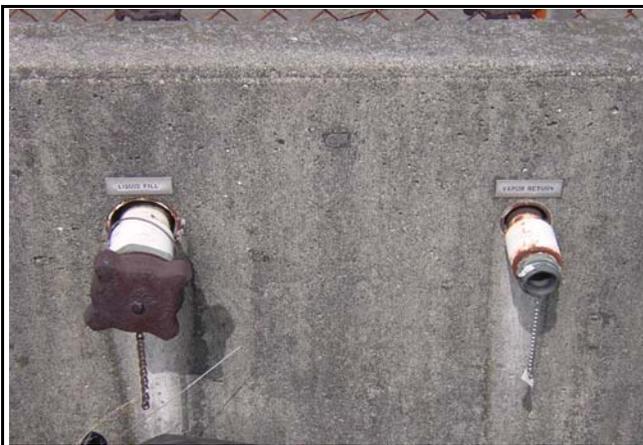
Photo 11. Concrete pipe header suspected to be for removed propane tank.

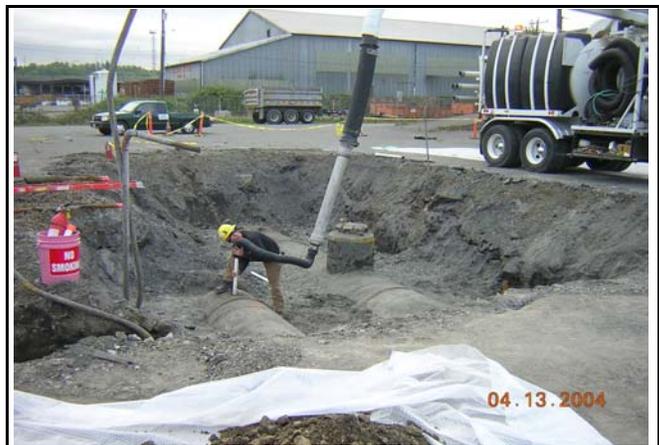
Photo 12. Pumping residual from diesel tank.
