Appendix C
Site Visit Report

Date: November 17, 2006
To: Iris Winstanley
From: Mark Dagele
Cc: Tina King
Subject: Trotsky site monitoring well inventory

**Site Visit: Industrial Container Services
November 15, 2006**

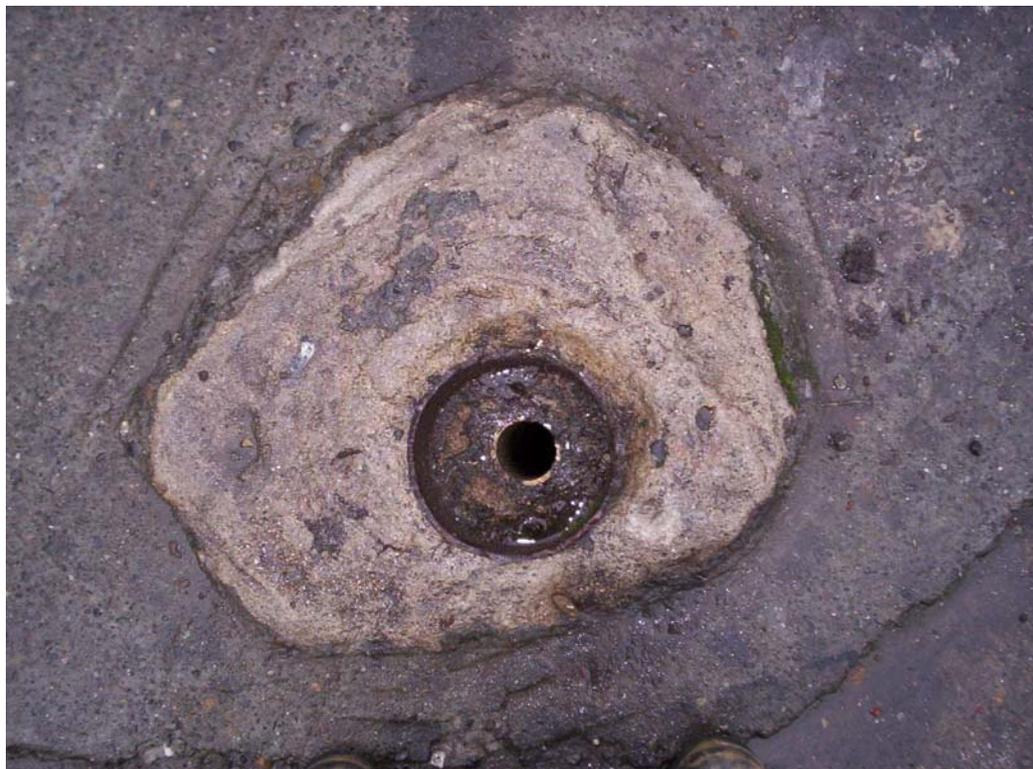
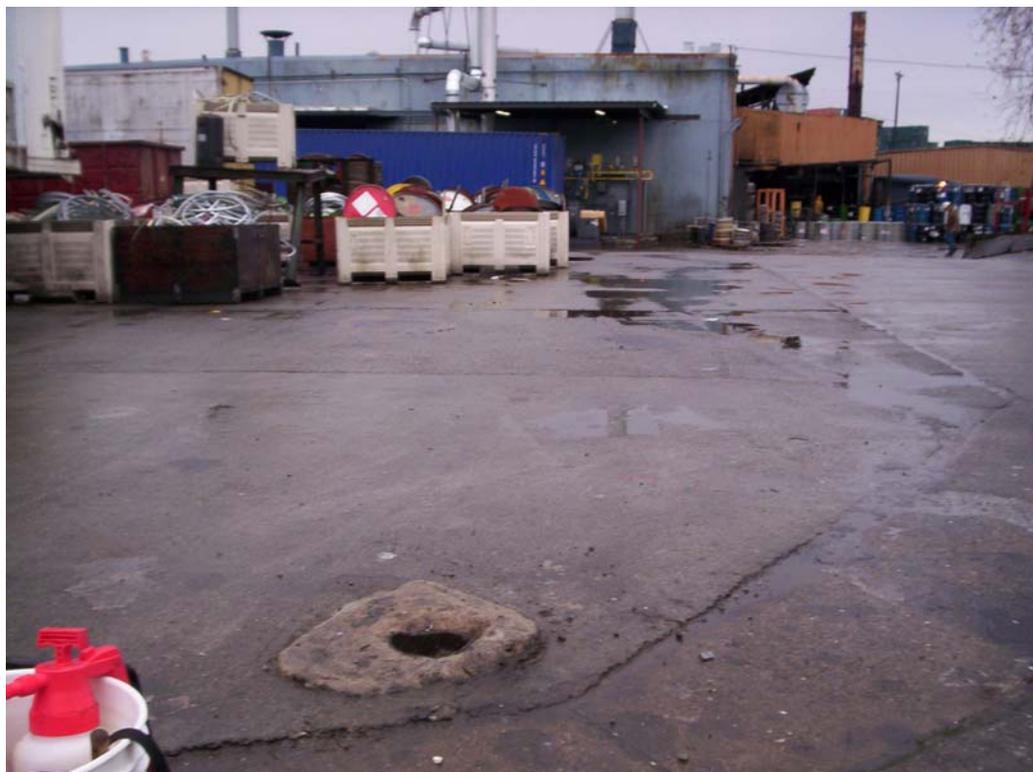
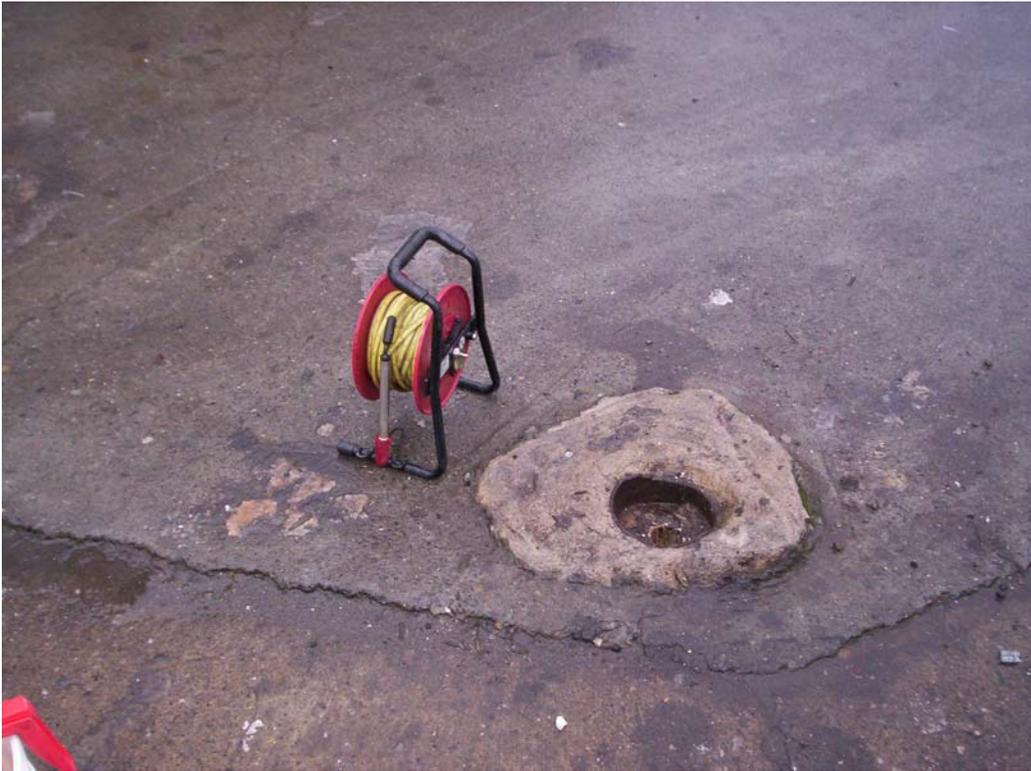
Photo 1: Well B-4

Notes: Subgrade completion in cast iron vault. Vault is broken (much of rim missing) and has no cover. PVC well was uncapped and cut flush with base of vault. Entire installation is in a concrete paved area.

Wells B-4 and B-5 are judged to be unsuitable for water quality monitoring. They appear to have been damaged and left open for an extended period of time. Staining in the PVC casing suggests that water and contaminants have likely run down into the wells over the years. These wells may be useable for water level elevation measurements only. In this case, the well completions should be replaced by a driller (licensed per WAC 173-162) so that they can be properly sealed and then properly maintained. Otherwise, these wells should be abandoned per WAC 173-160.

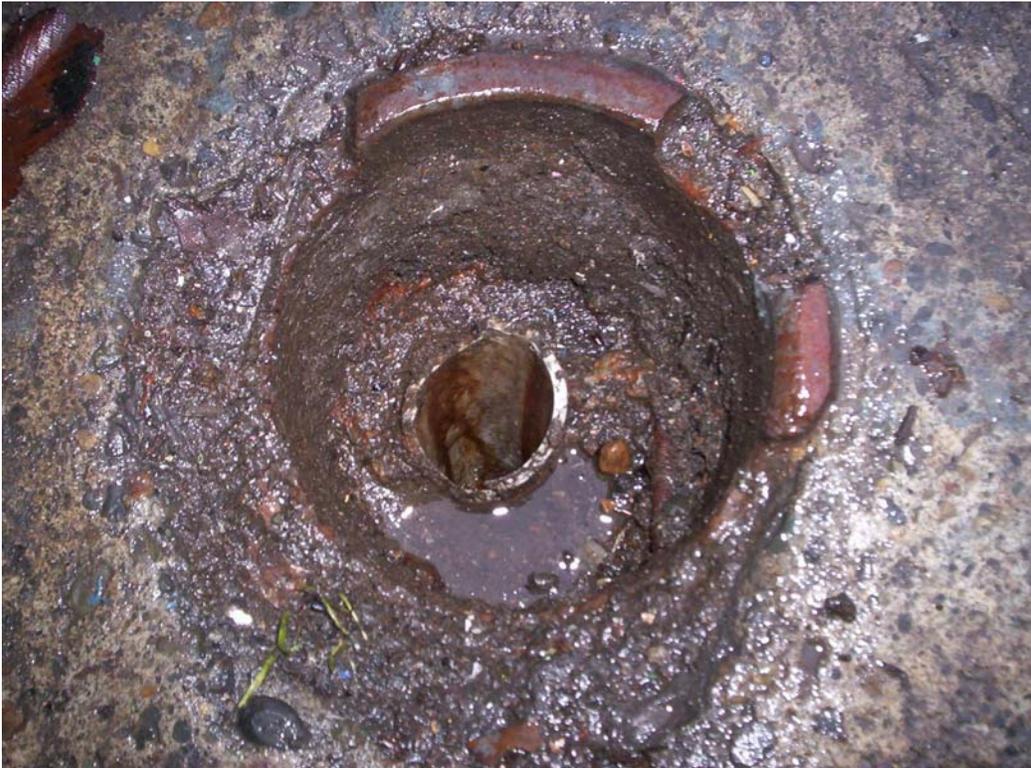
Photo 4: Well B-5

Notes: Subgrade completion in cast iron vault. Vault is broken (much of it is missing) and has no cover. PVC well was uncapped and broken flush with base of vault. Entire installation is in a concrete paved area.
