From: Dave McClure [DaveM@co.klickitat.wa.us]
Sent: Friday, December 17, 2004 4:59 PM
To: 303d
Cc: Schuler, Gregory A.
Subject: 0298-2002/2004 Water Quality Assessment (303[d]) List Information

Klickitat County's Comments regarding stream segments on Swale Creek, tributary to the Klickitat River, proposed for the 303(d) list

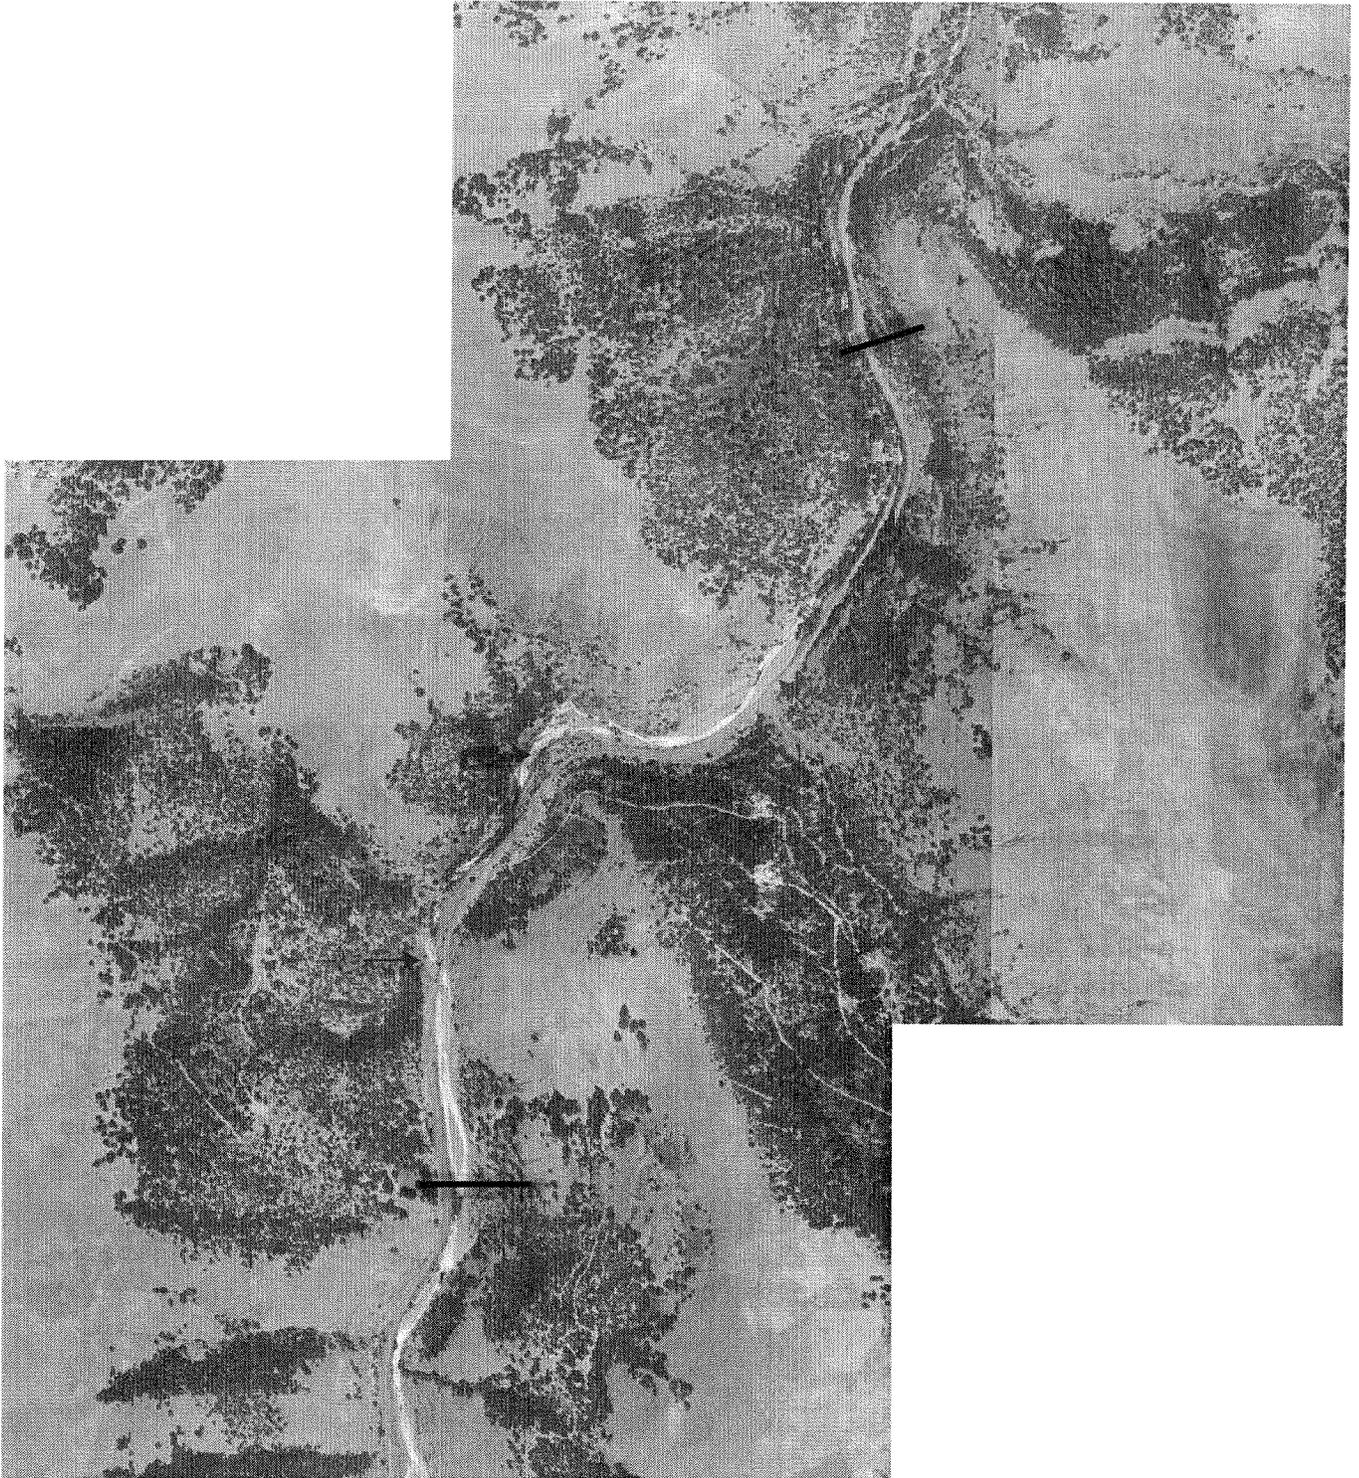
Figure 1. July 16, 1996 aerial photograph of the Swale Creek segment proposed for listing for temperature under category 5 (listing ID 7962). The blue lines correspond roughly to the boundaries of the segment. The red arrows indicate the locations of pools apparent in the photographs.

Summer flow in this stream segment is negligible. The segment goes largely dry in summer. Isolated pools are often present in some locations along the segment. On July 16, 1996, aerial photographs revealed the presence of 5 small pools along the segment (Figure 1), although a few others may be present in the shadows. The majority of the segment, however, was dry.

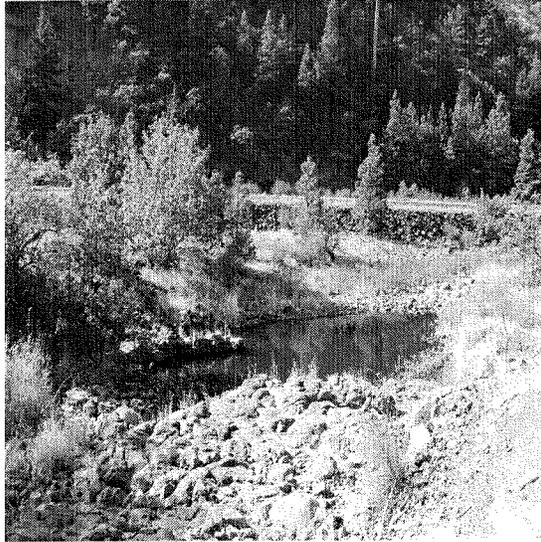
Figure 2. Photograph of dry channel in the subject reach (listing ID 7962).

A survey of the stream conditions in Swale Creek was completed in the summer of 2003 (WPN and Aspect, 2004, Appendix E). The listed segment is largely confined to basalt pools (Figures 2 and 3), often with a narrow stream trickling between the pools. There are long stretches with little or no vegetation along stretches of dry bed of cobble. Vegetation is associated with moisture availability. Vegetation is most found most commonly adjacent to perennial pools but is absent where bedrock outcrops exist. A short distance downstream of the listed segment, water is present continuously throughout the year, but is disconnected from the Klickitat River at the mouth, where flow goes subsurface in alluvial deposits. Flow in this area is less than 0.5 cfs (too low to be measured with conventional techniques). Where the stream is continuously wetted, vegetation is present and is relatively dense.

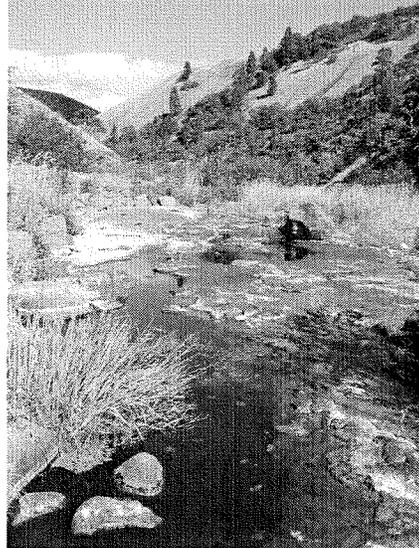
Figure 3. Photograph of one of the pools in the subject reach (listing ID 7962).

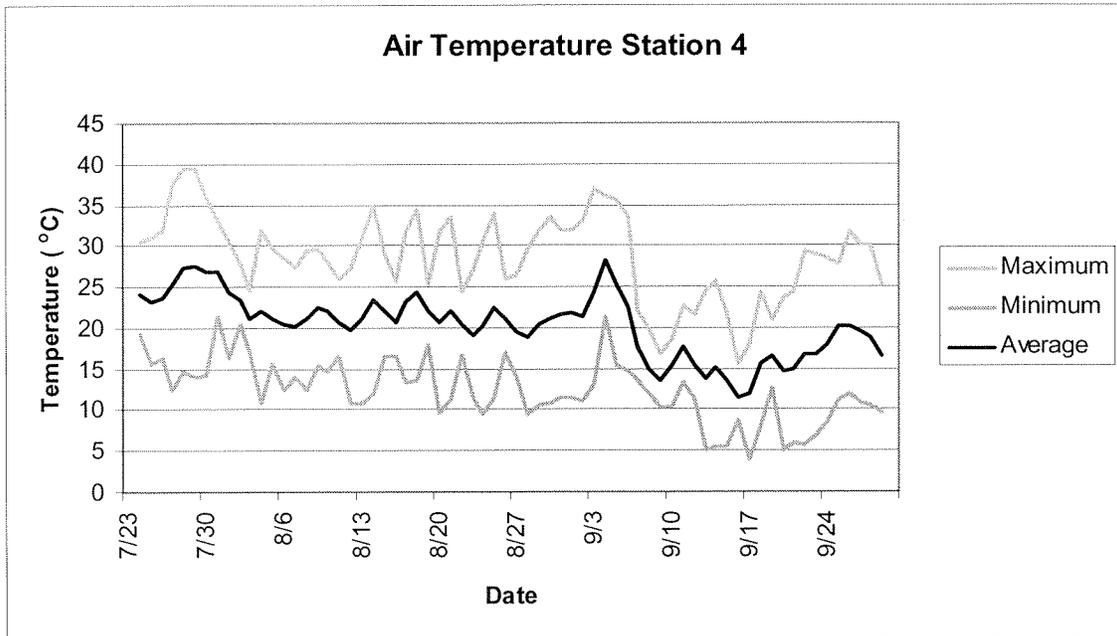
Figure 4. Air temperature recorded in 2003 near the downstream boundary of the listed segment (listing ID 7962).

Air temperatures in the area of the listed segment regularly reach 35°C (95°F) and can reach as high as 40°C (104°F) (Figure 4). These air temperatures have direct effects on the standing water in the few pools present in the reach. The corresponding water temperatures were not recorded since the stream went dry in summer within this reach.

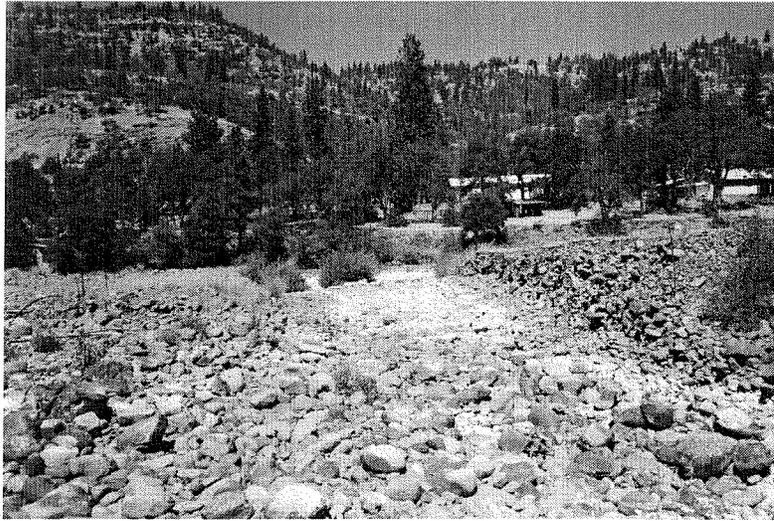
Figure 5. Picture of the stream segment (ID 6206) of Swale Creek near the confluence with the Klickitat River.

The stream segment that is proposed of listing for instream flow in Swale Creek is located near the confluence of the stream with the Klickitat River. This area goes dry in summer (Figure 5). Upstream of the segment, flows are not measurable using conventional methods, but have been estimated at less than 0.5 cfs. The listed segment is a depositional area that is avulsed (Figure 6). Here, flows go subsurface in the deposited alluvium. This fan is subject to disturbance by major storm events (WPN and Aspect, Appendix E). The high flow channel has shifted dramatically over time due to such events.

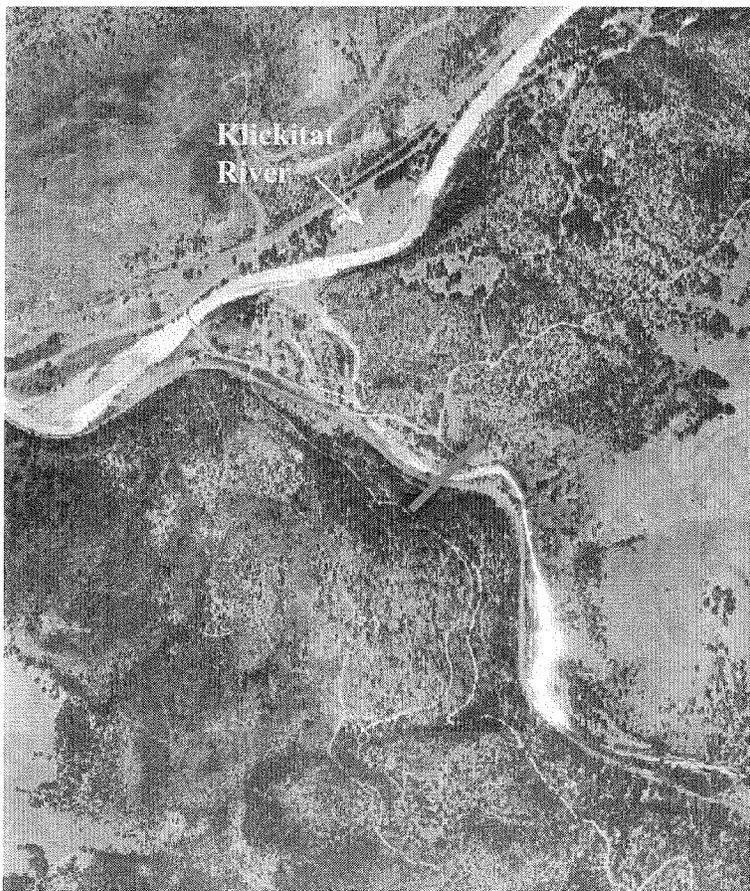
Figure 6. July 16, 1976 aerial photograph of the segment of Swale Creek (ID 6206) listed for instream flows. Note the presence of an alluvial fan at the confluence with the Klickitat River. The blue line indicates the upstream boundary of the segment.
