## Case Study 1: Valley View Middle School

## Case Study 2: Yelm Highway

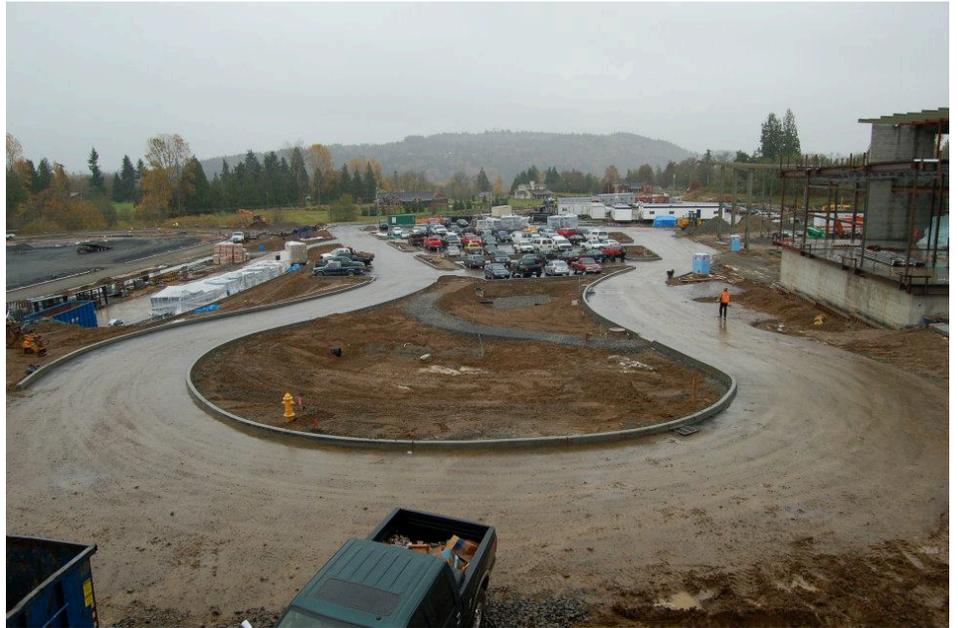
**Details:** Lenz Enterprises in Snohomish County has been making rain garden bioretention soil mixes. Two of their most recent projects included a rain garden at the Burlington Byway Center at Railroad Park in Burlington, Washington and another rain garden at Valley View Middle School in Snohomish, Washington. Earthscapes Northwest created the soil specification for the Valley View Middle School project. It took 6 months and 6 sets of tests to meet the parameters, but Lenz succeeded. The rain gardens have been installed and are functioning well.

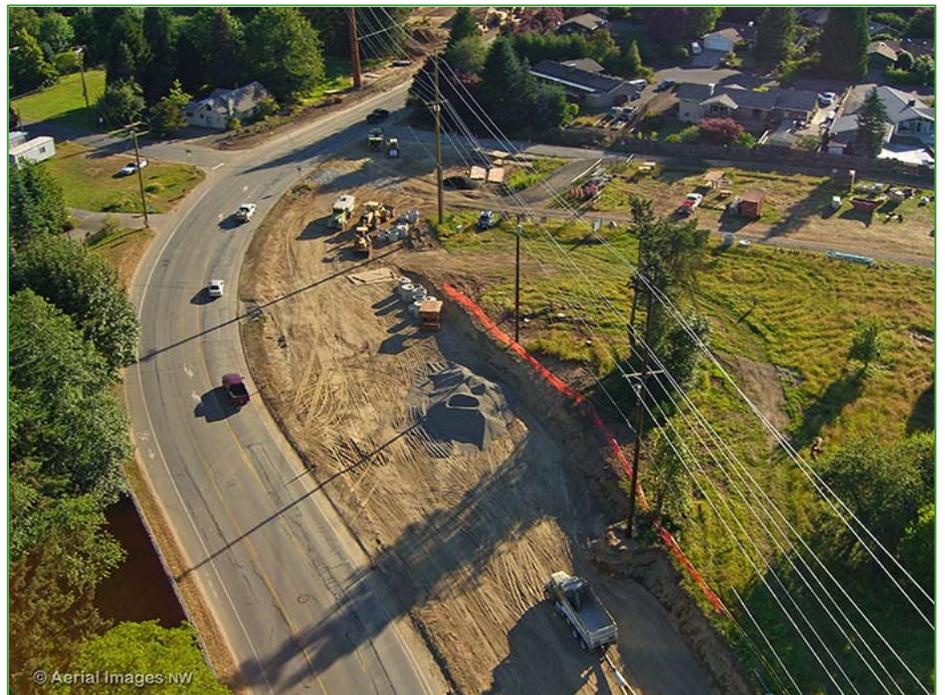
**Details:** The Yelm Highway project was a roadside bioretention project calling for a 60% sand and 40% compost mix. The client requested the cost of additional testing needed to meet the specification be carried by the compost supplier. The bioretention soil mix (BSM) was sampled every 5 loads on delivery to assure consistency of the product. Halfway through the project, the customer determined that the mix was too fine and returned the mix for reprocessing. After the project was completed, the customer found cobbles in the mix and brought up the issue with the bioretention mix supplier. The supplier indicated that cobbles could not make it through their grinder. After further site investigation, it was discovered that augers had been used to drill through the BSM to install trees and during that process, had mixed cobbles from the native soil into the BSM.
