Documenting Progress Report for Effectiveness Monitoring of the South 356th Street Retrofit and Expansion Project, Federal Way, WA (Deliverable D2.2)

Submitted to Brandi Lubliner, Ecology – RSMP Coordinator

Submitted by Kate Macneale, King County

Submitted on February 10, 2016

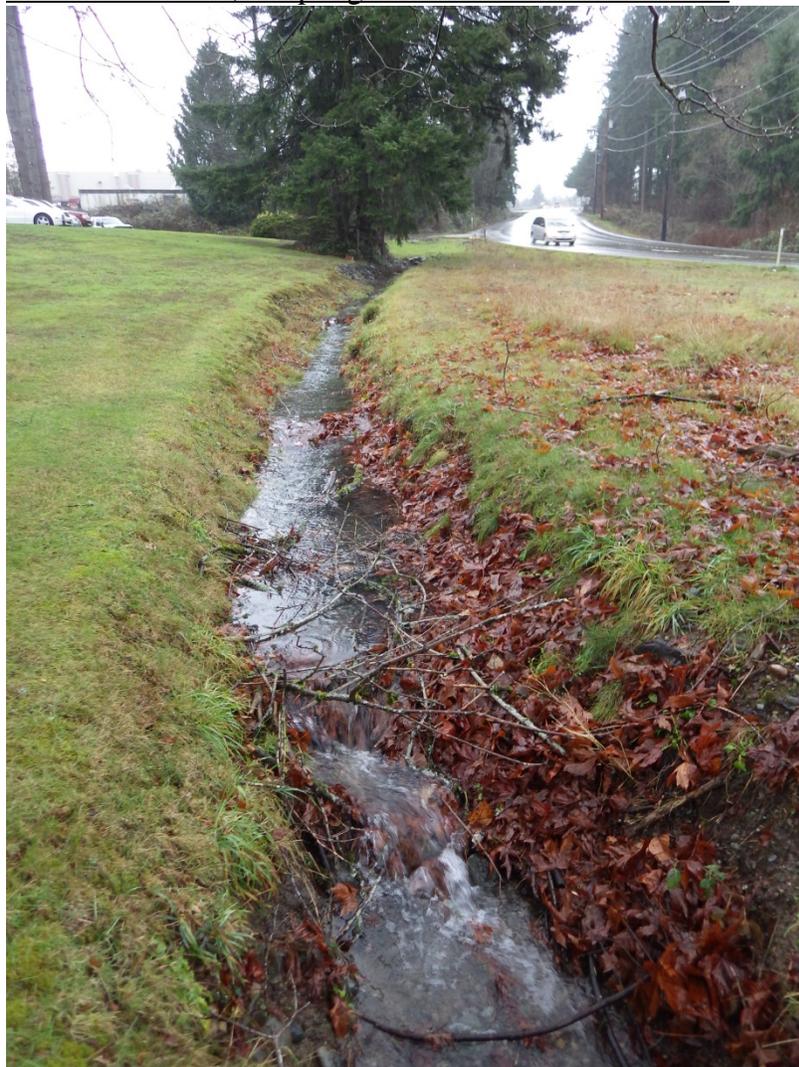
Stormwater runoff flowing towards bioretention facilities on December 21, 2015 (photo taken looking upstream and east on S. 356th Street).

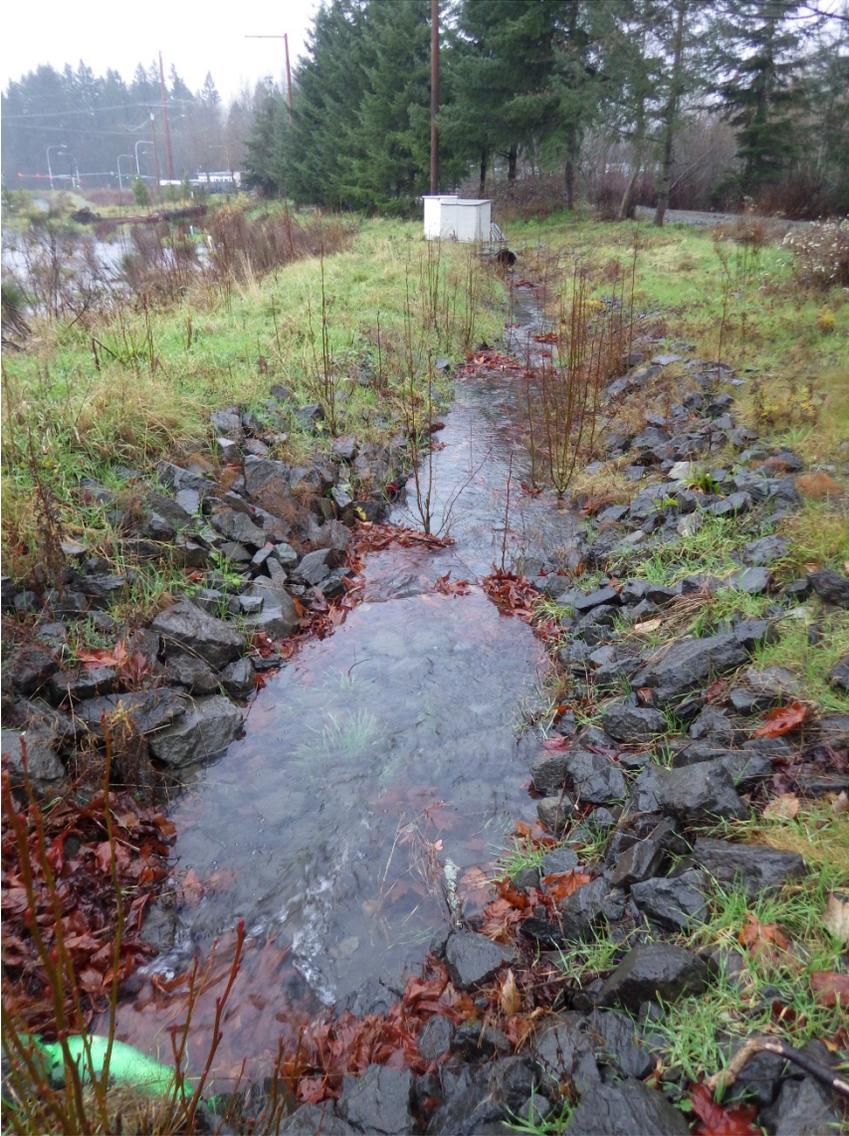
Stormwater runoff flowing towards bioretention facilities on December 21, 2015 (photo taken looking downstream). The east bioretention facility can be seen in the background.

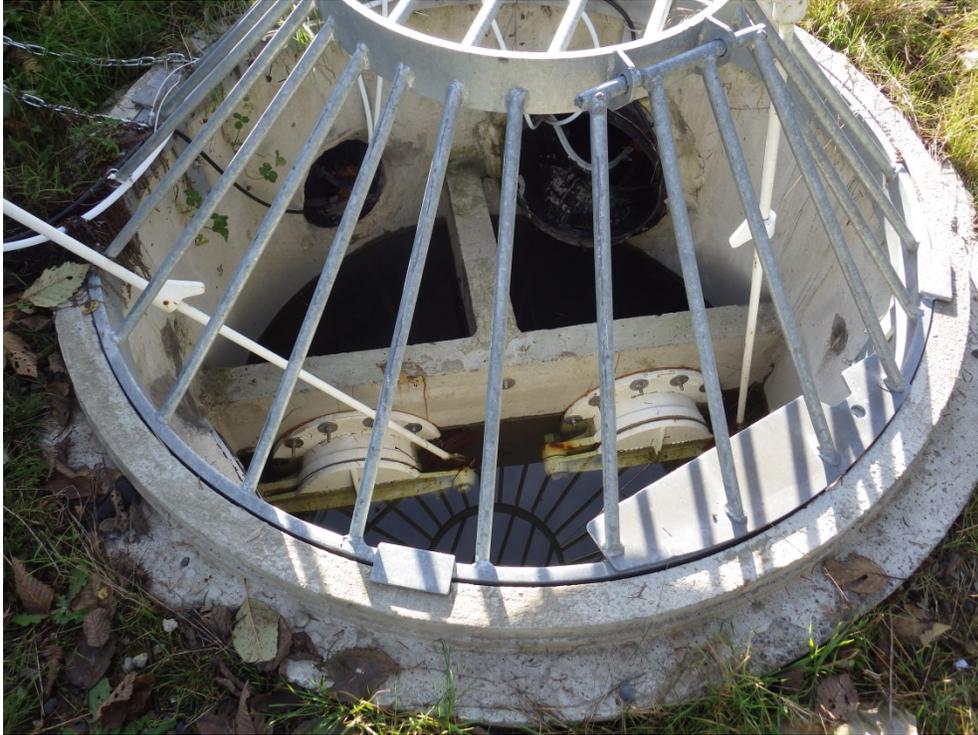
Inflow sampling locations for the east (left) and west (right) bioretention facilities on November 20, 2015.

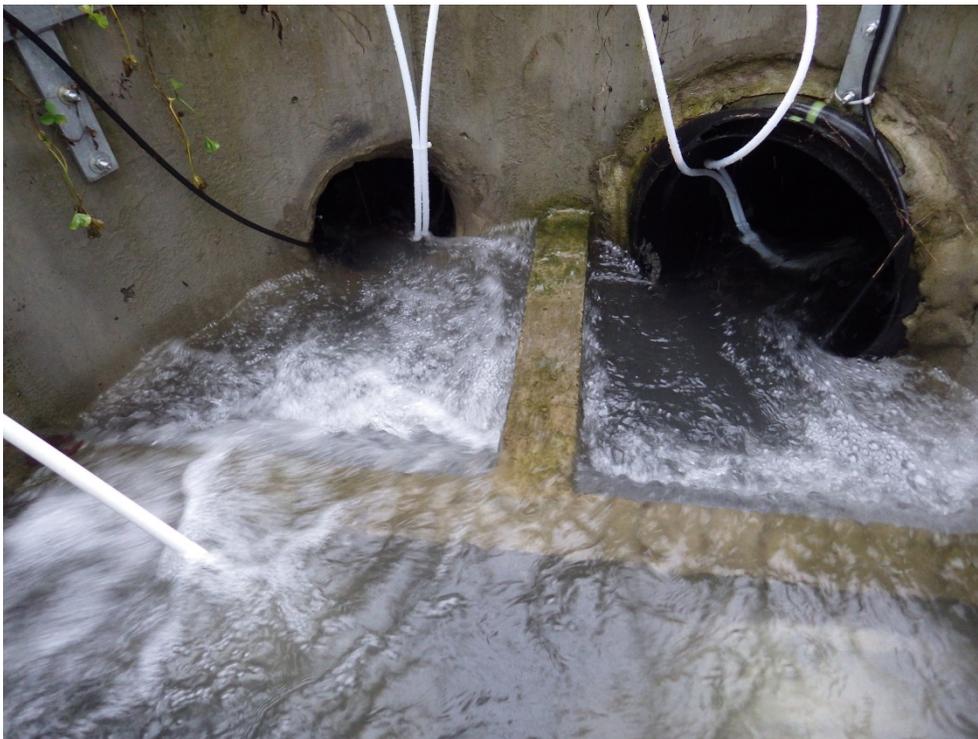
Inflow sampling locations for the east (left) and west (right) bioretention facilities on December 21, 2015.

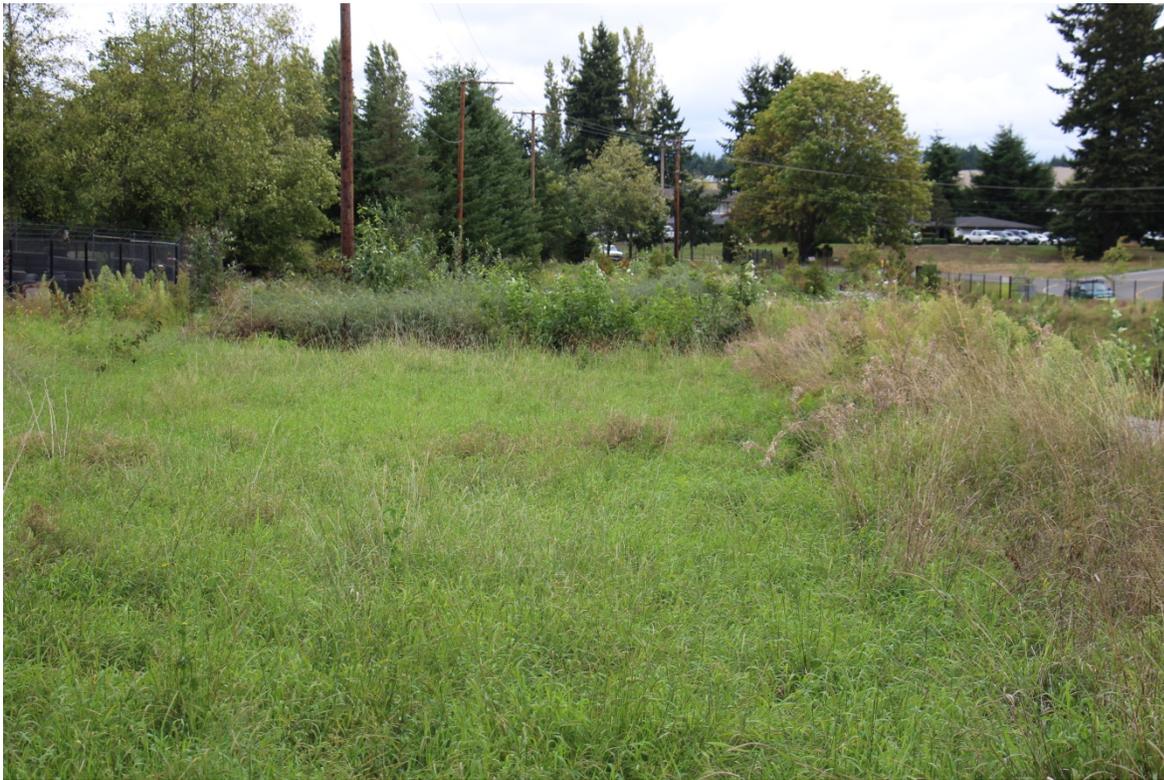
The west bioretention facility on September 17, 2015. The facility was dry throughout.

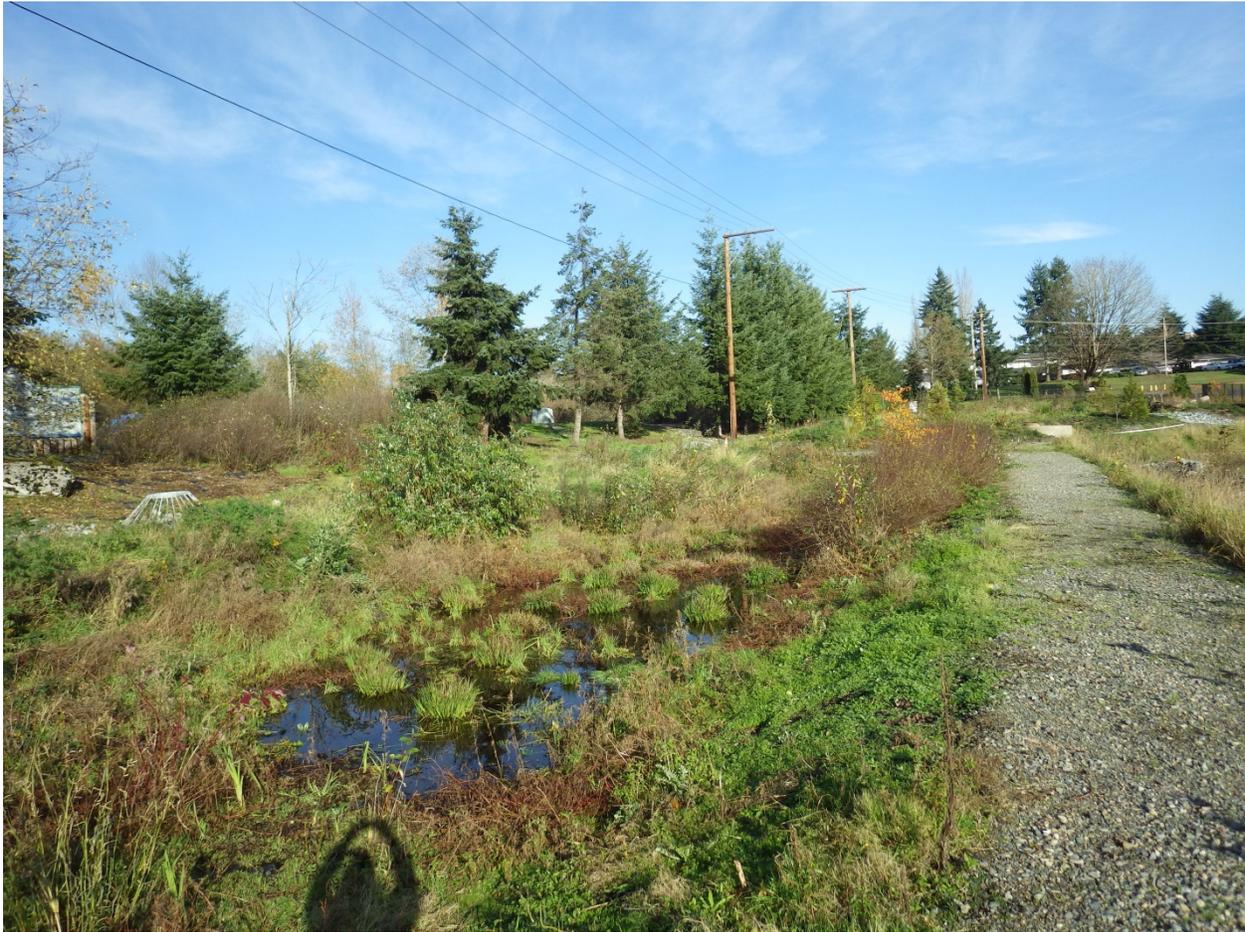
The west bioretention facility on November 20, 2015. It had rained 1.3 inches three days before this photo and there was standing water remaining in the eastern half (where it is not underdrained, seen in photo) but none in the western half (that is underdrained, not seen in photo).

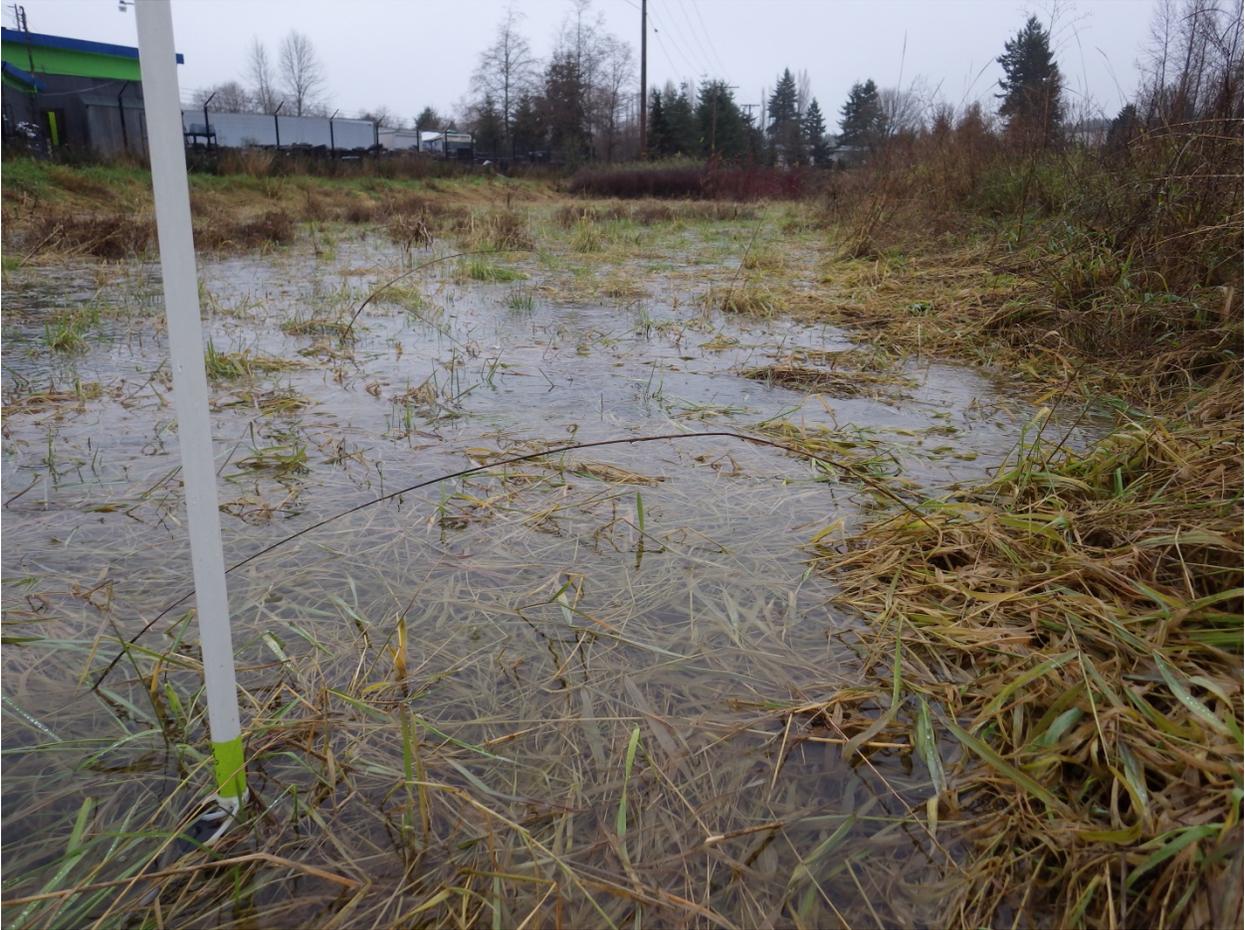
The west bioretention facility on December 21, 2015. The submerged depth logger is attached to the white stake.

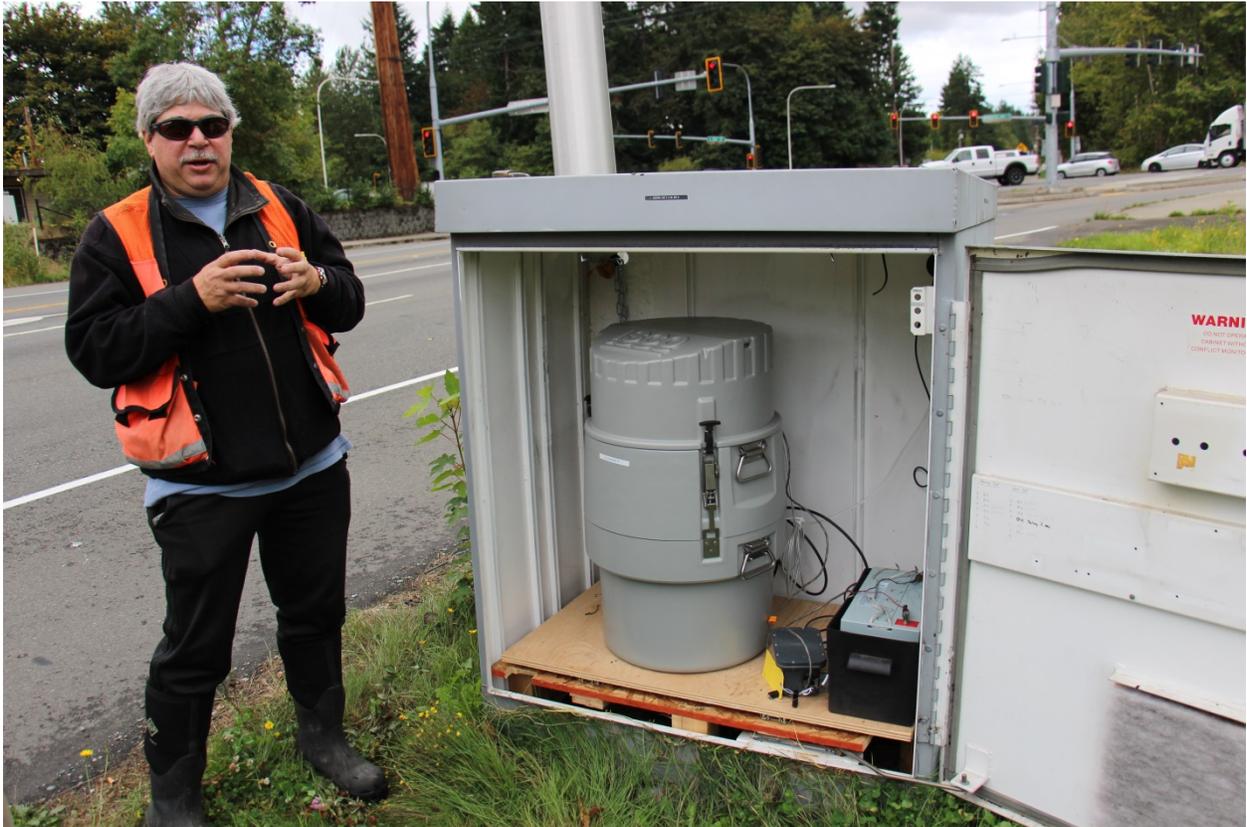
Jeff Droker (King County) standing near sampling location and the autosampler at the west bioretention outlet (WBO).

Flow data at the WBO were unreliable initially because there were obstructions in the pipe and the water in the catch basin was backing up. By early January 2016, the problems were resolved by removing rocks in the pipe that were obstructing flow, replacing the bubbler meter with an AVM meter, and positioning the AVM meter far enough in the pipe to avoid the backed-up water in the catch basin.

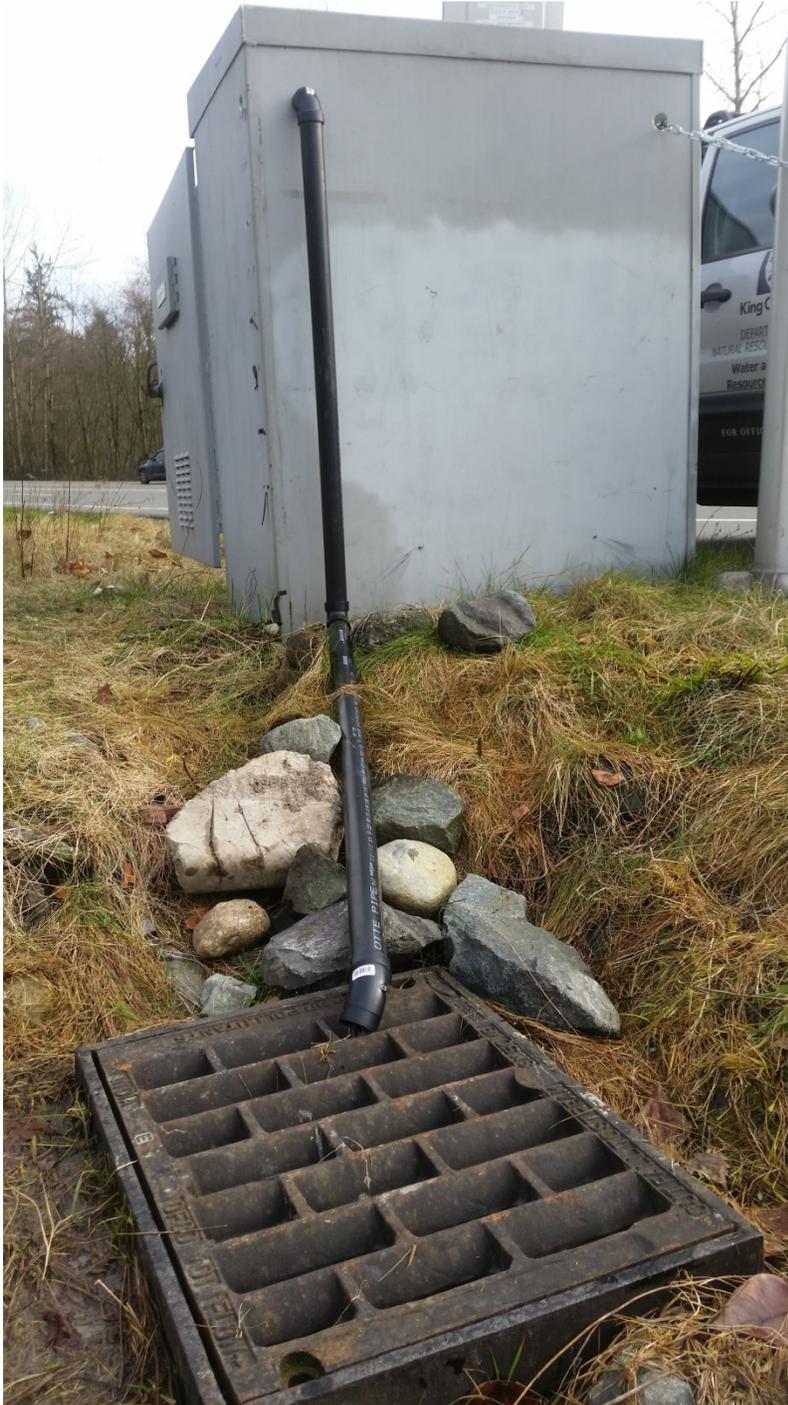
Grate over catch basin that WBO drains to, and the shed that contains autosampler for WBO. The black pipe protects the sample tubing that runs from the WBO to the autosampler.

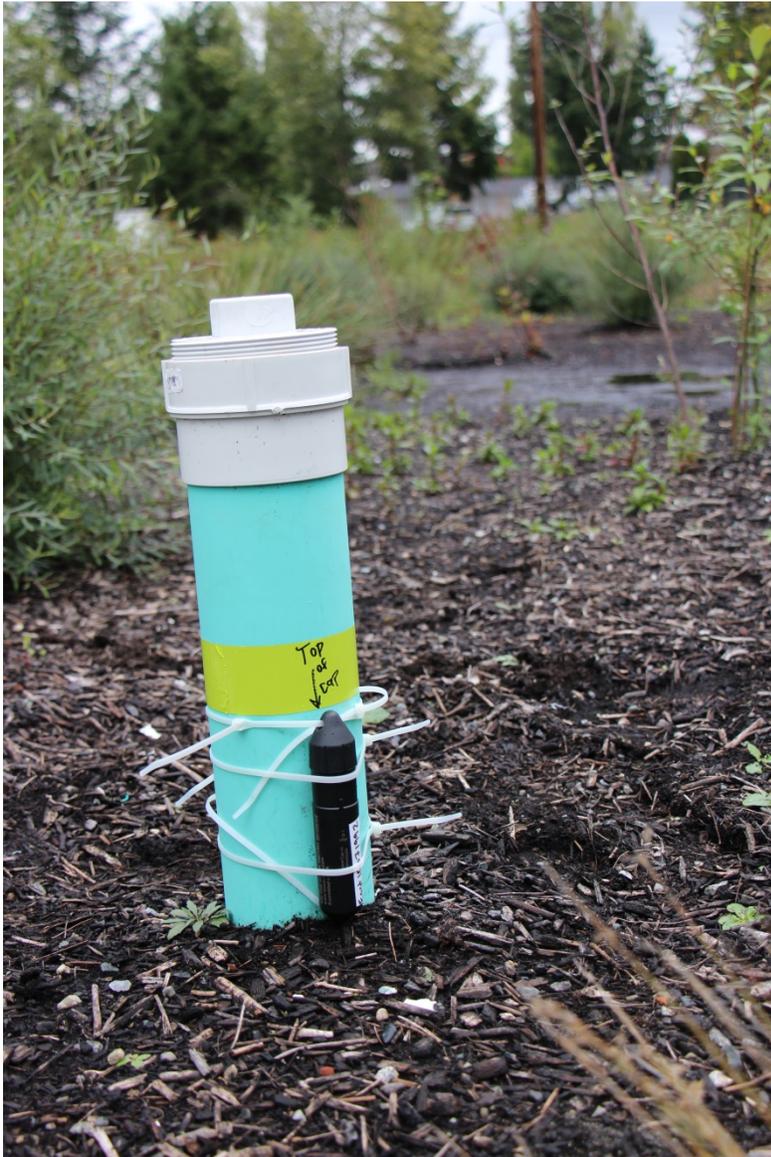
The depth logger in the east bioretention facility when it was installed on September 17, 2015.

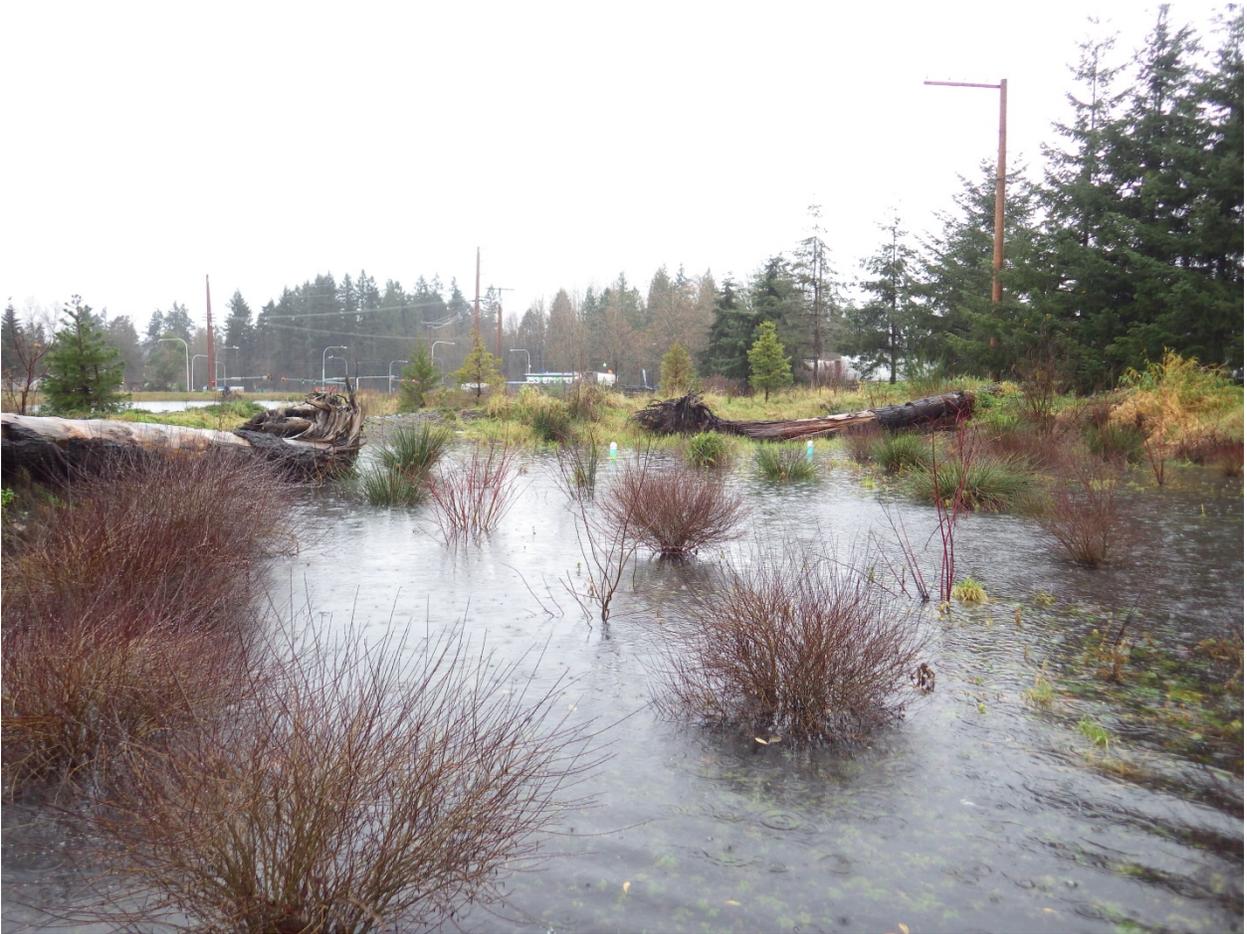
The east bioretention facility on December 21, 2015 (looking west).

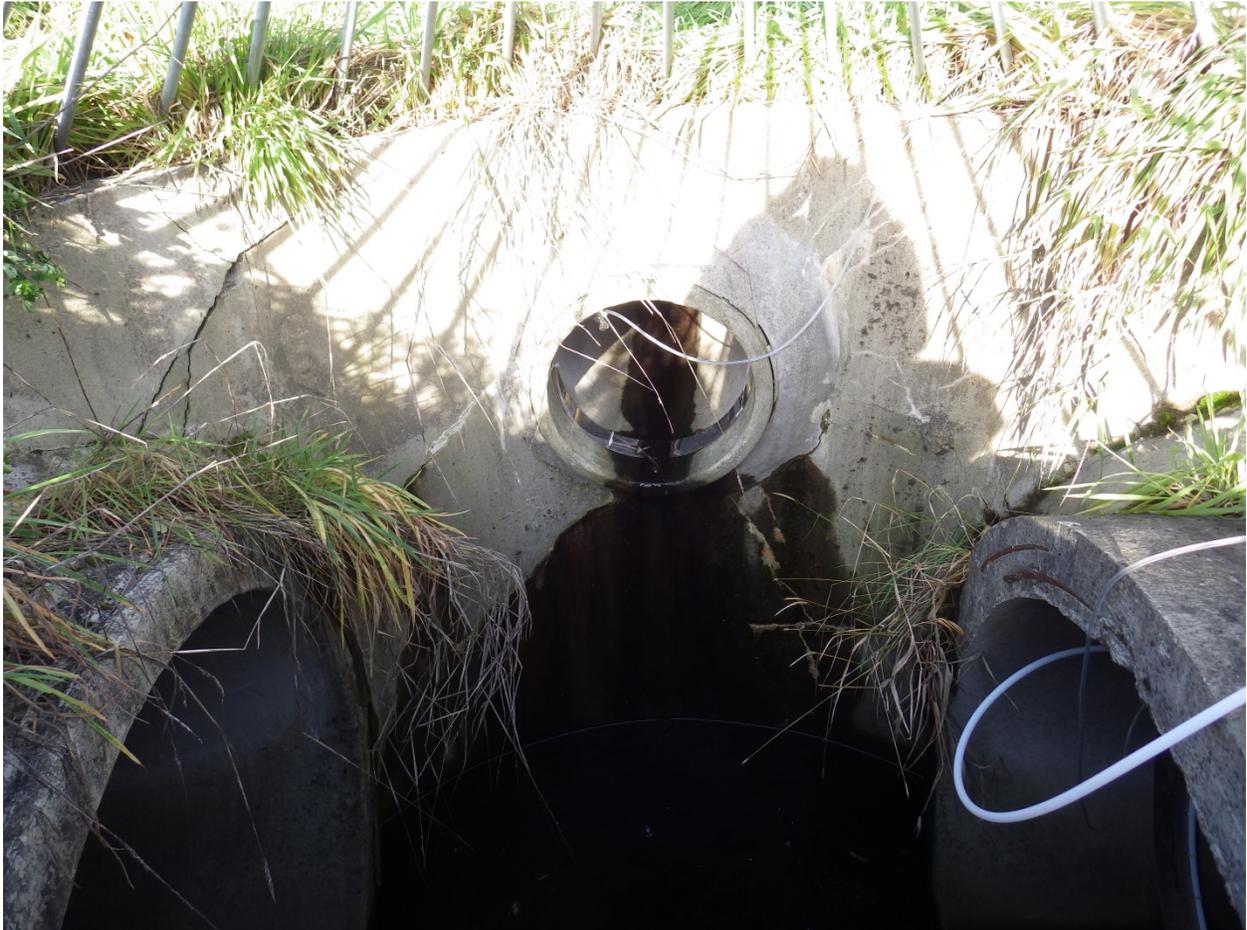
The small pipe was the initial sampling location for the east bioretention outlet. This location was moved in early January 2016 to a connector pipe upstream of this location. The new location is not influenced by flows diverted from the bioretention facilities (which can happen during large storms) and it receives only water flowing from the east bioretention facility.

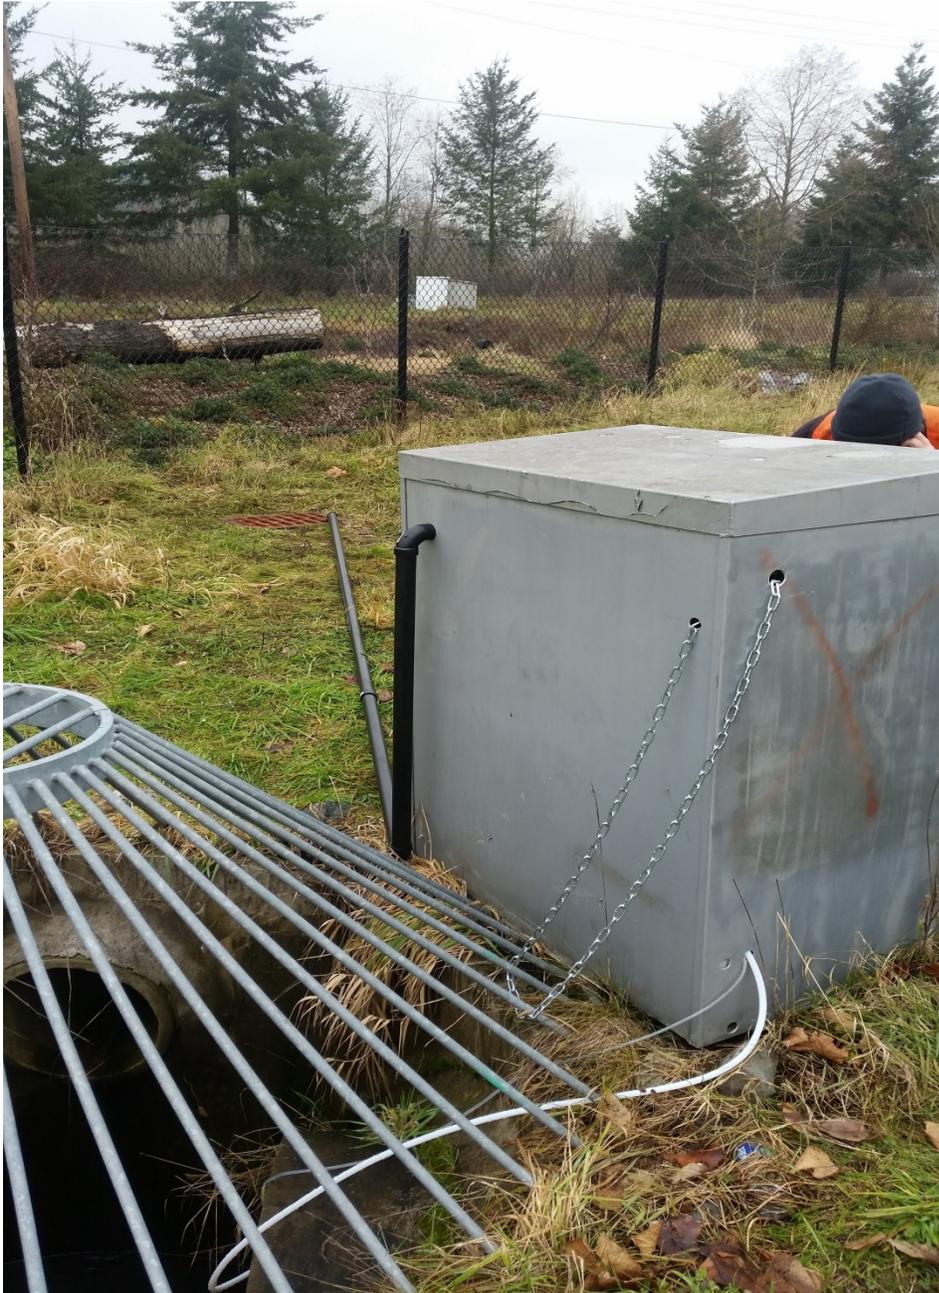
The new sampling location for the outlet of the east bioretention facility (EBO) is accessed through the grate at the far end of the black pipe.

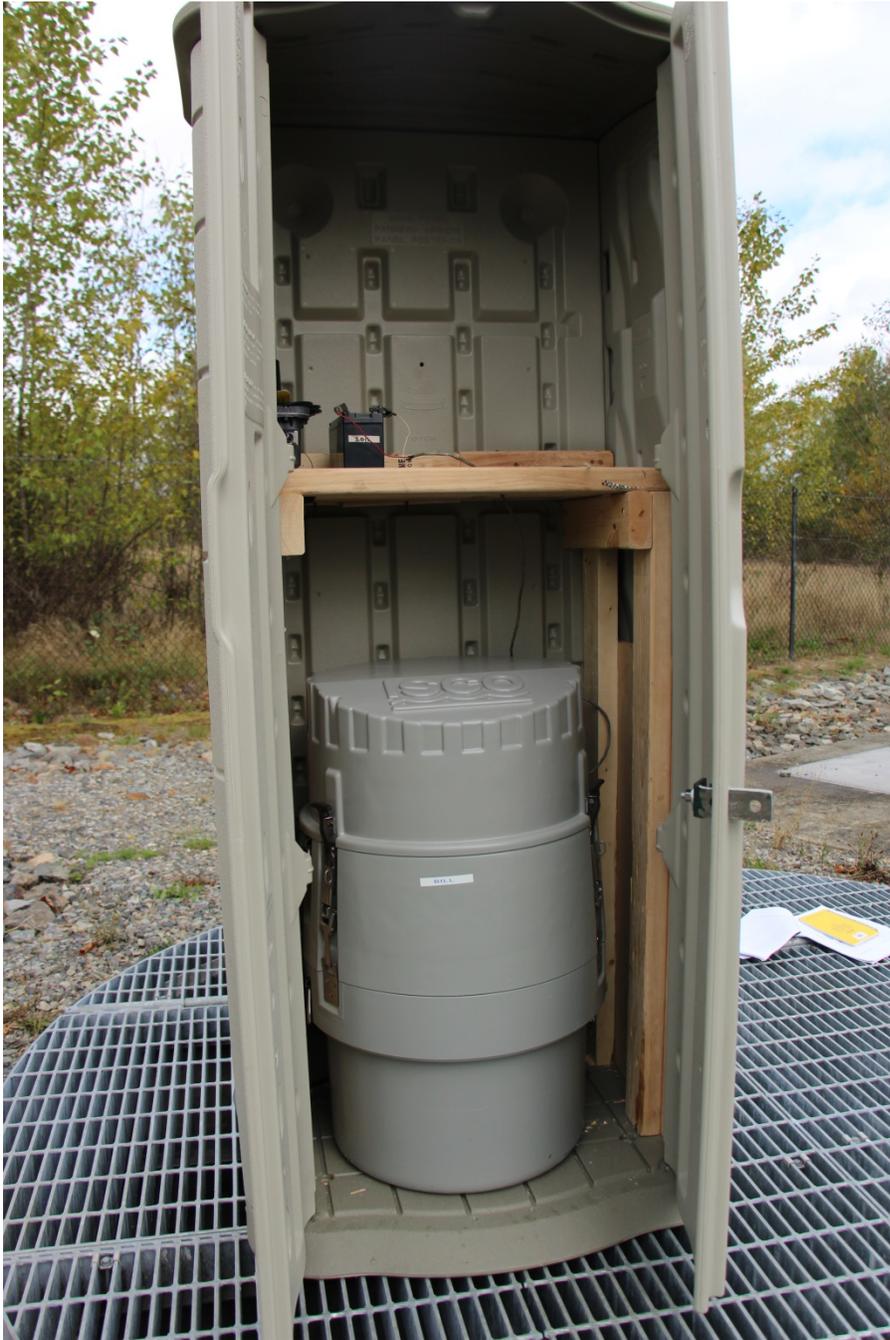
Autosampler and shed set up to sample the inflow to the “old” combined detention and stormwater treatment wetland (WCI).

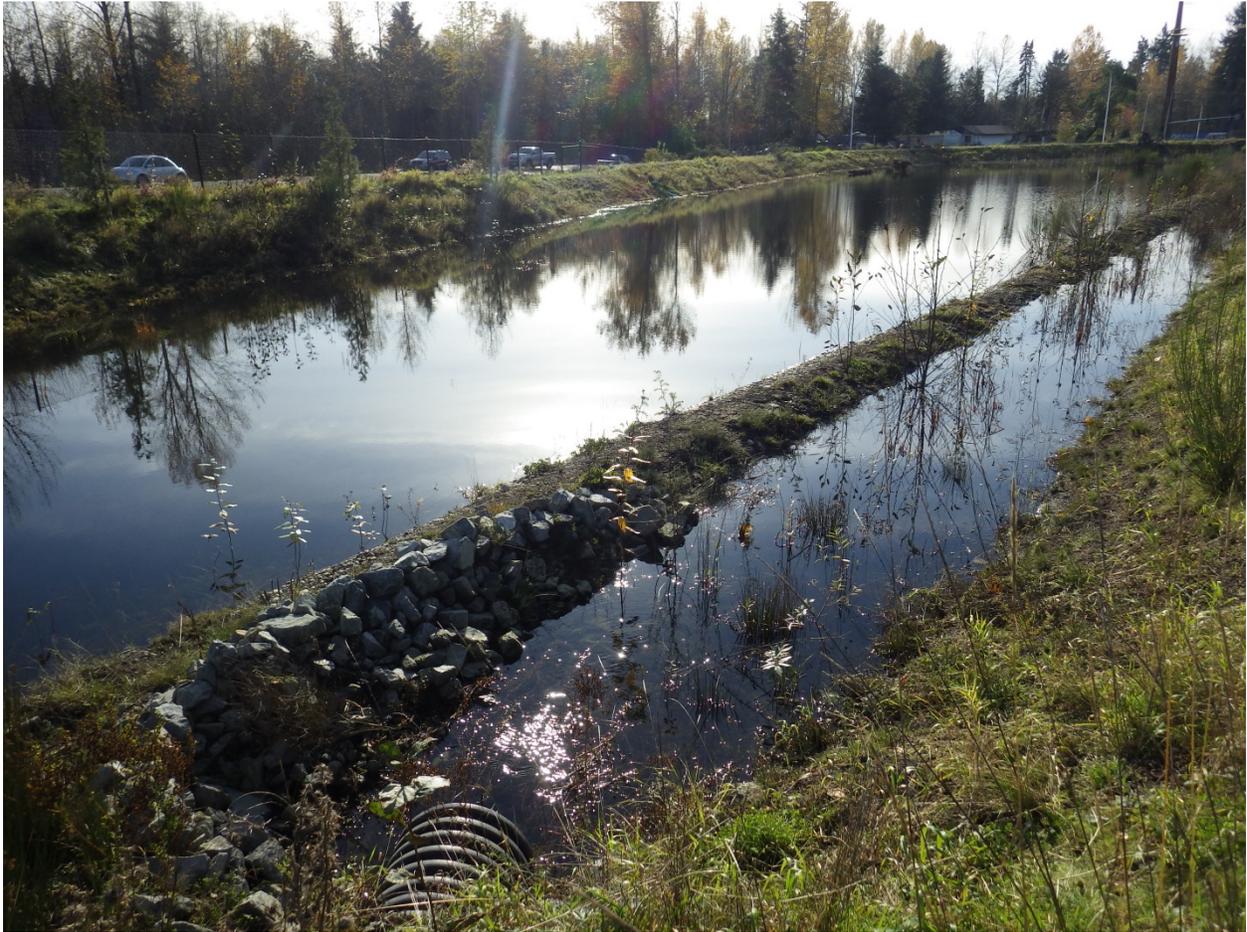
The new combined detention and stormwater treatment wetland on November 20, 2015.

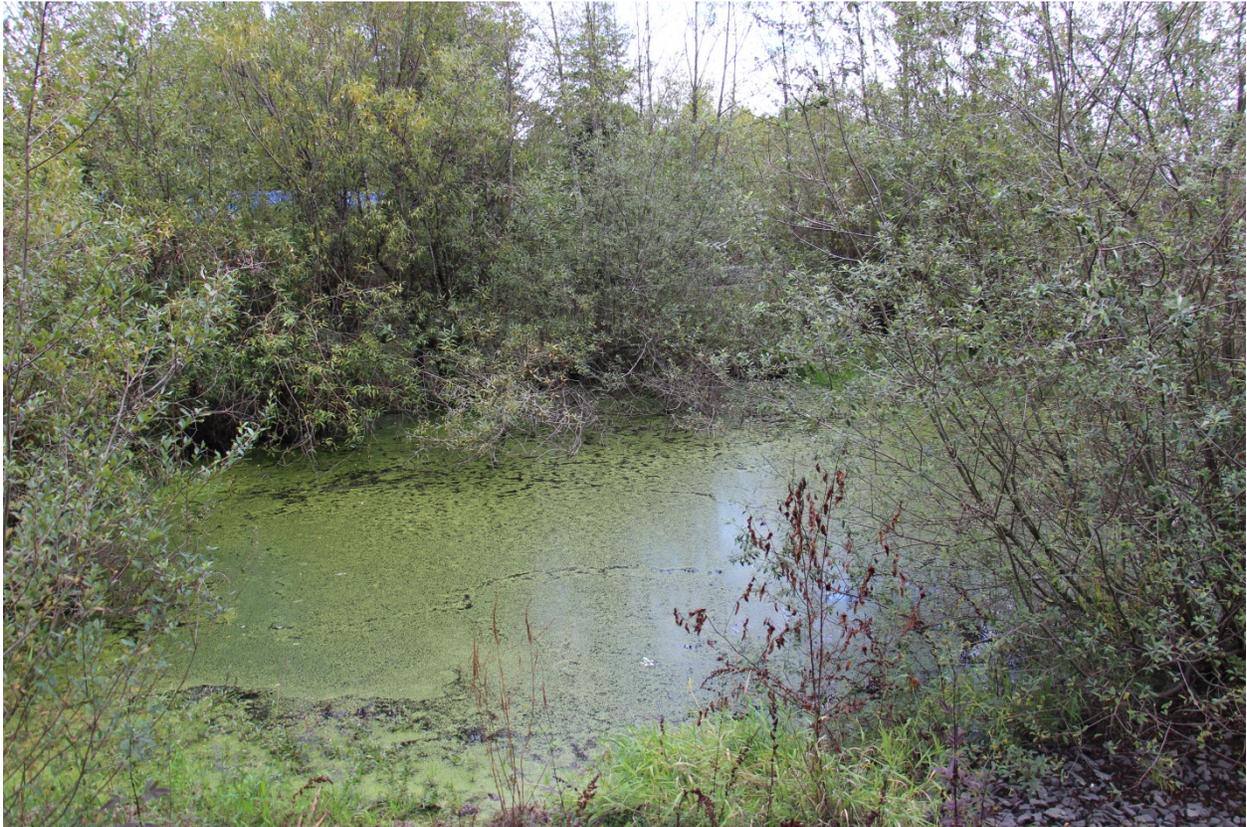
The old combined detention and stormwater treatment wetland in September 2015.

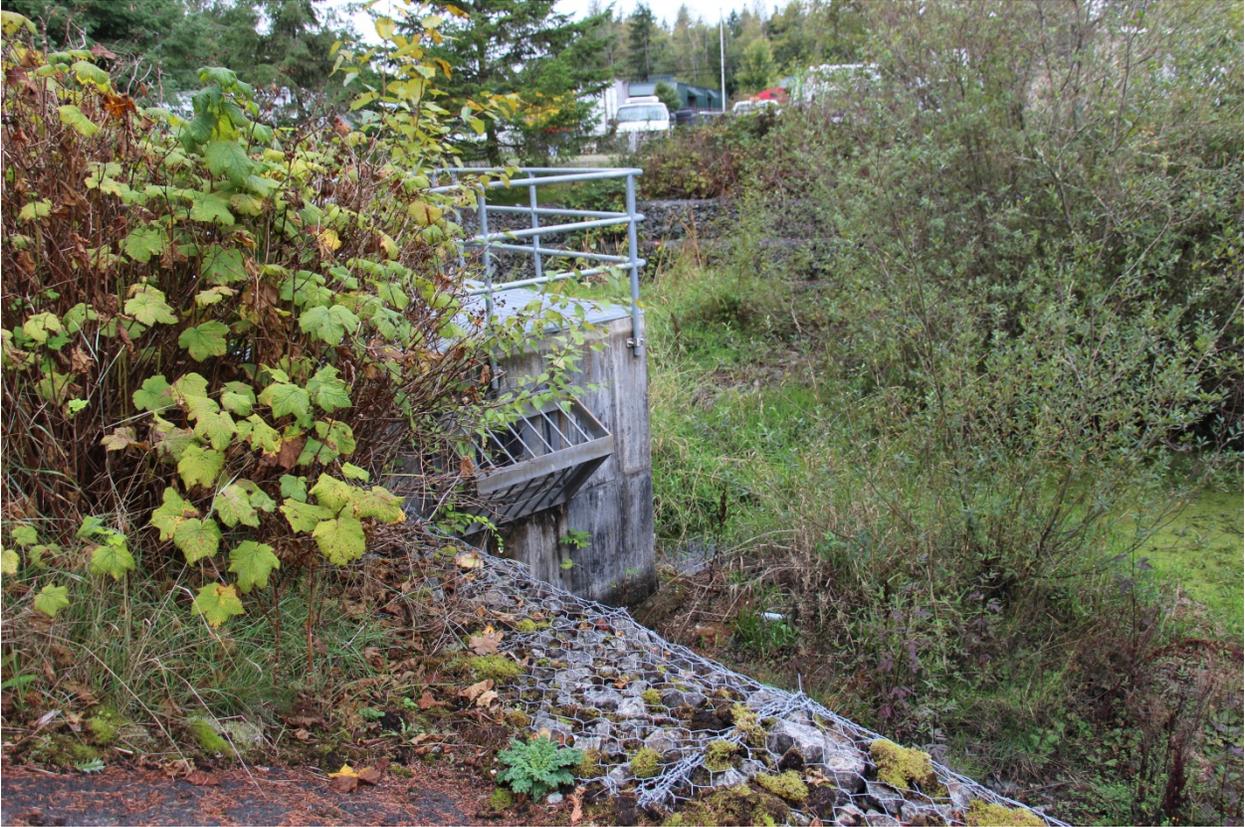
Outflow control structure in the old combined detention and stormwater treatment wetland in September 2015.

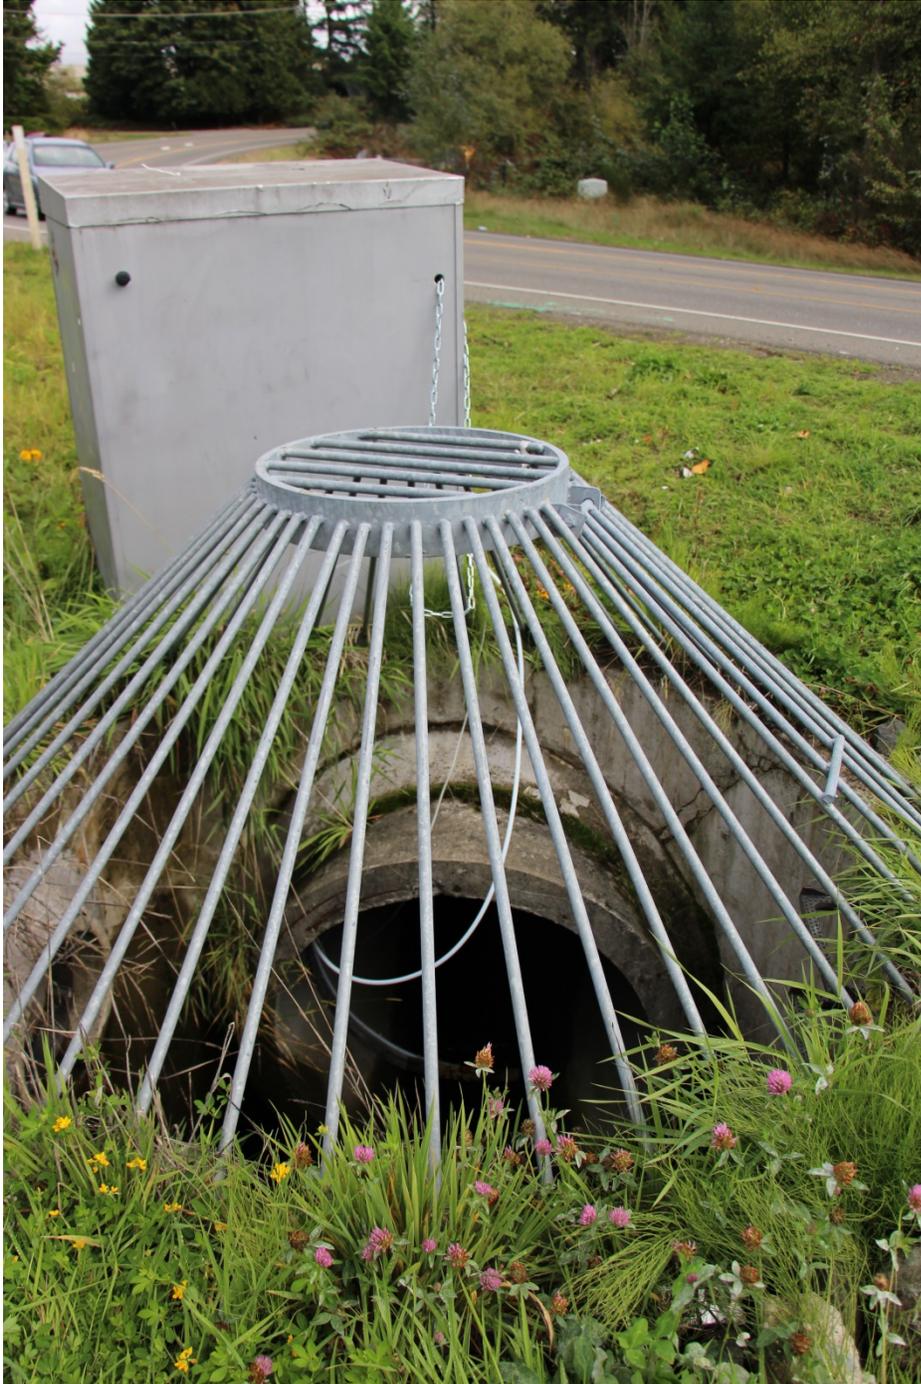
The sampling location for the outlet of the RDF (WCEBO). Flow through this pipe includes outflow from the two wetlands, outflow (and any overflow) from the east bioretention facility, and any flows that were diverted from the bioretention facilities (in the case of large storms). This pipe flows under the road and discharges to the creek.

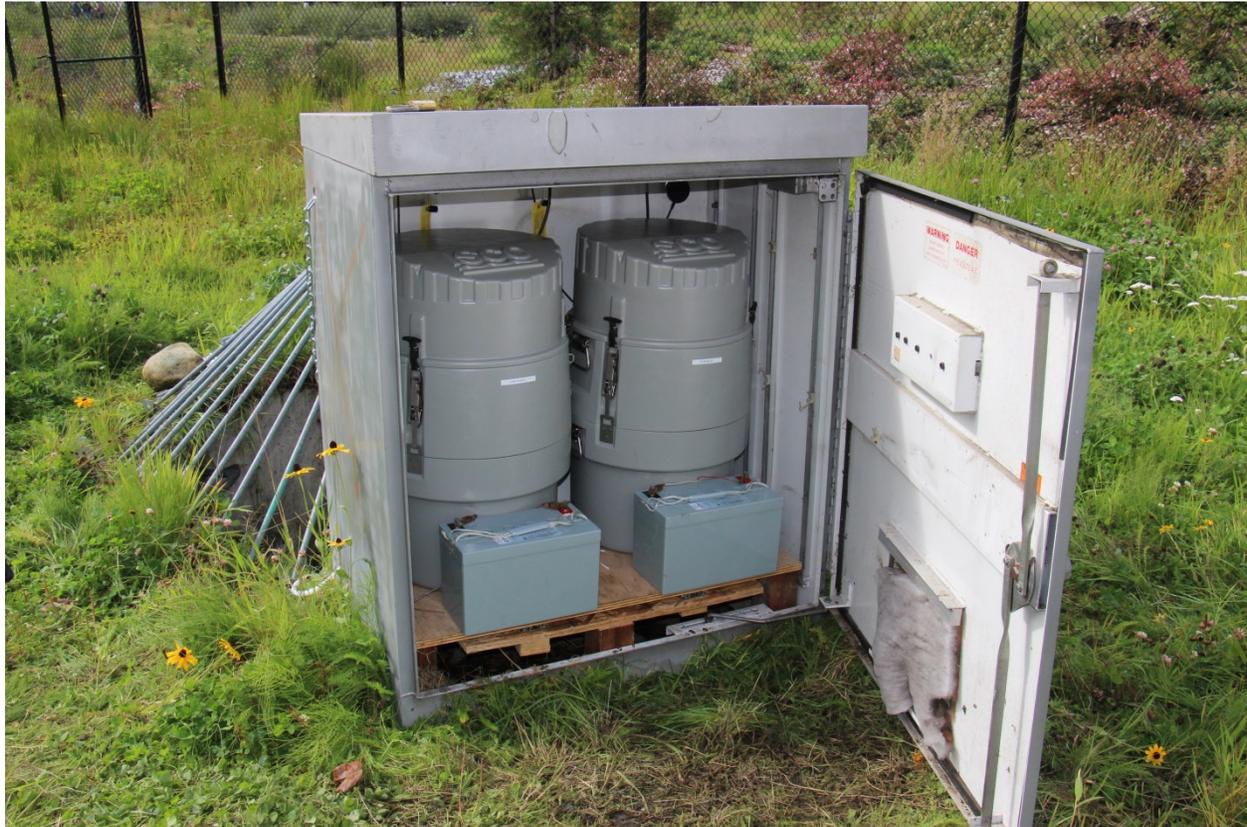
Autosamplers in shed that sample the WCEBO and EBO.

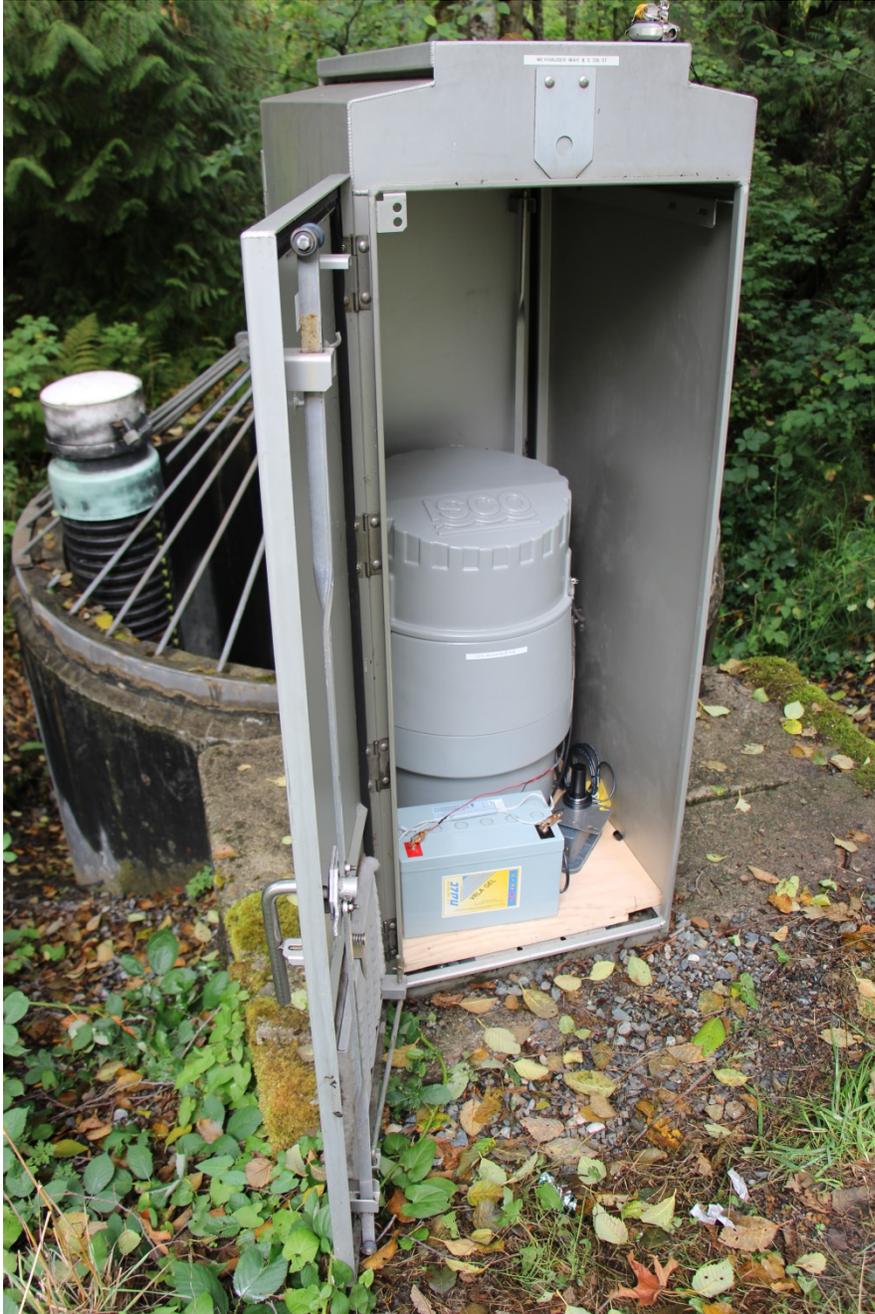
Autosampler set up to sample at site on the North Fork of West Hylebos Creek (NWH) (photo taken September 17, 2015).

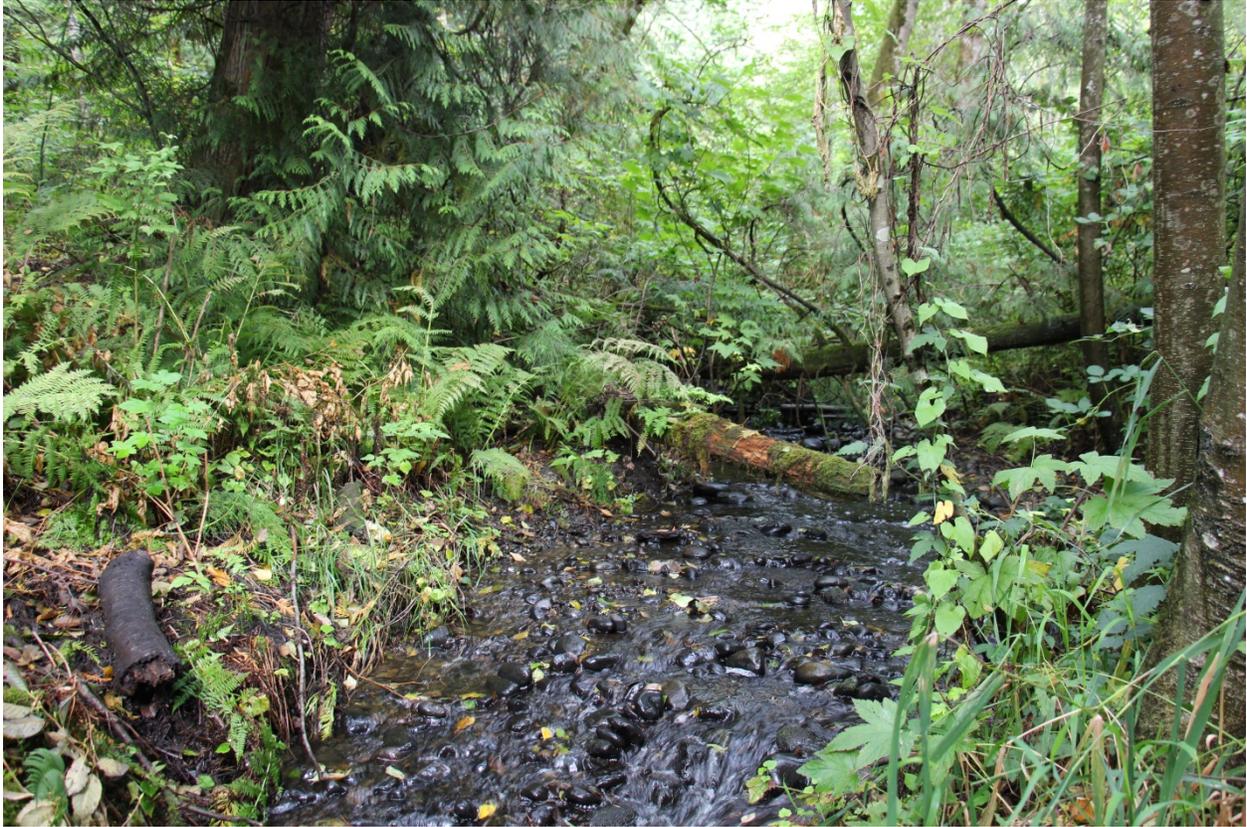
North Fork of West Hylebos Creek, just upstream of the flow control structure and culvert under S. 359th Street (photo taken September 17, 2015).
