State of Washington Department of Ecology
Cruise Ship Memorandum of Understanding, Cruise Operations in Washington State Inspection Report

Name and Location of Site Inspected: CROWN PRINCESS, Princess Cruises Pier 66 Seattle, Washington	Additional Participants/Inspectors:
On-Site Representative(s): Name/Title/Phone/e-mail Aleksandar (Alex) L. Nikolov, Environmental Officer KPDEVOF1@princesscruises.com	
Responsible Official(s): Name/Title/Address/Phone/e-mail Andrew Lorenzana, Environmental Operations Manager Princess Cruises 24200 Magic Mountain Parkway, Santa Clarita, CA 91355-1283 661-753-2755; alorenzana@princesscruises.com	Other Facility Data: Notification made to Andrew Lorenzana on September 10, 2014

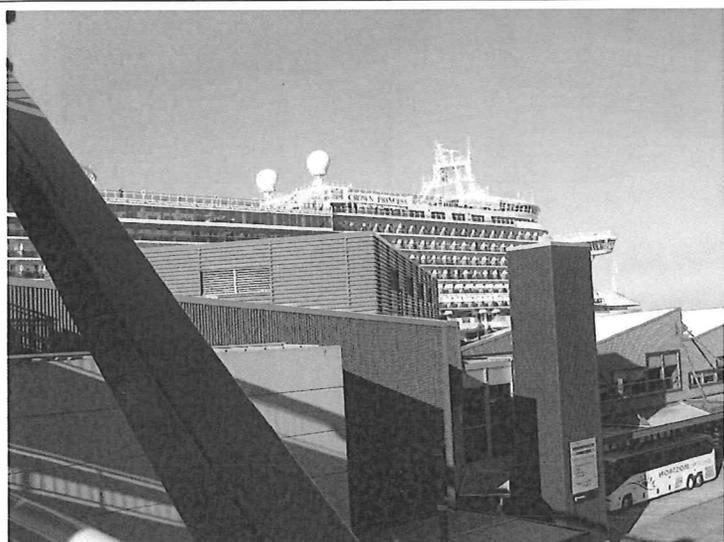
PHOTO #:01 DATE: SEPTEMBER 15, 2014
TAKEN BY: AMY JANKOWIAK FILE No.: P1010015
DESCRIPTION: CROWN PRINCESS VESSEL, PIER 66

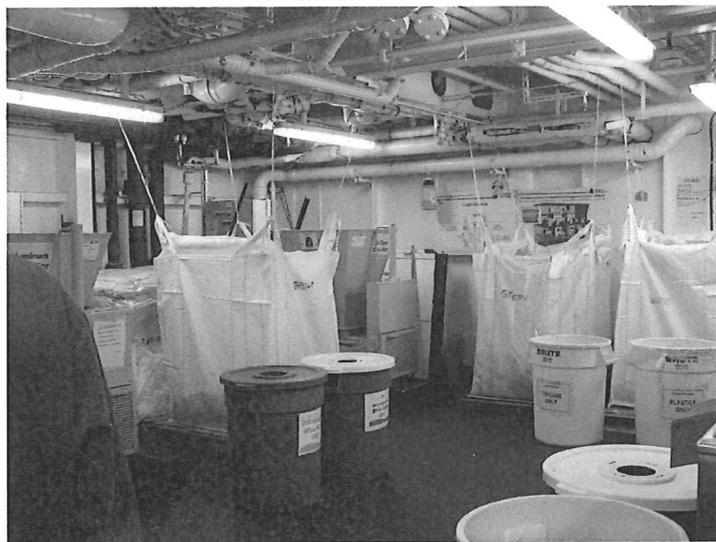
Solid waste (garbage, recyclables, etc) is sorted at the source (photo #31) and is collected and sorted in the garbage and recycling room and is either reused, recycled, incinerated or offloaded to shore as appropriate. Glass that is color separated (photo #02) and crushed, some cardboard, compacted aluminum (photo #04), scrap metal (photo #05), some plastics, some paper, used cooking oil and other items are recycled. Reduction, reuse and recycling progress is tracked for minimization improvements. The vessel and its vendors are ISO14001 certified. The minimization efforts vary by Port call, length of itinerary (2 week voyages have space constraints for offloads) and by staff efforts.

PHOTO #:02 DATE: SEPTEMBER 15, 2014
TAKEN BY: AMY JANKOWIAK FILE No.: P1010016
DESCRIPTION: GARBAGE RECYCLING ROOM (GLASS SORTING)

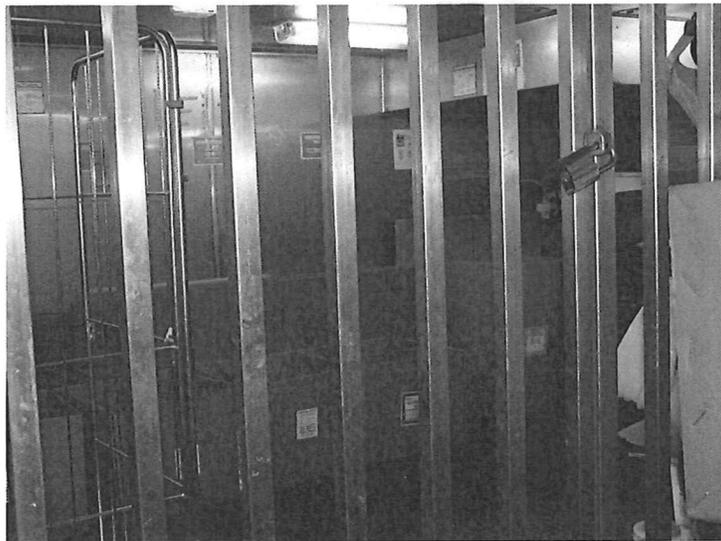
X-rays are done digitally and therefore do not have a waste product. Photo waste (photo #09) goes through a silver recovery system (photo #10), and is treated to less than 5 ppm and is then incinerated with one of two incinerators. Fluorescent bulbs along with other bulbs are collected and offloaded ashore without crushing. Hazardous waste materials typically include items such as used cartridges and filters, bulbs, paints, thinners, chemicals, incinerator ash, and batteries. Bio-hazardous waste includes sharps (photo #30) and red-bagged medical waste (photo #29) which is collected and incinerated. Hazardous waste is stored (photo #03) until offloaded. Hazardous waste logs were reviewed and appear to be consistent with MOU requirements.

PHOTO #:03 DATE: SEPTEMBER 15, 2014
TAKEN BY: AMY JANKOWIAK FILE No.: P1010017
DESCRIPTION: HAZARDOUS WASTE STORAGE

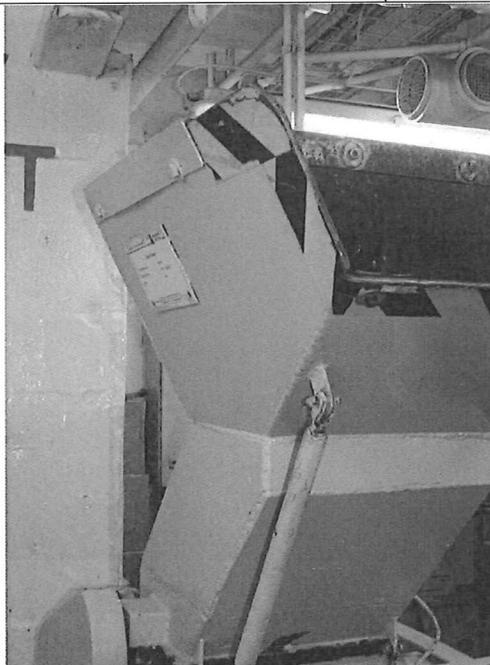
PHOTO #:04 DATE: SEPTEMBER 15, 2014
TAKEN BY: AMY JANKOWIAK FILE No.: P1010018
DESCRIPTION: GARBAGE RECYCLING ROOM - RECYCLING CRUSHER

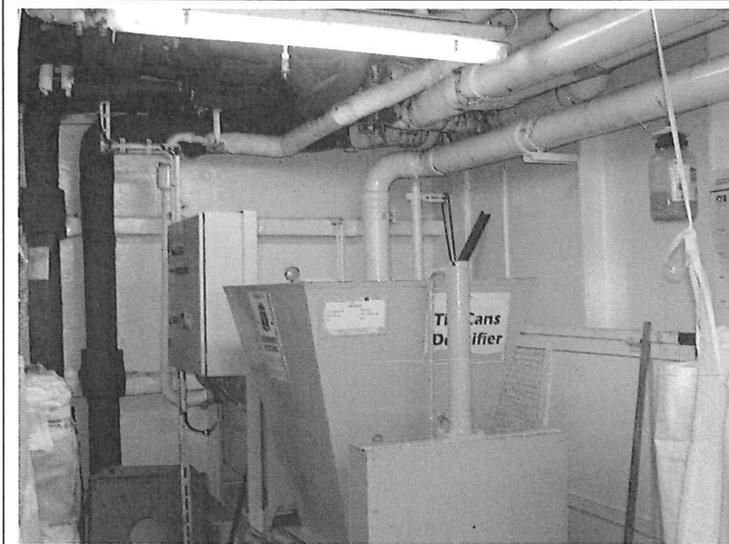
PHOTO #:05 DATE: SEPTEMBER 15, 2014
TAKEN BY: AMY JANKOWIAK FILE No.: P1010019
DESCRIPTION: GARBAGE RECYCLING ROOM - COMPACTOR

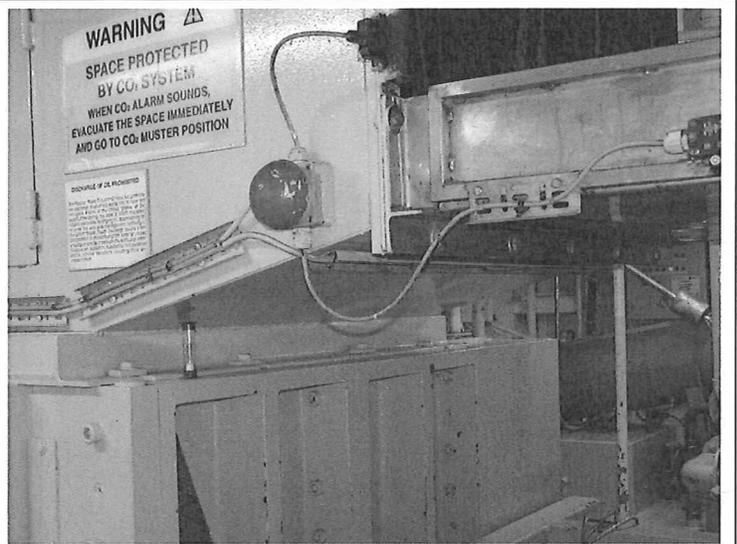
Oily rags, some food contaminated materials, most cardboard, medical bagged waste, treated photo waste, and some plastics are incinerated (photo #06). Incinerator ash is offloaded as hazardous waste as is tested regularly. Incinerators are used once underway.

PHOTO #:06 DATE: SEPTEMBER 15, 2014
TAKEN BY: AMY JANKOWIAK FILE No.: P1010020
DESCRIPTION: GARBAGE RECYCLING ROOM - INCINERATOR

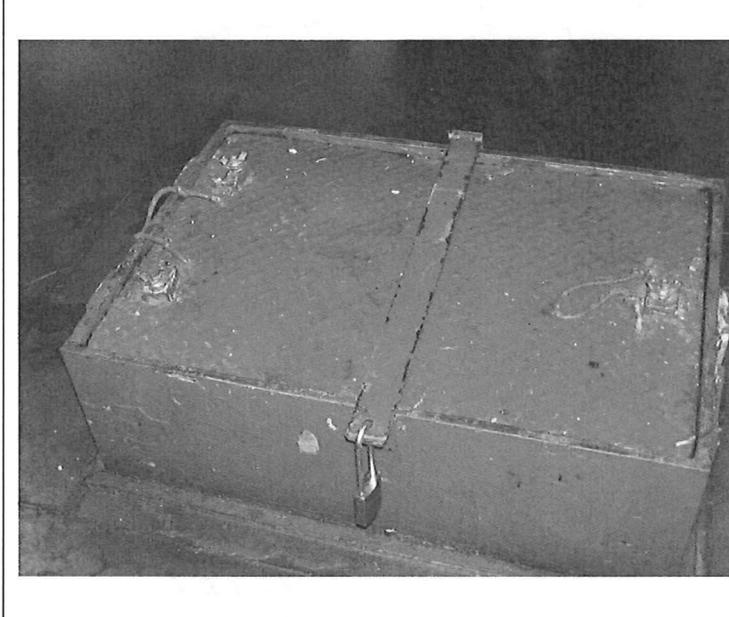
Food waste is sorted at the source in galleys and is then sent to the food pulper (photo #08). Food wastes that can't go through the pulper such as pineapple rinds are separated and stored cold until discharge with food waste through the chute (photo #07) outside of MOU related waters. Used cooking oil is sent ashore for recycling as bio-diesel. Galleys use Ecolab phosphate free and non-toxic detergents and degreasers. Grease is not collected via grease traps and a degreaser is used in the MBRs to break down the oils. Galley graywater is held untreated and discharged outside of MOU related waters.

PHOTO #:07 DATE: SEPTEMBER 15, 2014
TAKEN BY: AMY JANKOWIAK FILE No.: P1010021
DESCRIPTION: FOOD WASTE CHUTE (PADLOCKED)

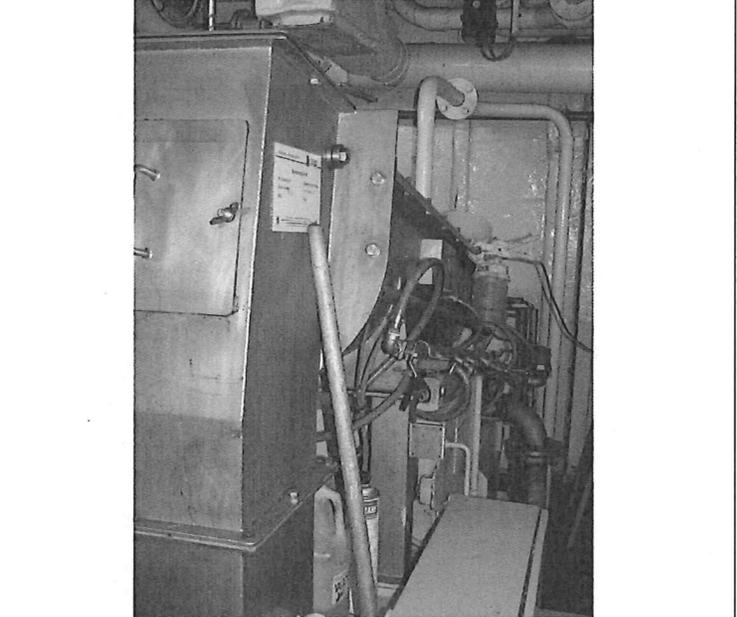
PHOTO #:08 DATE: SEPTEMBER 15, 2014
TAKEN BY: AMY JANKOWIAK FILE No.: P1010022
DESCRIPTION: FOOD WASTE PULPER

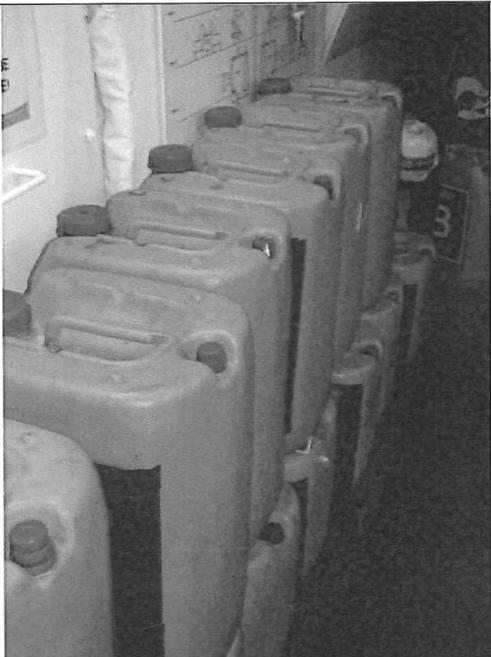
PHOTO #:09 DATE: SEPTEMBER 15, 2014
TAKEN BY: AMY JANKOWIAK FILE No.: P1010023
DESCRIPTION: PHOTO WASTE

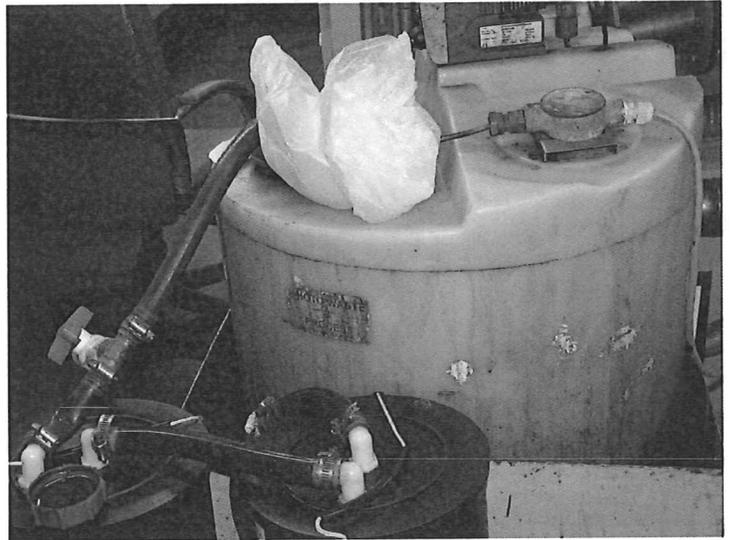
PHOTO #:10 DATE: SEPTEMBER 15, 2014
TAKEN BY: AMY JANKOWIAK FILE No.: P1010024
DESCRIPTION: SILVER RECOVERY SYSTEM FOR PHOTO WASTE

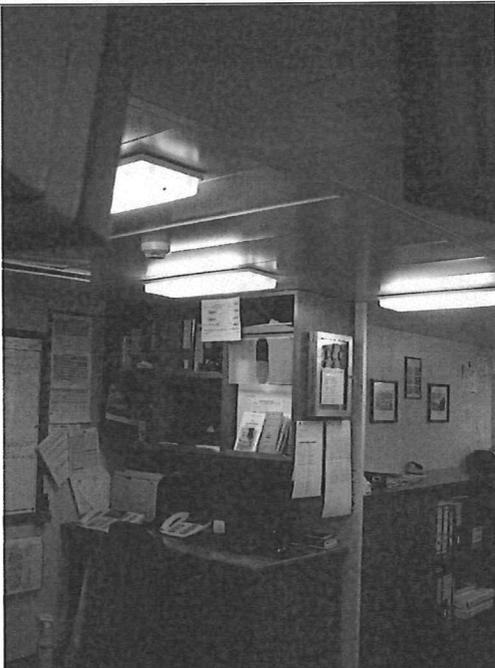
PHOTO #:11 DATE: SEPTEMBER 15, 2014
TAKEN BY: AMY JANKOWIAK FILE No.: P1010025
DESCRIPTION: ENGINE CONTROL ROOM (DISCHARGE PORT KEYS ON CABINET)

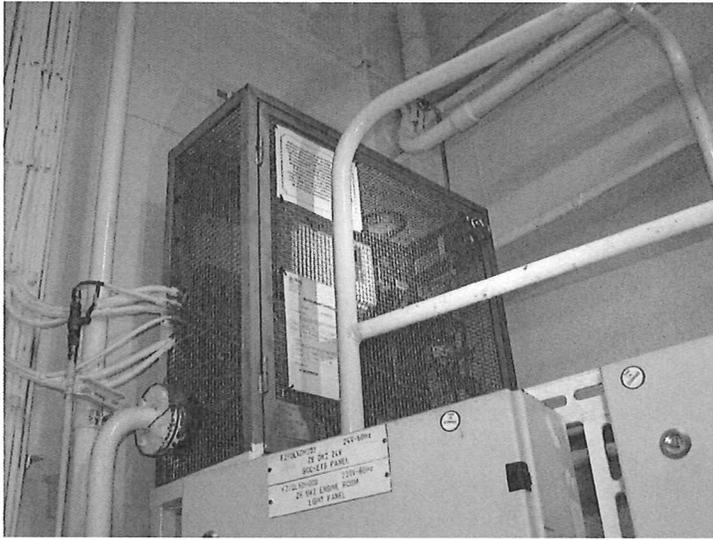
Oily bilge water is treated with a two step oily water separator (OWS) process. Oily bilge water is sent to the first system (photo #15) to treat to less than 50 ppm oily water content and then to a second system (photo #16) to less than 15 ppm. All OWS effluent is sent through a white box (photo #13) to confirm less than 15 ppm prior to discharge. The vessel has a new OWS (photo #17) on the vessel that is soon to be installed and is capable of treating to less than 5 ppm. Discharges (photo #12) of treated oily bilge take place outside of MOU related waters.

PHOTO #:13 DATE: SEPTEMBER 15, 2014
TAKEN BY: AMY JANKOWIAK FILE No.: P1010027
DESCRIPTION: OWS WHITE BOX

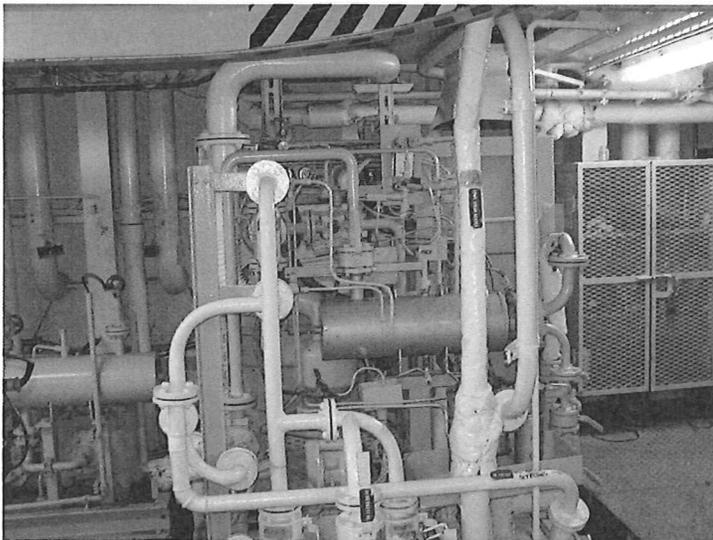
PHOTO #:15 DATE: SEPTEMBER 15, 2014
TAKEN BY: AMY JANKOWIAK FILE No.: P1010030
DESCRIPTION: OWS 1ST STAGE (TO <50PPM OIL CONTENT)

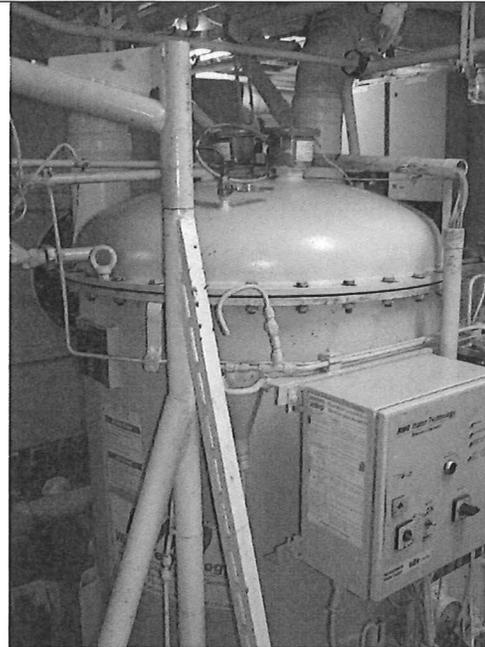
PHOTO #:16 DATE: SEPTEMBER 15, 2014
TAKEN BY: AMY JANKOWIAK FILE No.: P1010031
DESCRIPTION: OWS 2ND STAGE (TO <15PPM OIL CONTENT)

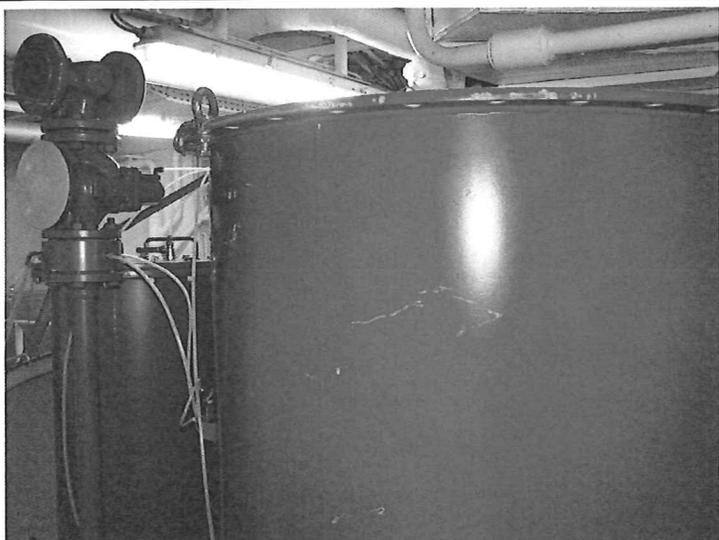
PHOTO #:17 DATE: SEPTEMBER 15, 2014
TAKEN BY: AMY JANKOWIAK FILE No.: P1010032
DESCRIPTION: NEW OWS (TO <5PPM OIL CONTENT) TO BE
INSTALLED

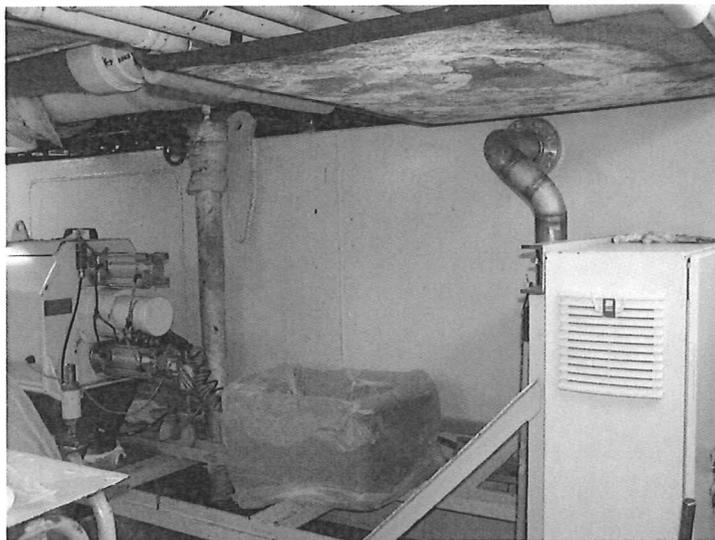
PHOTO #:18 DATE: SEPTEMBER 15, 2014
TAKEN BY: AMY JANKOWIAK FILE No.: P1010033
DESCRIPTION: MBR TANK (BIG BOX)

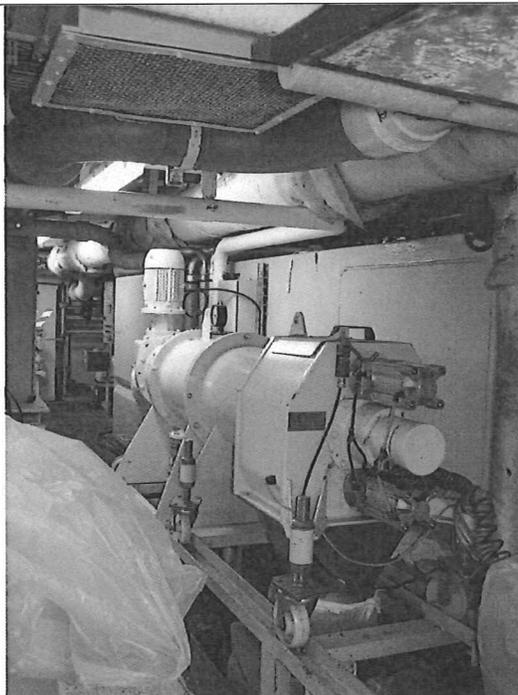
Black water is collected by vacuum to collection tanks and is then sent to the MBR. Gray water which includes sink and shower water and laundry water is piped to one of the gray water collection tanks prior to going to the MBRs. Black water flow moves to the screen press (photo #19). The solids are screened into bags (photo #20) and are then sent to the incinerator. The liquid moves to the 1st stage of the membrane bioreactor (photo #18) where aeration occurs. From the 1st stage, flow moves to the Inter-stage Russel filters (photo #21). The inter-stage filtered solids are returned back to the screen press. The liquid moves onto the 2nd stage of the MBR for further aeration. From the 2nd stage MBR, flow is sent to the membrane modules (photo #22) for ultrafiltration. The membranes use a backwash for regular cleaning. Effluent from the membrane modules are sent to a permeate tank (photo #23) where turbidity is monitored. Flow then goes to holding tanks if not in an area of discharge. Flow for discharge is then sent for ultraviolet (UV) disinfection (photo #24) prior to discharge. Currently, effluent is held and discharged outside of MOU waters. There is a sample port (photo #14) for treated effluent (photos #25 and #26).

PHOTO #:19 DATE: SEPTEMBER 15, 2014
TAKEN BY: AMY JANKOWIAK FILE No.: P1010034
DESCRIPTION: MBR SCREEN PRESS

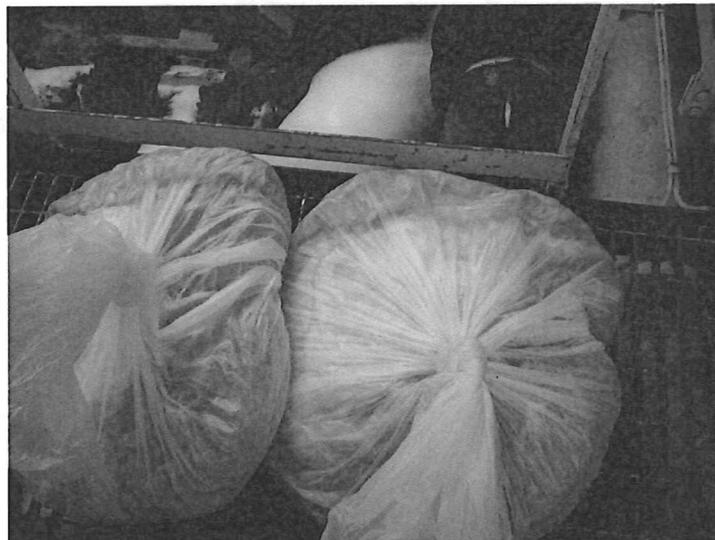
The biomass or solids from the black water MBRs is collected first from the screen presses, bagged and incinerated. The biomass or solids from the MBRs are wasted to a holding tank and discharged outside of MOU related waters.

PHOTO #:20 DATE: SEPTEMBER 15, 2014
TAKEN BY: AMY JANKOWIAK FILE No.: P1010035
DESCRIPTION: MBR SCREEN PRESS SCREENINGS (BAGGED FOR
INCINERATION)

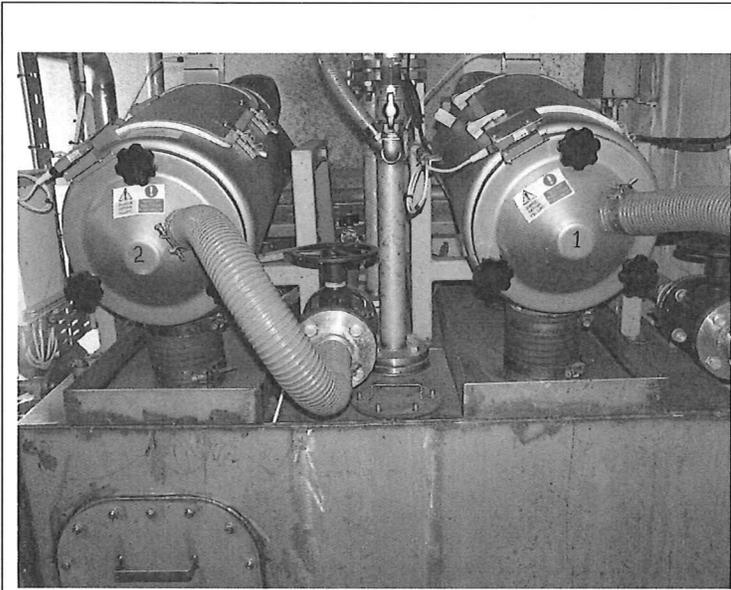
PHOTO #:21 DATE: SEPTEMBER 15, 2014
TAKEN BY: AMY JANKOWIAK FILE No.: P1010036
DESCRIPTION: MBR INTERMEDIATE FILTERS

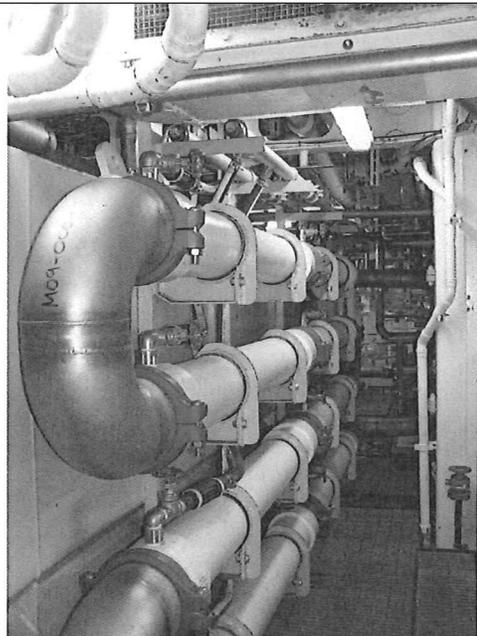
PHOTO #:22 DATE: SEPTEMBER 15, 2014
TAKEN BY: AMY JANKOWIAK FILE No.: P1010037
DESCRIPTION: MBR MEMBRANE FILTERS

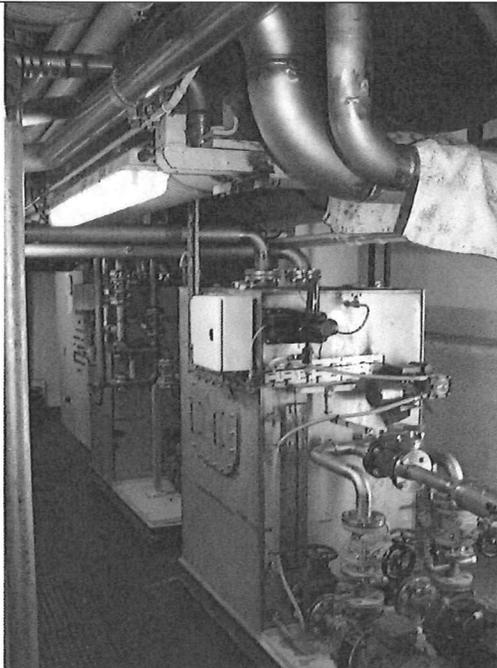
Turbidity is measured continuously on each of the MBR permeate tanks. The MBRs use a degreaser and a defoamer and no other chemicals. The UV system consists of 6 bulbs which are alarmed. The maintenance system, AMOS, provides details of when all maintenance is needed and there is a dedicated plumber for the MBRs overseen by the Staff Engineer and the EO. Monitoring also occurs on the vessel to assure system operations including total suspended solids (typically less than 20 mg/l), total and free chlorine (typically non-detect), total coliform (typically non-detect), ammonia (typically <10 mg/l for graywater and about 100-120 mg/l for blackwater), and pH (typically 6-8).

PHOTO #:23 DATE: SEPTEMBER 15, 2014
TAKEN BY: AMY JANKOWIAK FILE No.: P1010038
DESCRIPTION: MBR PERMEATE TANK (STEEL BOX)

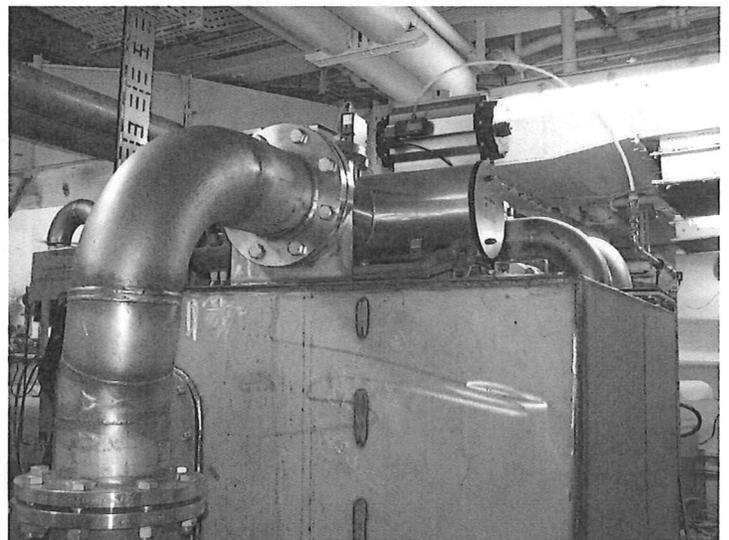
PHOTO #:24 DATE: SEPTEMBER 15, 2014
TAKEN BY: AMY JANKOWIAK FILE No.: P1010041
DESCRIPTION: MBR ULTRAVIOLET (UV) LIGHT DISINFECTION
UNIT

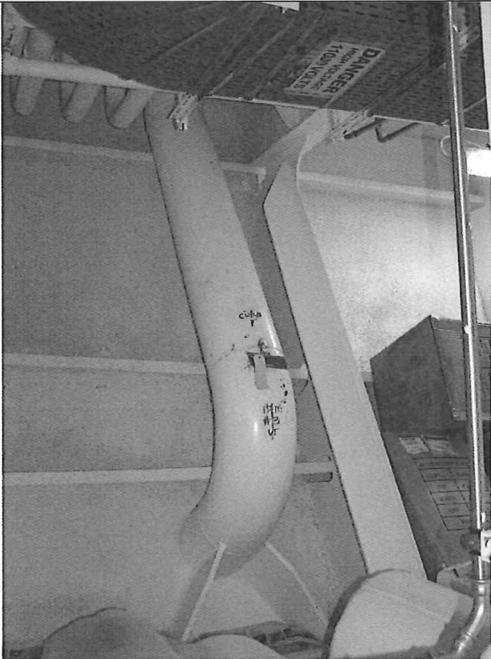
PHOTO #:25 DATE: SEPTEMBER 15, 2014
TAKEN BY: AMY JANKOWIAK FILE No.: P1010043
DESCRIPTION: MBR GW OVERBOARD PIPE (AFTER UV)

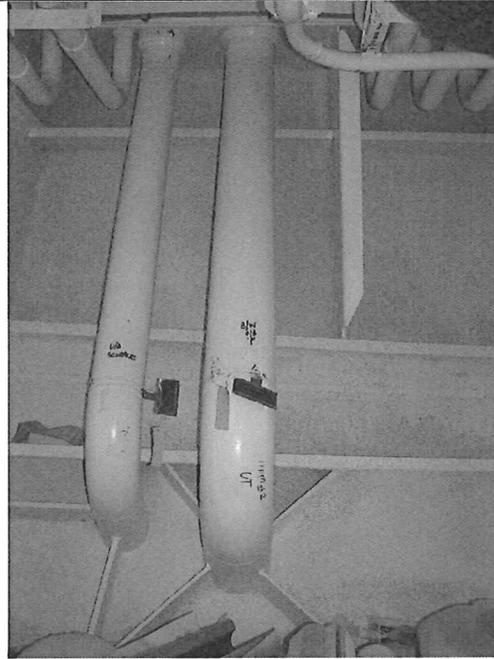
PHOTO #:26 DATE: SEPTEMBER 15, 2014
TAKEN BY: AMY JANKOWIAK FILE No.: P1010044
DESCRIPTION: MBR BW OVERBOARD PIPE (AFTER UV) (AND
SCUPPERS PIPE)

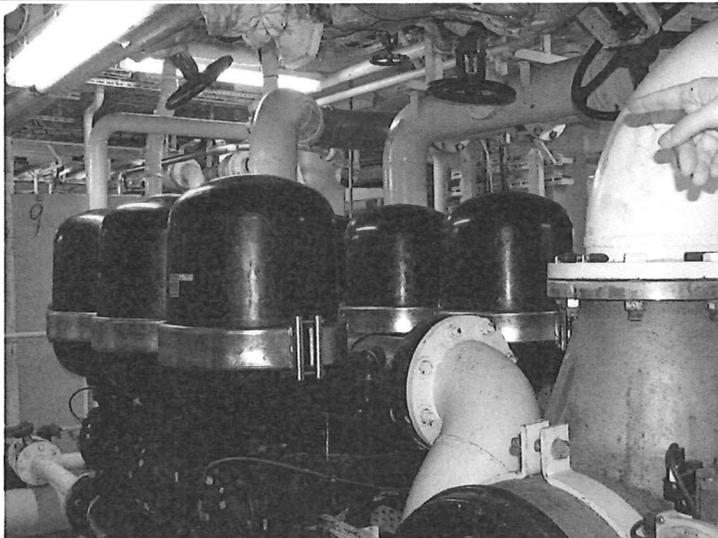
The CROWN PRINCESS has a treatment system on board for ballast water that includes filtration (photo #27) and ultraviolet light (UV) disinfection (photo #28), without any chemical treatment. The next ballast discharge is to occur in San Francisco.

PHOTO #:27 DATE: SEPTEMBER 15, 2014
TAKEN BY: AMY JANKOWIAK FILE No.: P1010039
DESCRIPTION: BALLAST WATER TREATMENT SYSTEM FILTERS

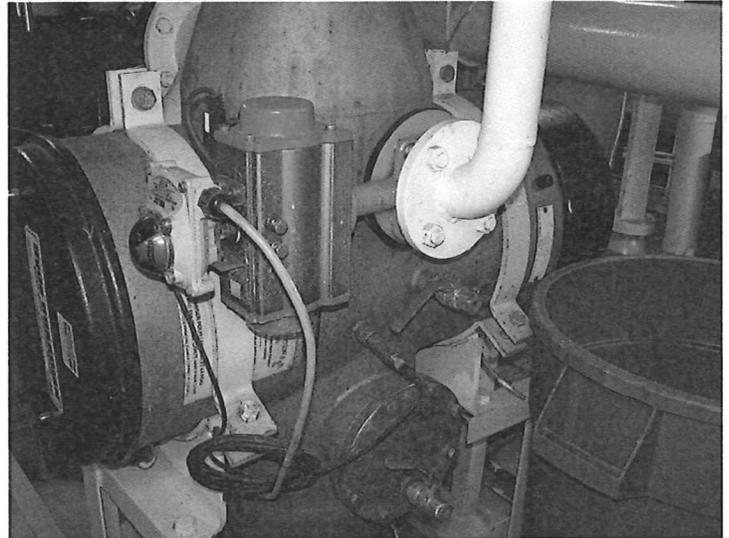
PHOTO #:28 DATE: SEPTEMBER 15, 2014
TAKEN BY: AMY JANKOWIAK FILE No.: P1010040
DESCRIPTION: BALLAST WATER TREATMENT SYSTEM UV

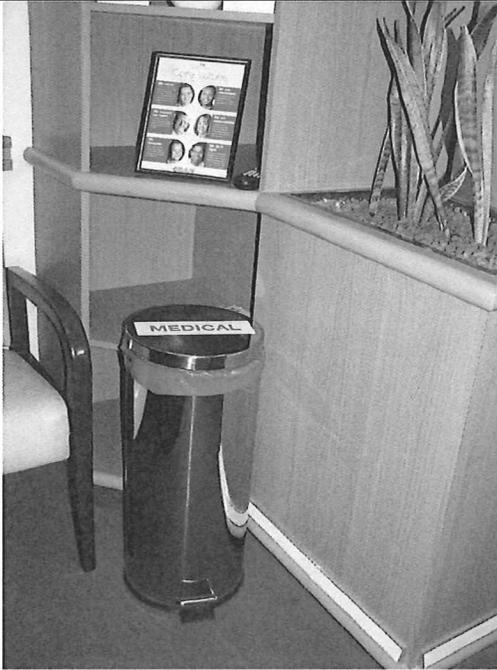
PHOTO #:29 DATE: SEPTEMBER 15, 2014
TAKEN BY: AMY JANKOWIAK FILE No.: P1010046
DESCRIPTION: MEDICAL FACILITY RED-BAGGED WASTE

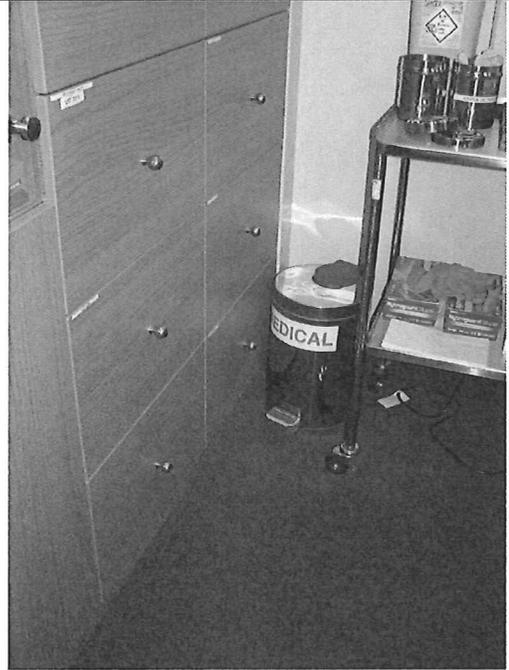
PHOTO #:30 DATE: SEPTEMBER 15, 2014
TAKEN BY: AMY JANKOWIAK FILE No.: P1010047
DESCRIPTION: MEDICAL FACILITY RED-BAGGED WASTE AND SHARPS (YELLOW BOX)

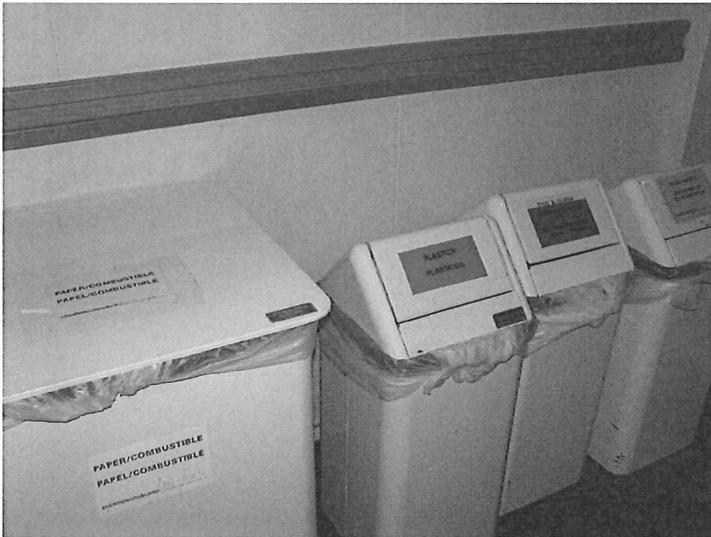
PHOTO #:31 DATE: SEPTEMBER 15, 2014
TAKEN BY: AMY JANKOWIAK FILE No.: P1010048
DESCRIPTION: MEDICAL FACILITY – SOURCE WASTE SORTING
