State of Washington Department of Ecology
Cruise Ship Memorandum of Understanding, Cruise Operations in Washington State Inspection Report

Amy Jankowiak, Washington State Department of Ecology (Ecology) Northwest Regional Office, Water Quality Program (NWRO-WQ), along with Kevin Leung, NWRO-WQ and Jessica Engel, NWRO-WQ conducted the inspection of the Carnival Cruise Lines CARNIVAL MIRACLE on September 10, 2013. The main contact on board the CARNIVAL MIRACLE was Vinay Suresh Bodke, Environmental and OCC Safety Officer (EOSO) for the CARNIVAL MIRACLE. Prior notification of the visit was given on August 14, 2013 for security protocol. The purpose of the inspection was to evaluate compliance with the *Memorandum of Understanding Cruise Operations in Washington State* (MOU), as amended. The CARNIVAL MIRACLE is not approved to discharge in MOU waters.

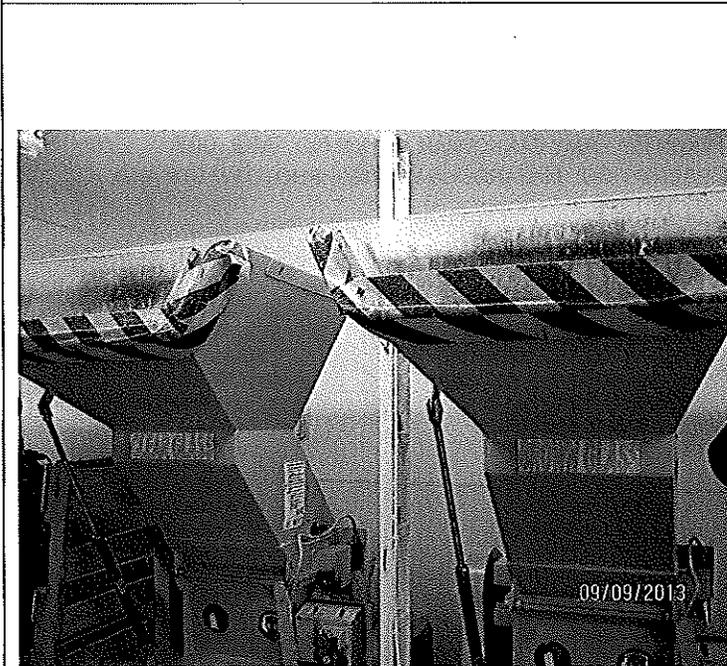
Solid waste (garbage, recyclables, etc) is collected sorted and either reused, recycled, incinerated or offloaded to shore as appropriate. Materials such as glass (photo #03), metals, plastic, aluminum, and some cardboard is recycled. The garbage record book was reviewed and showed consistency with requirements.

PHOTO #:03 DATE: SEPTEMBER 10, 2013
TAKEN BY: AMY JANKOWIAK FILE No.:IMG_004
DESCRIPTION: GARBAGE/RECYCLING - GLASS RECYCLING

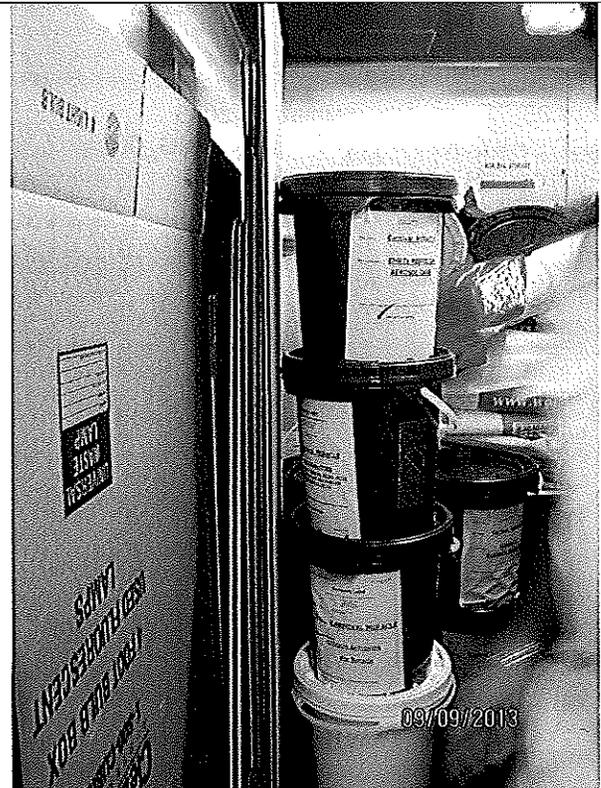
Any photo waste is collected, drummed (photo #06) and sent ashore as hazardous waste. Fluorescent bulbs (photo #05) are offloaded as universal waste and not crushed on board. Hazardous waste materials include items such as oily rags, incinerator ash, aerosols, sharps, used cartridges and filters, and expired chemicals. Hazardous waste (photo #04) is offloaded in Seattle on this voyage. Hazardous waste logs were reviewed and appear to be consistent with MOU requirements.

PHOTO #:04 DATE: SEPTEMBER 10, 2013
TAKEN BY: AMY JANKOWIAK FILE No.:IMG_005
DESCRIPTION: HAZARDOUS WASTE STORAGE - AERSOLS

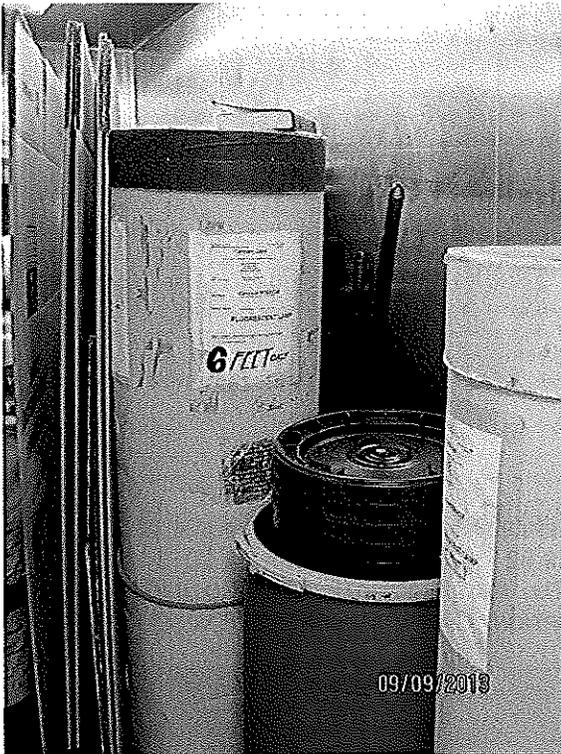
PHOTO #:05 DATE: SEPTEMBER 10, 2013
TAKEN BY: AMY JANKOWIAK FILE No.:IMG_006
DESCRIPTION: HAZARDOUS WASTE - LAMPS

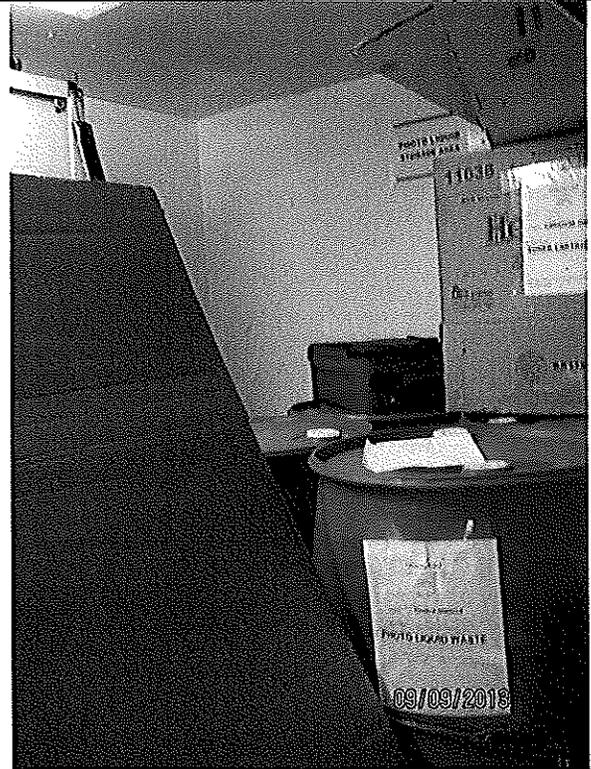
PHOTO #:06 DATE: SEPTEMBER 10, 2013
TAKEN BY: AMY JANKOWIAK FILE No.:IMG_007
DESCRIPTION: HAZARDOUS WASTE - PHOTO WASTE AND CARTRIDGES

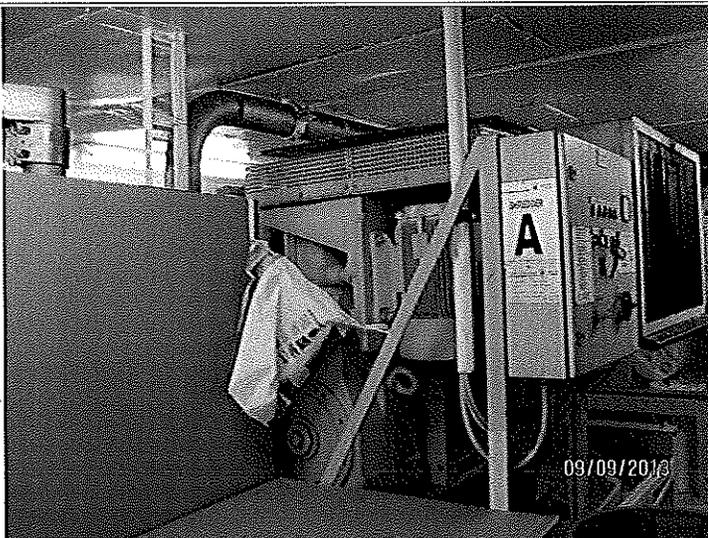
PHOTO #:07 DATE: SEPTEMBER 10, 2013
TAKEN BY: AMY JANKOWIAK FILE No.:IMG_008
DESCRIPTION: INCINERATOR

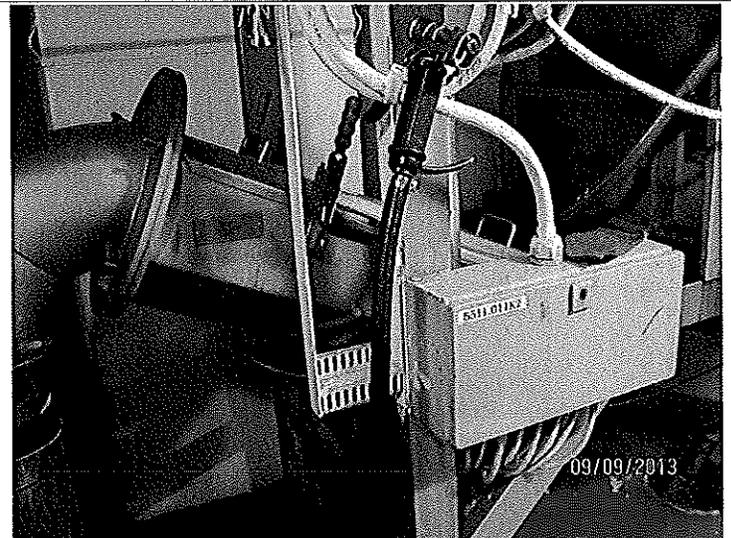
Food waste is collected in various locations, is sorted and then sent through a pulper (photo #08). Galley waste water goes through a grease separator where the grease is either incinerated or sent to shore. The galley water is discharged outside of MOU related waters along with the pulped food waste. Certain food waste is collected and incinerated if it does not go into the pulper. Cooking oil is reused in the fuel tanks after being filtered. Filtered materials go to the food waste system. Records reviewed were consistent with these protocols. Sorting is periodically checked and monitored to ensure only allowed food waste gets discharged. Galleys use phosphate free and non-toxic detergents and degreasers.

PHOTO #:08 DATE: SEPTEMBER 10, 2013
TAKEN BY: AMY JANKOWIAK FILE No.:IMG_010
DESCRIPTION: FOOD WASTE PULPER

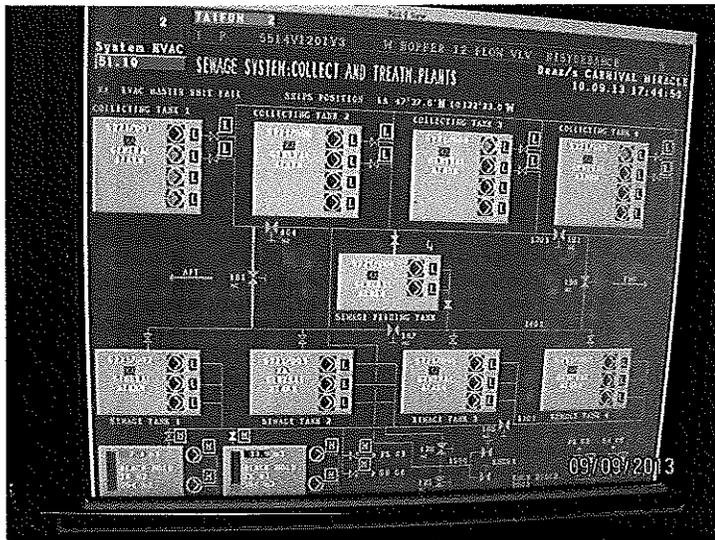
The CARNIVAL MIRACLE uses four FORMAT traditional Type II MSDs to treat blackwater (photos #10 and #11). Blackwater is collected by vacuum to collection tanks and then to a feed unit that disperses the blackwater to the four units. The unit volumes can be seen electronically in the ECR (photo #09). Each unit (photo #13) includes screening, aeration, settling and chlorination (photos #12 and #15). Chlorine dosing can be adjusted (photo #14), but monitoring is not done for the systems. The MSDs are cleaned and checked about once a month. Laundry graywater is collected in a separate tank and held for overboard discharge outside of MOU related waters without treatment. Accommodation, sink, shower galley and Jacuzzi water is sent to graywater holding tanks and held for overboard discharge outside of MOU related waters without treatment.

PHOTO #:09 DATE: SEPTEMBER 10, 2013
TAKEN BY: AMY JANKOWIAK FILE No.:IMG_013
DESCRIPTION: MSD SYSTEM SCREEN SHOT IN ECR

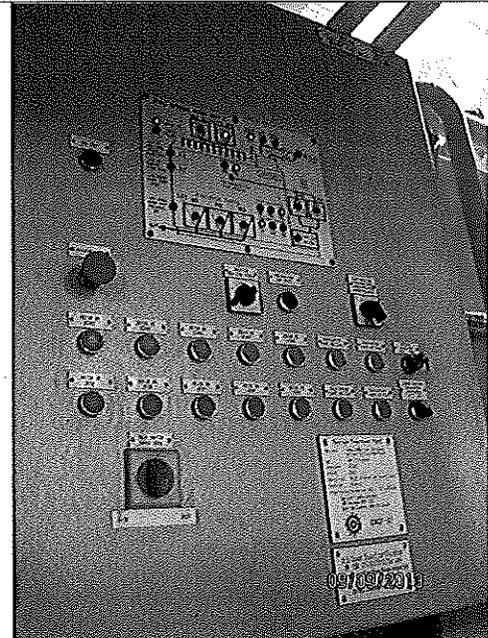
PHOTO #:10 DATE: SEPTEMBER 10, 2013
TAKEN BY: AMY JANKOWIAK FILE No.:IMG_014
DESCRIPTION: MSD CONTROLS

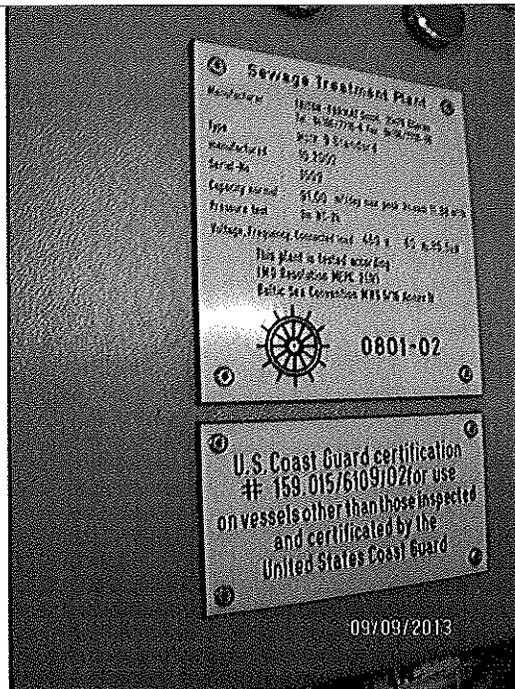
PHOTO #:11 DATE: SEPTEMBER 10, 2013
TAKEN BY: AMY JANKOWIAK FILE No.:IMG_015
DESCRIPTION: MSD - TRITON FORMAT SIGNAGE

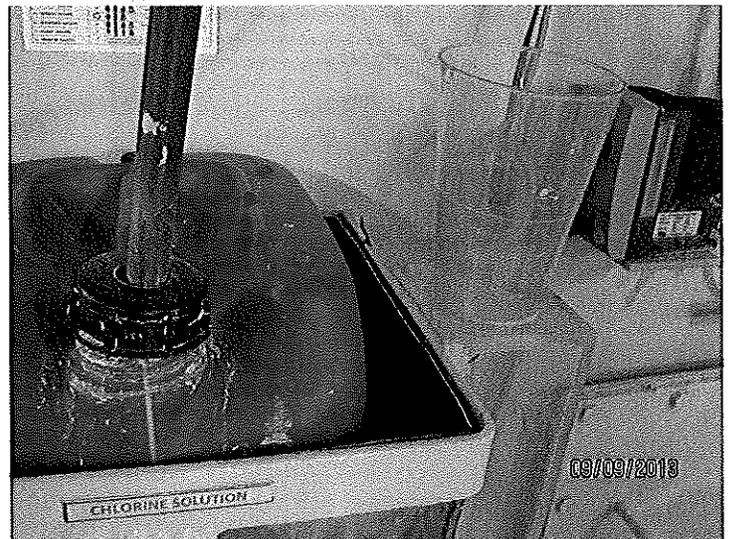
PHOTO #:12 DATE: SEPTEMBER 10, 2013
TAKEN BY: AMY JANKOWIAK FILE No.:IMG_017
DESCRIPTION: MSD CHLORINE SOLUTION TANK

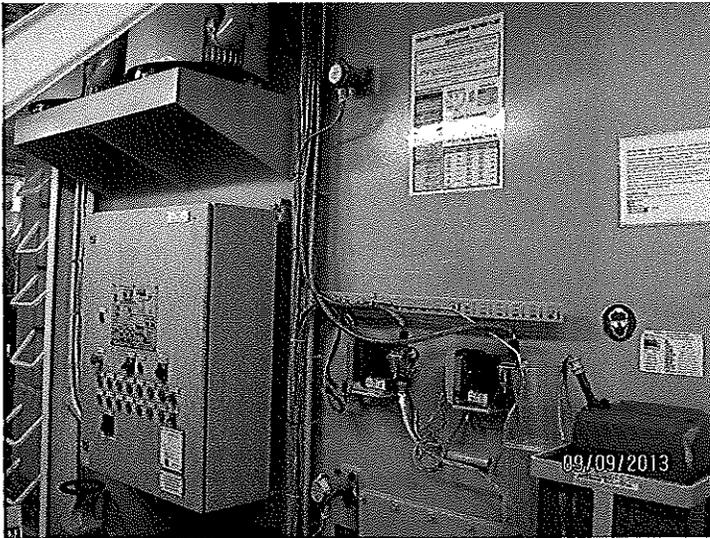
PHOTO #:13 DATE: SEPTEMBER 10, 2013
TAKEN BY: AMY JANKOWIAK FILE No.:IMG_028
DESCRIPTION: MSD TREATMENT TANK

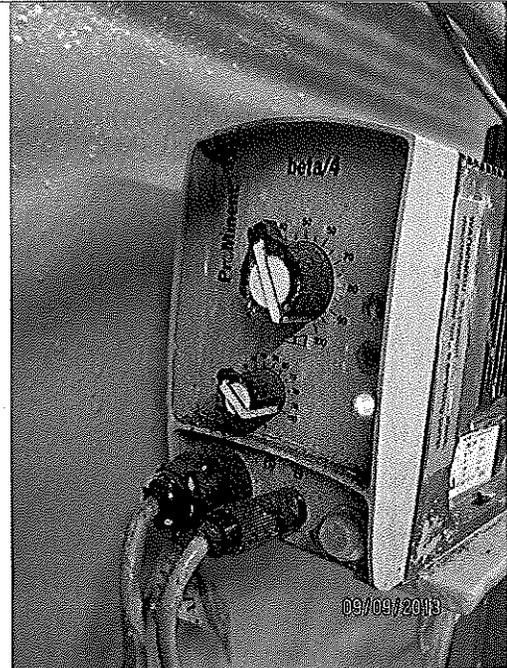
PHOTO #:14 DATE: SEPTEMBER 10, 2013
TAKEN BY: AMY JANKOWIAK FILE No.:IMG_029
DESCRIPTION: MSD CHLORINE DOSING

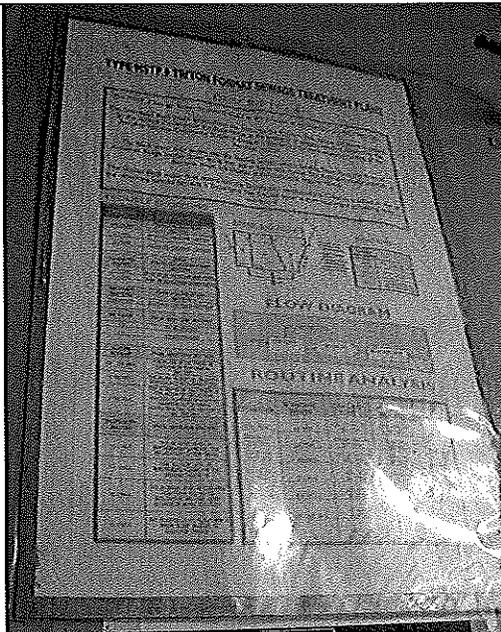
PHOTO #:15 DATE: SEPTEMBER 10, 2013
TAKEN BY: AMY JANKOWIAK FILE No.:IMG_032
DESCRIPTION: MSD SIGNAGE – FLOW AND PROCESS INFO

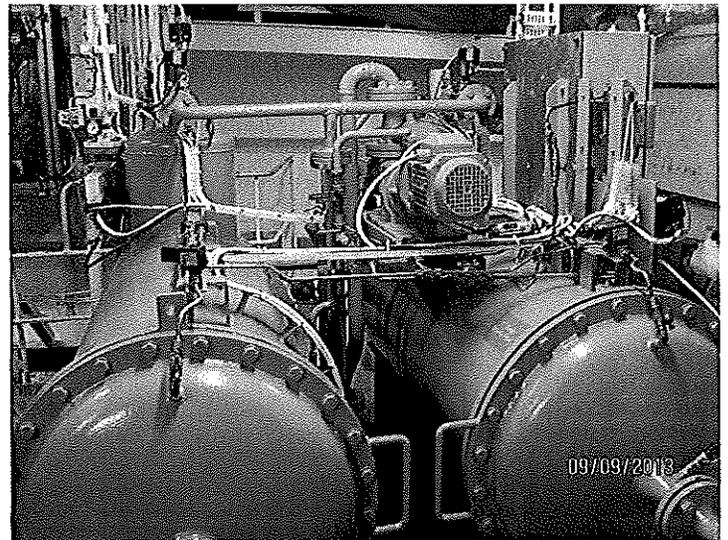
Oily bilge water is treated with a two oily water separators (OWSs) (photos #16 and #17). A white box (photo #18) is used to only allow discharges at less than 15 ppm oil content maximum, though discharges are typically lower between 6-7 ppm. All discharges from the OWSs take place outside of MOU related waters.

PHOTO #:16 DATE: SEPTEMBER 10, 2013
TAKEN BY: AMY JANKOWIAK FILE No.:IMG_018
DESCRIPTION: OILY WATER SEPARATORS (OWS) FOR BILGE WATER

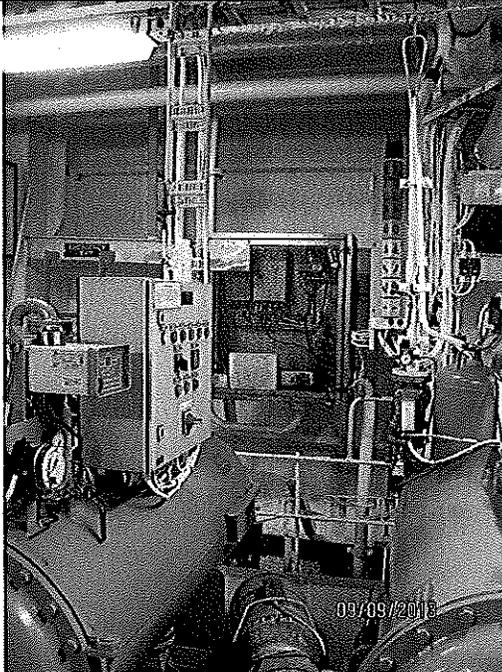
PHOTO #:17 DATE: SEPTEMBER 10, 2013
TAKEN BY: AMY JANKOWIAK FILE No.:IMG_019
DESCRIPTION: OWS WHITE BOX

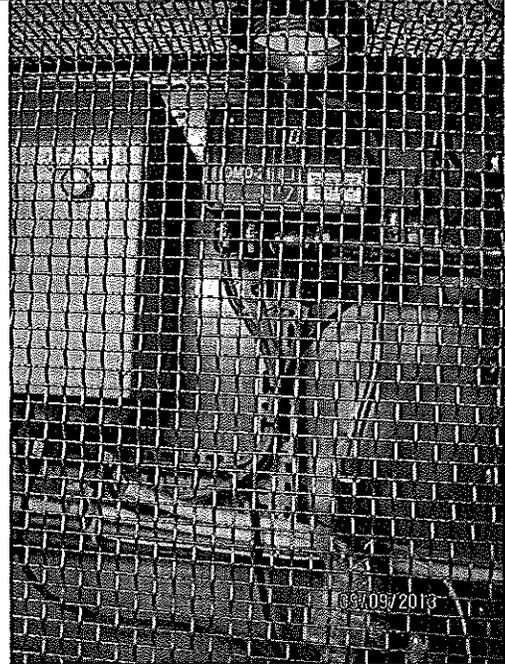
PHOTO #:18 DATE: SEPTEMBER 10, 2013
TAKEN BY: AMY JANKOWIAK FILE No.:IMG_023
DESCRIPTION: OWS WHITE BOX

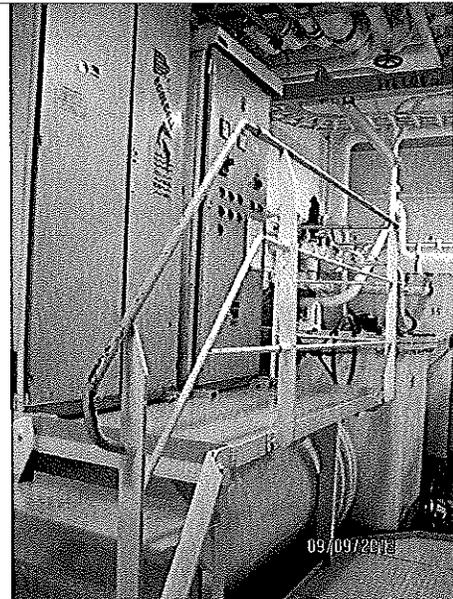
Freshwater is bunkered in and produced on board. The vessels sea chest uses an antifouling system (photo #20).

PHOTO #:20 DATE: SEPTEMBER 10, 2013
TAKEN BY: AMY JANKOWIAK FILE No.:IMG_030
DESCRIPTION: ANTI-FOULING SYSTEM

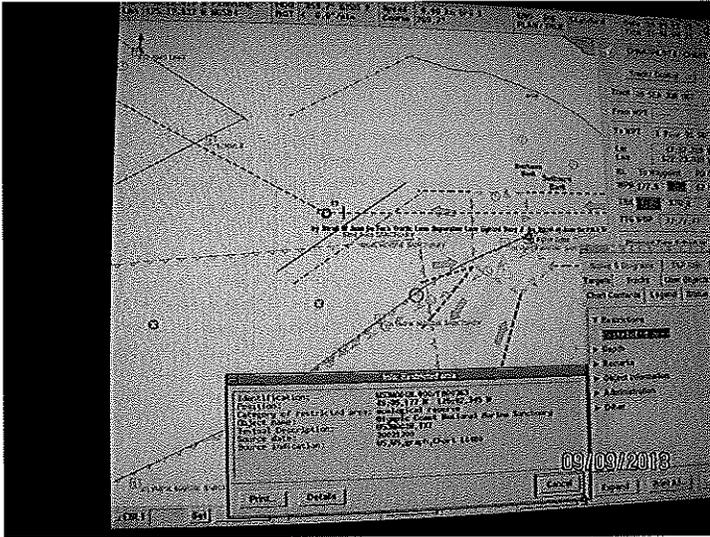
PHOTO #21 DATE: SEPTEMBER 10, 2013
TAKEN BY: AMY JANKOWIAK FILE No.:IMG_033
DESCRIPTION: NAVIGATION SCREEN SHOT – OCNMS AREA
