State of Washington Department of Ecology
Cruise Ship Memorandum of Understanding, Cruise Operations in Washington State Inspection Report

Inspection Date August 27, 2012	Permit Number NA	County King	Receiving Waters Marine Waters	Ecology Inspector Amy Jankowiak
Entry Time 9:07 am	Photos Taken <input type="checkbox"/> Yes <input type="checkbox"/> No	Samples Taken <input type="checkbox"/> Yes <input checked="" type="checkbox"/> No	Inspection Announced <input checked="" type="checkbox"/> Yes <input type="checkbox"/> No	Discharges to: <input checked="" type="checkbox"/> Surface Water <input type="checkbox"/> Ground Water <input type="checkbox"/> Dewater <input type="checkbox"/> POTW
Exit Time 11:09 am	Name and Location of Site Inspected: DISNEY WONDER, Disney Cruise Line Pier 91 Seattle, Washington			Additional Participants/Inspectors: Stjepo Milicic, <u>Staff Captain:</u> DCL.WDR.STCAPT.00005@disney.com
On-Site Representative(s): <i>Name/Title/Phone/e-mail</i> Ioannis Kollarois, Environmental Officer DCL.WDR.ENVOFF.00015@disney.com			Cheryl Thompson, Ecology

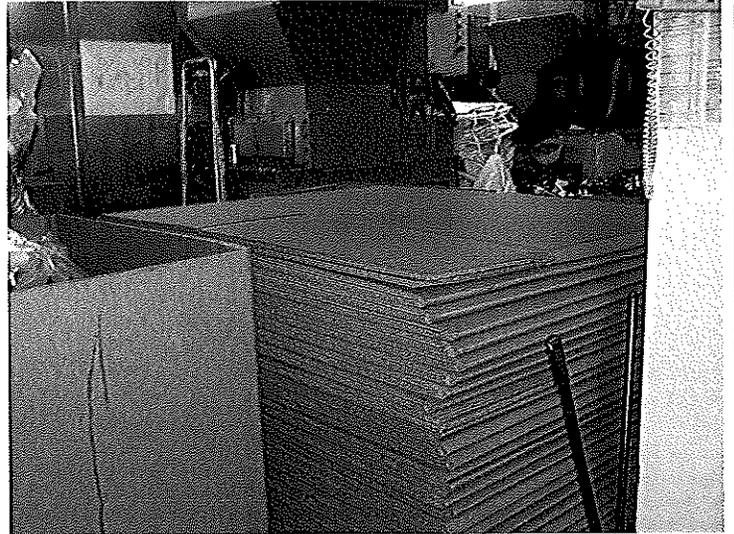
Glass (photo #05), aluminum, tin, scrap metal, some plastics (photo #3), some paper and cardboard (photo # 02), some electronics, batteries and used cooking oil are recycled. Reduction, reuse and recycling progress is tracked and minimization improvements are constant.

PHOTO #:02 DATE: AUGUST 27, 2012
TAKEN BY: AMY JANKOWIAK FILE No.: P8270003
DESCRIPTION: TRI WALL CARDBOARD - RECYCLING

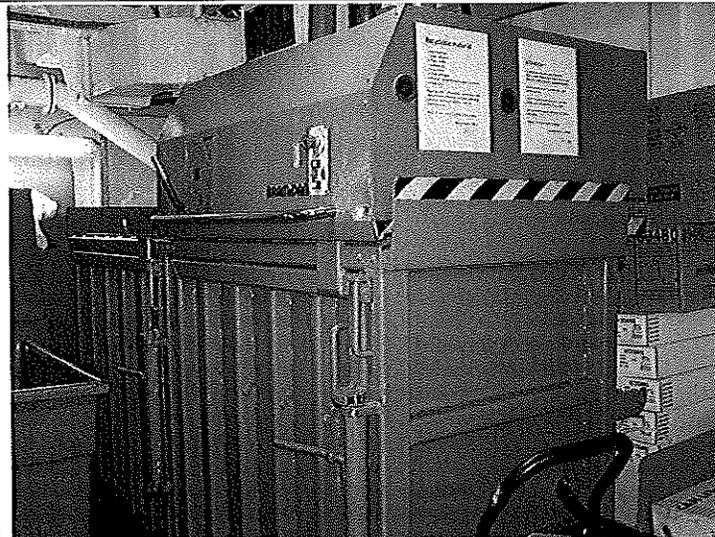
PHOTO #:03 DATE: AUGUST 27, 2012
TAKEN BY: AMY JANKOWIAK FILE No.: P8270004
DESCRIPTION: RECYCLING DENSIFIER

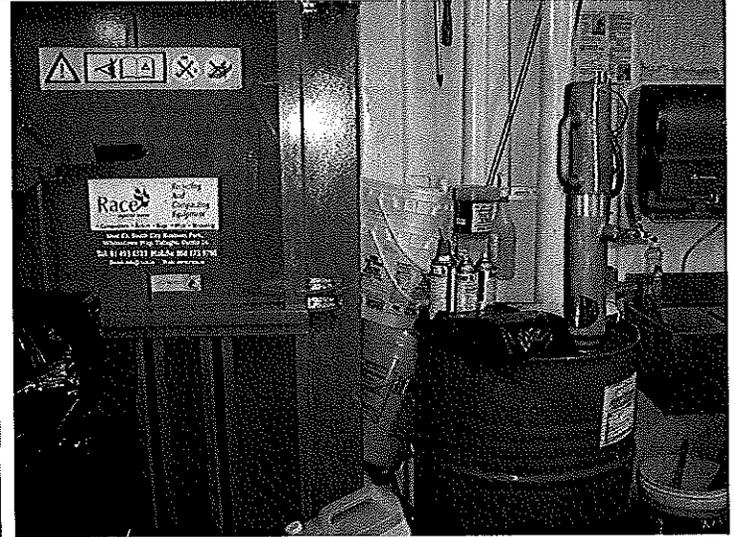
PHOTO #:04 AUGUST 27, 2012
TAKEN BY: AMY JANKOWIAK FILE No.: P8270005
DESCRIPTION: AEROSOL CANISTER REMOVAL SYSTEM

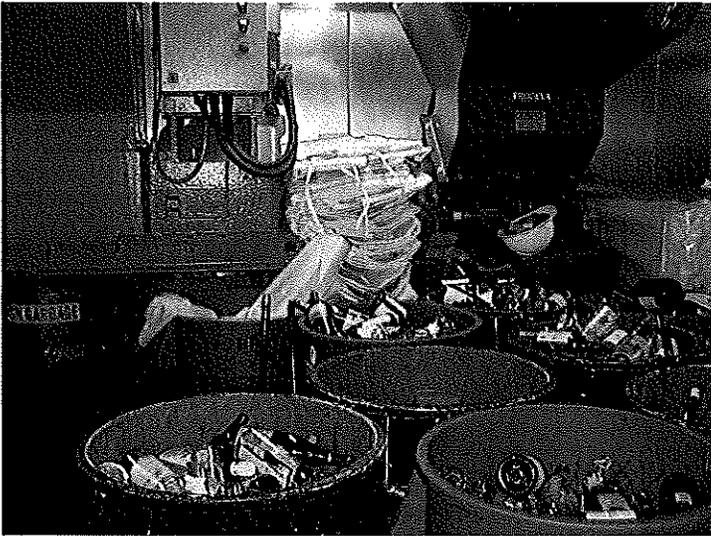
PHOTO #:05 DATE: AUGUST 27, 2012
TAKEN BY: AMY JANKOWIAK FILE No.: P8270006
DESCRIPTION: GLASS RECYCLING

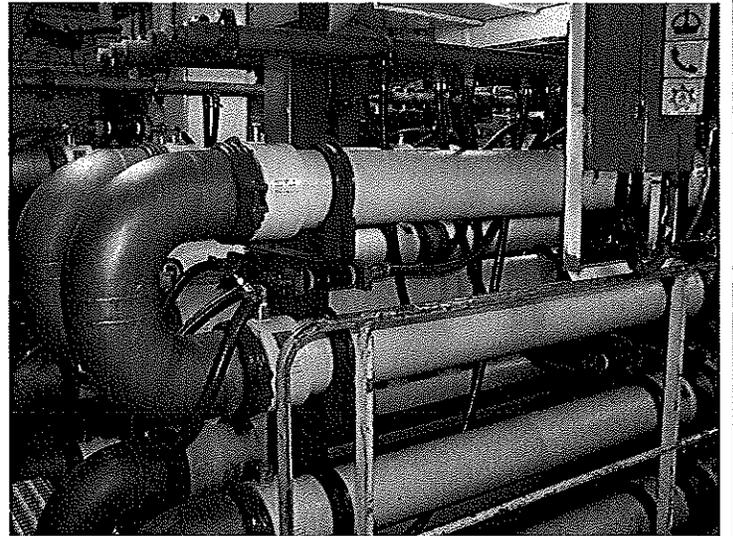
PHOTO #:06 DATE: AUGUST 27, 2012
TAKEN BY: AMY JANKOWIAK FILE No.: P8270008
DESCRIPTION: HAMWORTHY MEMBRANES

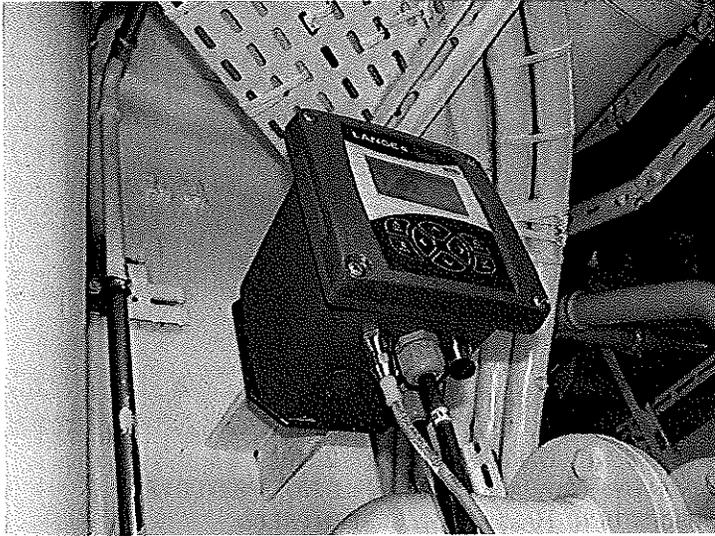
PHOTO #:09 DATE: AUGUST 27, 2012
TAKEN BY: AMY JANKOWIAK FILE No.:P8270011
DESCRIPTION: HAMWORTHY PH METER (7.62)

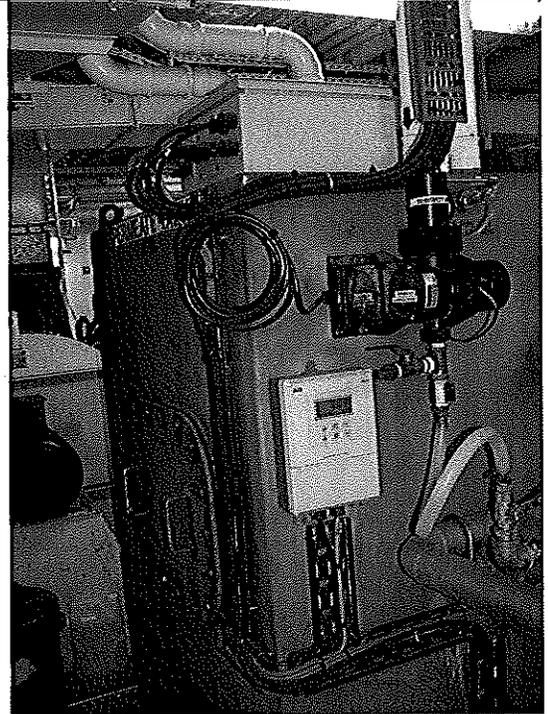
Turbidity is measured continuously on each of the MBR permeate tanks. The UV system consists of 4 lights and the system has alarm settings. The maintenance system provides details of when all maintenance is needed. A pH continuous meter (photo #09) is also alarmed. Samples are taken throughout the system to monitor for process control. COD, TSS, e-coli, pH and free chlorine are all analyzed on the vessel in a small laboratory area (photos #07 and #08). The operator keeps a log book of operation activities (photo #13). The operator of the system had vast knowledge of the intricacies of the treatment system, both physical and biological.

PHOTO #:10 DATE: AUGUST 27, 2012
TAKEN BY: AMY JANKOWIAK FILE No.: P8270012
DESCRIPTION: CONTINUOUS TURBIDIMETER ON HAMWORTHY
PERMEATE TANK (0.03)

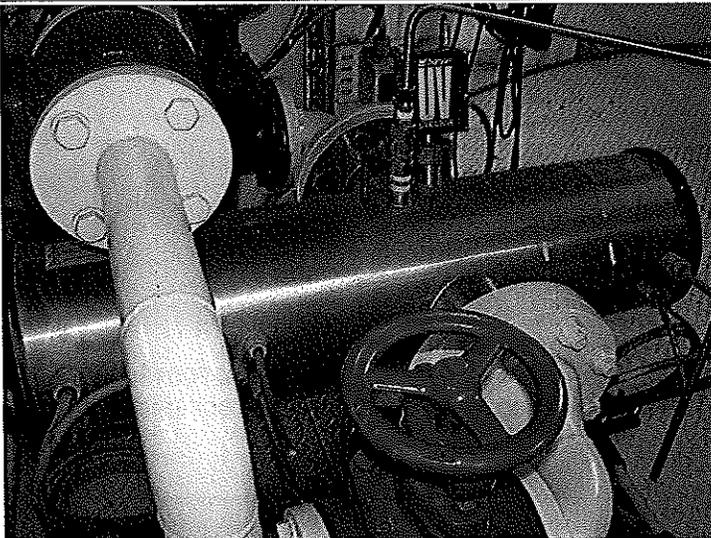
PHOTO #:11 DATE: AUGUST 27, 2012
TAKEN BY: AMY JANKOWIAK FILE No.: P8270013
DESCRIPTION: HAMWORTHY ULTRAVIOLET LIGHT (UV)
DISINFECTION UNIT

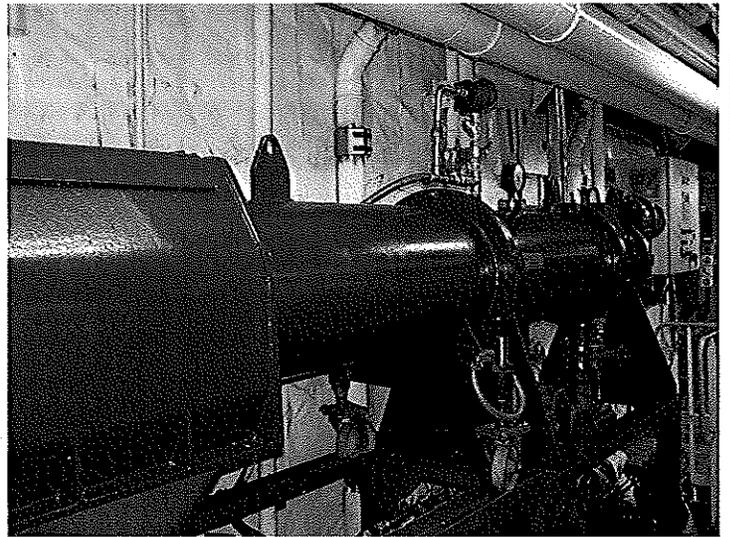
Screenings and grit from the Hamworthy system screen press are collected and incinerated. The solids separated out by the bioreactors are discharged outside of MOU related waters.

PHOTO #:14 DATE: AUGUST 27, 2012
TAKEN BY: AMY JANKOWIAK FILE No.: P8270017
DESCRIPTION: HAMWORTHY SCREEN PRESS

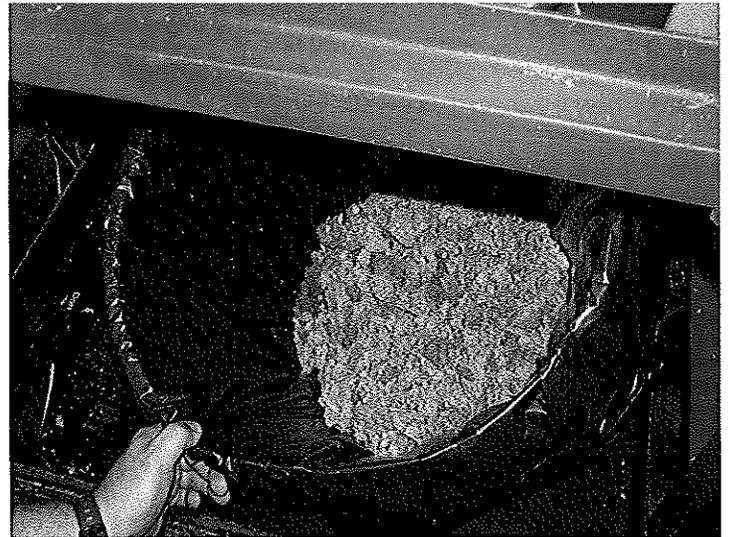
PHOTO #:16 AUGUST 27, 2012
TAKEN BY: AMY JANKOWIAK FILE No.: P8270019
DESCRIPTION: HAMWORTHY SCREEN PRESS SCREENINGS

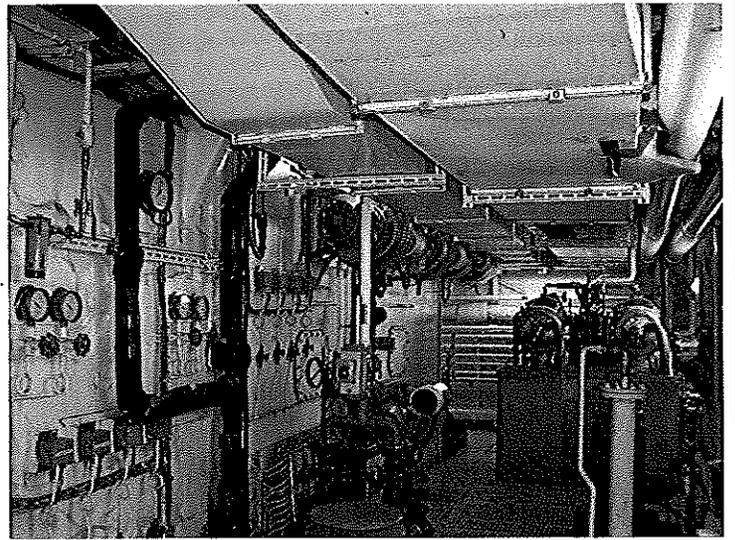
PHOTO #:18 DATE: AUGUST 27, 2012
TAKEN BY: AMY JANKOWIAK FILE No.: P8270021
DESCRIPTION: HAMWORTHY BIOREACTOR TANKS (LEFT)

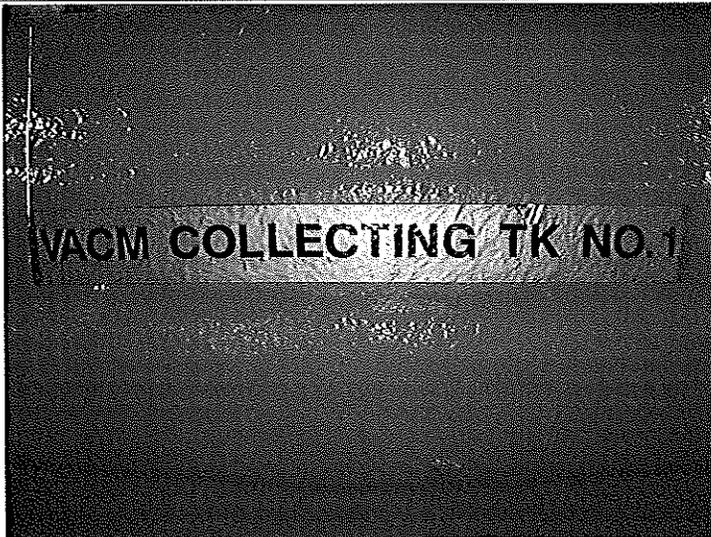
Black water is collected by vacuum to one of three collection tanks (photo #19) and is then sent to one screen presses. Gray water is piped to one of the nine gray water collection tanks prior to going to the screen presses. Black and gray water flow moves (photo #15) to the screen press (photos #14 and #16) where the larger solids are pressed through into bags and are then sent to the incinerator. The liquid moves to the 1st stage of the membrane bioreactor (photo #18) where aeration occurs. From the 1st stage, flow moves to the Inter-stage filters (photo #17). The inter-stage filtered solids are returned back to the 1st stage of the bioreactor or are sent to the solids tank for discharge outside of MOU related waters. The AWTS engineer monitors total suspended solids and COD to evaluate the optimal time to waste the solids. The liquid from the inter-stage filters moves onto the 2nd stage of the bioreactor for further aeration. From the 2nd stage, flow is sent to the membrane modules (photo #06) for ultrafiltration. The MBRs are cleaned by weekly backwash and is sanitized with chlorine. Once a month a chemical flushing is done which takes approximately 10 hours. Effluent from the membrane modules are sent to a permeate tank where turbidity is monitored (photo #10). The permeate tanks are cleaned weekly. The turbidity on the system viewed during the inspection was 0.03 NTU. Flow then combines with the other MBR train for ultraviolet (UV) disinfection (photos #11 and #12). Disinfected effluent either goes directly overboard or to a holding tank if not in an approved area for discharge. Currently, effluent is held and discharged outside of MOU related waters. There is a sample port for treated effluent after UV disinfection.

PHOTO #:19 DATE: AUGUST 27, 2012
TAKEN BY: AMY JANKOWIAK FILE No.: P8270022
DESCRIPTION: BLACKWATER COLLECTION TANK

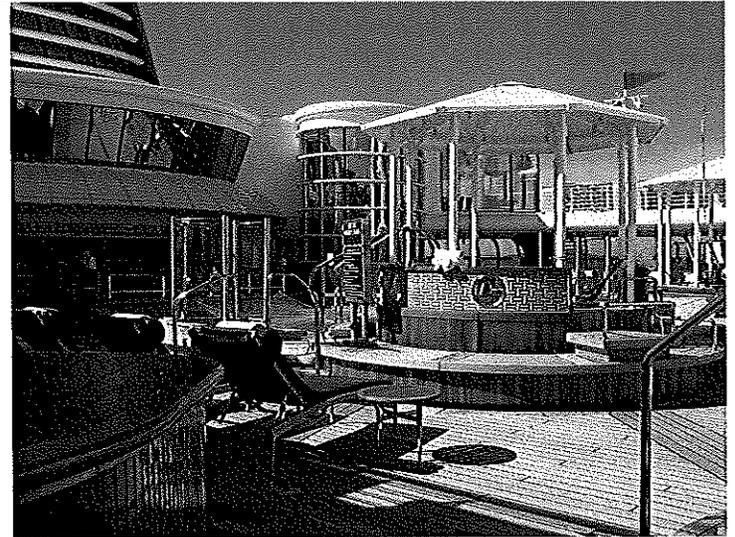
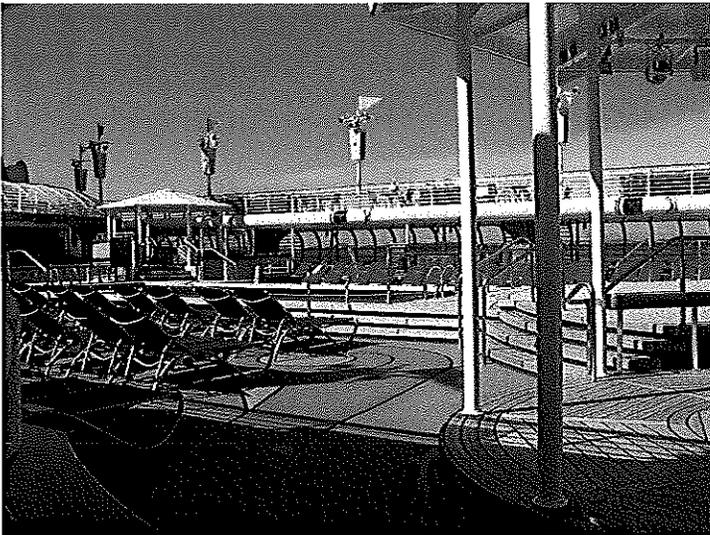
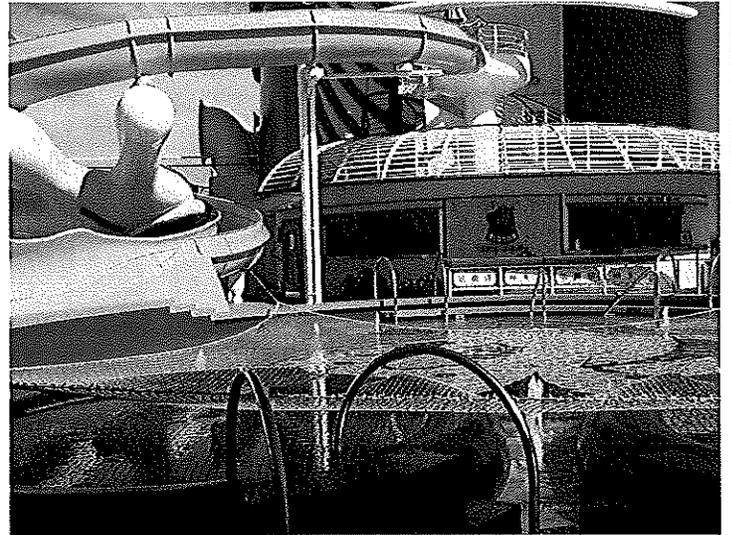
The Environmental Officer reported that pool (photos #20, #21, and #22) and spa water is discharged underway after being dechlorinated with sodium thiosulfite. Although the matrix states that no pool or spa water discharges are to occur in Washington state waters.

PHOTO #:20 AUGUST 27, 2012
TAKEN BY: AMY JANKOWIAK FILE No.: P8270023
DESCRIPTION: POOL AREA

PHOTO #:21 DATE: AUGUST 27, 2012
TAKEN BY: AMY JANKOWIAK FILE No.: P8270024
DESCRIPTION: POOL AREA

PHOTO #:22 DATE: AUGUST 27, 2012
TAKEN BY: AMY JANKOWIAK FILE No.: P8270025
DESCRIPTION: KID POOL AREA

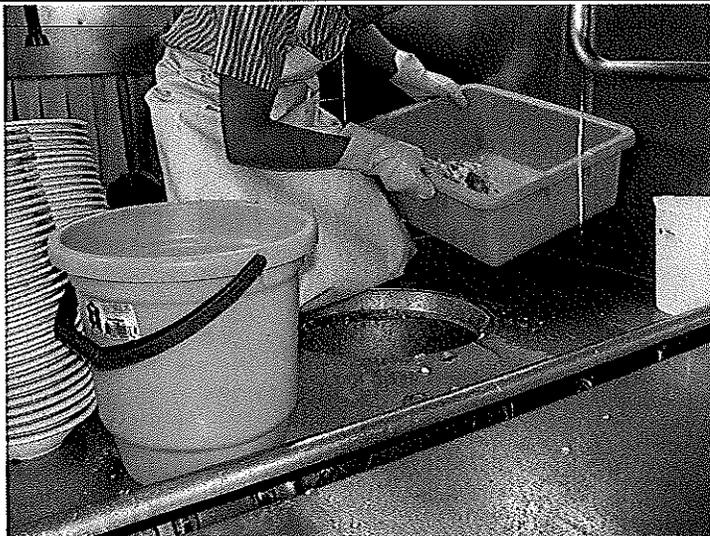
Food waste is collected in various locations, is sorted and then sent through a pulper (photo #23). Pulped food waste and galley water is discharged outside of MOU related waters. Records reviewed were consistent with this protocol. There is a dumping chute for larger food waste items that cannot go in the filters such as pineapple heads. A bone crusher is also used. Galleys use Ecolab phosphate free and non-toxic detergents and degreasers.

PHOTO #:23 DATE: AUGUST 27, 2012
TAKEN BY: AMY JANKOWIAK FILE No.: P8270026
DESCRIPTION: GALLEY PULPER AREA

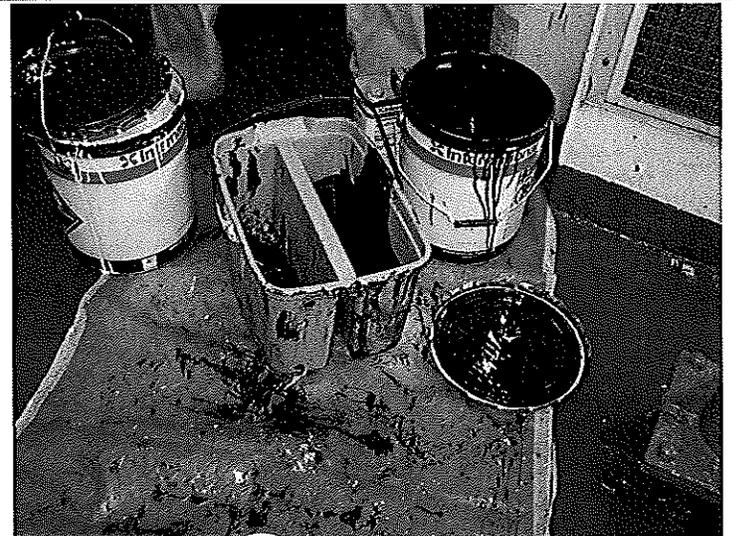
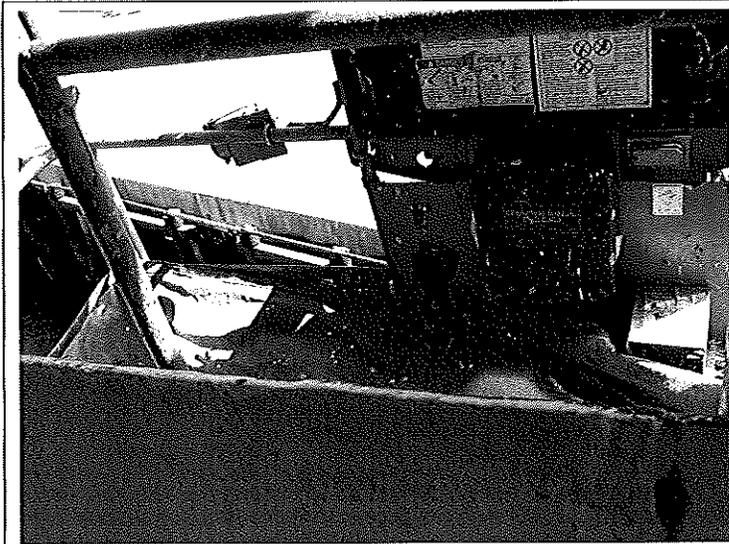
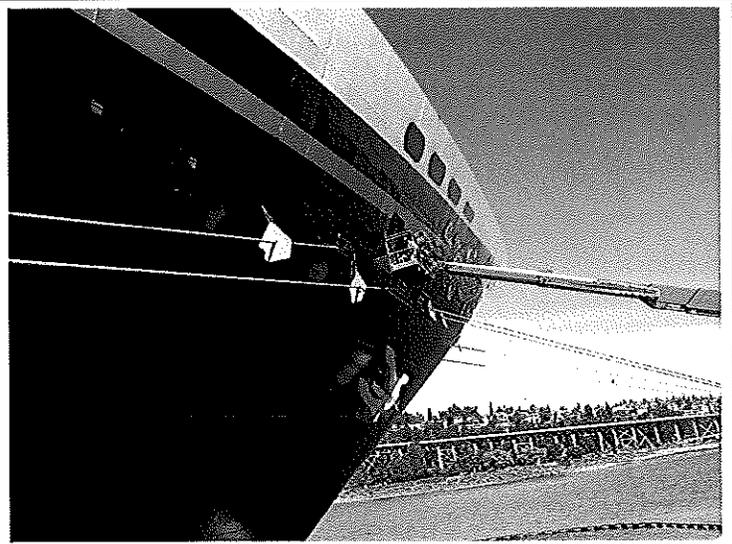
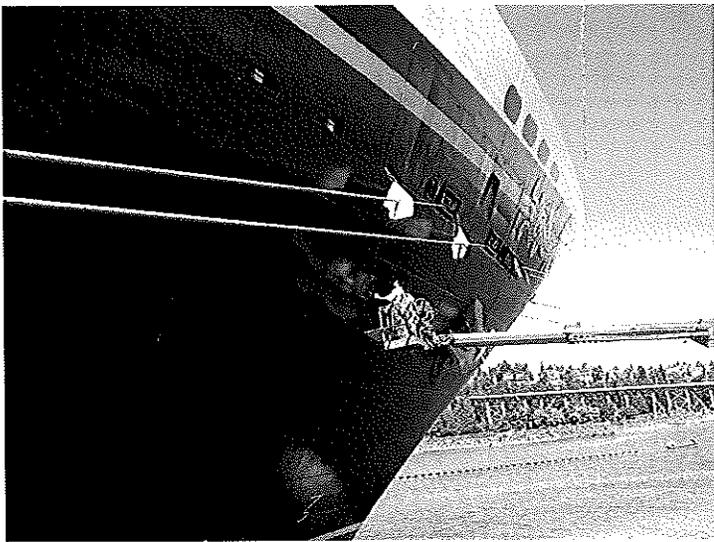
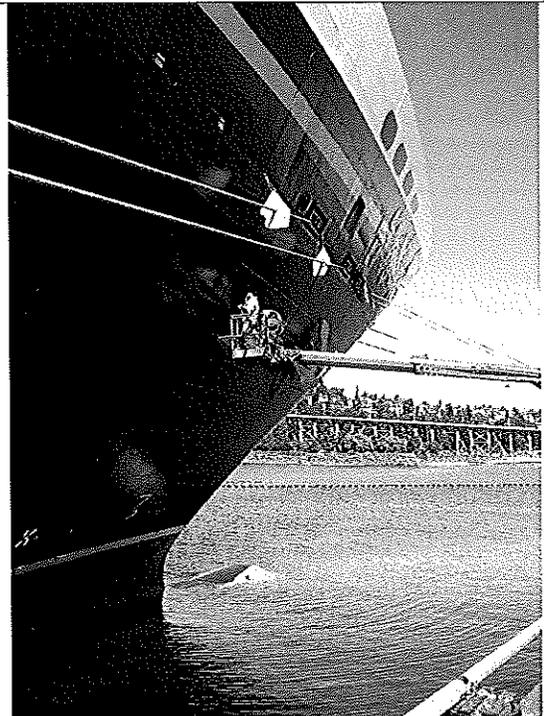
Hull cleaning is occasionally done with divers. Fresh water only is used for washing the outside of the hull and windows. Paint chipping and painting is done in port. The Staff Captain provided a copy of the form used prior to painting which includes some guidelines such as not working in winds over 18 knots or bad weather and having approval from port authorities if applicable and includes safety procedures. Painting was getting underway during the on-board portion of the inspection. Staff were mixing the paint on-board into a small bucket (photo #24) and the cherry picker included a cloth tarp over the grating (photo #25). A small blue tarp was used as paint catchment. After disembarking the vessel, we observed staff beginning to paint (photos #26, #27, and #28). The small blue tarp catchment was not adequate. There was space between the tarp and the vessel below where the paint rollers were being used. This causes a risk of paint drops going directly into the water. It is recommended that staff review the protocols for painting/paint chipping and use a larger catchment for paint/chip droppings. Some vessels have also used magnets to attach catchments to the vessel to close the gap and/or have used tarping directly over the water for catchment. The cloth tarp over the grating is likely insufficient to be able to contain paint if the paint bucket were to tip over on the cherry picker. More substantial containment is recommended. The Port of Seattle best management practices for painting should also be reviewed by staff.

PHOTO #:24 AUGUST 27, 2012
TAKEN BY: AMY JANKOWIAK FILE No.: P8270027
DESCRIPTION: OUTSIDE PAINGING PREPARATION

PHOTO #:25 DATE: AUGUST 27, 2012
TAKEN BY: AMY JANKOWIAK FILE No.: P8270028
DESCRIPTION: OUTSIDE VESSEL PAINTING CHERRY PICKER WITH
FABRIC TARP

PHOTO #:26 DATE: AUGUST 27, 2012
TAKEN BY: AMY JANKOWIAK FILE No.: P8270029
DESCRIPTION: OUTSIDE VESSEL PAINTING

PHOTO #:27 DATE: AUGUST 27, 2012
TAKEN BY: AMY JANKOWIAK FILE No.: P8270030
DESCRIPTION: OUTSIDE VESSEL PAINTING – SMALL BLUE TARP
CATCHMENT – APPROX 2 FEET AWAY FROM VESSEL

PHOTO #:28 AUGUST 27, 2012
TAKEN BY: AMY JANKOWIAK FILE No.: P8270031
DESCRIPTION: OUTSIDE VESSEL PAINTING

It is recommended that staff review the protocols for painting/paint chipping and use a larger catchment for paint/chip droppings. The cloth tarp over the grating is likely insufficient to be able to contain paint if the paint bucket were to tip over on the cherry picker. More substantial containment is recommended. The Port of Seattle best management practices for painting should also be reviewed by staff.
