State of Washington Department of Ecology
Cruise Ship Memorandum of Understanding, Cruise Operations in Washington State Inspection Report

Amy Jankowiak, Washington State Department of Ecology (Ecology) Northwest Regional Office, Water Quality Program (NWRO-WQ) conducted the inspection of the Norwegian Cruise Line (NCL) NORWEGIAN JEWEL on August 11, 2012. The main contact on board the NORWEGIAN JEWEL was Sue Lobo, Environmental Officer for the NORWEGIAN JEWEL. Prior notification of the visit was given on August 9, 2012 for security protocol. The purpose of the inspection was to evaluate compliance with the *Memorandum of Understanding Cruise Operations in Washington State* (MOU), as amended. The NORWEGIAN JEWEL is not approved to discharge wastewater in MOU waters.

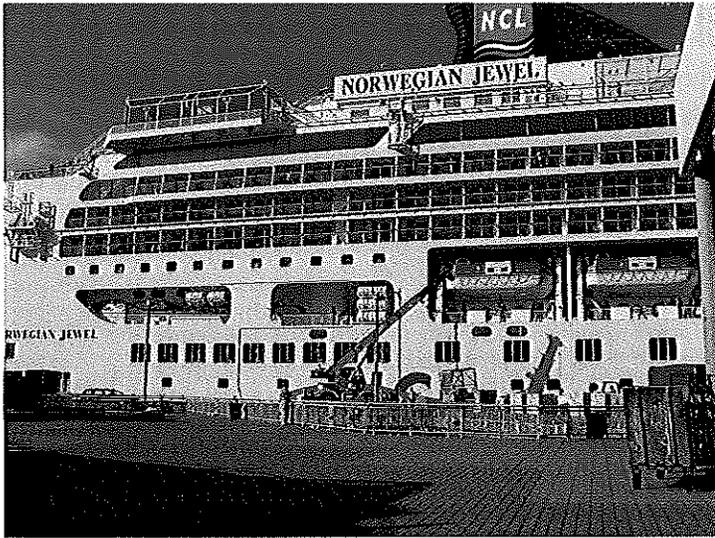
I arrived and boarded the ship (photo #01) at about 8:54 am and began with introductions and a plan for the day with Sue Lobo, Environmental Officer (EO) and met with Captain Lars Bergstrom and navigation staff. We discussed discharge protocols on the bridge and then met in the engine control room (ECR) to discuss various waste streams and discharge protocols. We then reviewed the various discharge and environmental records. We then toured the Scanship blackwater and graywater Advanced Wastewater Treatment System (AWTS) and the oily bilge treatment system. We toured the garbage and recycling rooms, hazardous waste storage and one of the galleys and food waste system. The inspection was then finalized with a debriefing and I disembarked the vessel at about 11:08 am.

PHOTO #:01 DATE: AUGUST 11, 2012
TAKEN BY: AMY JANKOWIAK FILE No.: P8110001
DESCRIPTION: NORWEGIAN JEWEL VESSEL

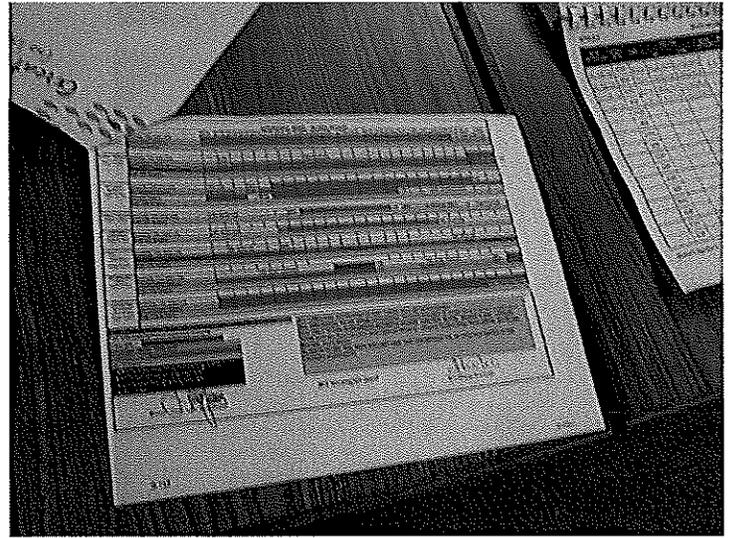
The discharge protocol for wastewater includes an "environmental voyage plan" (photo #02) that is discussed and planned prior to the cruise season and is marked on the charts. When a discharge is to occur, a request is made to the bridge where locations are verified and upon discharge, the locations are logged on the bridge and in the ECR as well as electronically. The EO and the Captain are the only ones who have the port keys to unlock the discharge port. The EO is notified to open the discharge port. The environmental voyage plan for the 2012 season requires that all discharges (wastewater, oily bilge, ballast water, galley water, pool water, etc.) be stopped prior to entering into the Olympic Coast National Marine Sanctuary (OCNMS) and Washington State and MOU waters and resuming discharges only when outside of those waters.

PHOTO #:02 DATE: AUGUST 11, 2012
TAKEN BY: AMY JANKOWIAK FILE No.: P8110002
DESCRIPTION: ENVIRONMENTAL VOYAGE PLAN

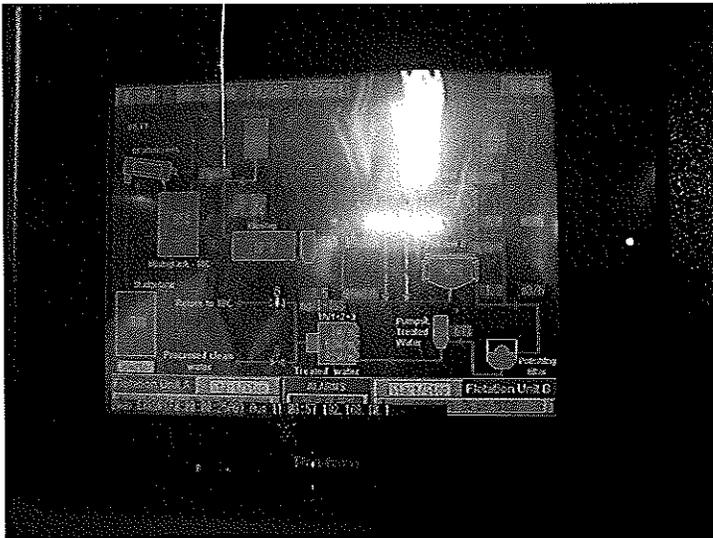
Blackwater, which includes toilet water and infirmary drains and graywater which includes sink and shower and laundry water is treated with a Scanship AWTS (photo #03) and is discharged outside of OCNMS and Washington State and MOU waters. Discharges occur in Canadian waters near Victoria after approximately 3am.

PHOTO #:03 DATE: AUGUST 11, 2012
TAKEN BY: AMY JANKOWIAK FILE No.: P8110003
DESCRIPTION: SCANSHIP SYSTEM OPERATIONS

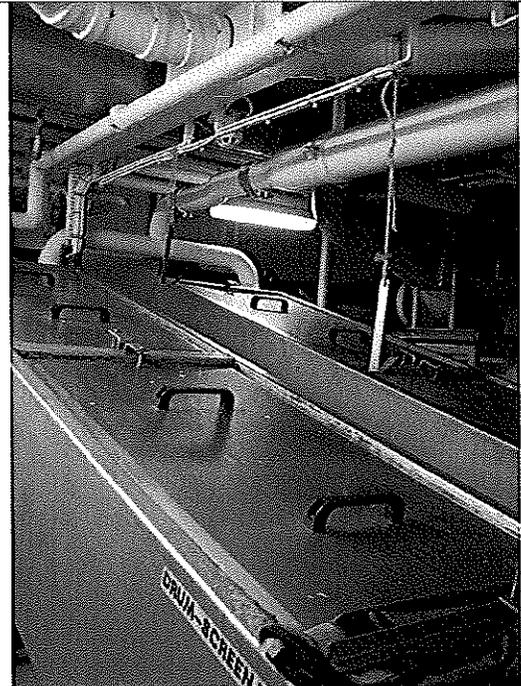
entering the drum screens. There are two drum screens (photos #04 and #05) which provide pre-screening. The drum screens are cleaned weekly with water. Solids from the drum screens go to the sludge tank. Liquid flow from the drum screens then enters the biostep tanks (photos #06 and #07) for biological treatment (biofilm on rotating plastic pieces – 2 tanks in series, air added). After biostep, coagulants (photo #9) and polymers are added. Clarification then occurs via flotation tanks (photo #08). Solids from the flotation tanks are sent to the sludge tank along with the screenings to be held for later discharge. Liquid flow then moves to the polishing filters (photo #10) for ultrafiltration (2 rotating mesh drums). Flow then moves to ultraviolet light (UV) disinfection (photos #11 and #12). There are three UV units, of which two are typically used with 14 bulbs each. The bulbs are alarmed for bulb failure and intensity at 10 watts. The UV sleeves are cleaned by dosing Ameroid RSR (new cleaner) cleaner automatically, daily. The UV light sleeves are also hand wiped about once a month. Flow from the UV units is either discharged directly overboard via the discharge port (photo #14) or is held for discharge later outside of MOU waters. A total suspended solids (TSS) meter (photo #13) measures solids (equivalent to turbidity) continuously at the UV system. At the time of the inspection, the reading was 3.28 mg/l. The TSS meter is alarmed at 29.9 to shut down the discharge. The Scanship operator said that the meter only spikes when cleaning occurs.

PHOTO #:04 AUGUST 11, 2012
TAKEN BY: AMY JANKOWIAK FILE No.: P8110004
DESCRIPTION: SCANSHIP DRUM SCREENS

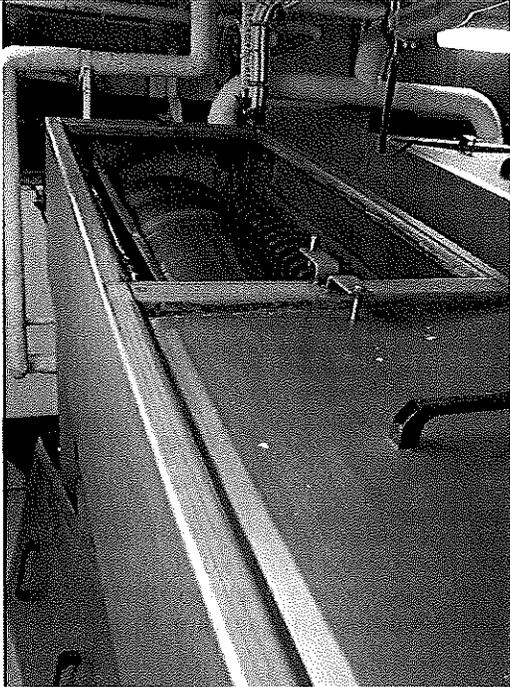
PHOTO #:05 DATE: AUGUST 11, 2012
TAKEN BY: AMY JANKOWIAK FILE No.: P8110005
DESCRIPTION: INSIDE OF SCANSHIP DRUM SCREEN

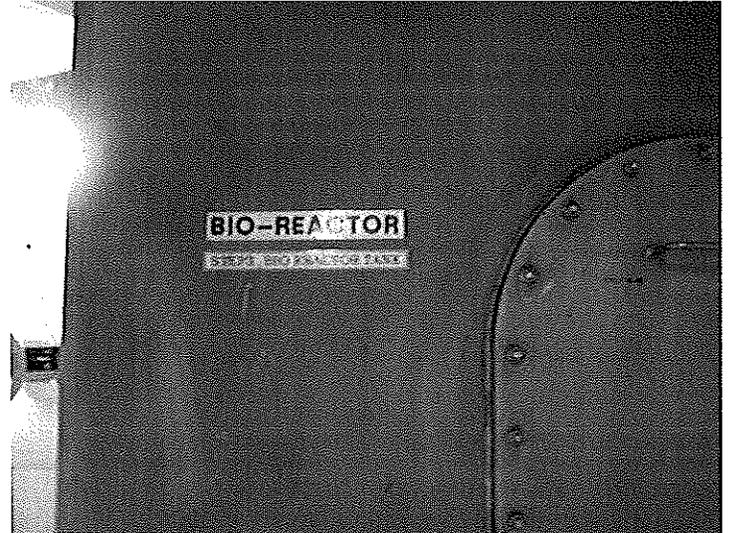
PHOTO #:06 DATE: AUGUST 11, 2012
TAKEN BY: AMY JANKOWIAK FILE No.: P8110006
DESCRIPTION: SCANSHIP BIO-REACTOR TANK (BIOSTEP)

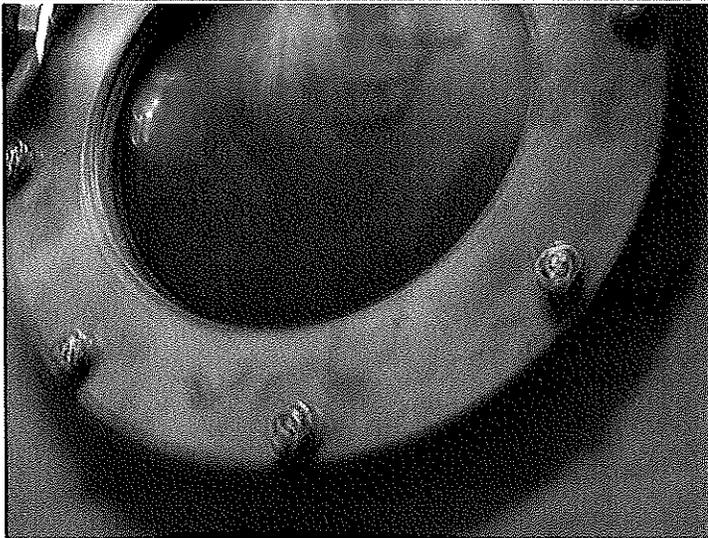
PHOTO #:07 DATE: AUGUST 11, 2012
TAKEN BY: AMY JANKOWIAK FILE No.: P8110007
DESCRIPTION: INSIDE OF SCANSHIP BIO-REACTOR

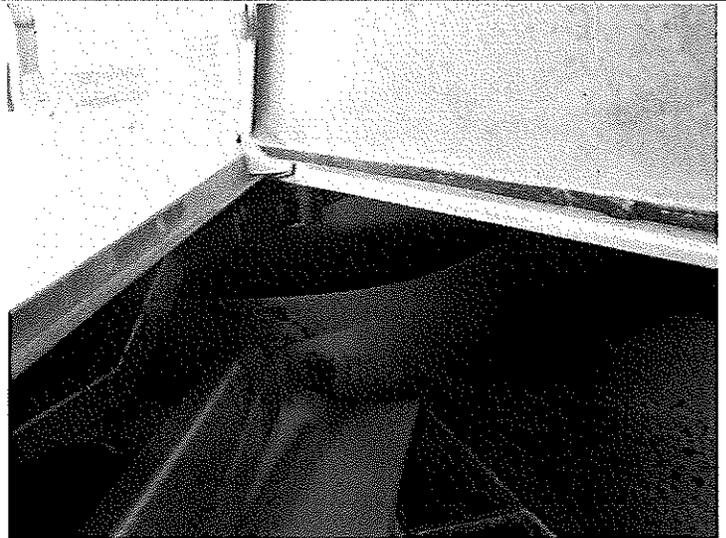
PHOTO #:08 AUGUST 11, 2012
TAKEN BY: AMY JANKOWIAK FILE No.: P8110008
DESCRIPTION: INSIDE OF SCANSHIP FLOTATION TANK

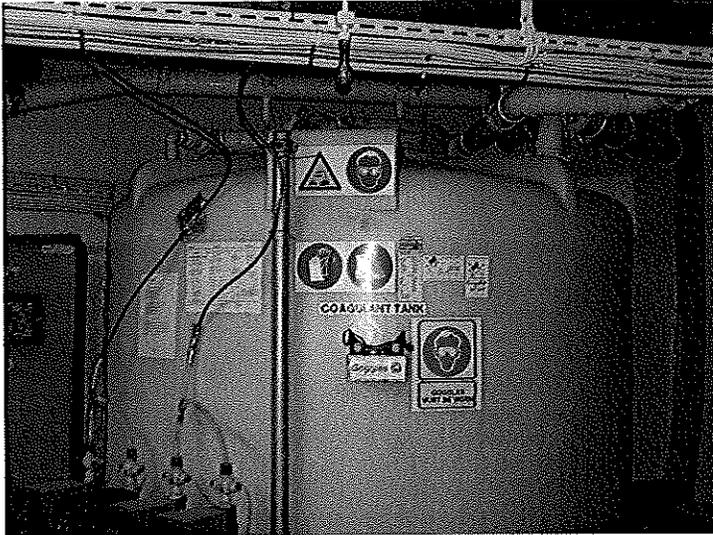
PHOTO #:09 DATE: AUGUST 11, 2012
TAKEN BY: AMY JANKOWIAK FILE No.:P8110009
DESCRIPTION: SCANSHIP COAGULANT TANK

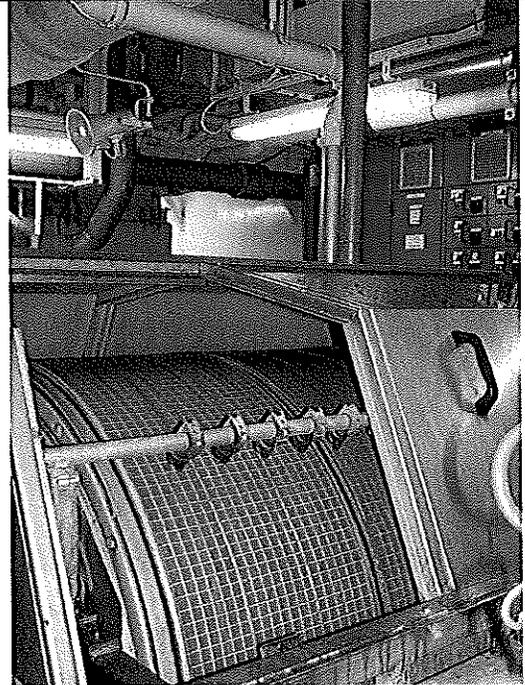
PHOTO #:10 DATE: AUGUST 11, 2012
TAKEN BY: AMY JANKOWIAK FILE No.: P8110010
DESCRIPTION: INSIDE OF SCANSHIP POLISHING FILTER

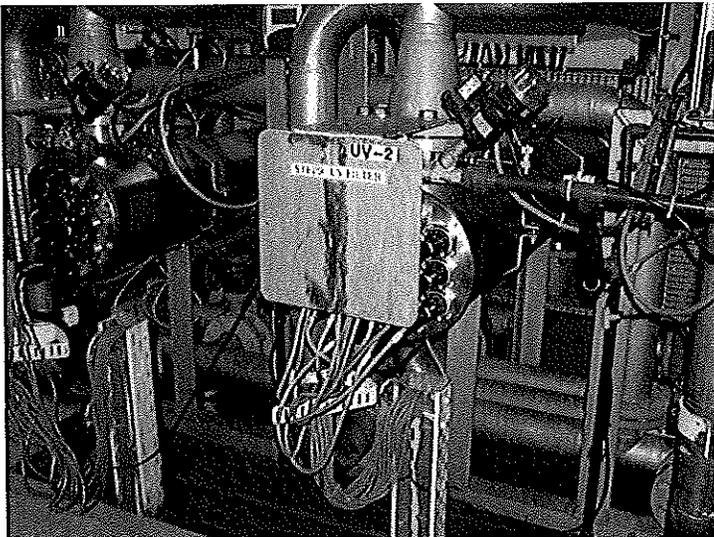
PHOTO #:11 DATE: AUGUST 11, 2012
TAKEN BY: AMY JANKOWIAK FILE No.: P8110011
DESCRIPTION: SCANSHIP ULTRAVIOLET LIGHT DISINFECTION
SYSTEM

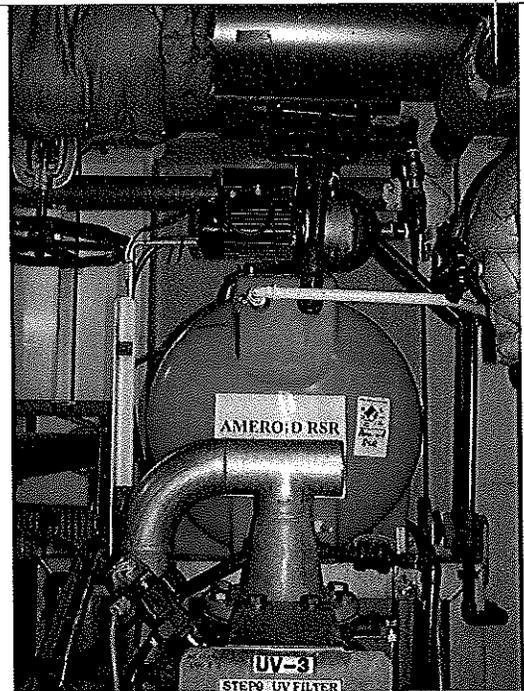
PHOTO #:12 AUGUST 11, 2012
TAKEN BY: AMY JANKOWIAK FILE No.: P8110012
DESCRIPTION: SCANSHIP ULTRAVIOLET LIGHT DISINFECTION
SYSTEM CLEANER

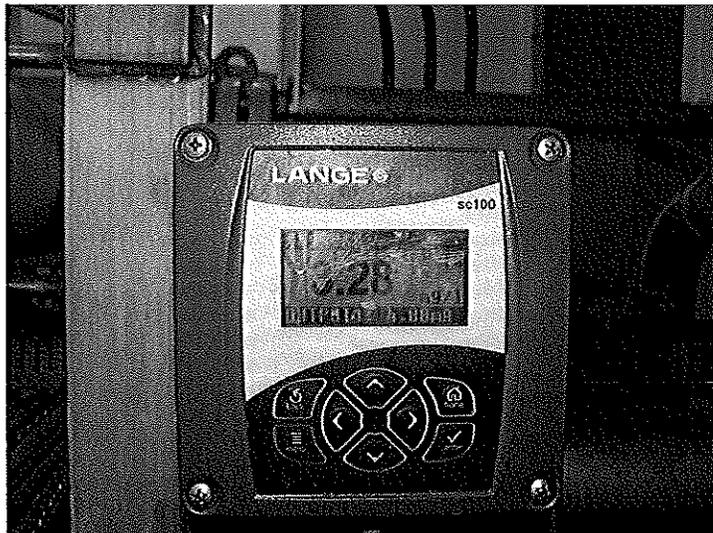
PHOTO #:13 DATE: AUGUST 11, 2012
TAKEN BY: AMY JANKOWIAK FILE No.: P8110013
DESCRIPTION: SCANSHIP TSS SENSOR (3.28 MG/L)

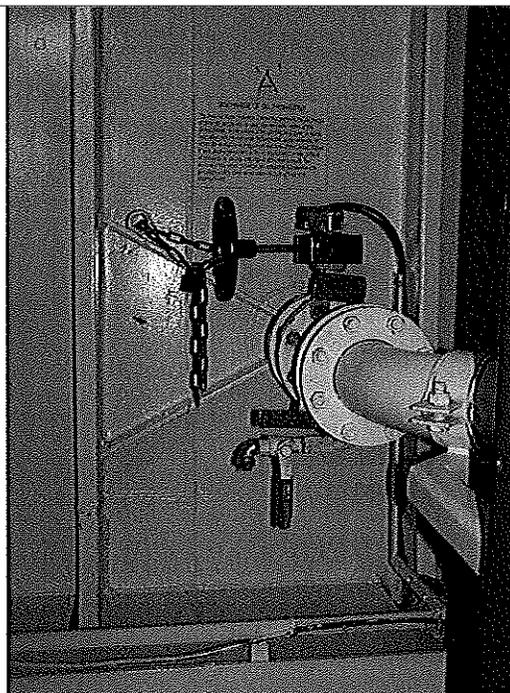
PHOTO #:14 DATE: AUGUST 11, 2012
TAKEN BY: AMY JANKOWIAK FILE No.: P8110014
DESCRIPTION: SCANSHIP TSG DISCHARGE PORT

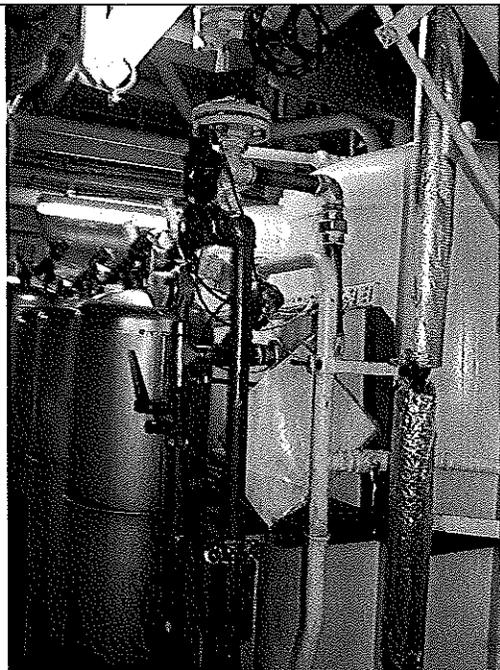
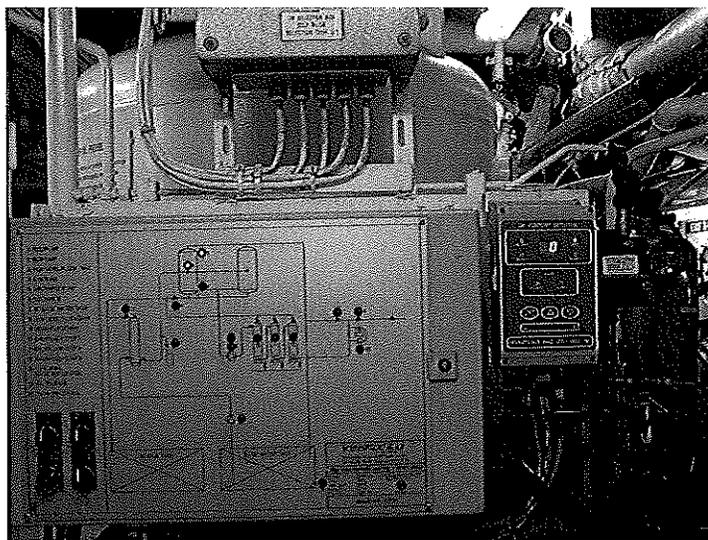
Oily bilge is treated first with a Marin Floc oily water separator system (photos #15 and #16) and then with an RWO oily water separator system (photo #17) to bring oil content down to <15 ppm. Values are usually less than 5 ppm. Discharges (photo #19) occur at less than 15 ppm and >12 nautical miles, >6 knots and at Sea. A white box (photo #18) is used to prevent discharges of more than 15 ppm. Oily sludge is drummed and offloaded for proper disposal. Oily rags are incinerated.

PHOTO #:15 DATE: AUGUST 11, 2012
TAKEN BY: AMY JANKOWIAK FILE No.: P8110015
DESCRIPTION: MARIN FLOC OILY BILGE WATER SEPARATOR

PHOTO #:16 AUGUST 11, 2012
TAKEN BY: AMY JANKOWIAK FILE No.: P8110016
DESCRIPTION: MARIN FLOC OILY BILGE WATER SEPARATOR

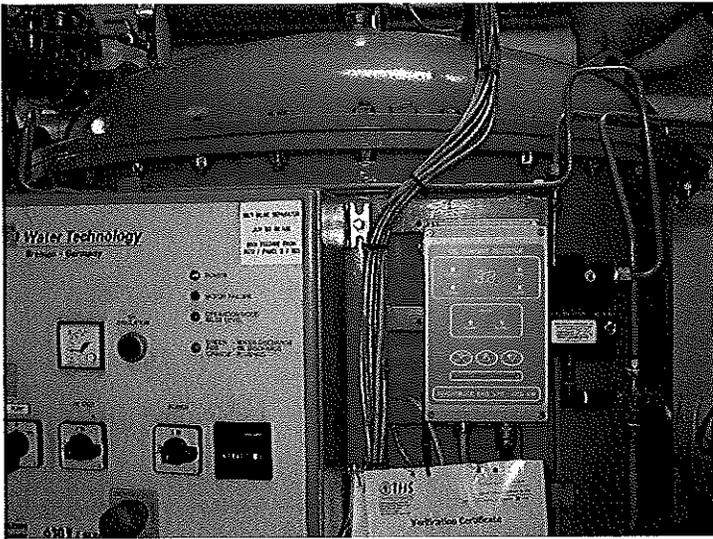
PHOTO #:17 DATE: AUGUST 11, 2012
TAKEN BY: AMY JANKOWIAK FILE No.:P8110017
DESCRIPTION: RWO OILY BILGE WATER SEPARATOR

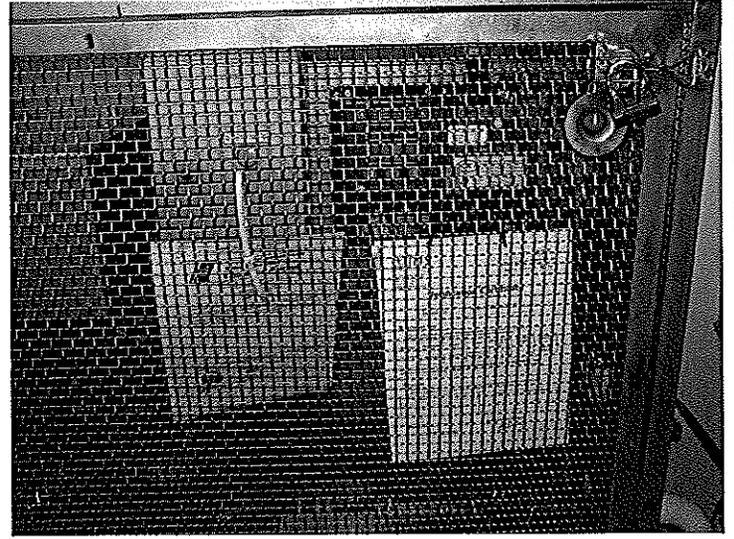
PHOTO #:18 DATE: AUGUST 11, 2012
TAKEN BY: AMY JANKOWIAK FILE No.: P811018
DESCRIPTION: OILY BILGE WATER WHITE BOX

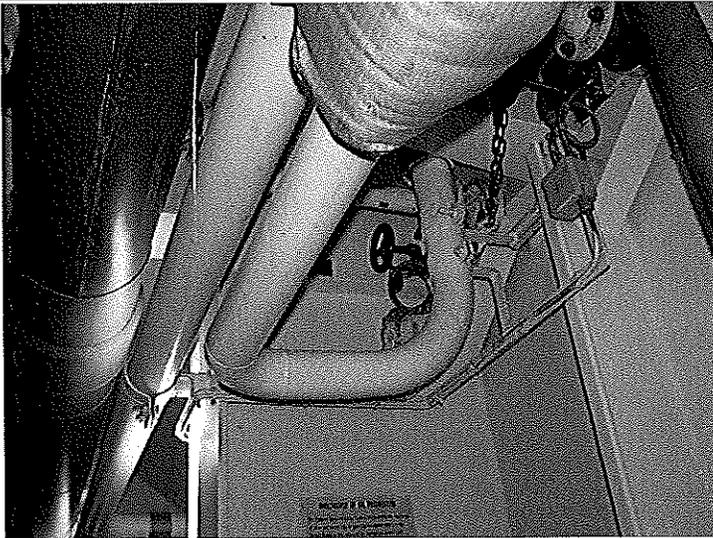
PHOTO #:19 DATE: AUGUST 11, 2012
TAKEN BY: AMY JANKOWIAK FILE No.: P8110019
DESCRIPTION: CLEAN OILY BILGE DISCHARGE PORT

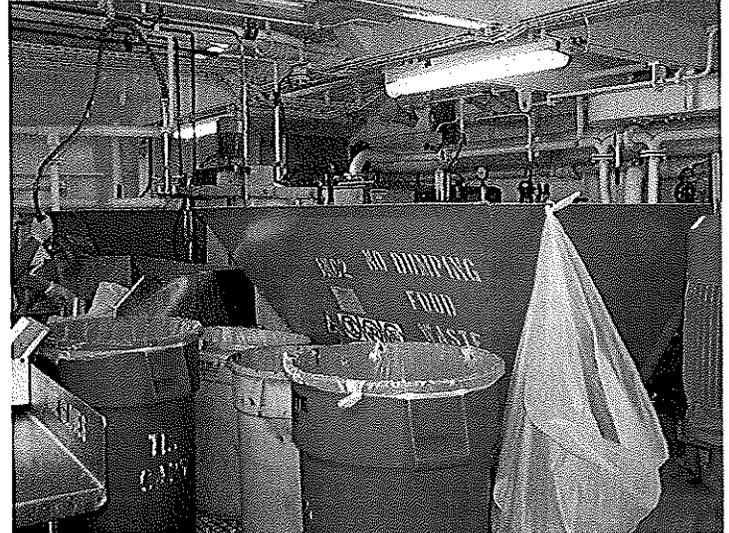
Solid waste is managed properly. The various solid waste streams are collected, sorted (photo #20), stored, and sent ashore or incinerated as appropriate. The garbage record book was reviewed and showed consistency with requirements. Glass is recycled and not discharged.

PHOTO #:20 AUGUST 11, 2012
TAKEN BY: AMY JANKOWIAK FILE No.: P8110020
DESCRIPTION: GARBAGE AND RECYCLING ROOM

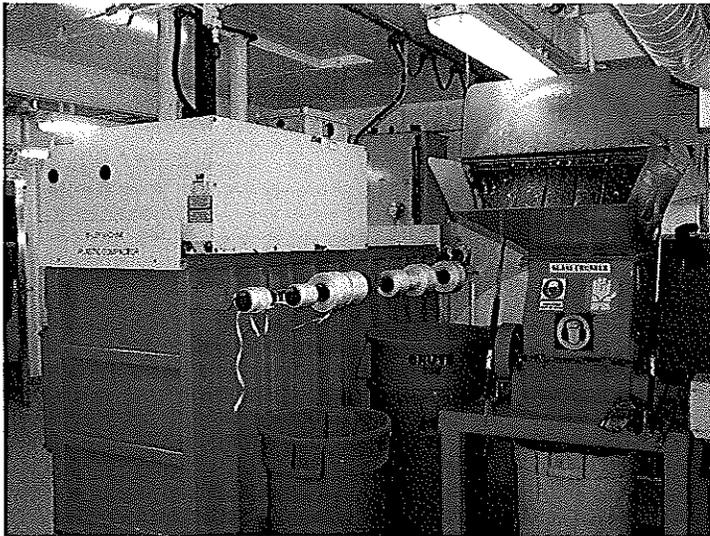
Glass and plastics (1-7) are crushed and compacted (photo #21), aluminum and tin are compacted (photo #22), scrap metal, some paper and non-contaminated cardboard, used cooking oil (photo #26), and other materials are recycled. Reduction and reuse opportunities are broadly used to prevent the amount of waste (photos #23 and #24). Some materials are stored in cold storage (photo #25).

PHOTO #:21 DATE: AUGUST 11, 2012
TAKEN BY: AMY JANKOWIAK FILE No.: P8110021
DESCRIPTION: GLASS CRUSHER AND PLASTIC COMPACTOR

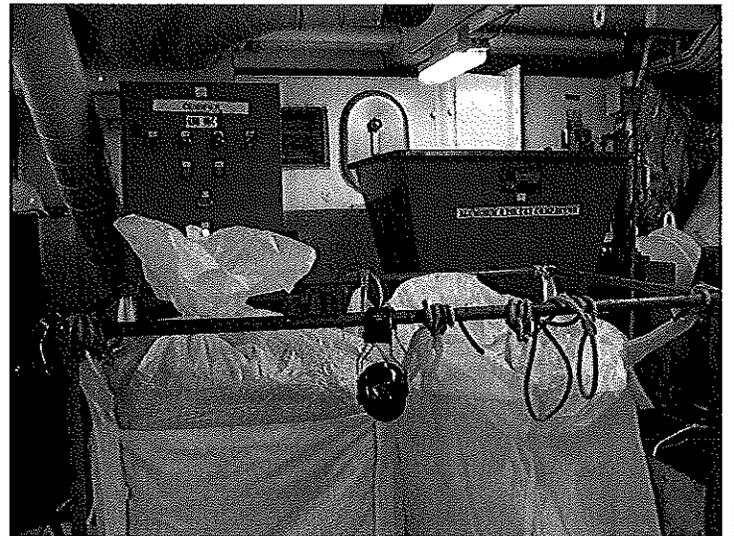
PHOTO #:22 DATE: AUGUST 11, 2012
TAKEN BY: AMY JANKOWIAK FILE No.: P8110022
DESCRIPTION: DENSIFIER AND ALUMINUM & TIN CAN COMPACTOR

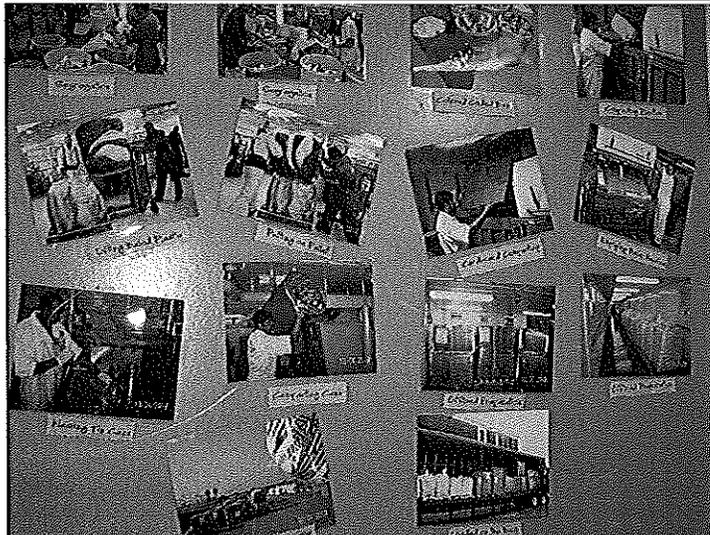
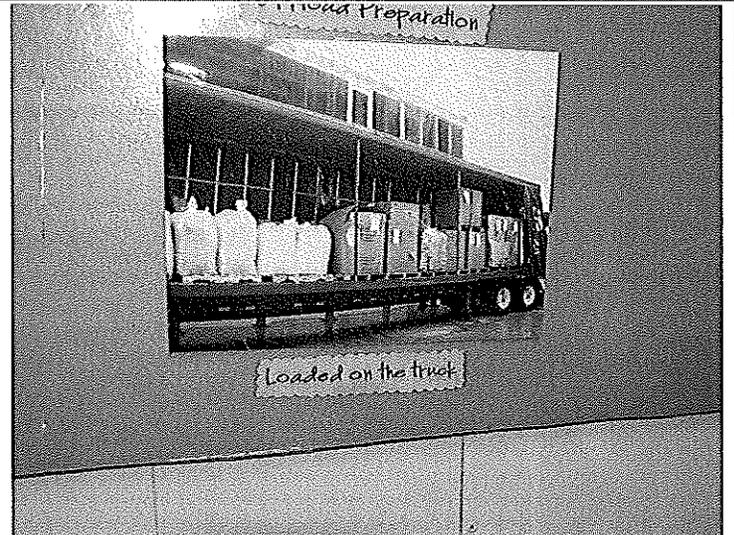
PHOTO #:23 DATE: AUGUST 11, 2012
TAKEN BY: AMY JANKOWIAK FILE No.: P8110023
DESCRIPTION: WASTE MANAGEMENT BOARD

PHOTO #:24 AUGUST 11, 2012
TAKEN BY: AMY JANKOWIAK FILE No.: P8110024
DESCRIPTION: RECYCLING OFF-LOAD TO TRUCK

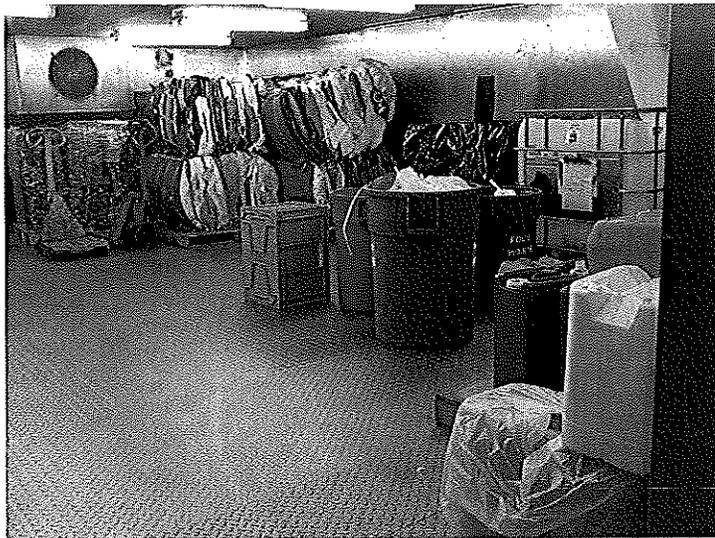
PHOTO #:25 DATE: AUGUST 11, 2012
TAKEN BY: AMY JANKOWIAK FILE No.: P8110025
DESCRIPTION: GARBAGE AND RECYCLING COLD STORAGE

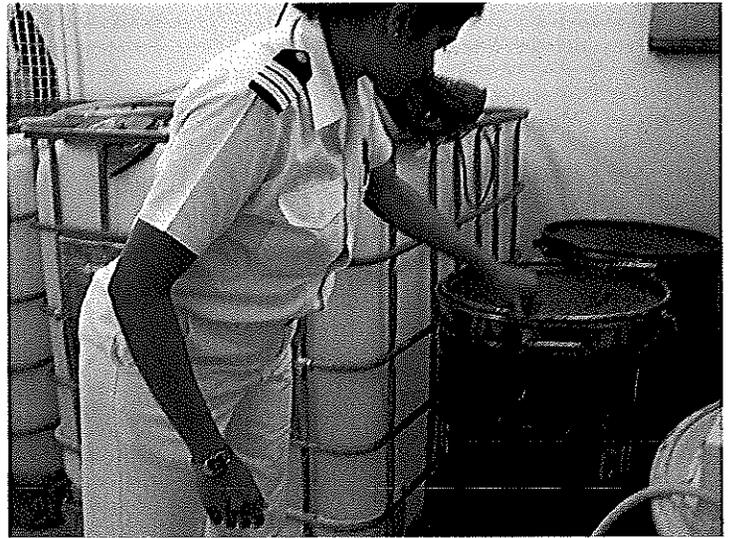
PHOTO #:26 DATE: AUGUST 11, 2012
TAKEN BY: AMY JANKOWIAK FILE No.: P8110026
DESCRIPTION: USED COOKING OIL STORAGE

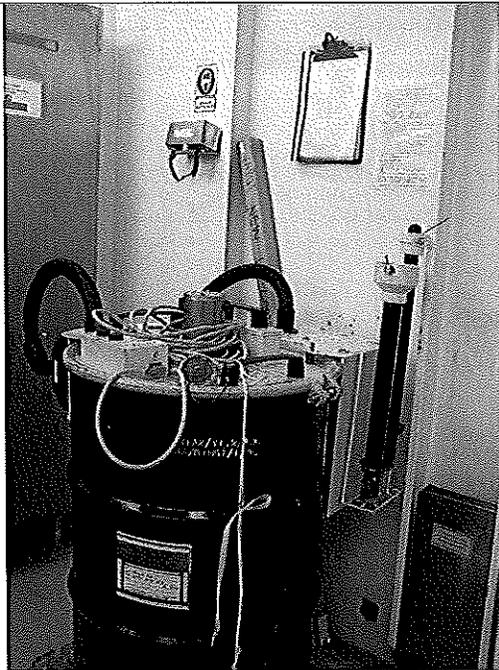
Fluorescent lamps go through a bulb crusher (photo #27) and offloaded. Mercury filters are offloaded as hazardous waste. Other types of bulbs are offloaded as hazardous waste. They are also looking at replacing bulbs throughout the ship with more energy efficient ones.

PHOTO #:27 DATE: AUGUST 11, 2012
TAKEN BY: AMY JANKOWIAK FILE No.: P8110027
DESCRIPTION: FLUORESCENT BULB CRUSHER

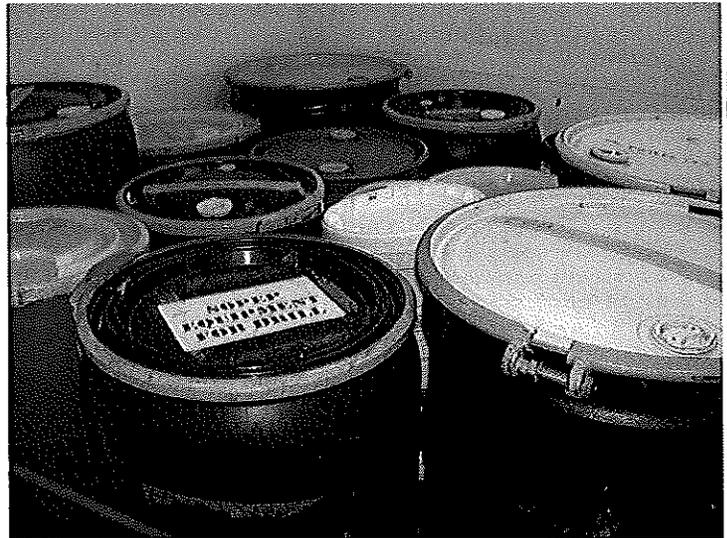
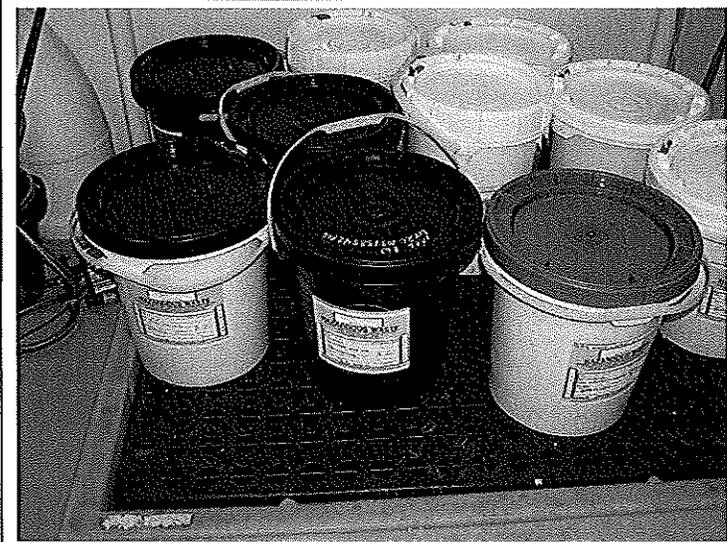
All hazardous waste (photos #28 and #29) that is collected is being sent off-shore in Victoria, Canada. Some logs were reviewed and showed consistency. Hazardous waste materials include items such as aerosols, paints, thinners, batteries, sharps and acupuncture needles, photo waste, and oil filters.

PHOTO #:28 AUGUST 11, 2012
TAKEN BY: AMY JANKOWIAK FILE No.: P8110028
DESCRIPTION: HAZARDOUS WASTE STORAGE

PHOTO #:29 DATE: AUGUST 11, 2012
TAKEN BY: AMY JANKOWIAK FILE No.: P8110029
DESCRIPTION: HAZARDOUS WASTE STORAGE

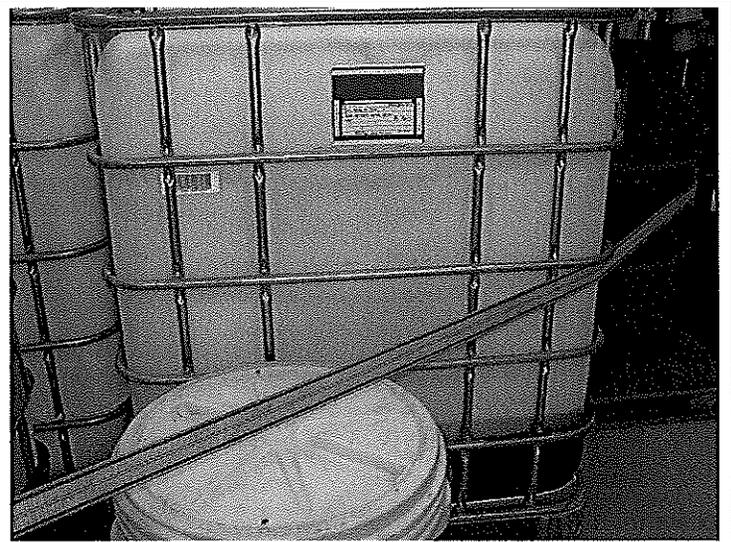
Dry cleaning uses PERC which is off-loaded with hazardous waste (photo #30). There are plans for the system to be changed out for a non-PERC system. Laundry water is collected and sent through the Scanship system.

PHOTO #:30 DATE: AUGUST 11, 2012
TAKEN BY: AMY JANKOWIAK FILE No.: P8110030
DESCRIPTION: PERC (DRY- CLEANING) HAZARDOUS WASTE

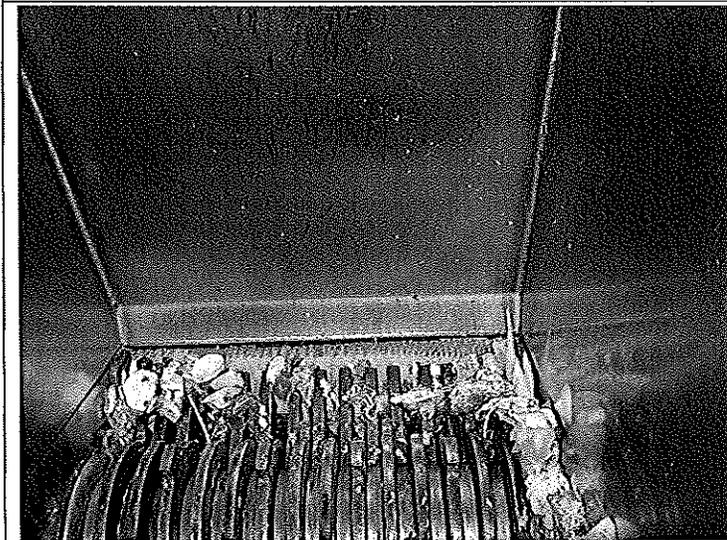
Food waste is sorted twice prior to going into the pulpers (photos #34 and #35). First in the various bins (photo #32) in the galley and again going into the pulper (photo #33). The galley staff are also trained and supervised. Bones are crushed (photo #31). Solid food waste is discharged outside of MOU waters after pulping. Some materials are incinerated such as chicken skin and pineapples. Galley water and pulper water goes to the Scanship system.

PHOTO #:31 DATE: AUGUST 11, 2012
TAKEN BY: AMY JANKOWIAK FILE No.: P8110032
DESCRIPTION: FOOD WASTE BONE CRUSHER

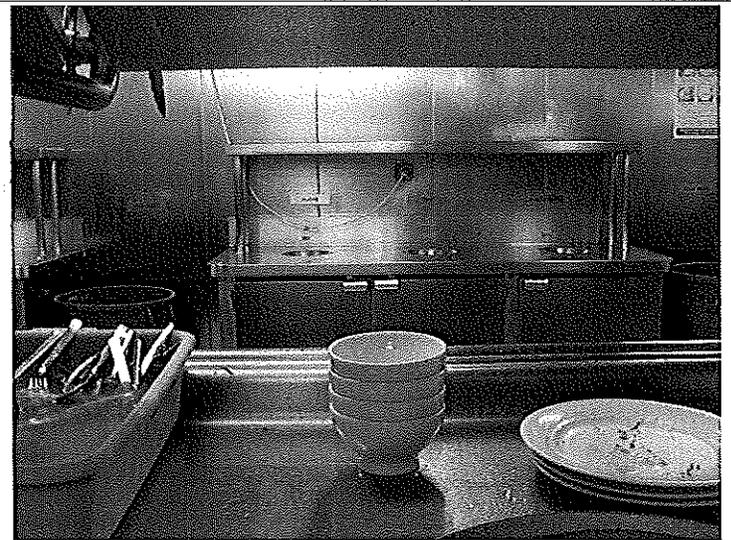
PHOTO #:32 AUGUST 11, 2012
TAKEN BY: AMY JANKOWIAK FILE No.: P8110033
DESCRIPTION: GALLEY WASTE SEPARATION

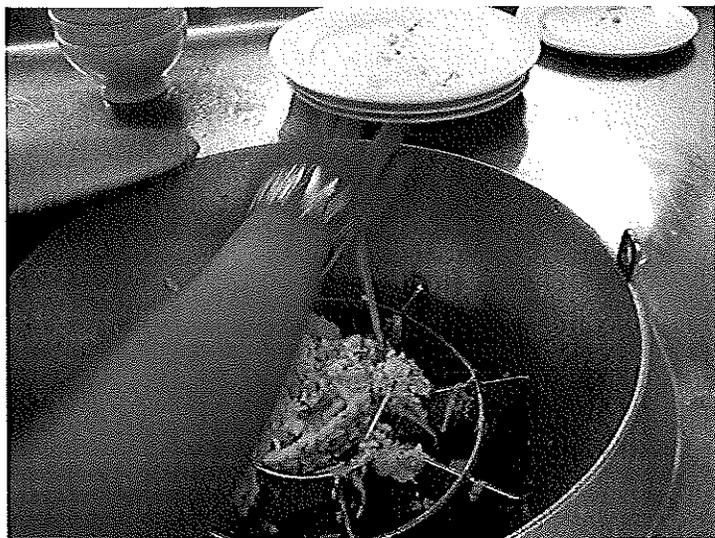
PHOTO #:33 DATE: AUGUST 11, 2012
TAKEN BY: AMY JANKOWIAK FILE No.: P8110034
DESCRIPTION: GALLEY FOOD WASTE TO PULPER

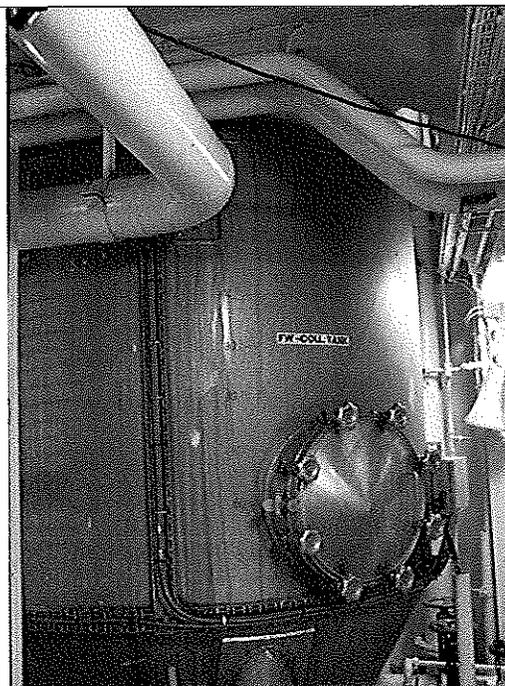
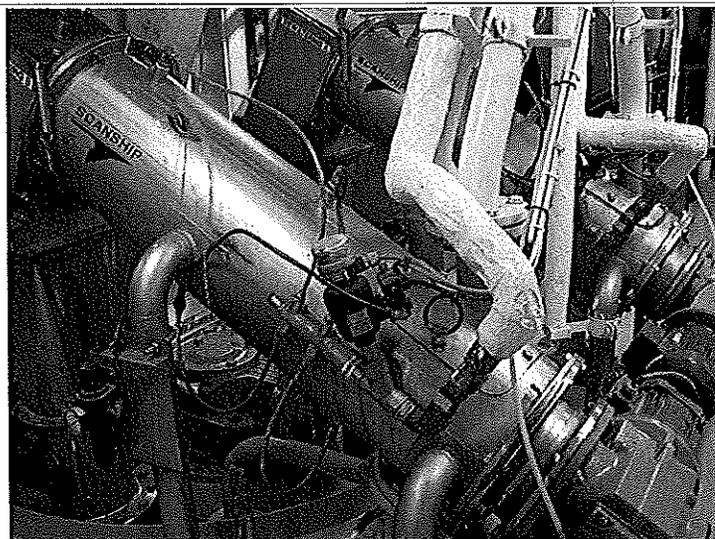
PHOTO #:34 DATE: AUGUST 11, 2012
TAKEN BY: AMY JANKOWIAK FILE No.: P8110035
DESCRIPTION: FOOD WASTE COLLECTION TANK

PHOTO #:35 DATE: AUGUST 11, 2012
TAKEN BY: AMY JANKOWIAK FILE No.: P8110036
DESCRIPTION: FOOD WASTE PULPER TO SCANSHIP

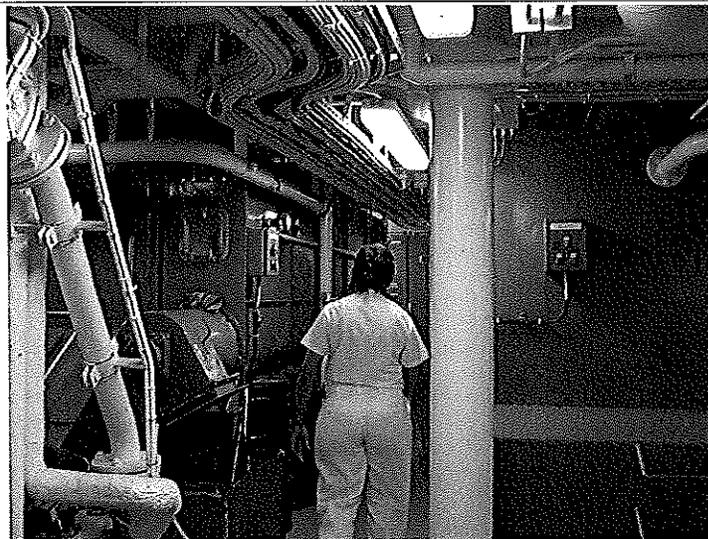
Incinerator ash is offloaded and tested annually for non-hazardous status. Results have passed. Incinerators (photo #36) are started up approximately 1 hour out of Seattle on the way to Canada. Fuel at <1% sulfur is used throughout the cruise.

PHOTO #:36 AUGUST 11, 2012
TAKEN BY: AMY JANKOWIAK FILE No.: P8110037
DESCRIPTION: INCINERATORS
