State of Washington Department of Ecology
Cruise Ship Memorandum of Understanding, Cruise Operations in Washington State Inspection Report

Inspection Date August 5, 2013	Permit Number NA	County King	Receiving Waters Marine Waters	Ecology Inspector Amy Jankowiak
Entry Time 9:01 am	Photos Taken	Samples Taken	Inspection Announced	Discharges to: <input checked="" type="checkbox"/> Surface Water
Exit Time 10:55 am	<input checked="" type="checkbox"/> Yes <input type="checkbox"/> No	<input type="checkbox"/> Yes <input checked="" type="checkbox"/> No	<input checked="" type="checkbox"/> Yes <input type="checkbox"/> No	<input type="checkbox"/> Ground Water <input type="checkbox"/> Dewater <input type="checkbox"/> POTW

Name and Location of Site Inspected: REGATTA, Oceania Cruises Pier 66 Seattle, Washington On-Site Representative(s): <i>Name/Title/Phone/e-mail</i> Davor Dragojevic, Environmental Officer REG_EnvOfficer@regatta.oceniacruz.com Responsible Official(s): <i>Name/Title/Address/Phone/e-mail</i> James S. Mitchell, Director – Environment & Public Health Prestige Cruise Holdings (Oceania Cruises ~ Regent Seven Seas Cruises) 8300 NW 33 rd St, Suite 100, Miami, FL 33122 305-514-4836; JM

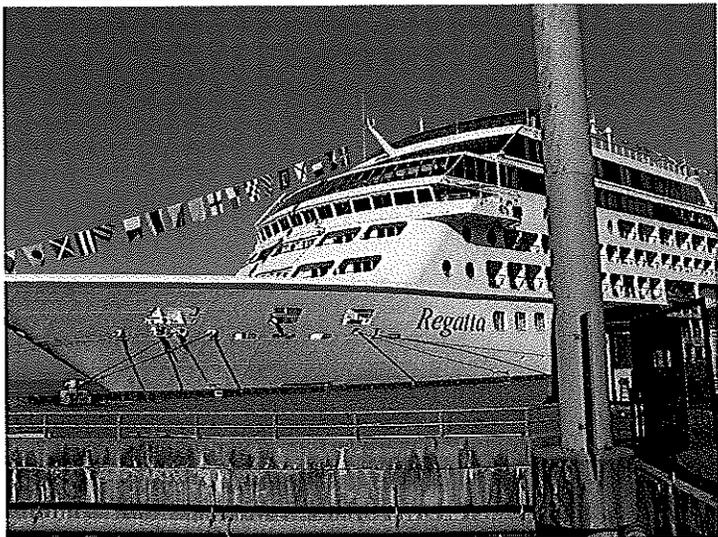
I arrived and boarded the ship (photo #01) at about 9:01 am and began with introductions and a plan for the day with Davor Dragojevic, EO. We discussed various waste streams and discharge protocols. We toured the garbage and recycling areas, food waste pulper, the Triton Water Membrane Bio-Reactors (MBR) advanced wastewater treatment system (AWTS) and the oily bilge water separator. We reviewed the various discharge and environmental records in the Engine Control Room (ECR) and on the Bridge. The inspection was then finalized with a debriefing and I disembarked the vessel at about 10:55 am.

PHOTO #01 . DATE: AUGUST 5, 2013
TAKEN BY: AMY JANKOWIAK FILE No.: P8050255
DESCRIPTION: REGATTA VESSEL

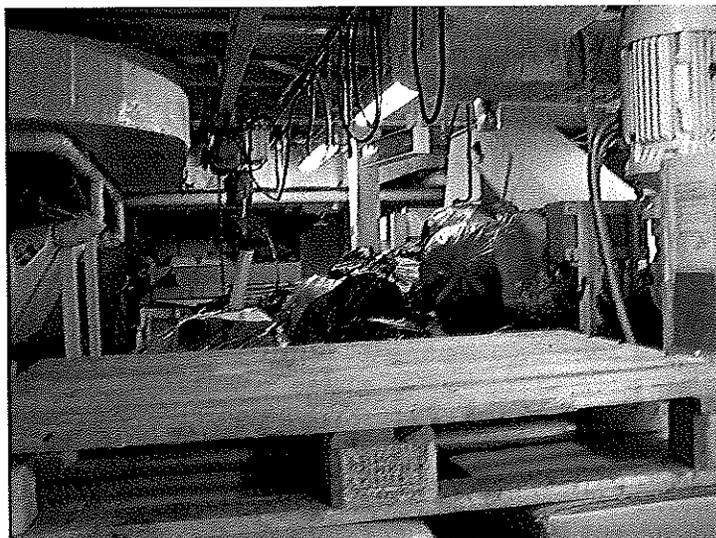
Solid waste (garbage, recyclables, etc) is collected (photo #02) sorted (photo #03) and either reused, recycled, incinerated or offloaded to shore as appropriate. The garbage record book was reviewed and showed consistency with requirements.

PHOTO #02 . DATE: AUGUST 5, 2013
TAKEN BY: AMY JANKOWIAK FILE No.: P8050256
DESCRIPTION: GARBAGE/RECYCLING ROOM

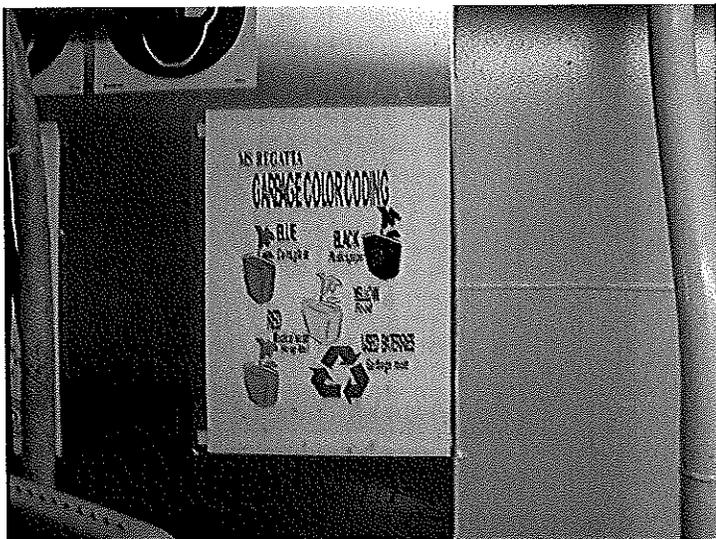
PHOTO #03 . DATE: AUGUST 5, 2013
TAKEN BY: AMY JANKOWIAK FILE No.: P8050258
DESCRIPTION: GARBAGE/RECYCLING COLOR CODING

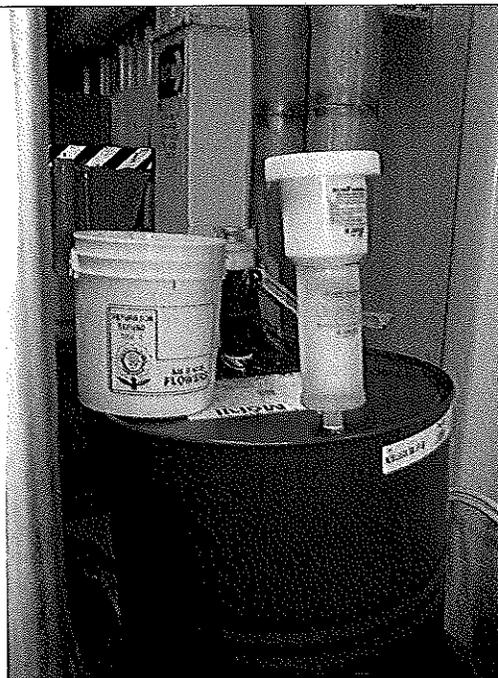
Any photo waste is collected and offloaded to shore as hazardous waste. Fluorescent bulbs (photos #06 and #08) are offloaded as hazardous waste and not crushed on board. Hazardous waste materials include items such as oily sludge, incinerator ash, some aerosols which punctured with aerosol removal system (photo #04), sharps, used cartridges and filters, electronics and batteries (photo #07). Hazardous waste is typically offloaded in Canada. Hazardous waste logs were reviewed and appear to be consistent with MOU requirements.

PHOTO #04. AUGUST 5, 2013
TAKEN BY: AMY JANKOWIAK FILE No.: P8050259
DESCRIPTION: GARBAGE/RECYCLING - AEROSOL REMOVAL SYSTEM

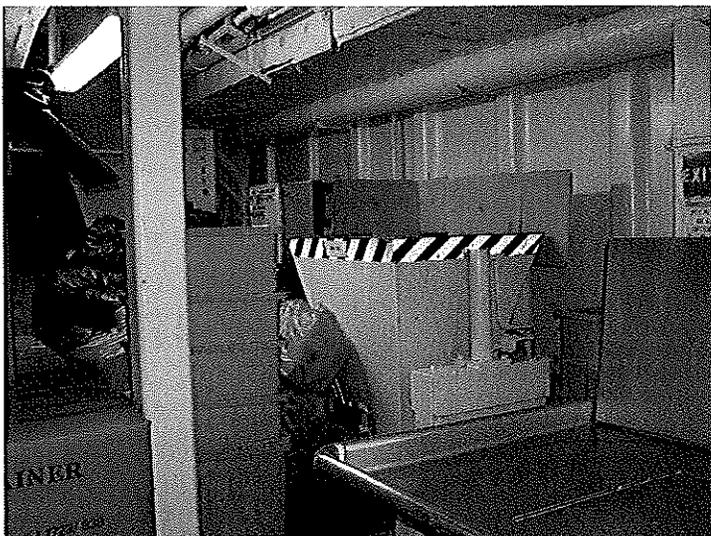
Glass, broken china, some plastics, scrap metals, aluminum (photo #05), some cardboard, wood pallets and paper and other items are recycled.

PHOTO #:05 DATE: AUGUST 5, 2013
TAKEN BY: AMY JANKOWIAK FILE No.: P8050260
DESCRIPTION: GARBAGE/RECYCLING -ALUMINUM COMPACTOR

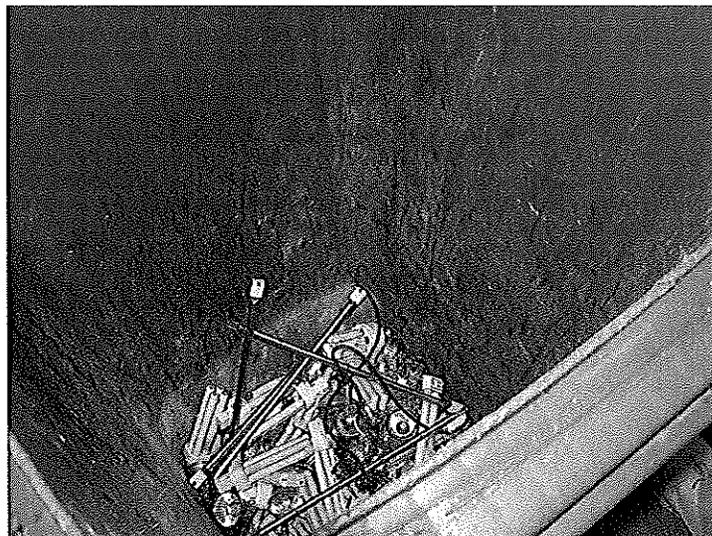
PHOTO #:06 DATE: AUGUST 5, 2013
TAKEN BY: AMY JANKOWIAK FILE No.: P8050261
DESCRIPTION: GARBAGE/RECYCLING - LIGHT BULB COLLECTION

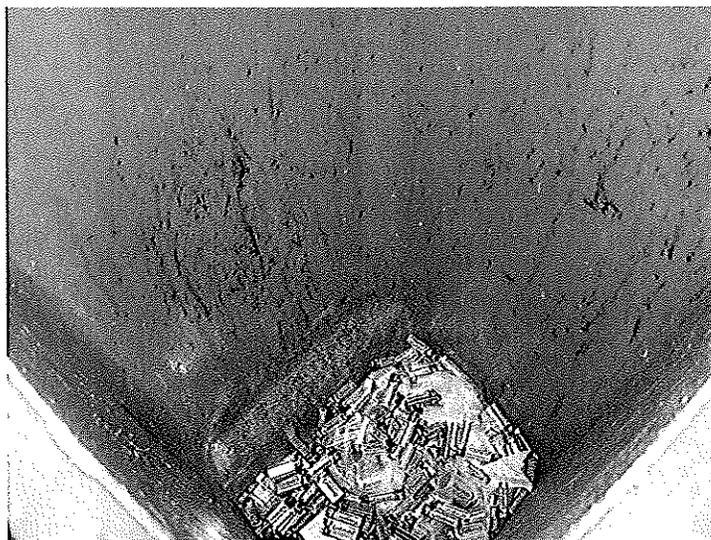
PHOTO #:07 DATE: AUGUST 5, 2013
TAKEN BY: AMY JANKOWIAK FILE No.: P8050262
DESCRIPTION: GARBAGE/RECYCLING - BATTERY COLLECTION

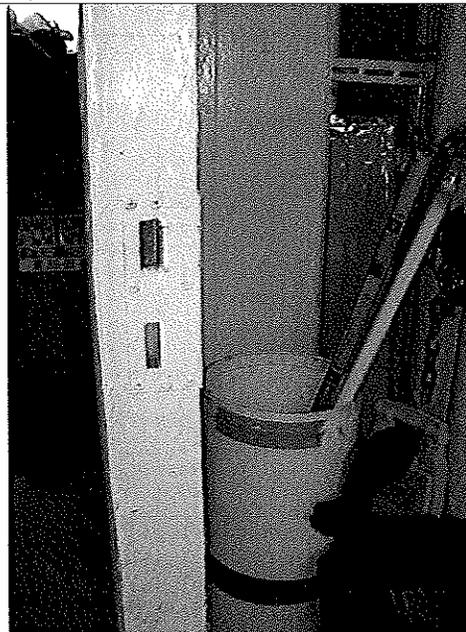
PHOTO #:08 AUGUST 5, 2013
TAKEN BY: AMY JANKOWIAK FILE No.: P8050263
DESCRIPTION: GARBAGE/RECYCLING - LARGE BULB COLLECTION

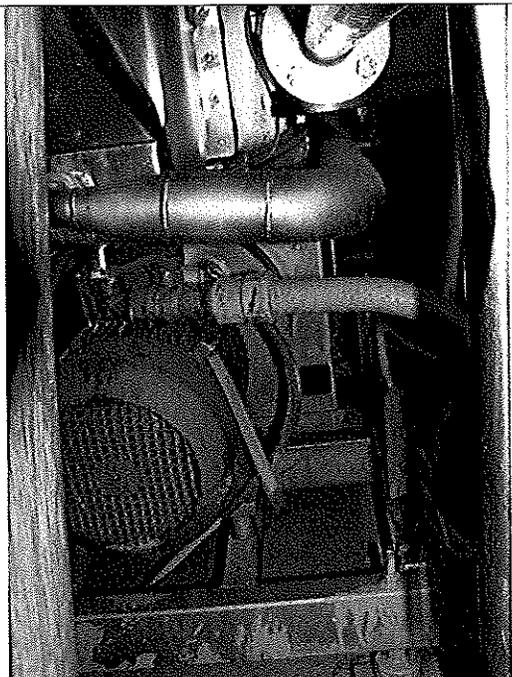
Food waste is collected in various locations, is sorted and then sent through a pulper (photo #09). Pulped food waste and galley water is discharged outside of MOU related waters. A food chute is used for food waste including bones and other food waste which the pulpers can't take. Records reviewed were consistent with this protocol. Sorting is periodically checked and monitored to ensure only allowed food waste gets discharged. Coffee grounds are separated prior to the pulper to prevent blockage. Galleys use phosphate free and non-toxic detergents and degreasers. Used cooking oil is discharged with food waste.

PHOTO #:09 DATE: AUGUST 5, 2013
TAKEN BY: AMY JANKOWIAK FILE No.: P8050264
DESCRIPTION: FOOD PULPER

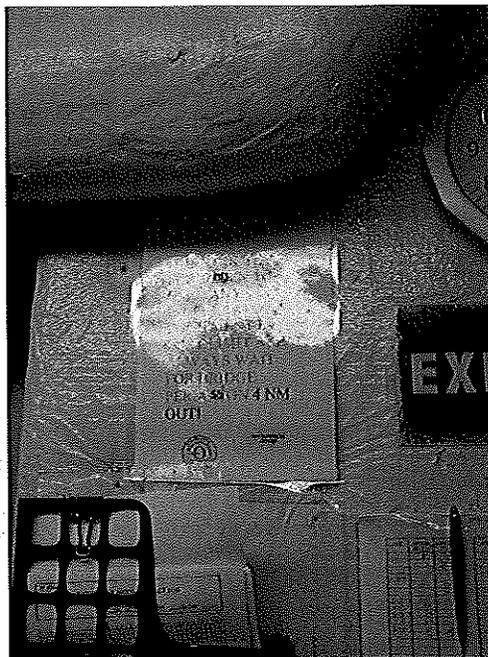
PHOTO #:10 DATE: AUGUST 5, 2013
TAKEN BY: AMY JANKOWIAK FILE No.: P8050265
DESCRIPTION: GARBAGE/RECYCLING – SIGNAGE ON
INCINERATION USE

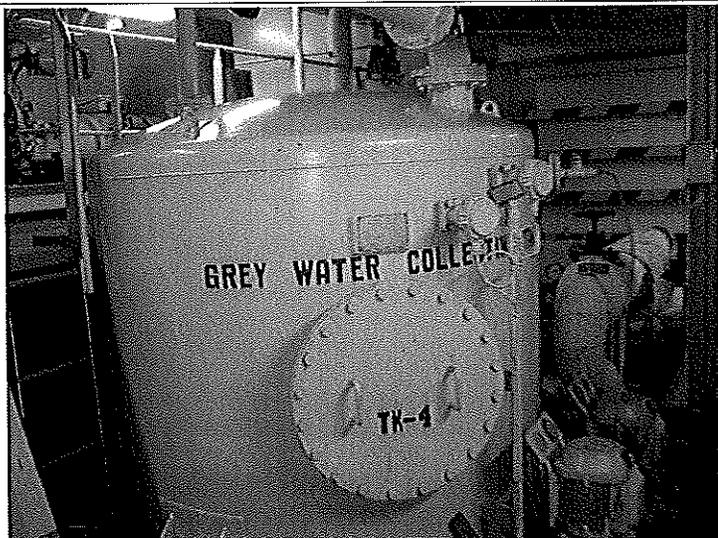
PHOTO #:11 DATE: AUGUST 5, 2013
TAKEN BY: AMY JANKOWIAK FILE No.: P8050266
DESCRIPTION: TRITON – GRAY WATER COLLECTION TANK

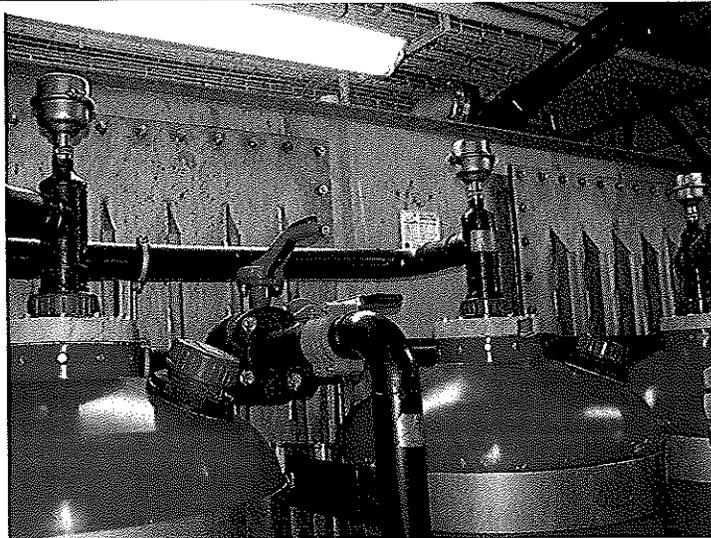
The REGATTA uses a Triton Water MBR AWTS (photo #12) for blackwater and the majority of graywater. Some graywater is held untreated and discharged outside of MOU related waters. The vessel has 850 cubic meters of holding capacity for graywater which is about 3 days worth and 86 cubic meters of holding capacity for blackwater which is about 5 days worth. There are two separate Triton MBR units on the vessel with control panels for operation (photo #13). Black water and graywater are sent to separate holding tanks (photo #11) by gravity. Wastewater is then sent to one of two screens (photo #21). The solids from the screen are held (photo #20) and later discharged outside of 12 miles and outside of MOU related waters along with any solids removed from the MBR units. From the screens, blackwater and graywater (typically 20% blackwater) is sent to the MBR tanks (photo #14) where air is added for biological treatment. Wastewater then flows through the membrane filters and is sent out as permeate. The permeate is then sent to a ultraviolet light (UV) disinfection unit. There are two Trojan UV units (photos #15 and #16) for the vessel, one for each Triton train. From the UV, effluent is either discharged out the discharge port (photo #18) if in an area where discharge is allowed, or it is sent to a holding tank to pass through the Triton system again. Currently, effluent from the UV is held and discharged outside of MOU related waters.

The Triton system was installed in 2011, however, the membranes had to be replaced recently due to an event of high chlorine/chemical cleaners to the system which caused foaming and bacteria to die off. The staff is now more careful about how chlorine and chemicals are added to the Triton system. The EO also had some questions about the chlorine limits identified in the Alaska discharge permit and how recent results from Admiralty should be compared to the limit. As this is a question about the Alaska permit, I deferred to ADEC for those questions, however, it appears that it is a question of the chlorine test's detection limit and the permit and ADECs interpretation of those results.

PHOTO #:12 AUGUST 5, 2013
TAKEN BY: AMY JANKOWIAK FILE No.: P8050267
DESCRIPTION: TRITON – MAIN TANKS/MEMBRANES BEHIND

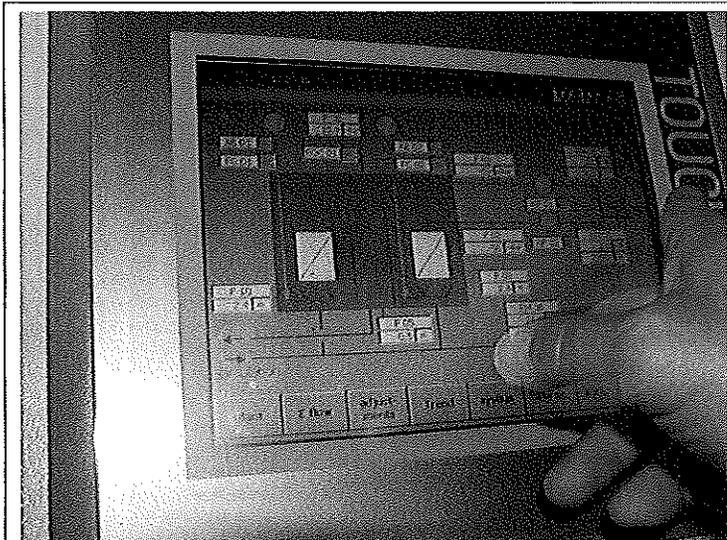
PHOTO #:13 DATE: AUGUST 5, 2013
TAKEN BY: AMY JANKOWIAK FILE No.: P8050268
DESCRIPTION: TRITON – CONTROL PANEL

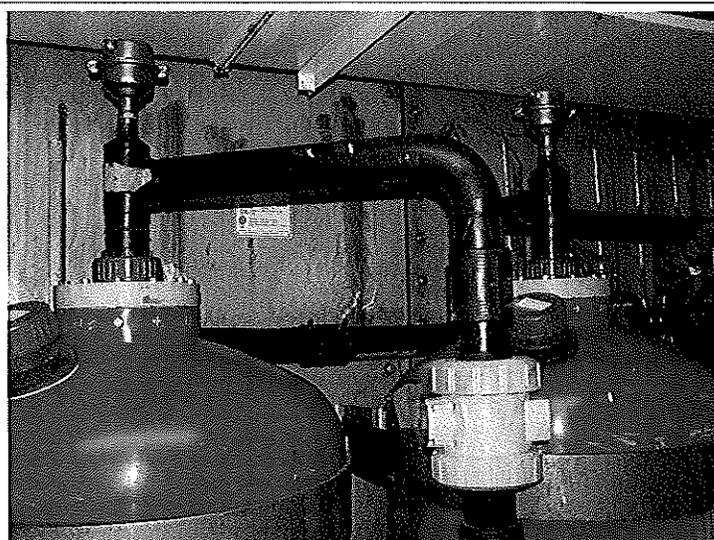
PHOTO #:14 DATE: AUGUST 5, 2013
TAKEN BY: AMY JANKOWIAK FILE No.: P8050269
DESCRIPTION: TRITON – 2ND SYSTEM

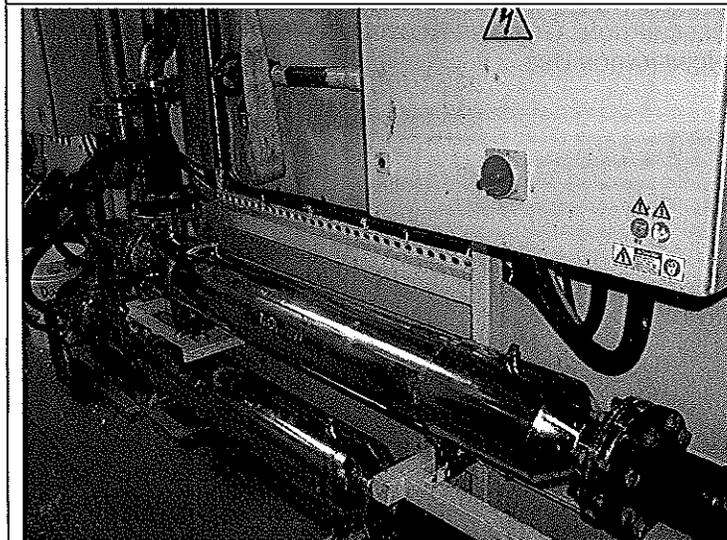
PHOTO #:15 DATE: AUGUST 5, 2013
TAKEN BY: AMY JANKOWIAK FILE No.: P8050270
DESCRIPTION: TRITON – TROJAN - ULTRAVIOLET DISINFECTION
UNITS (2)

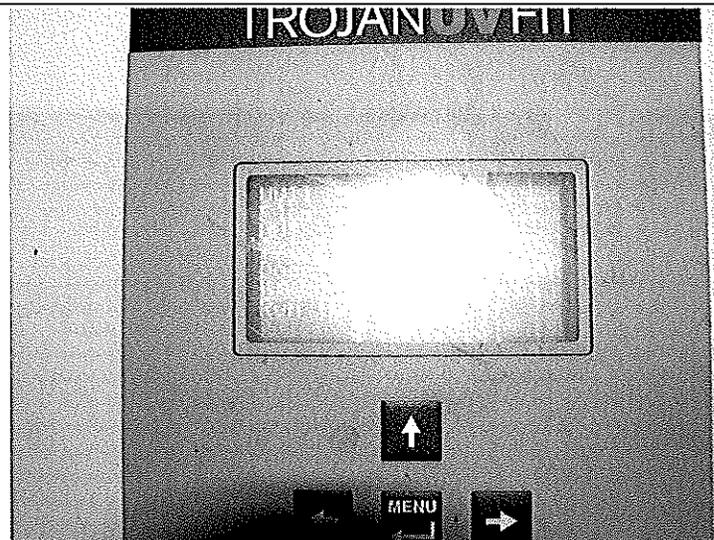
PHOTO #:16 AUGUST 5, 2013
TAKEN BY: AMY JANKOWIAK FILE No.: P8050271
DESCRIPTION: TRITON – TROJAN UV CONTROL PANEL

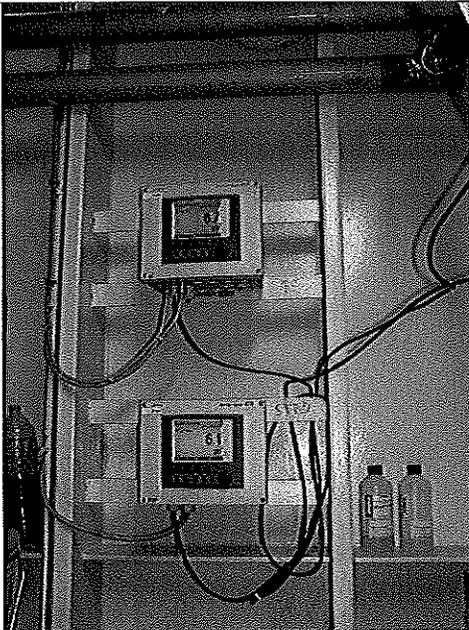
There is one dedicated engineer who operates and maintains the Triton systems along with the EO. The Triton system includes continuous monitoring of pH (photo #17) and turbidity (photo #19)/total suspended solids (TSS). If the system has a TSS greater than 24, the system shuts down and does not allow discharges to occur. This has reportedly not occurred in recent history. There is also a lab on site (ECR) for sampling and analyzing chlorine, TSS, coliform, biochemical oxygen demand (BOD) and chemical oxygen demand (COD). The ability to monitor and analyze on the vessel allows for quick adjustments for process control of the system.

PHOTO #:17 DATE: AUGUST 5, 2013
TAKEN BY: AMY JANKOWIAK FILE No.: P8050272
DESCRIPTION: TRITON - PH METERS

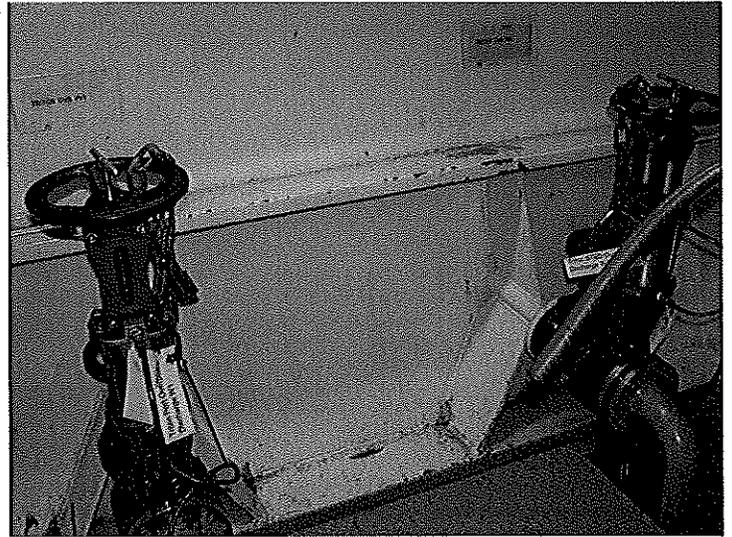
PHOTO #:18 DATE: AUGUST 5, 2013
TAKEN BY: AMY JANKOWIAK FILE No.: P8050273
DESCRIPTION: TRITON - TSG DISCHARGE PORTS

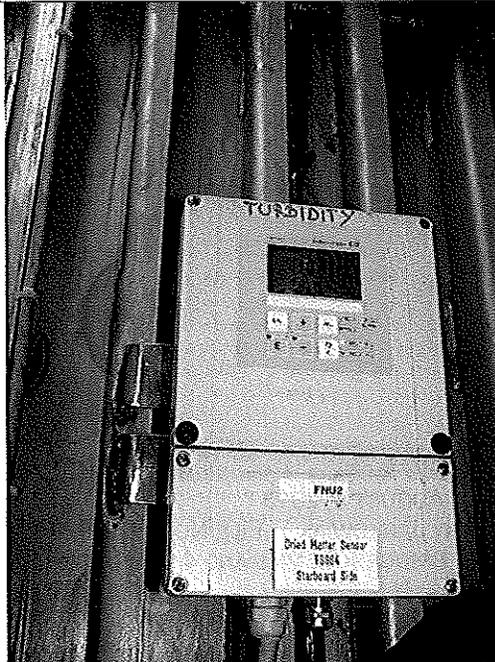
PHOTO #:19 DATE: AUGUST 5, 2013
TAKEN BY: AMY JANKOWIAK FILE No.: P8050274
DESCRIPTION: TRITON - TURBIDIMETER

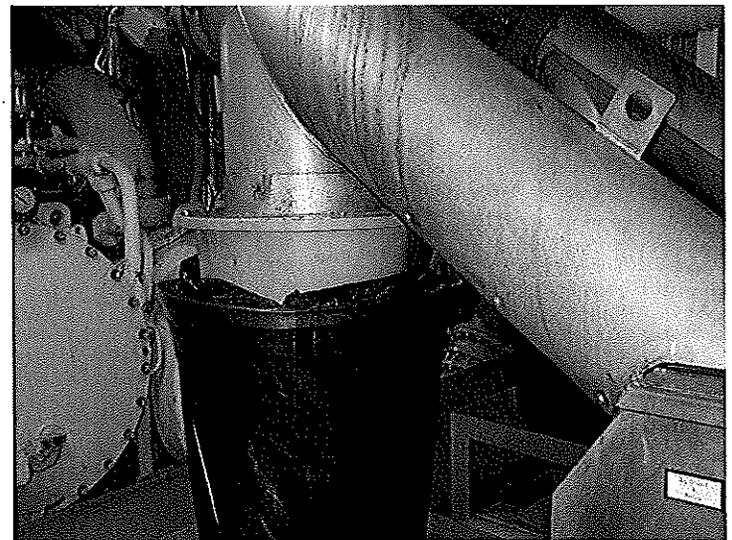
PHOTO #:20 AUGUST 5, 2013
TAKEN BY: AMY JANKOWIAK FILE No.: P8050275
DESCRIPTION: TRITON - SCREENINGS

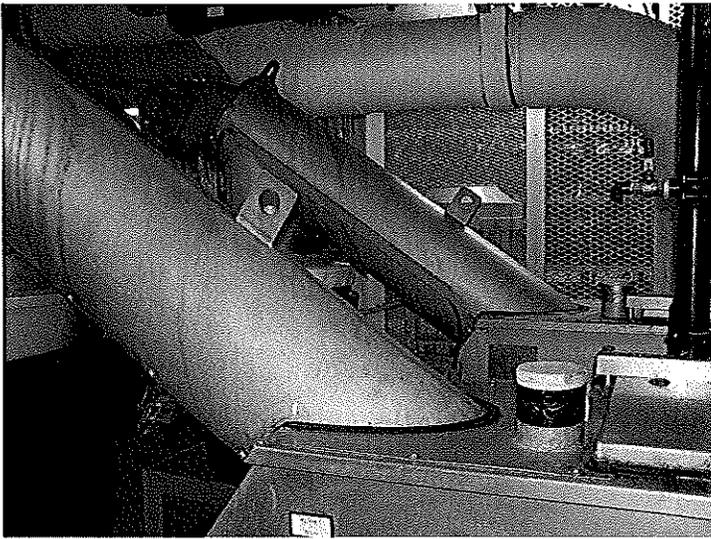
PHOTO #:21 DATE: AUGUST 5, 2013
TAKEN BY: AMY JANKOWIAK FILE No.: P8050276
DESCRIPTION: TRITON – SCREENINGS

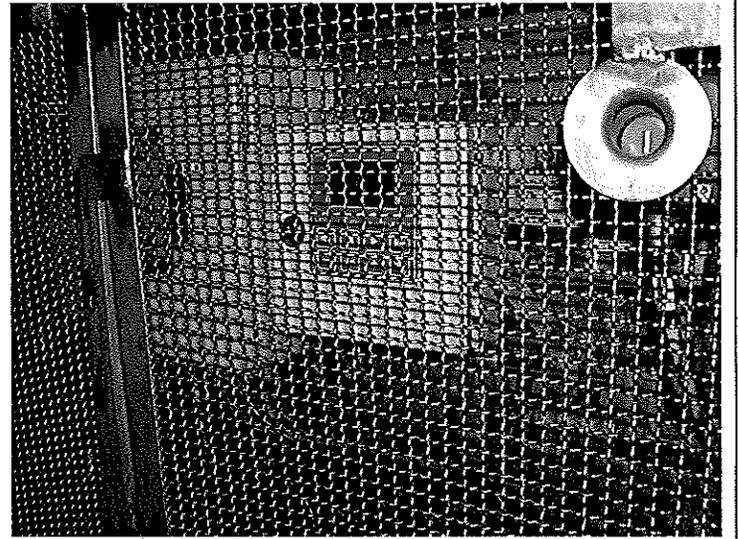
Oily bilge water is treated with a Westfalia oily water separator (photo #23). A white box (photo #22) is used to only allow discharges at less than 15 ppm oil content maximum. The discharge protocol is to discharge treated oily bilge at less than 10 ppm outside of MOU related waters.

PHOTO #:22 DATE: AUGUST 5, 2013
TAKEN BY: AMY JANKOWIAK FILE No.: P8050277
DESCRIPTION: OILY WATER SEPARATOR – BILGE – WHITE BOX

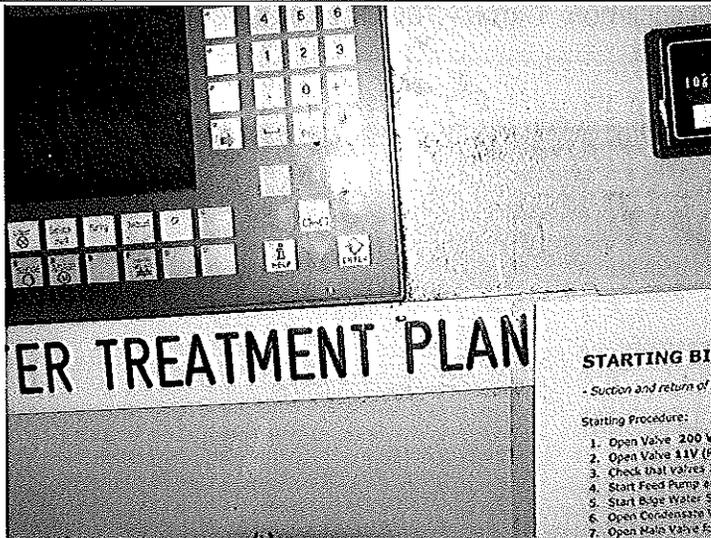
PHOTO #:23 DATE: AUGUST 5, 2013
TAKEN BY: AMY JANKOWIAK FILE No.: P8050278
DESCRIPTION: OILY WATER SEPARATOR – OILY BILGE WATER

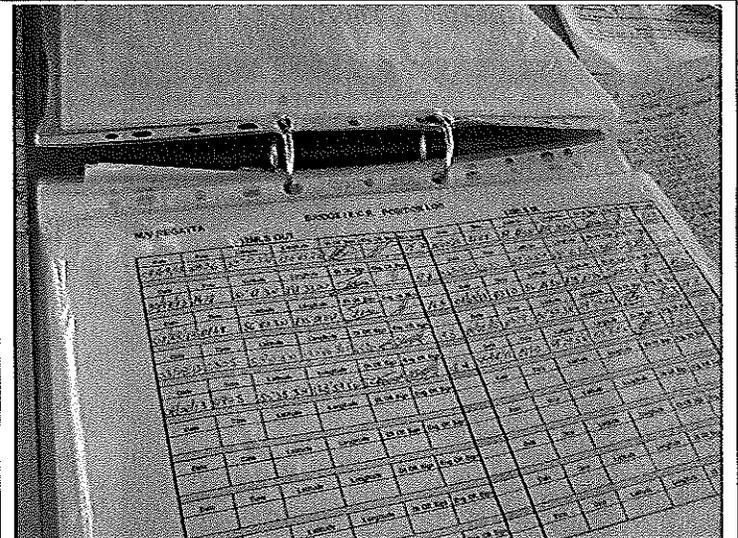
PHOTO #:24 AUGUST 5, 2013
TAKEN BY: AMY JANKOWIAK FILE No.: P8050279
DESCRIPTION: BRIDGE – 12 MILS AND 4 MILS LOG BOOK

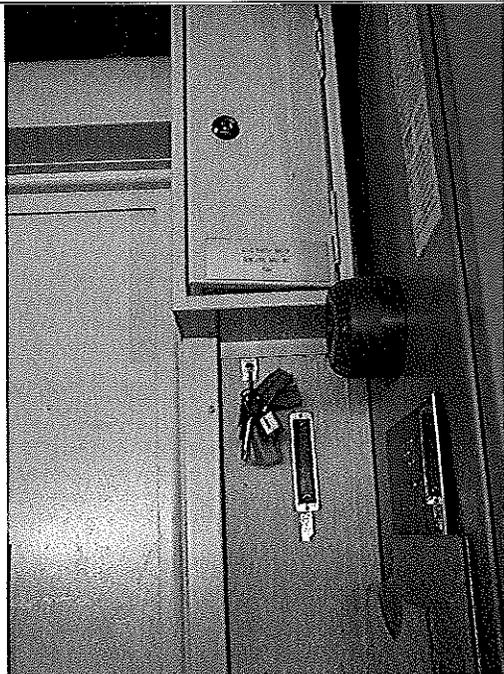
PHOTO #:25 DATE: AUGUST 5, 2013
TAKEN BY: AMY JANKOWIAK FILE No.: P8050281
DESCRIPTION: BRIDGE – DISCHARGE PORT (CHUTE) PADLOCK
KEYS
