State of Washington Department of Ecology
Cruise Ship Memorandum of Understanding, Cruise Operations in Washington State Inspection Report

Amy Jankowiak, Washington State Department of Ecology (Ecology) Northwest Regional Office, Water Quality Program (NWRO-WQ) conducted the inspection of Oceania Cruises REGATTA on July 31, 2014. Christopher Martin, Ecology NWRO-WQ also attended the inspection. The main contact on board the REGATTA was Christopher Nagy, Environmental Officer (EO) for the REGATTA. Prior notification of the visit was given on July 28, 2014 for security protocol. The purpose of the inspection was to evaluate compliance with the *Memorandum of Understanding Cruise Operations in Washington State* (MOU), as amended. The REGATTA is not approved to discharge wastewater in MOU waters.

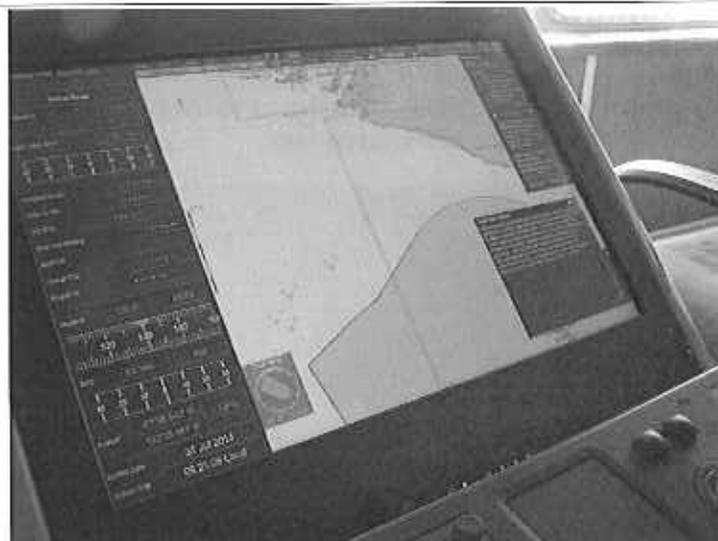
The discharge protocol starts with a plan before departure to be consistent with company rules and local requirements and daily check-ins with navigation officers for instructions and tank volume checks. Both paper and electronic navigational charts (photos #01 and #03) are used to mark and verify areas of allowed discharges. Discharges of blackwater, graywater, wastewater residual solids (biosludge), bilge water and food waste occur outside of 12 nautical miles from land (outside of MOU related waters). The Bridge staff calls the ECR notifying the ECR staff when they are in discharge locations. The Bridge logs any discharges upon notification from ECR. The discharge ports or chutes are padlocked and the ECR engineer on watch has access to the keys. All discharges are logged in the ECR and reviewed and compared to the Bridge log by the EO. There have been no reported problems with the communications between the Bridge and the ECR or with any discharges. No discharges of any kind occur in the Olympic Coast National Marine Sanctuary (OCNMS). For black water and gray water, the latitude and longitude coordinates are recorded in the *Sewage and Graywater Discharge Record Book*. The date, time and location of both the start and the stop of the discharges are recorded, along with port location, effluent type, and volumes. All wastewater discharge records that were reviewed appeared to be in compliance with the MOU and did not occur in MOU waters, Washington State waters or the Olympic Coast National Marine Sanctuary (OCNMS) (MOU related waters). A few records were copied and later verified to be outside of MOU related waters.

PHOTO #:03 DATE: JULY 31, 2014
TAKEN BY: AMY JANKOWIAK FILE NO.: P1010124
DESCRIPTION: NAVIGATIONAL ELECTRONIC MAP WITH OCNMS

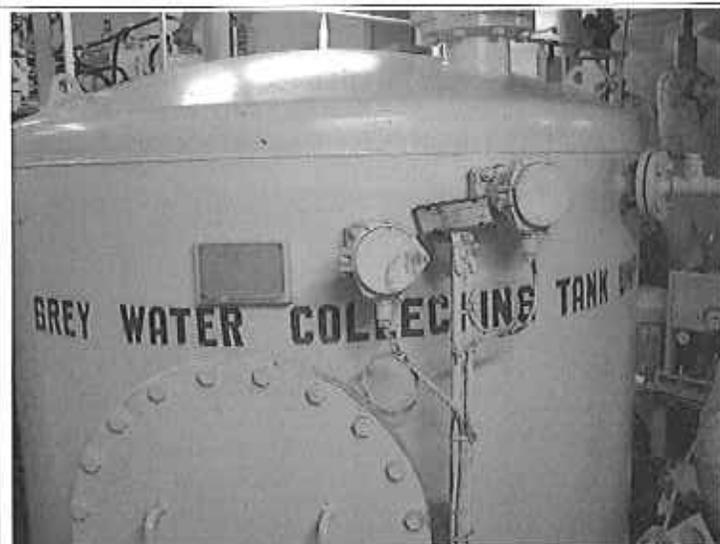
PHOTO #:04 JULY 31, 2014
TAKEN BY: AMY JANKOWIAK FILE NO.: P1010125
DESCRIPTION: TRITON GREY WATER COLLECTION TANK (1 OF 6)

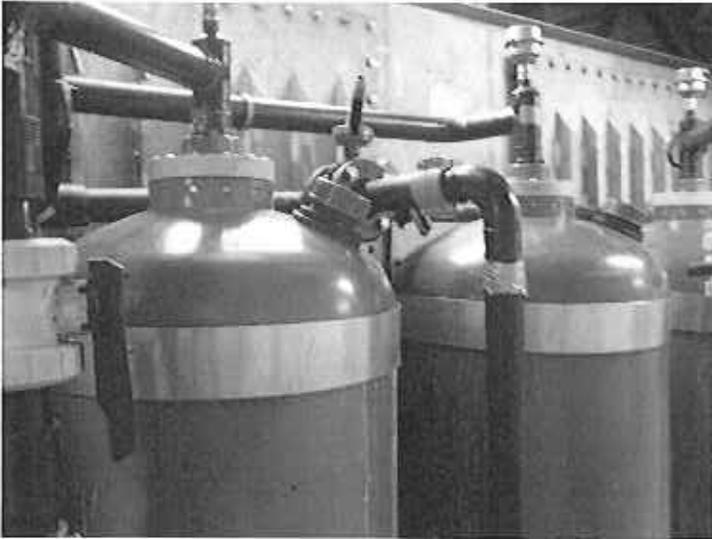
PHOTO #:05 DATE: JULY 31, 2014
TAKEN BY: AMY JANKOWIAK FILE No.: P1010127
DESCRIPTION: TRITON MBR FILTER TANK AND ION EXCHANGERS

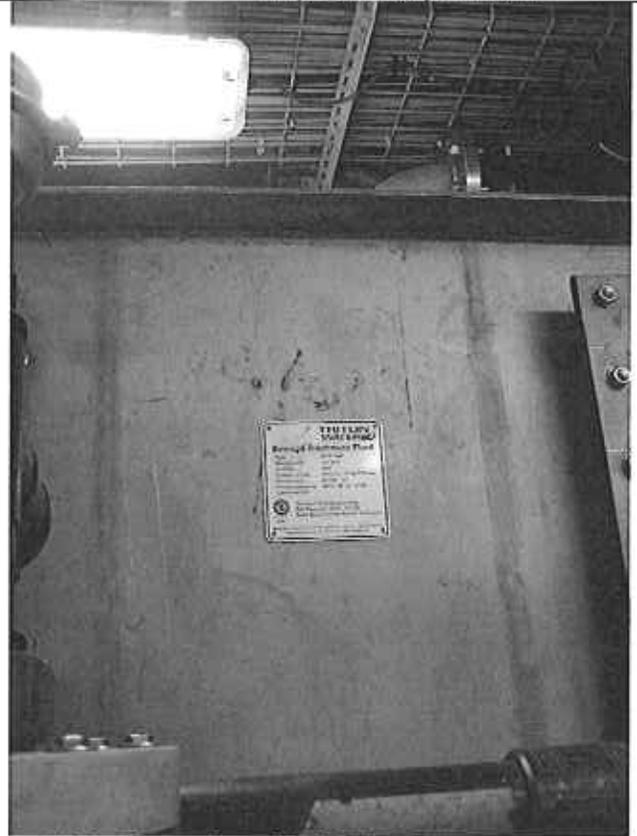
PHOTO #:06 DATE: JULY 31, 2014
TAKEN BY: AMY JANKOWIAK FILE No.: P1010128
DESCRIPTION: TRITON MBR FILTER TANK

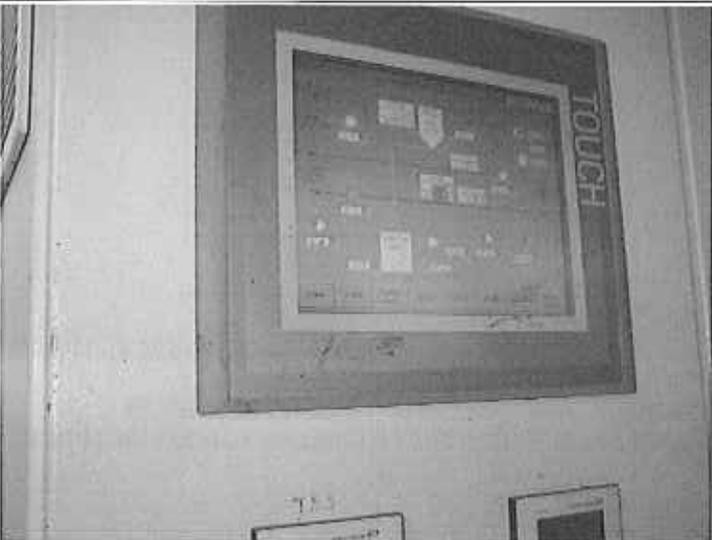
PHOTO #:07 DATE: JULY 31, 2014
TAKEN BY: AMY JANKOWIAK FILE No.: P1010129
DESCRIPTION: TRITON CONTROL SCREEN

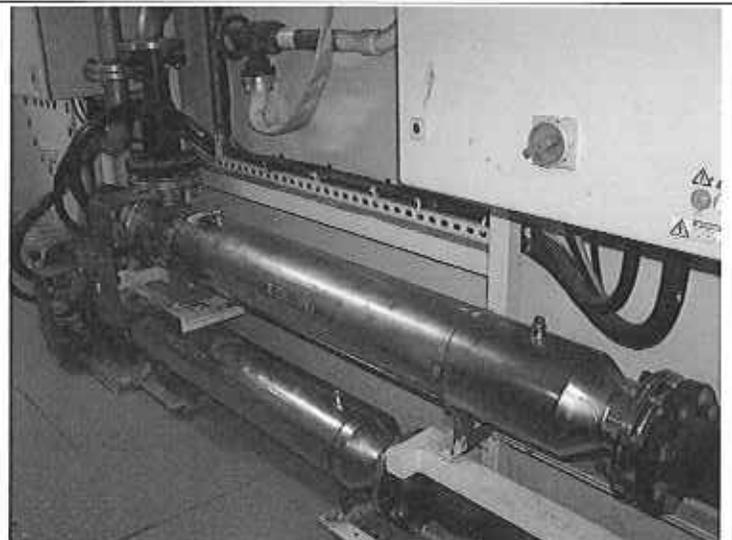
PHOTO #:08 JULY 31, 2014
TAKEN BY: AMY JANKOWIAK FILE No.: P1010130
DESCRIPTION: ULTRAVIOLET LIGHT (UV) DISINFECTION SYSTEM

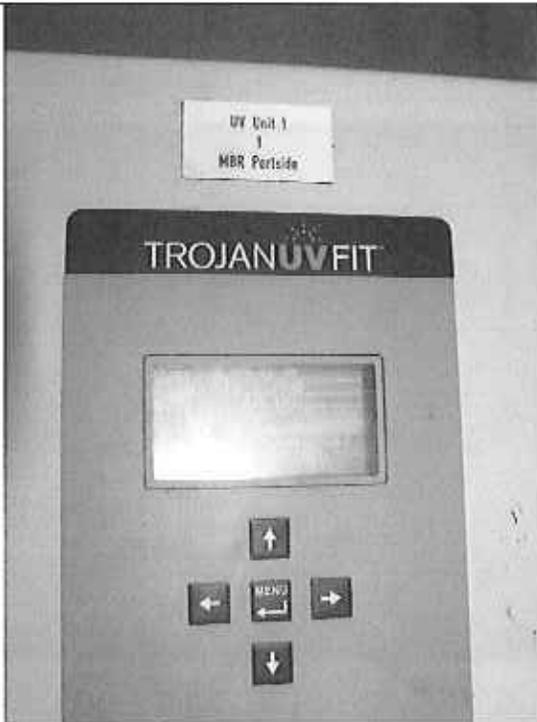
PHOTO #:09 DATE: JULY 31, 2014
TAKEN BY: AMY JANKOWIAK FILE No.: P1010131
DESCRIPTION: UV CONTROL PANEL

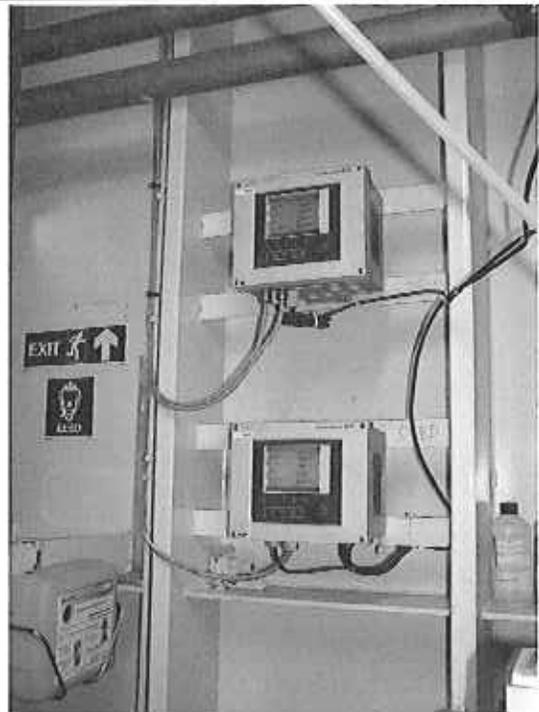
There is one dedicated engineer, Baldo Lucic, who operates and maintains the Triton systems along with the EO. The Triton system includes continuous monitoring of pH (photo #10), turbidity and total suspended solids (TSS). If the system has a TSS greater than 20, the system diverts the waste stream back into the system and does not allow discharges to occur. There is also a small lab (photos #20 and #21) on board for sampling and analyzing chlorine, TSS, coliform, pH, biochemical oxygen demand (BOD) and chemical oxygen demand (COD). The ability to monitor and analyze on the vessel allows for quick adjustments for process control of the system.

PHOTO #:10 DATE: JULY 31, 2014
TAKEN BY: AMY JANKOWIAK FILE No.: P1010132
DESCRIPTION: TRITON EFFLUENT PH METTERS

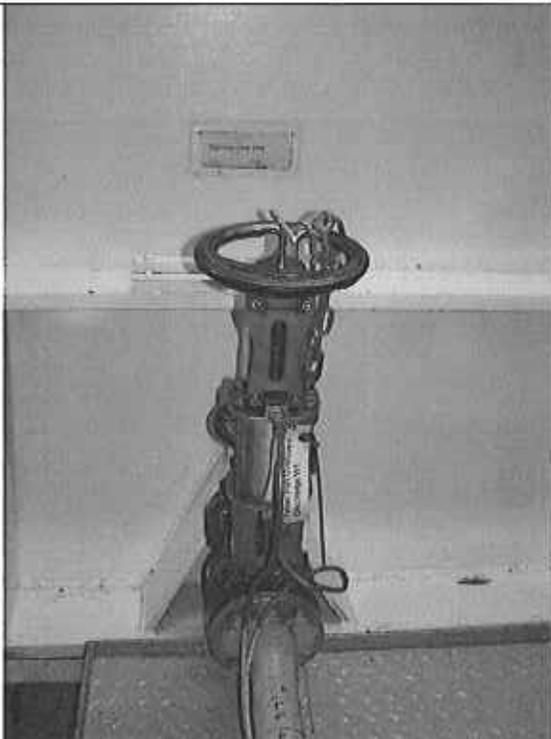
PHOTO #:11 DATE: JULY 31, 2014
TAKEN BY: AMY JANKOWIAK FILE No.: P1010133
DESCRIPTION: TRITON OVERBOARD DISCHARGE PORT

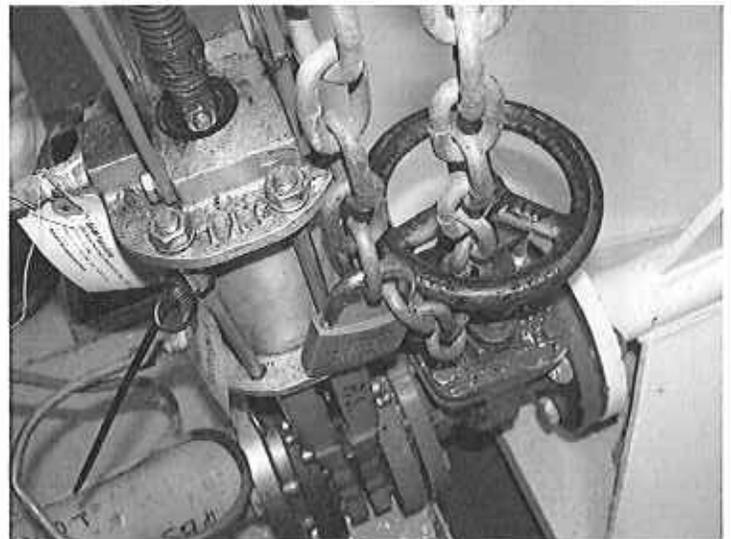
PHOTO #:12 JULY 31, 2014
TAKEN BY: AMY JANKOWIAK FILE No.: P1010134
DESCRIPTION: TRITON OVERBOARD DISCHARGE PORT PADLOCK

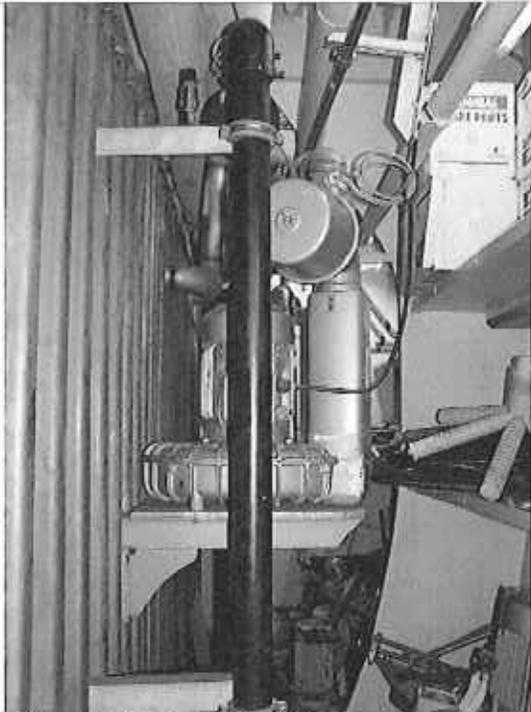
PHOTO #:13 DATE: JULY 31, 2014
TAKEN BY: AMY JANKOWIAK FILE No.: P1010135
DESCRIPTION: BLOWERS FOR TRITON MEMBRANE FILTERS

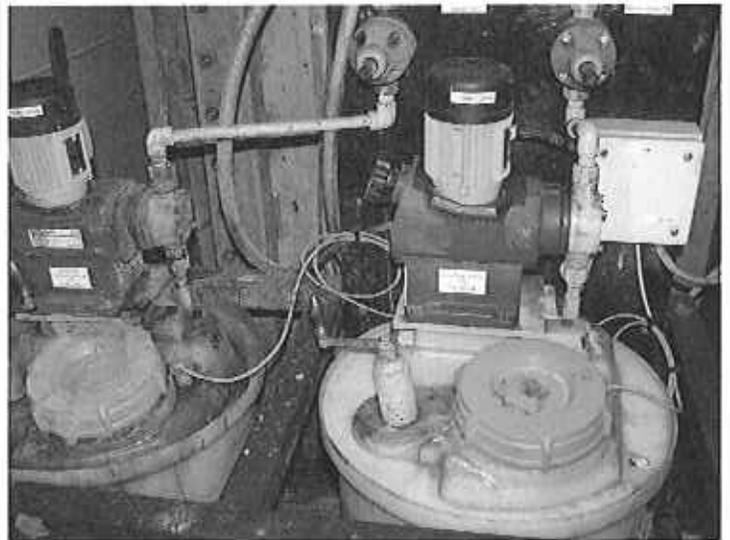
PHOTO #:14 DATE: JULY 31, 2014
TAKEN BY: AMY JANKOWIAK FILE No.: P1010136
DESCRIPTION: TRITON DEFOAMER DOSING

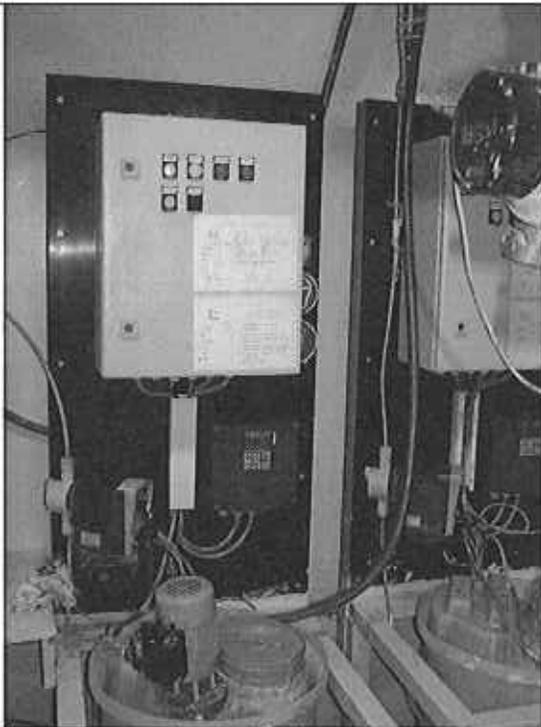
PHOTO #:15 DATE: JULY 31, 2014
TAKEN BY: AMY JANKOWIAK FILE No.: P1010137
DESCRIPTION: TRITON PH CONTROL DOSING

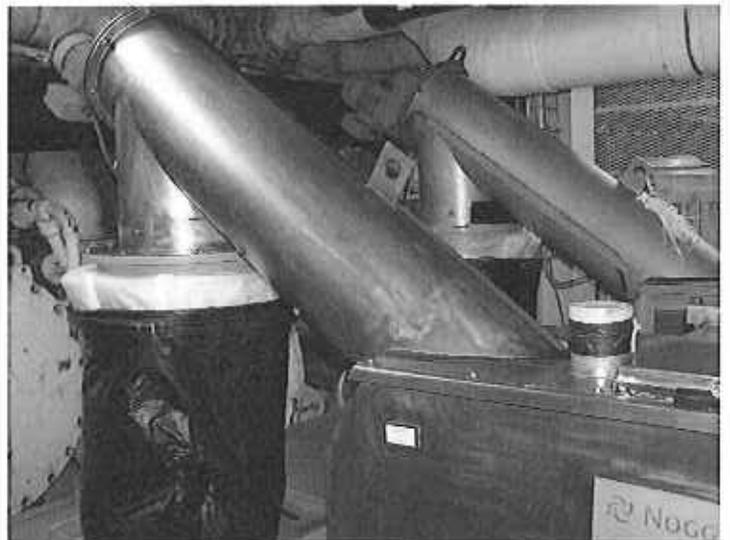
PHOTO #:16 JULY 31, 2014
TAKEN BY: AMY JANKOWIAK FILE No.: P1010138
DESCRIPTION: TRITON SCREENS

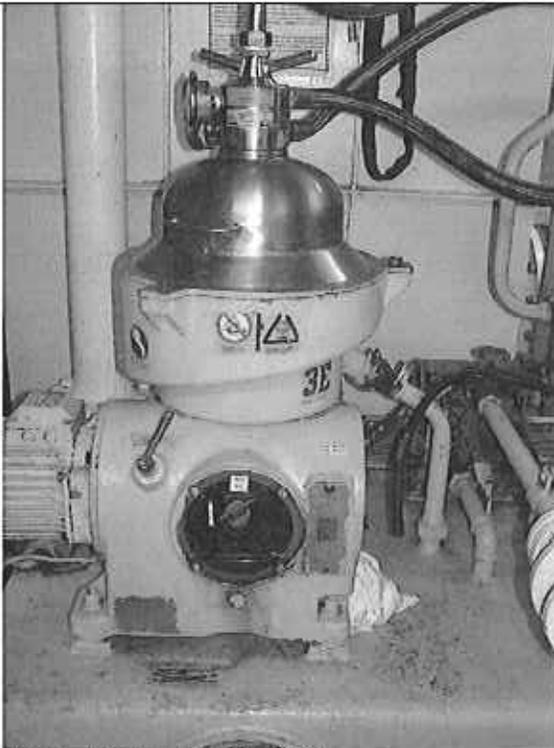
Oily bilge water is treated with a Westfalia oil water separator (photo #17). A white box (photo #19) is used to only allow discharges (photo #18) at less than 15 ppm oil content maximum and discharges occur outside of MOU related waters.

PHOTO #:17 DATE: JULY 31, 2014
TAKEN BY: AMY JANKOWIAK FILE No.: P1010140
DESCRIPTION: BILGE - OILY WATER SEPARATOR (OWS)

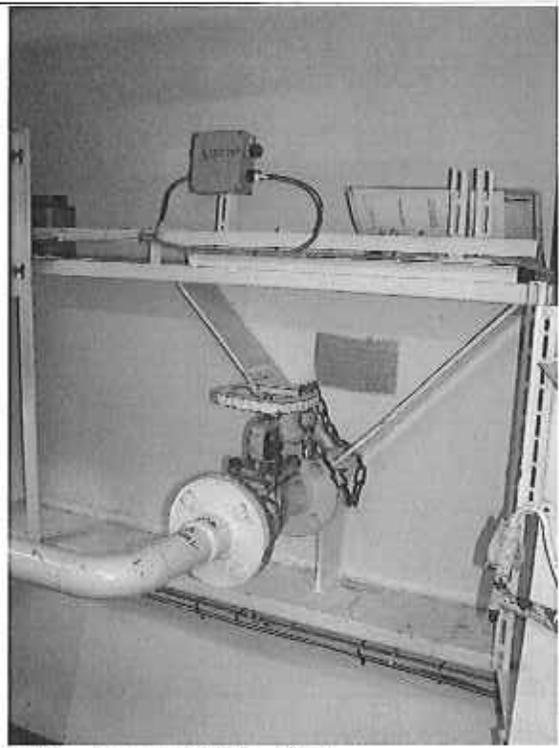
PHOTO #:18 DATE: JULY 31, 2014
TAKEN BY: AMY JANKOWIAK FILE No.: P1010141
DESCRIPTION: OWS DISCHARGE PORT

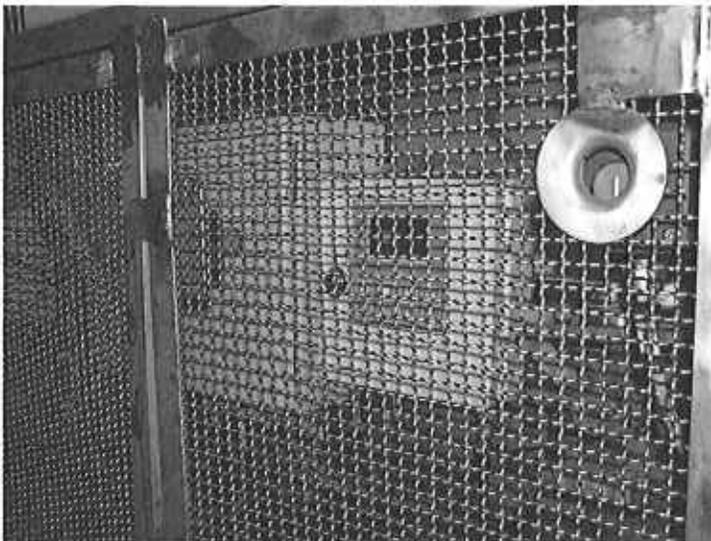
PHOTO #:19 DATE: JULY 31, 2014
TAKEN BY: AMY JANKOWIAK FILE No.: P1010142
DESCRIPTION: OWS WHITE BOX

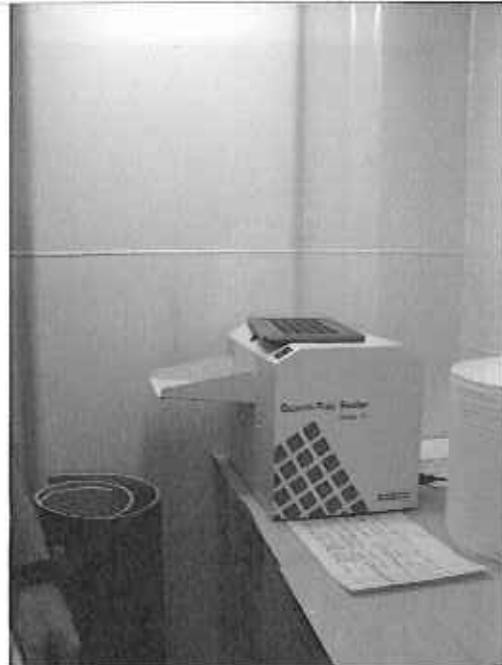
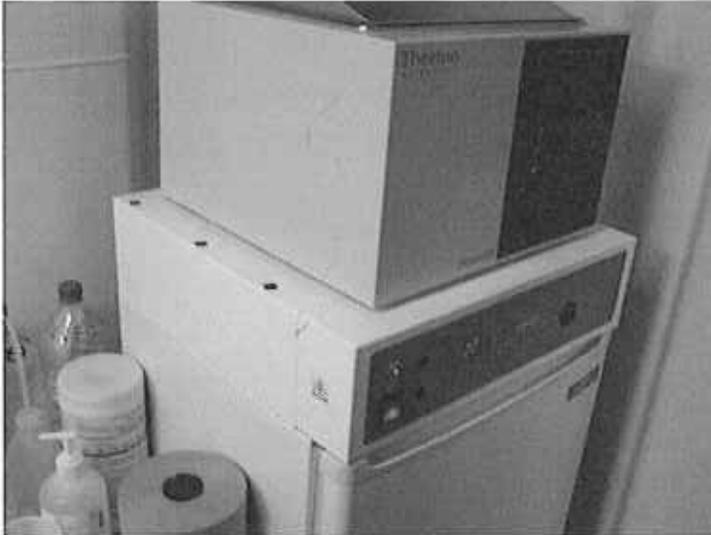
PHOTO #:20 JULY 31, 2014
TAKEN BY: AMY JANKOWIAK FILE No.: P1010144
DESCRIPTION: PROCESS CONTROL LABORATORY

PHOTO #21 DATE: JULY 31, 2014
TAKEN BY: AMY JANKOWIAK FILE No.: P1010145
DESCRIPTION: PROCESS CONTROL LABORATORY

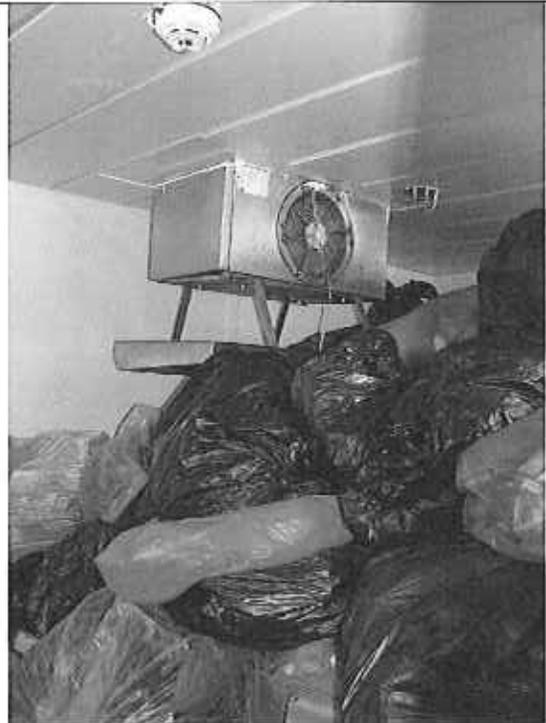
Solid waste (garbage, recyclables, etc) (photo #22) is collected, sorted, and either reused, recycled, incinerated or off-loaded to shore as appropriate. The garbage record book was reviewed and showed consistency with requirements.

PHOTO #22 DATE: JULY 31, 2014
TAKEN BY: AMY JANKOWIAK FILE No.: P1010150
DESCRIPTION: COLD ROOM GARBAGE STORAGE

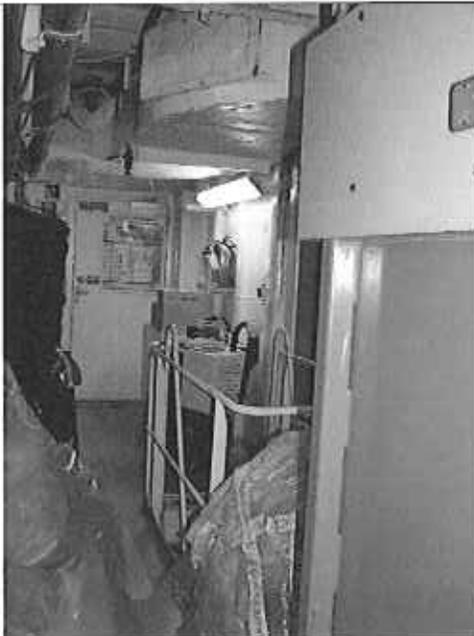
There is no photo waste as all photos are digital. X-rays do produce waste which is collected, and off-loaded as hazardous waste. The vessel has a new digital x-ray machine onboard awaiting installation. Fluorescent bulbs are crushed with a newly installed Bulb Eater mercury vapor removal system (photo #23). When the filters are changed out, they are off-loaded as hazardous waste. Hazardous waste materials include items such as paints, chemicals, some aerosols which are punctured with an aerosol removal system, sharps, used cartridges and filters, electronics and some batteries. Hazardous waste is typically off-loaded in Canada. Hazardous waste logs were reviewed and appear to be consistent with MOU requirements.

PHOTO #23 DATE: JULY 31, 2014
TAKEN BY: AMY JANKOWIAK FILE No.: P1010147
DESCRIPTION: FLUORESCENT BULB EATER (BACK RIGHT)

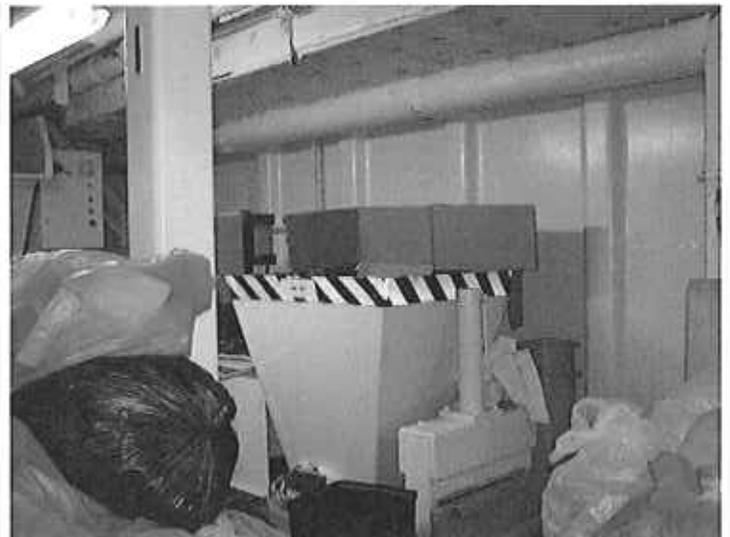
Glass, broken china, some plastics (photo #26), scrap metals, aluminum and tin cans (photo #24), some cardboard, some batteries and paper and other items are recycled.

PHOTO #24 JULY 31, 2014
TAKEN BY: AMY JANKOWIAK FILE No.: P1010148
DESCRIPTION: CAN COMPACTOR

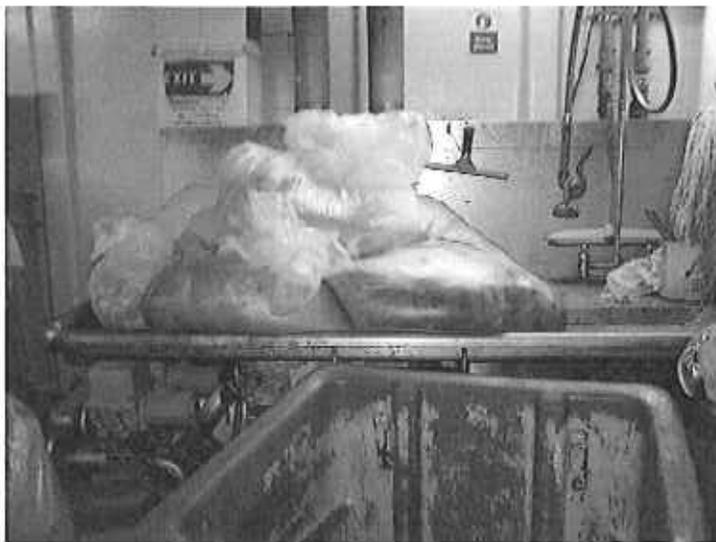
Food waste is collected in various locations, bagged, brought to the waste storage area and is then processed through the pulper (photo #25). Pulped food waste and galley water is discharged outside of MOU related waters. Pulper water is recirculated and eventually wasted to a graywater collection tank. Some food items and grease is collected and off-loaded ashore. A food chute is used for food waste including bones, shells, and other food waste which the pulper can't take. The chute is padlocked and monitored (photo #28). Garbage records were reviewed and were consistent with the protocols. Sorting is periodically checked and monitored to ensure only allowed food waste gets discharged. Galleys use phosphate free and non-toxic detergents and degreasers. Used cooking oil is discharged with food waste.

PHOTO #:25 DATE: JULY 31, 2014
TAKEN BY: AMY JANKOWIAK FILE No.: P1010149
DESCRIPTION: FOOD WASTE PULPER

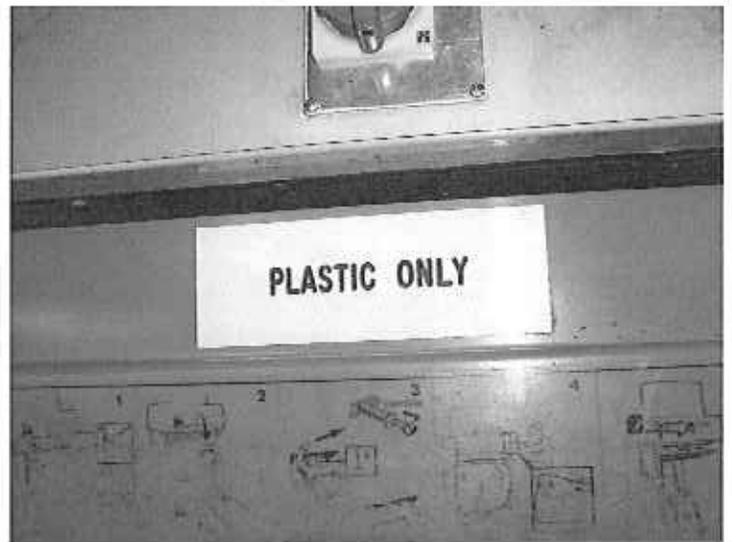
PHOTO #:26 DATE: JULY 31, 2014
TAKEN BY: AMY JANKOWIAK FILE No.: P1010151
DESCRIPTION: PLASTICS COMPACTOR

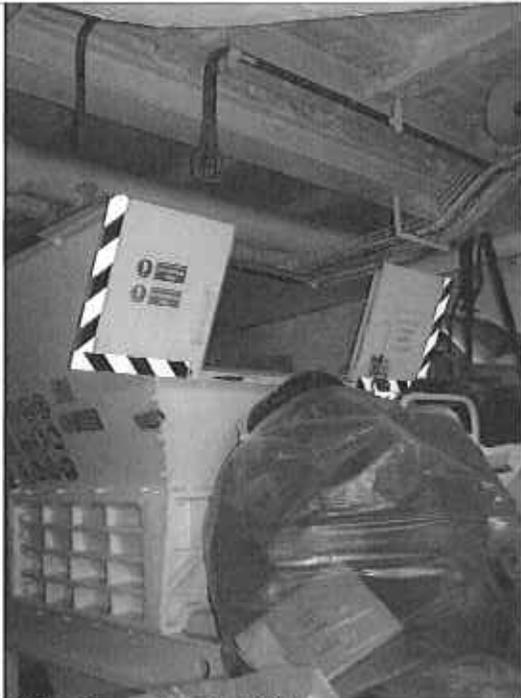
Unused or outdated pharmaceuticals and narcotics are incinerated. Drains from the medical facility go to the blackwater tanks. Sharps are off-loaded as bio-hazardous waste and red bagged medical waste is incinerated. Oily rags, dry garbage, paper, and some cardboard are incinerated (photo #27). Incinerator ash is off-loaded as regulated waste and tested annually to ensure non-metals status. Recent results have passed for non-metals.

PHOTO #:27 DATE: JULY 31, 2014
TAKEN BY: AMY JANKOWIAK FILE No.: P1010152
DESCRIPTION: INCINERATOR RECEIVER

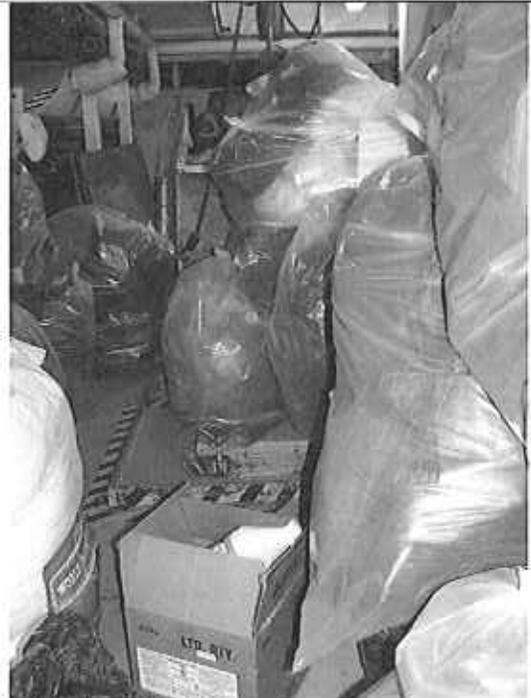
PHOTO #:28 JULY 31, 2014
TAKEN BY: AMY JANKOWIAK FILE No.: P1010153
DESCRIPTION: GARBAGE AND FOOD WASTE CHUTE (TAPED OFF LATCHED AREA)
