State of Washington Department of Ecology
Cruise Ship Memorandum of Understanding, Cruise Operations in Washington State Inspection Report

Name and Location of Site Inspected: STATENDAM, Holland America Line Pier 91 Seattle, Washington	Additional Participants/Inspectors:
On-Site Representative(s): Name/Title/Phone/e-mail Joe Parks, Safety, Environmental & Health Officer SADM-SEH_Officer@HollandAmerica.com	
Responsible Official(s): Name/Title/Address/Phone/e-mail Michael D. Inman, Vice President – Safety and Environmental Management Systems Holland America Line 300 Elliott Ave. West, Seattle WA 98119 206-281-3535 Minman@hollandamerica.com	Other Facility Data: Notification made to John Turvey and Dan Grabb on September 17, 2015 IMO Number 8919245

Inspection

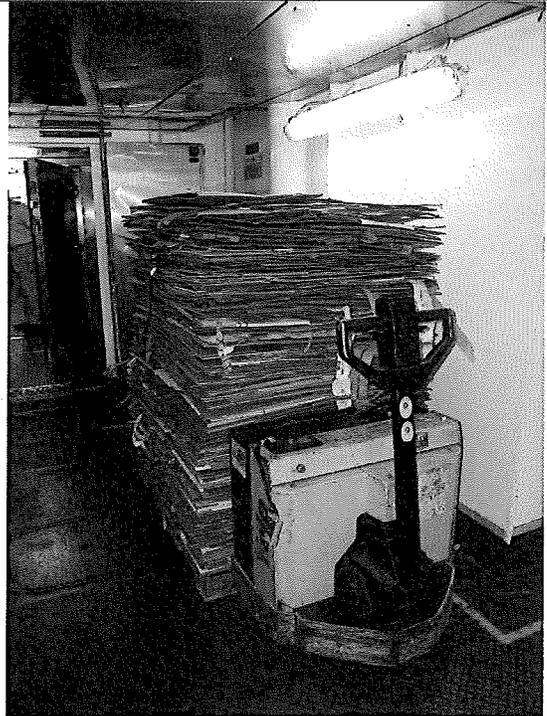
PHOTO #:02 DATE: SEPTEMBER 21, 2015
TAKEN BY: AMY JANKOWIAK FILE No.: P1010001
DESCRIPTION: CARDBOARD STORAGE FOR RECYCLING

Solid waste (garbage, recyclables, etc) is sorted at the source with color-coded bins (photo #08) and is sorted in the garbage and recycling room (photo #04) and is either reused, recycled, incinerated or offloaded to shore as appropriate. Some materials are stored in a cold storage room (photo #03). Paper, cardboard (photo #2), plastics, metals, glass and aluminum are compacted and crushed (photo #05) and recycled. Cartridges, toners and filters are recycled or offloaded. Batteries without fluid are recycled. Items including food contaminated cardboard, wood, red-bagged medical waste are incinerated (photo #06). Incinerators are stopped 1 hour prior to arriving and started one hour after departing and not permitted in Admiralty Inlet and Elliott Bay. Incinerator ash (photo #21) is tested annually and recent results are in compliance. Materials are tracked and monitored for effective minimization of wastes. There has been a large increase in recycling and fewer offloads of waste in recent years. Vessels compare results and review what works for implementation. Garbage records were reviewed and appear to be in compliance with the MOU.

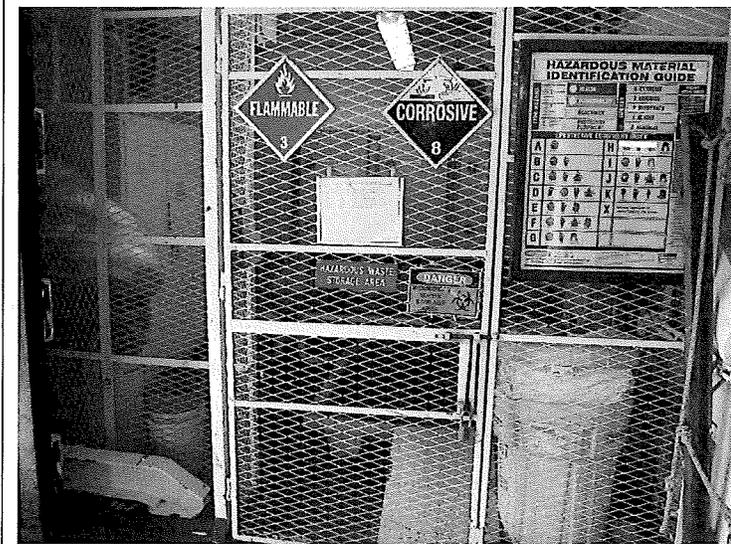
PHOTO #:09 DATE: SEPTEMBER 21, 2015
TAKEN BY: AMY JANKOWIAK FILE No.: P1010012
DESCRIPTION: HAZARDOUS WASTE STORAGE

Hazardous waste is not offloaded in Seattle. Hazardous waste includes items such as oily rags, photo waste, sharps, solvents and paints. A process following hazardous waste items from cradle to grave is used to assure that materials are handled properly. Incinerator ash and oil sludge are offloaded as non-hazardous waste.

X-rays are done digitally and therefore do not have a waste product. Photo waste is collected and processed with a silver recovery unit to less than 5ppm, recorded and is then offloaded. Fluorescent bulbs are crushed with a mercury removal system and offloaded ashore. Hazardous waste is stored until offloaded.

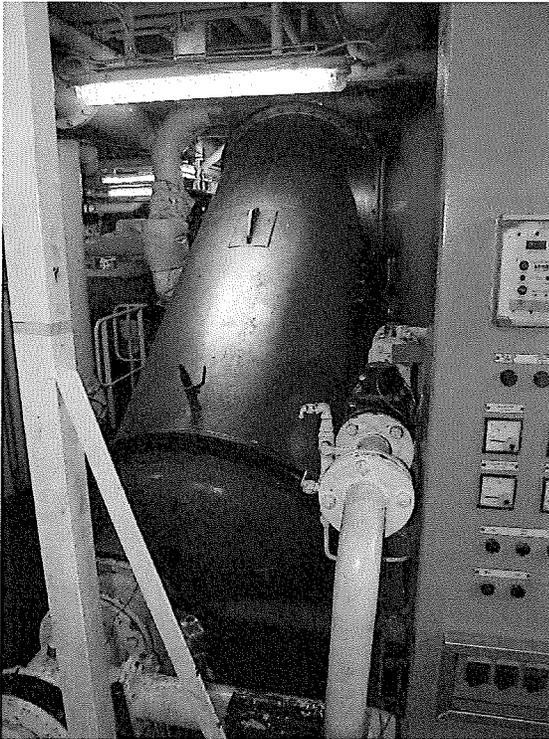
PHOTO #:13 DATE: SEPTEMBER 21, 2015
TAKEN BY: AMY JANKOWIAK FILE No.: P1010019
DESCRIPTION: EVAPORATOR FOR WATER PRODUCTION

The STATENDAM uses fuel with a sulfur content of 0.1% MGO in MOU related waters and can use approximately 3.5% (typically about 1.5%) sulfur content in other areas. The vessel was bunkering fuel at this port call. Fresh water was also being bunkered and can be produced on board with either a reverse osmosis system (photos #18 and #19) or evaporators (photo #13) with chlorine (photo #17) and stored (photo #20). The vessel does not use shore power.

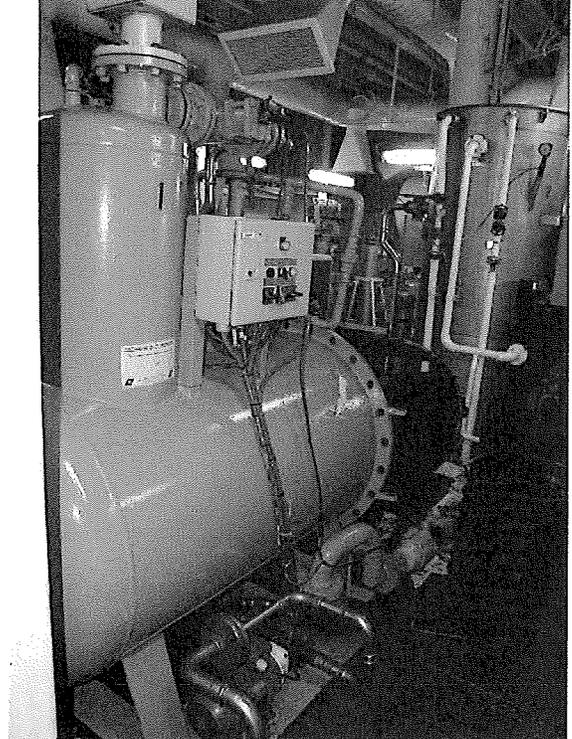
PHOTO #:14 DATE: SEPTEMBER 21, 2015
TAKEN BY: AMY JANKOWIAK FILE No.: P1010020
DESCRIPTION: OILY WATER SEPARATOR (OWS) FACET SYSTEM

Oily bilge water is treated first with a SERAP oily water separator (OWS) (photo #15) that treats to <50 parts per million (ppm) oil content. The water is then treated by a FACET OWS (photo #14) to less than 15 ppm. If the content is >15 ppm for 10 seconds, it is automatically recirculated for reprocessing with the white box. The OWS is monitored in the ECR. The white box (photo #16) is used for secure discharges and the discharge port is padlocked with keys held by the SEH and Chief Engineer. Oil sludge is offloaded as non-hazardous waste.

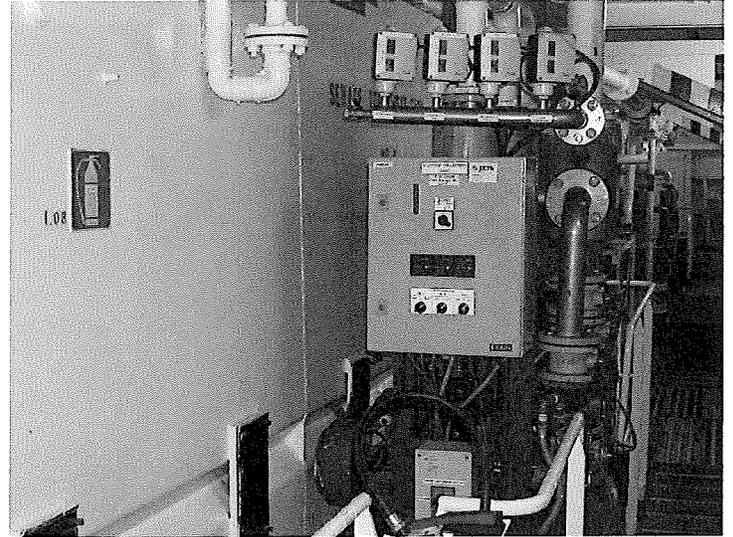
PHOTO #:22 DATE: SEPTEMBER 21, 2015
TAKEN BY: AMY JANKOWIAK FILE No.: P1010030
DESCRIPTION: BLACKWATER HOLDING TANK

Blackwater, which includes toilet waste and most graywater, which includes accommodation and crew sink and shower water and laundry water is collected (photos #22 and #23) and combined and treated with one of two Zenon membrane bioreactor, which is an advanced wastewater treatment system. Discharges take place outside of MOU related waters. The Black/ Gray Water Discharge Record book was reviewed and there were no discharges in MOU related waters observed. The systems operate continuously. Excess graywater is held untreated and discharged outside of MOU related waters.

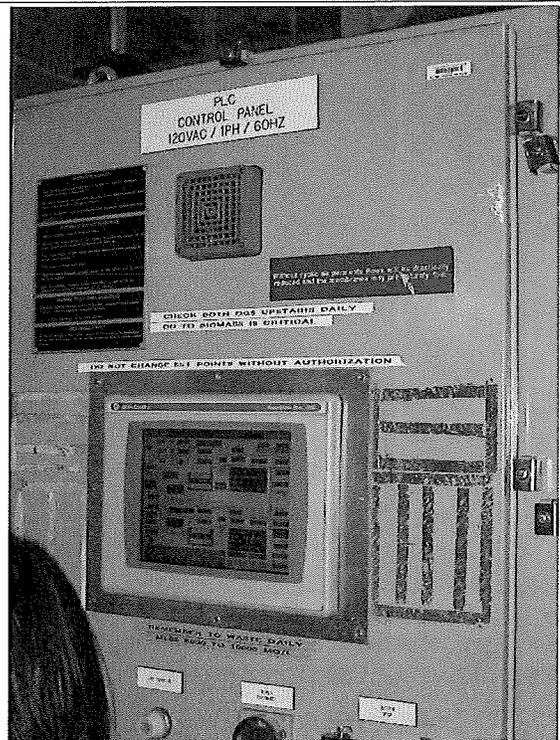
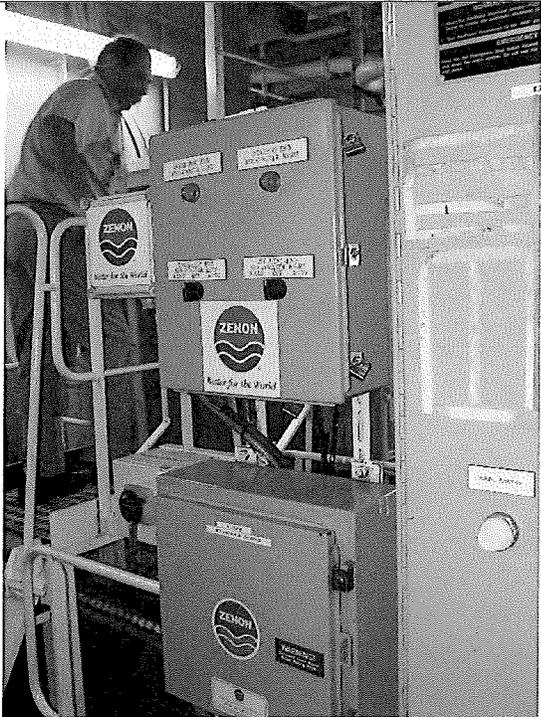
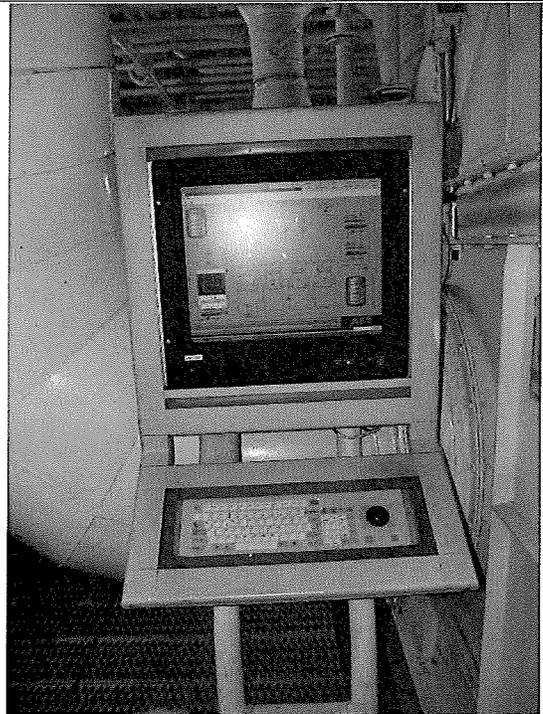
Black water is collected by vacuum and combined with graywater to an equalization tank. Flow then goes to the screens where solids are separated and sent to a solids tank. Liquid moves to the bioreactor tank (photo #28) for biological treatment with air circulation. Solids from the bioreactor, biomass, is sent to the solids tank. Solids are discharged outside of MOU related waters. Liquid from the bioreactor goes through the membranes for ultrafiltration. Permeate then moves to the ultraviolet disinfection system (photo #30) to permeate tanks for holding until discharged (photo #31) outside of MOU related waters. Turbidity is monitored on the permeate (photo #29). The system is operated, maintained and monitored by the Zenon engineer (photos #24, #25, and #26).

PHOTO #:24 DATE: SEPTEMBER 21, 2015
TAKEN BY: AMY JANKOWIAK FILE No.: P1010036
DESCRIPTION: ZENON CONTROLS

PHOTO #:25 DATE: SEPTEMBER 21, 2015
TAKEN BY: AMY JANKOWIAK FILE No.: P1010037
DESCRIPTION: ZENON CONTROLS

PHOTO #:26 DATE: SEPTEMBER 21, 2015
TAKEN BY: AMY JANKOWIAK FILE No.: P1010045
DESCRIPTION: ZENON CONTROLS
