State of Washington Department of Ecology
Cruise Ship Memorandum of Understanding, Cruise Operations in Washington State Inspection Report

Inspection Date 09/26/2011	Permit Number NA	County King	Receiving Waters Marine Waters	Ecology Inspector Amy Jankowiak
Entry Time 8:55 am Exit Time 11:08 am	Photos Taken <input checked="" type="checkbox"/> Yes <input type="checkbox"/> No	Samples Taken <input type="checkbox"/> Yes <input checked="" type="checkbox"/> No	Inspection Announced <input checked="" type="checkbox"/> Yes <input type="checkbox"/> No	Discharges to: <input checked="" type="checkbox"/> Surface Water <input type="checkbox"/> Ground Water <input type="checkbox"/> Dewater <input type="checkbox"/> POTW
Name and Location of Site Inspected: CELEBRITY INFINITY, Celebrity Cruises Pier 66 Seattle, Washington				Additional Participants/Inspectors: Mark Henley, P.E., Ecology
On-Site Representative(s): <i>Name/Title/Phone/e-mail</i> Nikolaos Alvanos, Environmental Officer IN_ENVIRONMENTALOFFICER@CELEBRITY.COM				
Responsible Official(s): <i>Name/Title/Address/Phone/e-mail</i> Rich Pruitt, Director Environmental Programs Royal Caribbean International 1080 Caribbean Way, Miami, FL 33132 O

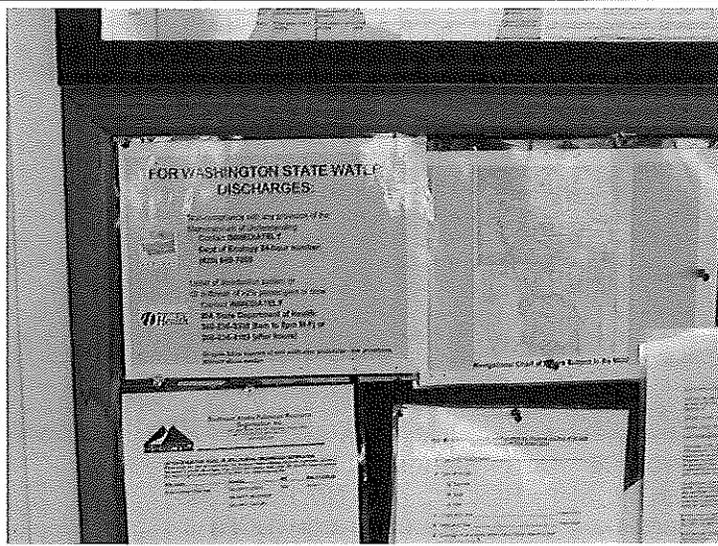
PHOTO #:01 DATE: SEPTEMBER 26, 2011
TAKEN BY: MARK HENLEY FILE No.:P9260001
DESCRIPTION: NOTIFICATION TO ECOLOGY/HEALTH POSTINGS ON THE BRIDGE

The bridge had the notification requirements per the MOU posted (photo #01).

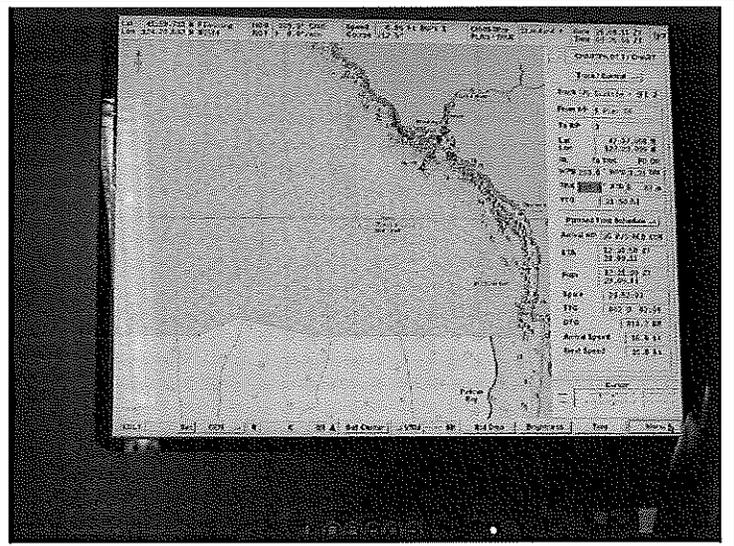
PHOTO #:02 DATE: SEPTEMBER 26, 2011
TAKEN BY: MARK HENLEY FILE No.:P9260002
DESCRIPTION: NAVIGATION CHARTS ON THE BRIDGE

The discharge protocol for wastewater includes the bridge notifying the Engine Control Room (ECR) when they are 12 nautical miles (nm) from land, outside of MOU waters, and outside of the Olympic Coast National Marine Sanctuary (OCNMS). Navigation charts on the bridge (photos #02 and #03) clearly identifies the OCNMS and locations. Communications of discharge are tracked by log and an excel discharge start/stop log (photo #04). A discharge policy (photo #05) is also displayed. There is one key to the padlocked discharge ports kept in the ECR and the use is logged.

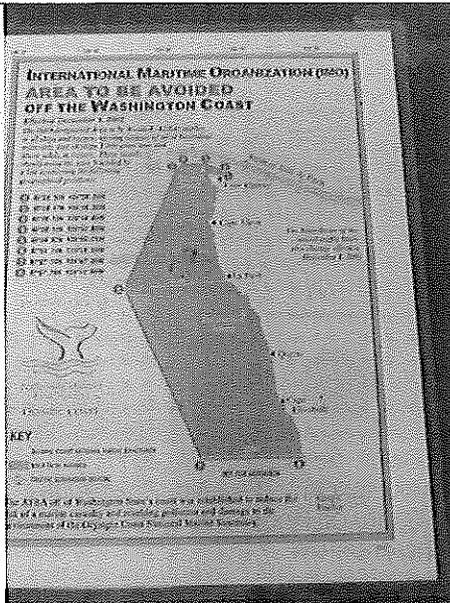
PHOTO #:03 DATE: SEPTEMBER 26, 2011
TAKEN BY: MARK HENLEY FILE No.:P9260003
DESCRIPTION: OCNMS MAP ON THE BRIDGE

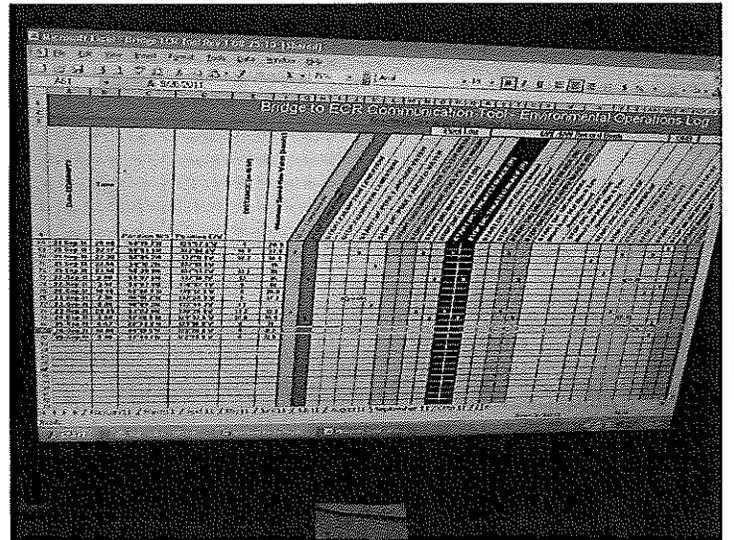
PHOTO #:04 DATE: SEPTEMBER 26, 2011
TAKEN BY: MARK HENLEY FILE No.:P9260004
DESCRIPTION: EXCEL DISCHARGE START/STOP IN EO OFFICE.

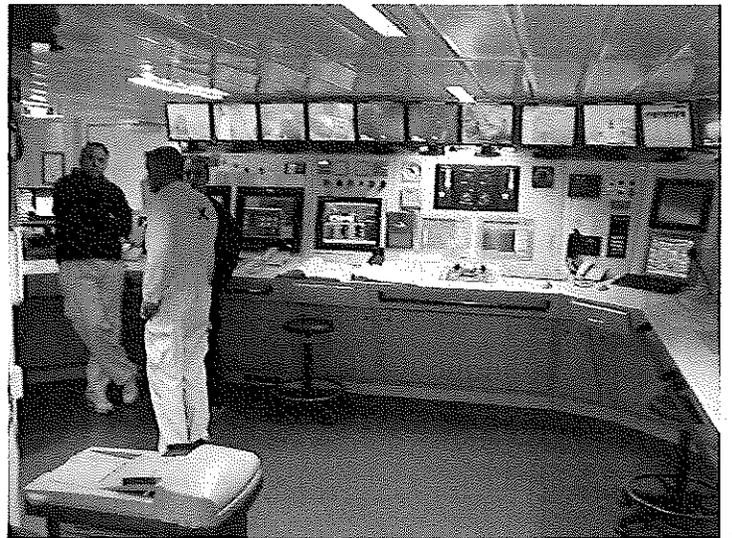
PHOTO #:06 DATE: SEPTEMBER 26, 2011
TAKEN BY: MARK HENLEY FILE No.:P9260006
DESCRIPTION: ENGINE CONTROL ROOM (ECR)

We arrived and boarded the ship at about 8:55 am and began with introductions and a plan for the day with Nikolaos Alvanos, Environmental Officer. We discussed various waste streams and discharge protocols. We then went to the Bridge and to the Engine Control Room (photo #06) to review navigation, notification protocols, and discharge protocols. We reviewed the various discharge and environmental records. We then toured the Garbage and Recycling Areas, and the galley and food waste system. Next we toured the Advanced Wastewater Treatment System (AWTS) and the oily water separator. The inspection was then finalized with a debriefing and we disembarked the vessel at about 11:08 am.

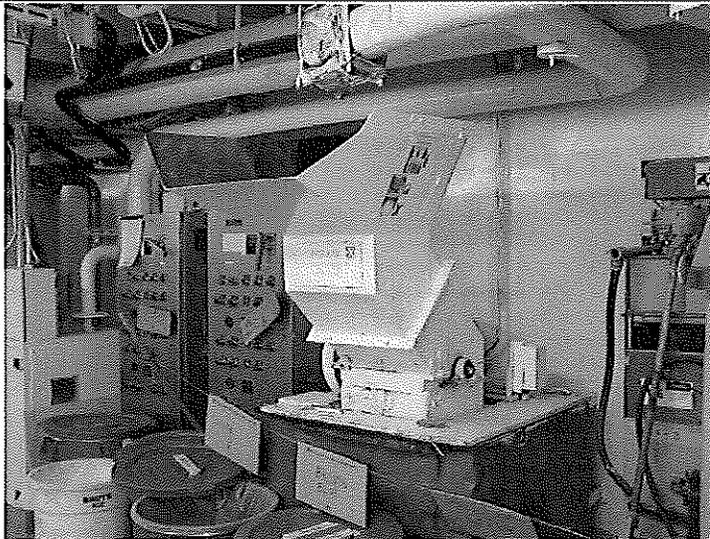
PHOTO #:07 DATE: SEPTEMBER 26, 2011
TAKEN BY: MARK HENLEY FILE No.:P9260007
DESCRIPTION: GARBAGE ROOM – GLASS SORTING AND CRUSHER

Solid waste is managed properly. The various solid waste streams are collected, sorted, stored (photo #14), and sent ashore or incinerated as appropriate. The garbage record book was reviewed and showed consistency with requirements. Glass is recycled (photo #07) and not discharged.

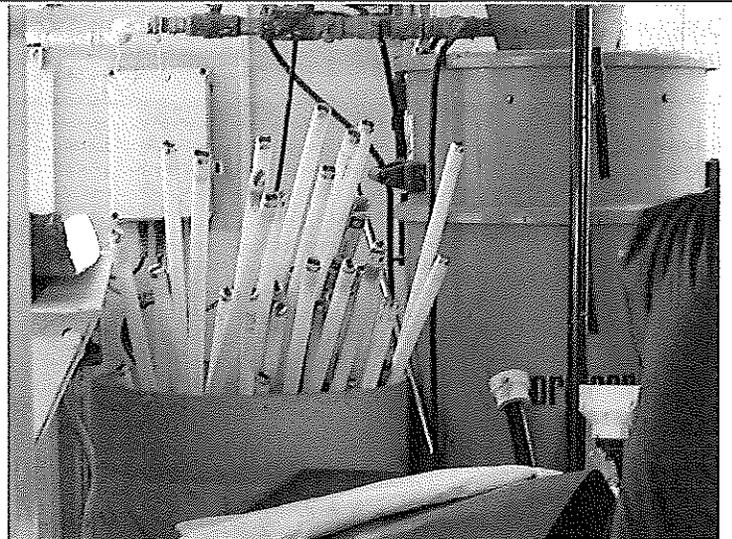
PHOTO #:08 DATE: SEPTEMBER 26, 2011
TAKEN BY: MARK HENLEY FILE No.:P9260008
DESCRIPTION: GARBAGE ROOM – FLUORESCENT LAMP
COLLECTION AND CRUSHER.

Fluorescent lamps are crushed (photo #08) on board with a mercury vapor removal system, and then offloaded.

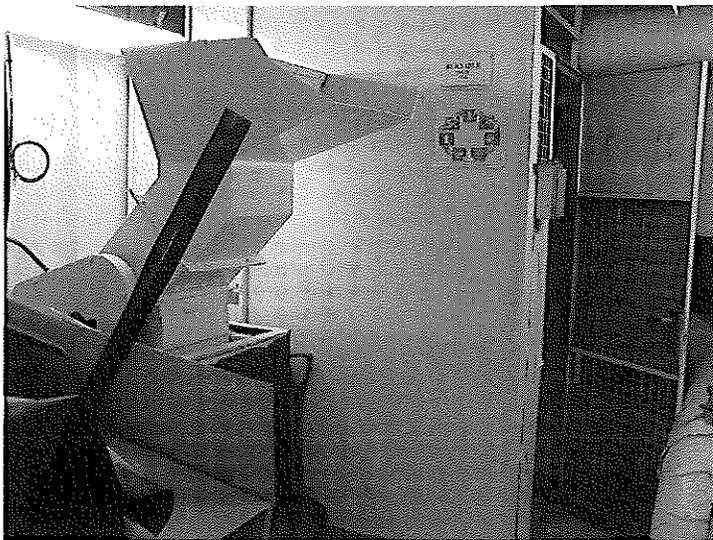
PHOTO #:09 DATE: SEPTEMBER 26, 2011
TAKEN BY: MARK HENLEY FILE No.:P9260009
DESCRIPTION: GARBAGE ROOM - COMPACTOR

Plastics, paper, electronics, cardboard (photo #09), glass, aluminum, some batteries and metals are materials recycled (photo #13). Reduction and reuse opportunities are broadly used to prevent the amount of waste. Recycling is offloaded in Victoria.

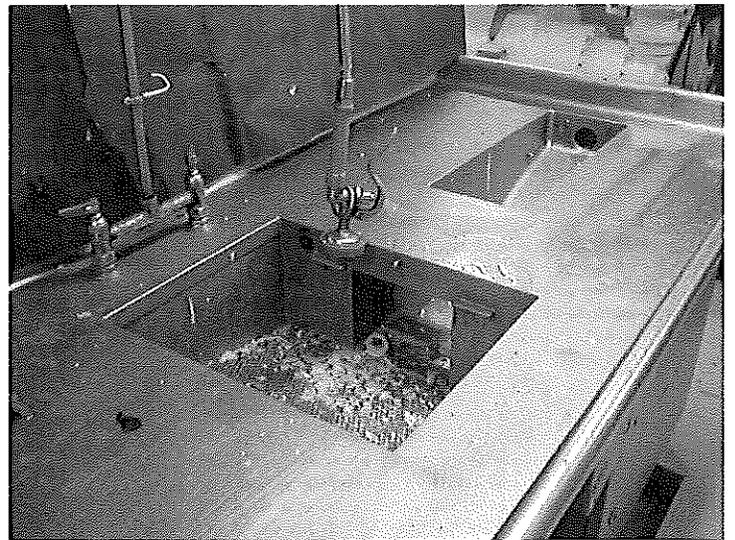
PHOTO #:10 DATE: SEPTEMBER 26, 2011
TAKEN BY: MARK HENLEY FILE No.:P9260010
DESCRIPTION: GARBAGE ROOM - CAN CLEANER - TO PULPER

Food waste is sorted (photos #10 and #15) prior to going into the pulpers. Solid food waste is discharged outside of MOU waters after pulping (photo #11). Some materials are incinerated. Galley water is discharged outside of MOU waters. Used cooking oil is recycled in Seattle.

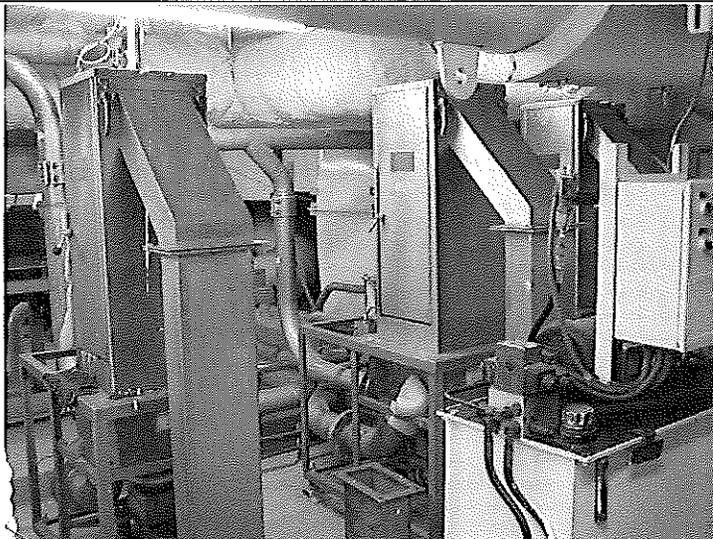
PHOTO #:11 DATE: SEPTEMBER 26, 2011
TAKEN BY: MARK HENLEY FILE No.:P9260011
DESCRIPTION: GARBAGE ROOM - FOOD PULPERS (3)

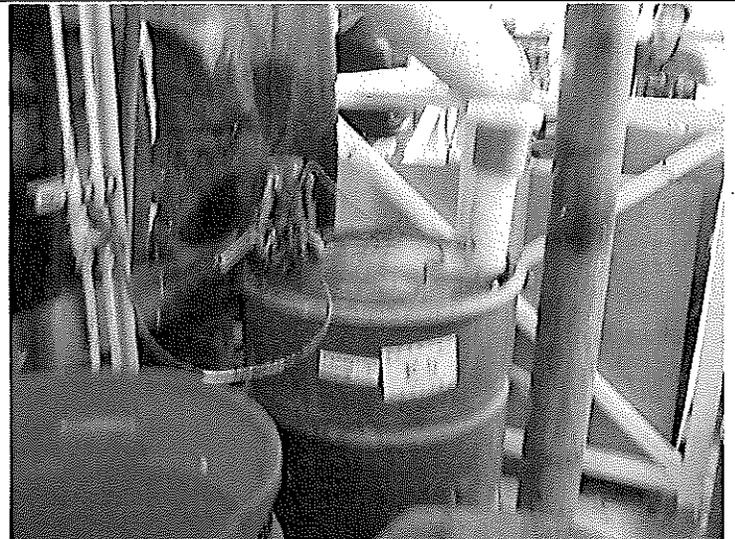
PHOTO #:12 DATE: SEPTEMBER 26, 2011
TAKEN BY: MARK HENLEY FILE No.:P9260012
DESCRIPTION: GARBAGE ROOM - AEROSOL DEPRESSURIZER

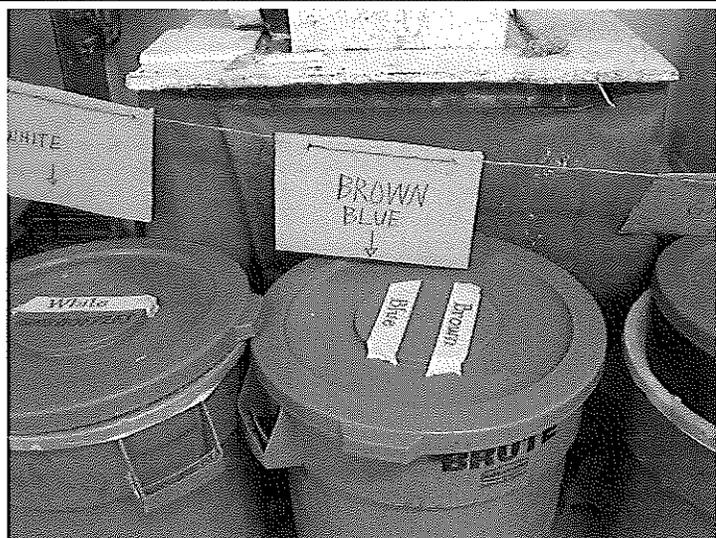
PHOTO #:13 DATE: SEPTEMBER 26, 2011
TAKEN BY: MARK HENLEY FILE No.:P9260013
DESCRIPTION: GARBAGE ROOM – GLASS COLOR SORTING

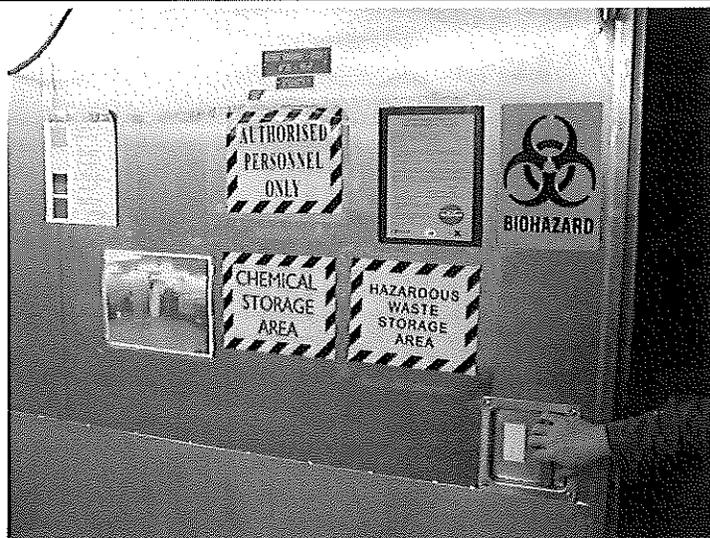
PHOTO #:14 DATE: SEPTEMBER 26, 2011
TAKEN BY: MARK HENLEY FILE No.:P9260014
DESCRIPTION: DRY GARBAGE/HAZ WASTE/CHEMICAL STORAGE ROOM

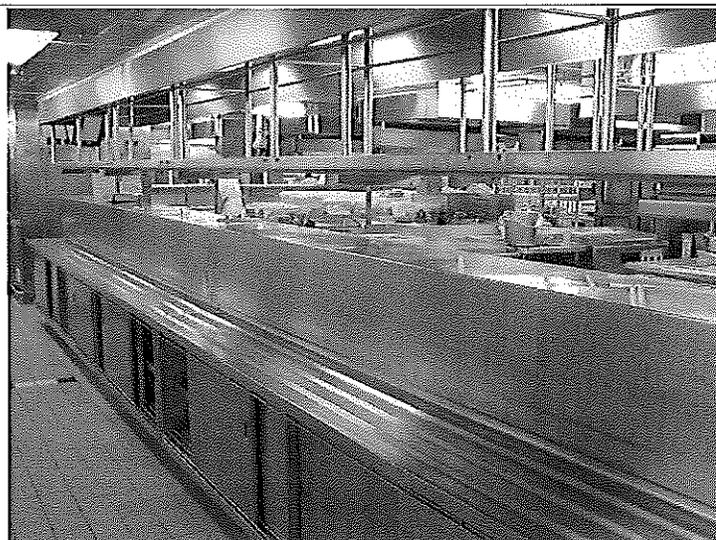
PHOTO #:15 DATE: SEPTEMBER 26, 2011
TAKEN BY: MARK HENLEY FILE No.:P9260015
DESCRIPTION: GALLEY

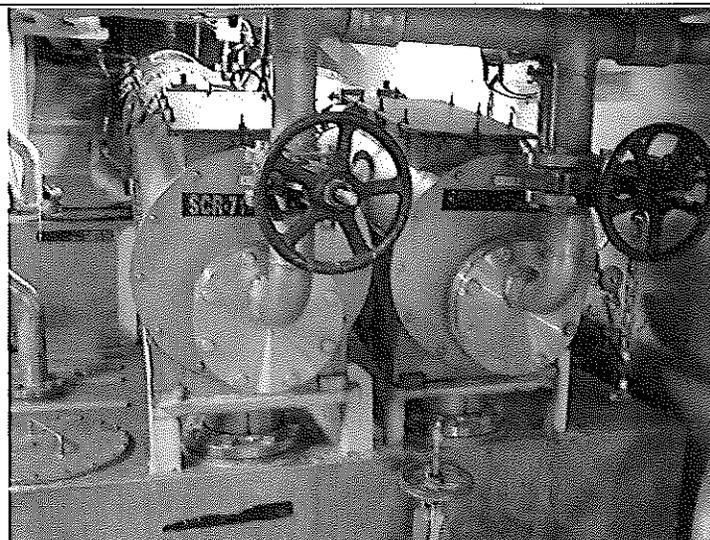
PHOTO #:16 DATE: SEPTEMBER 26, 2011
TAKEN BY: MARK HENLEY FILE No.:P9260016
DESCRIPTION: AWTS – DRUM SCREENS (2)

The advanced wastewater treatment system, Zenon, consists of two separate membrane bioreactors. Black water, which includes toilet waste and infirmity drains is collected by vacuum to black water collection tanks. Gray water, which includes sink and shower water, and laundry water is collected to gray water collection tanks. The gray water and black water then combine just as they enter the screening units (drum screens) (photo #16). The initial screenings are incinerated. Solids from the screening unit first go to the wasting tank and are then held for discharge or go to the old Haaman traditional MSD to further break down the residue prior to discharge.

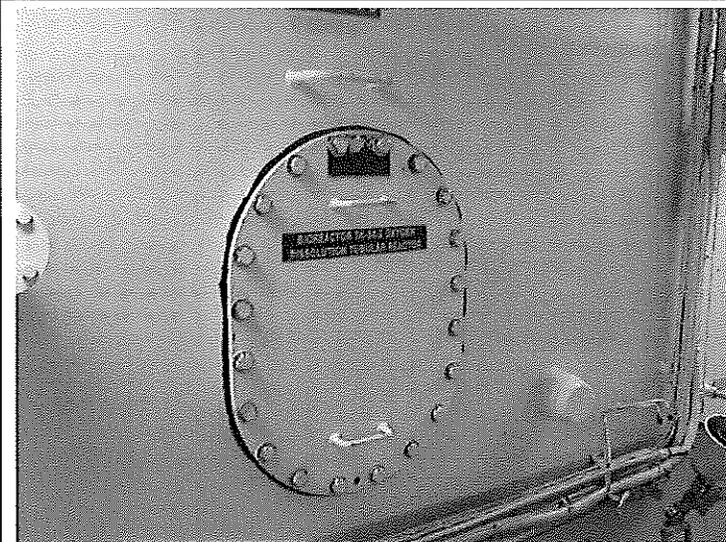
PHOTO #:17 DATE: SEPTEMBER 26, 2011
TAKEN BY: MARK HENLEY FILE No.:P9260017
DESCRIPTION: AWTS – BIOREACTOR TANK

The liquid from the screening units moves to the bioreactors (photos #17 and #21). The MBRs use blowers (photo #18) to enhance biological activity. The membrane bioreactors are cleaned automatically (photo #19) about once every three hours with citric acid or chlorine and hand cleaned about once every three months. Solids that are wasted from the MBRs periodically are sent to the wasting tank. Effluent from the MBRs is combined and sent to the ultraviolet disinfection unit (photos #22, #23, #24 and #25). After UV, the effluent is sent to permeate holding tanks if not in an area for discharge. When discharging, effluent from the holding tanks goes through another UV system prior to discharge. The UV systems have lighted alarms when bulbs go out and alarms for intensity and overheating.

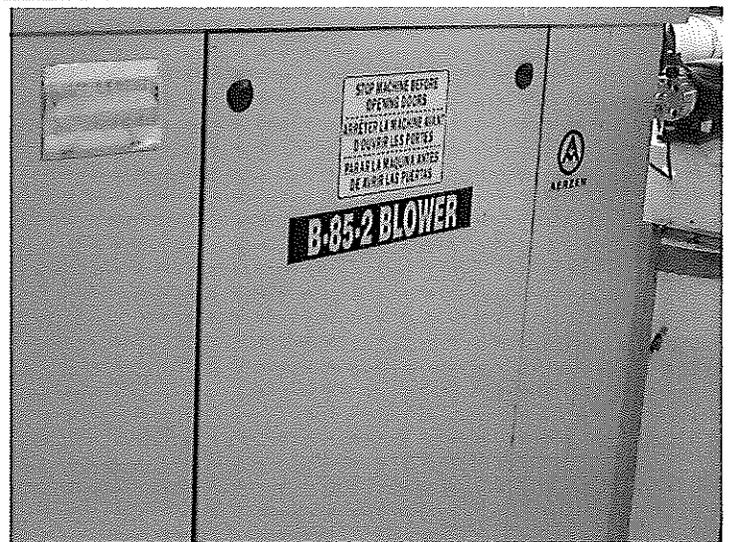
PHOTO #:18 DATE: SEPTEMBER 26, 2011
TAKEN BY: MARK HENLEY FILE No.:P9260018
DESCRIPTION: AWTS – BLOWER FOR MBR

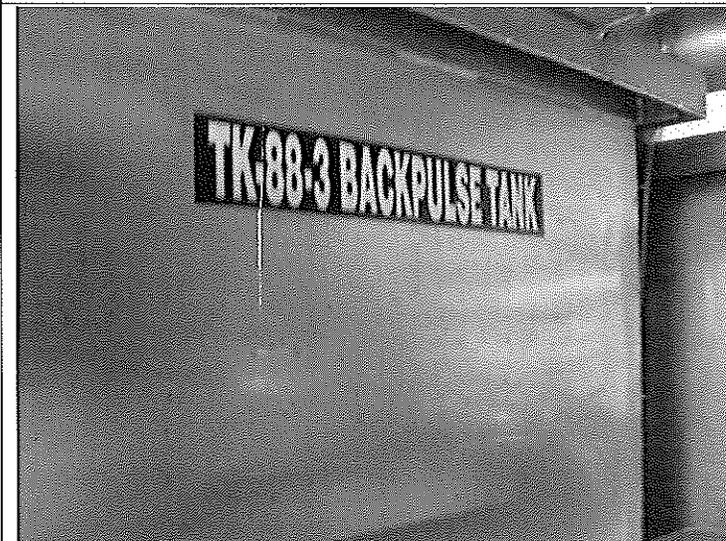
PHOTO #:19 DATE: SEPTEMBER 26, 2011
TAKEN BY: MARK HENLEY FILE No.:P9260019
DESCRIPTION: AWTS – MBR BACKPULSE TANK

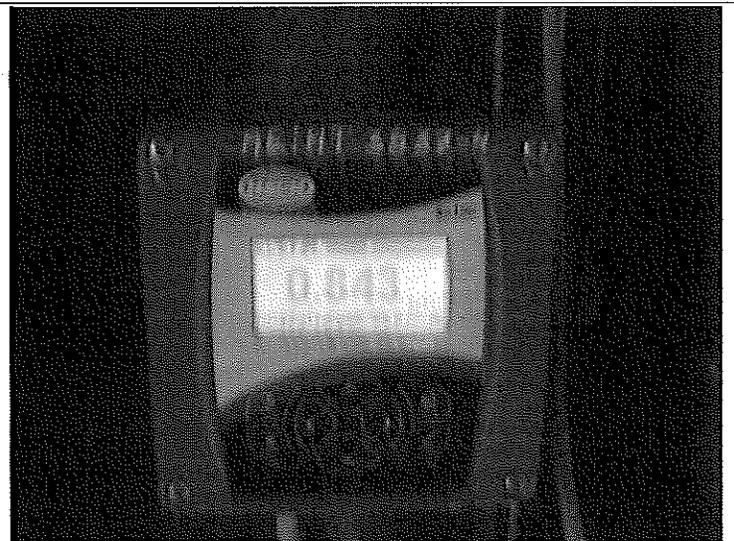
Sampling is done for process control on board the vessel. Parameters include total suspended solids, chemical oxygen demand, biochemical oxygen demand, chlorine and total coliform. There are turbidity meters on each bioreactor with alarms, although not all meters are working properly (photo #20). Sampling for compliance is also done once per month as needed with an outside contractor.

PHOTO #:20 DATE: SEPTEMBER 26, 2011
TAKEN BY: MARK HENLEY FILE No.:P9260020
DESCRIPTION: AWTS – TURBIDIMETER ON MBR (NOT WORKING ACCURATELY)

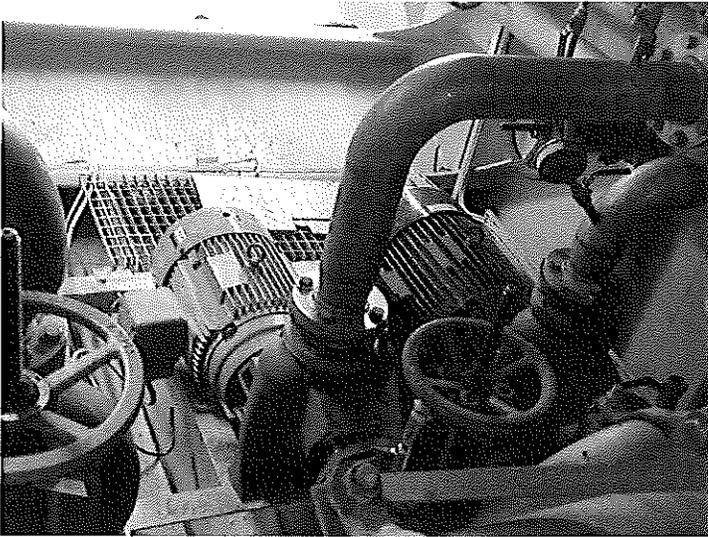
PHOTO #:21 DATE: SEPTEMBER 26, 2011
TAKEN BY: MARK HENLEY FILE No.:P9260021
DESCRIPTION: AWTS – MBR PUMPS

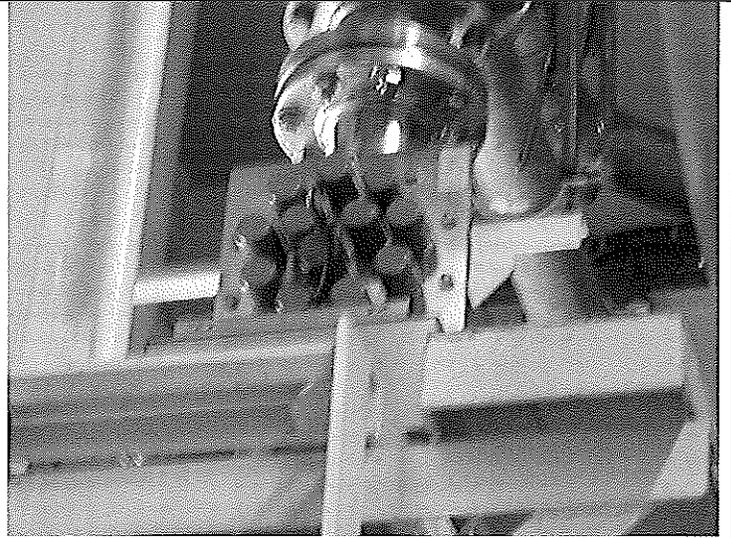
PHOTO #:22 DATE: SEPTEMBER 26, 2011
TAKEN BY: MARK HENLEY FILE No.:P9260022
DESCRIPTION: AWTS – UV DISINFECTION

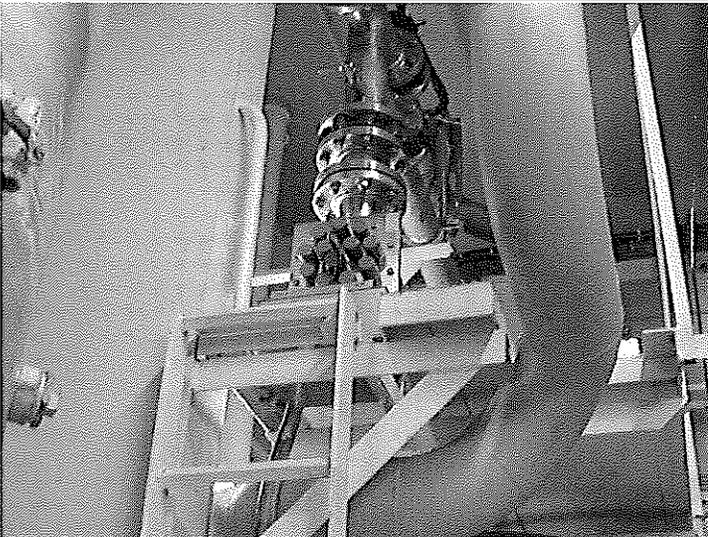
PHOTO #:23 DATE: SEPTEMBER 26, 2011
TAKEN BY: MARK HENLEY FILE No.:P9260023
DESCRIPTION: AWTS – UV DISINFECTION UNIT

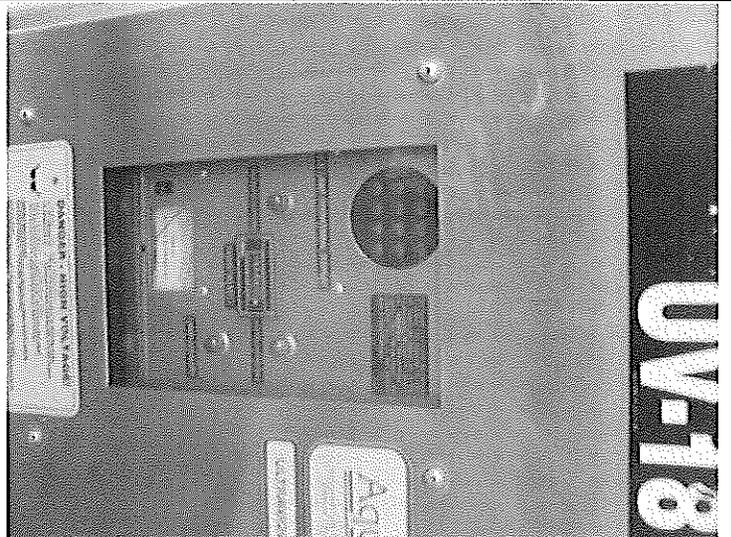
PHOTO #:24 DATE: SEPTEMBER 26, 2011
TAKEN BY: MARK HENLEY FILE No.:P9260025
DESCRIPTION: AWTS – UV DISINFECTION CONTROL PANEL

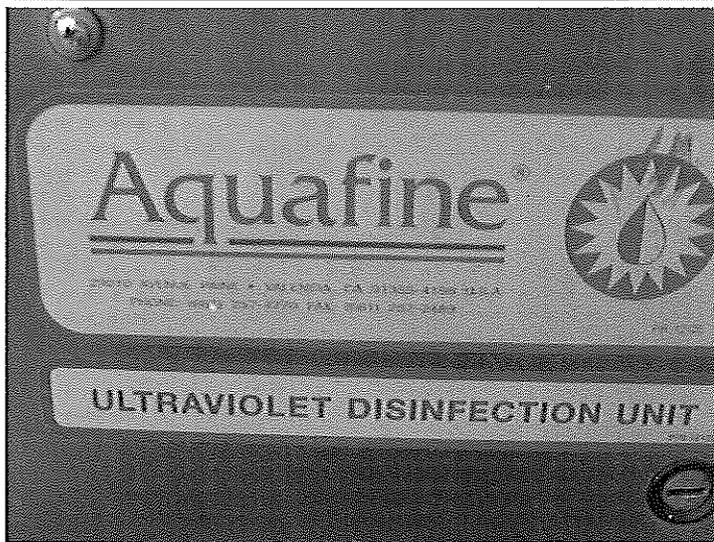
PHOTO #:25 DATE: SEPTEMBER 26, 2011
TAKEN BY: MARK HENLEY FILE No.:P9260026
DESCRIPTION: AWTS – UV DISINFECTION SYSTEM

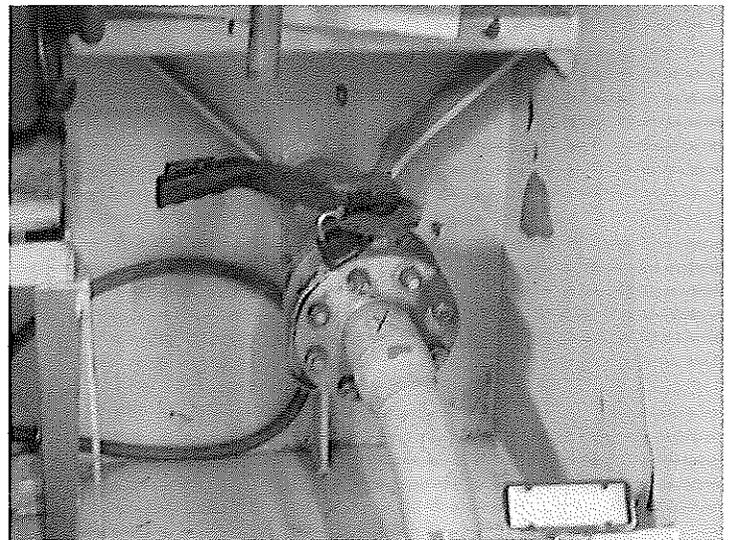
PHOTO #:26 DATE: SEPTEMBER 26, 2011
TAKEN BY: MARK HENLEY FILE No.:P9260027
DESCRIPTION: DISCHARGE PORT FOR OILY BILGE WATER

Oily bilge is treated with a Marin Flocc oily water separator system (photos #29 and #30). Discharges (photos #26 and #27) occur at less than 15 ppm and outside of MOU waters. A white box (photo #28) is used to prevent discharges of more than 15 ppm.

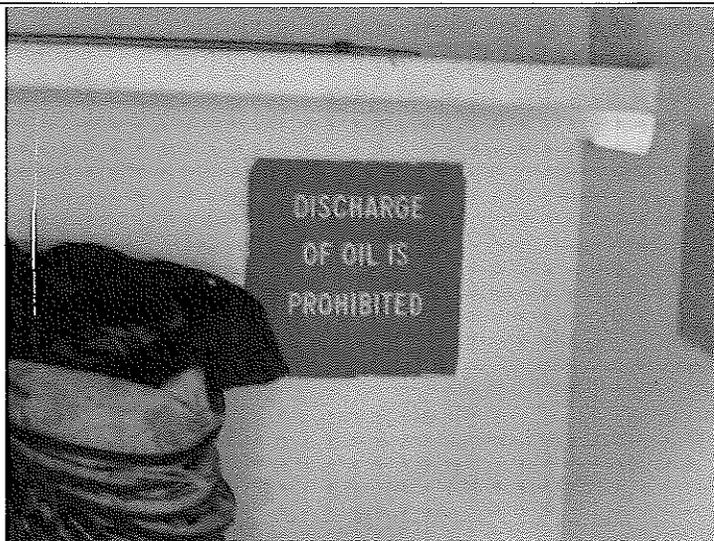
PHOTO #:27 DATE: SEPTEMBER 26, 2011
TAKEN BY: MARK HENLEY FILE No.:P9260028
DESCRIPTION: OILY BILGE DISCHARGE PORT SIGNAGE

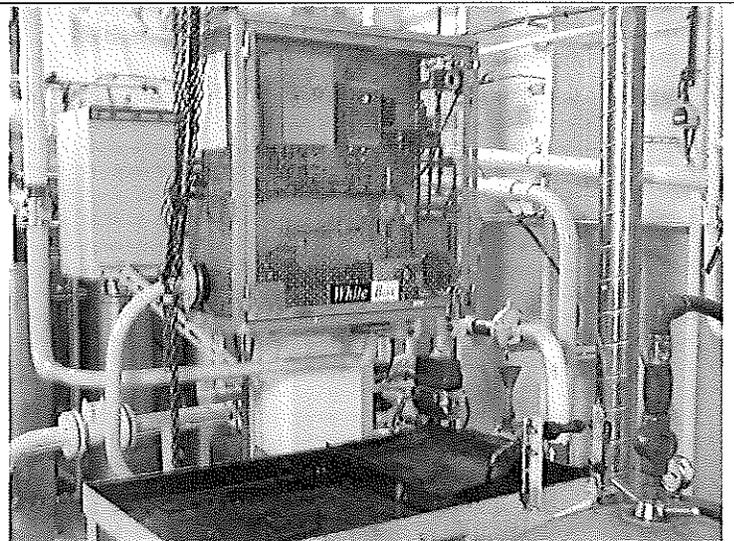
PHOTO #:28 DATE: SEPTEMBER 26, 2011
TAKEN BY: MARK HENLEY FILE No.:P9260030
DESCRIPTION: OILY BILGE WHITE BOX

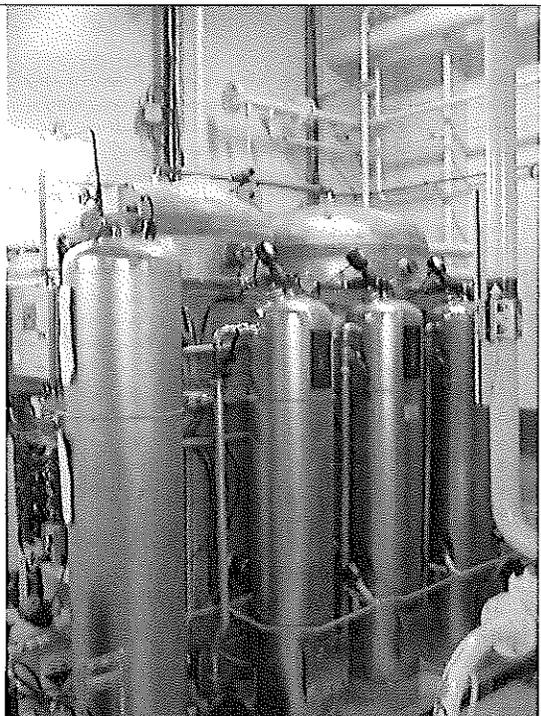
PHOTO #:29 DATE: SEPTEMBER 26, 2011
TAKEN BY: MARK HENLEY FILE No.:P9260031
DESCRIPTION: OILY WATER SEPARATOR - MARIN FLOC SYSTEM

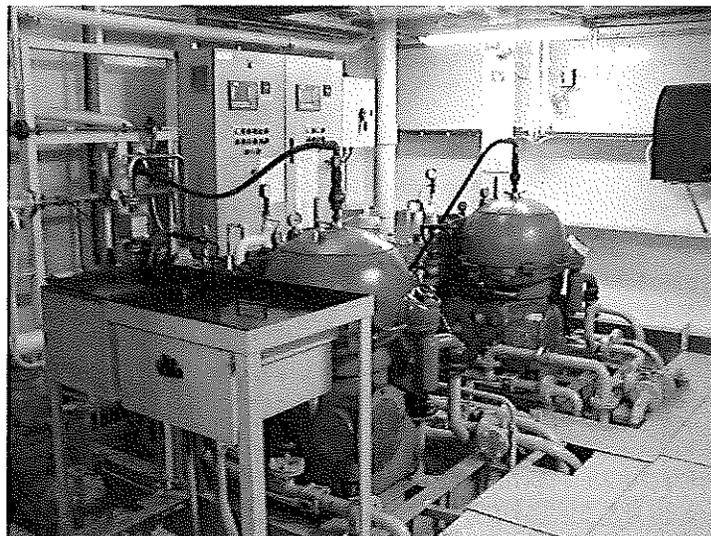
PHOTO #:30 DATE: SEPTEMBER 26, 2011
TAKEN BY: MARK HENLEY FILE No.:P9260032
DESCRIPTION: OILY BILGE SYSTEMS
