State of Washington Department of Ecology
Cruise Ship Memorandum of Understanding, Cruise Operations in Washington State Inspection Report

Amy Jankowiak, Washington State Department of Ecology (Ecology) Northwest Regional Office, Water Quality Program (NWRO-WQ) conducted the inspection of the Norwegian Cruise Line (NCL) NORWEGIAN STAR on September 3, 2011. The main contact on board the NORWEGIAN STAR was Freddy Pettersen, Environmental and Sanitation Officer for the NORWEGIAN STAR. Prior notification of the visit was given on August 29, 2011 for security protocol. The purpose of the inspection was to evaluate compliance with the *Memorandum of Understanding Cruise Operations in Washington State* (MOU), as amended. The NORWEGIAN STAR is approved to discharge at least one nautical mile away from port and traveling at a speed of at least six knots in MOU waters.

The NORWEGIAN STAR was built in 2001, is 965 feet long with 15 decks and about a 28-foot draft. The passenger capacity is about 2348 and the crew capacity is about 1100.

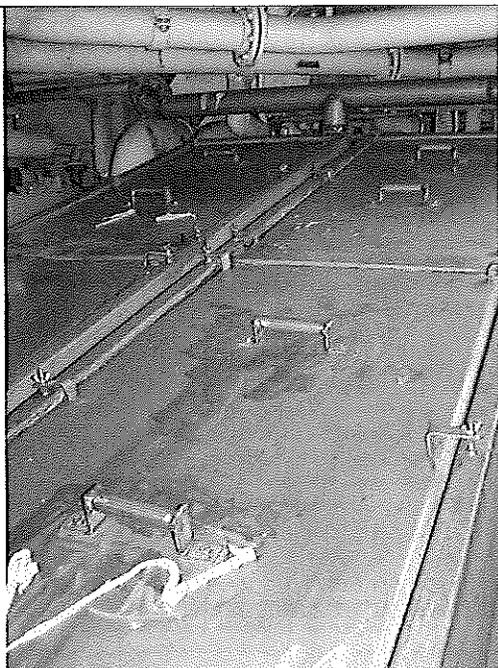
Blackwater, which includes toilet waste and infirmiry drains goes to one of 4 collection tanks (photo #12) and graywater which includes sink and shower and laundry water, combines in tanks before combining and entering the drum screens. There are two drum screens (photos #03 and #04) which provide pre-screening. The drum screens are cleaned weekly with water (photo #05). Solids from the drum screens go to the sludge tank. Liquid flow from the drum screens then enters the biostep tanks (photos #06 and #-7) for biological treatment (biofilm on rotating plastic pieces – 2 tanks in series, air added). After biostep, flocculants and polymers (photos #09 and #11) are added. Clarification then occurs via flotation tanks. The flotation tanks (photo #08) are cleaned by manual spray about once a week. Solids from the flotation tanks (photo #10) are sent to the sludge tank along with the screenings to be held for later discharge. Liquid flow then moves to the polishing filters (photo #13) for ultrafiltration (2 rotating mesh drums), and then to ultraviolet disinfection. Flow then moves to ultraviolet light (UV) disinfection (photos #14 and #15). There are three UV units, of which two are typically used with 14 bulbs each. The bulbs are alarmed for bulb failure and intensity at 10 watts. The UV sleeves are cleaned by dosing Metal Bright cleaner automatically. Flow from the UV units is either discharged directly overboard via the discharge port (photo #16) or is held for discharge later outside of MOU waters.

PHOTO #:03 DATE: SEPTEMBER 3, 2011
TAKEN BY: AMY JANKOWIAK FILE No.:P9030017
DESCRIPTION: SCANSHIP DRUM SCREENS

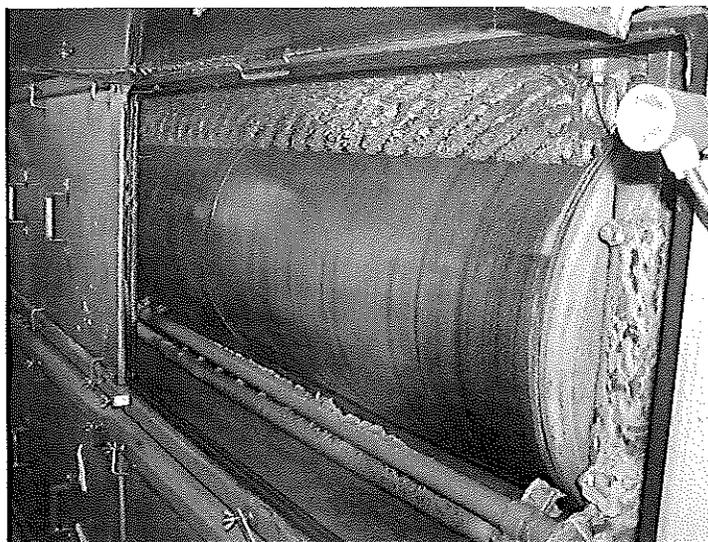
PHOTO #:04 DATE: SEPTEMBER 3, 2011
TAKEN BY: AMY JANKOWIAK FILE No.:P9030018
DESCRIPTION: INSIDE OF SCANSHIP DRUM SCREEN

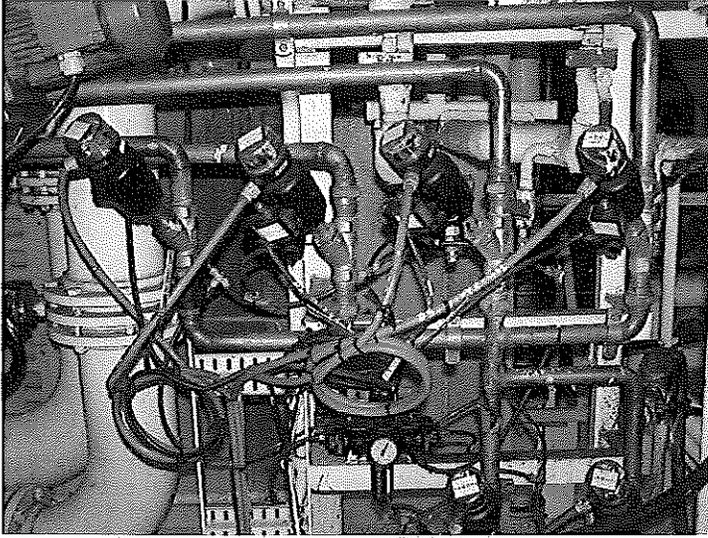
PHOTO #05 DATE: SEPTEMBER 3, 2011
TAKEN BY: AMY JANKOWIAK FILE No.:P9030020
DESCRIPTION: SCANSHIP DRUM SCREEN WASHING SYSTEM

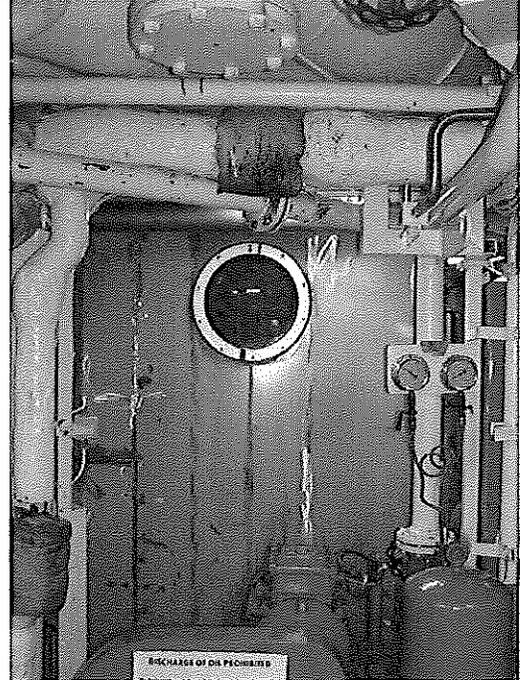
PHOTO #06 DATE: SEPTEMBER 3, 2011
TAKEN BY: AMY JANKOWIAK FILE No.:P9030021
DESCRIPTION: SCANSHIP BIOSTEP (1 OF 2)

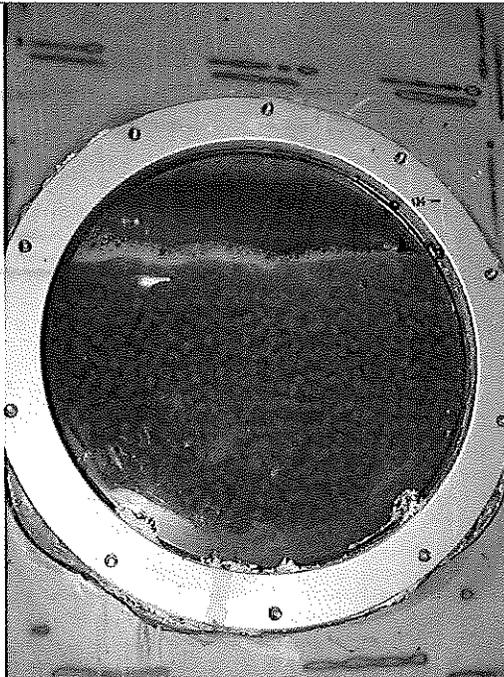
PHOTO #07 DATE: SEPTEMBER 3, 2011
TAKEN BY: AMY JANKOWIAK FILE No.:P9030022
DESCRIPTION: SCANSHIP BIOSTEP (2 OF 2)

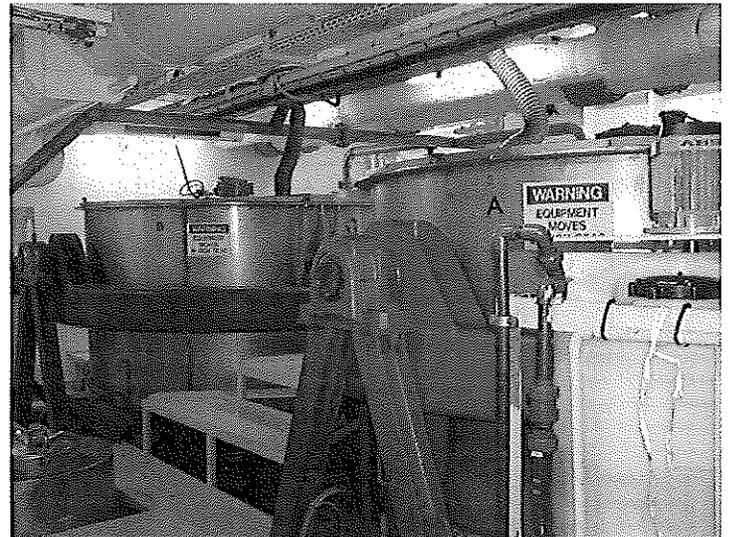
PHOTO #08 DATE: SEPTEMBER 3, 2011
TAKEN BY: AMY JANKOWIAK FILE No.:P9030023
DESCRIPTION: SCANSHIP FLOTATION TANKS

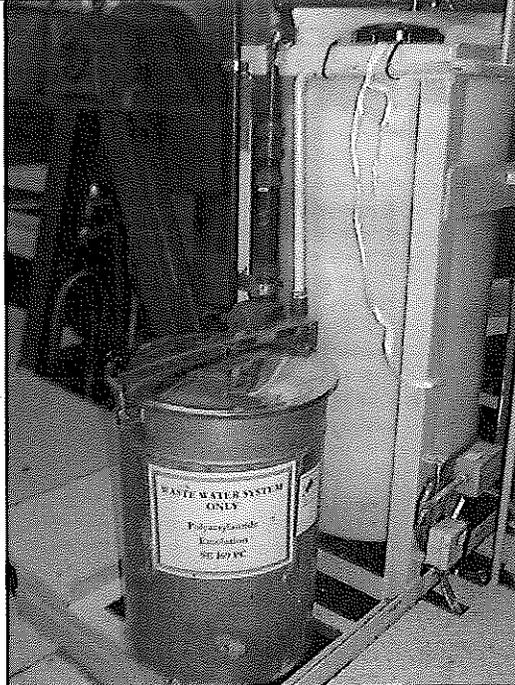
PHOTO #:09 DATE: SEPTEMBER 3, 2011
TAKEN BY: AMY JANKOWIAK FILE No.:P9030024
DESCRIPTION: SCANSHIP POLYMER ADDITION SYSTEM

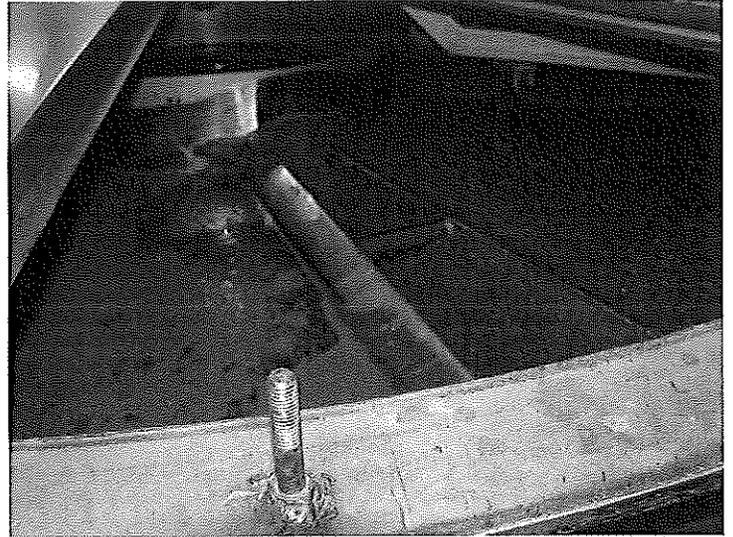
PHOTO #:10 DATE: SEPTEMBER 3, 2011
TAKEN BY: AMY JANKOWIAK FILE No.:P9030025
DESCRIPTION: INSIDE OF SCANSHIP FLOTATION TANK

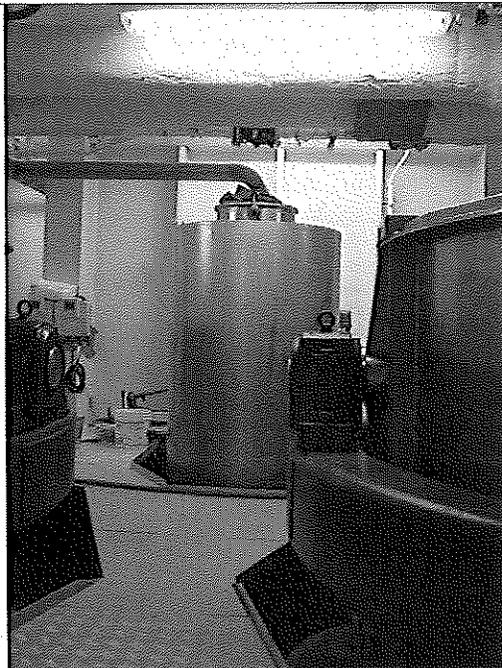
PHOTO #:11 DATE: SEPTEMBER 3, 2011
TAKEN BY: AMY JANKOWIAK FILE No.:P9030027
DESCRIPTION: SCANSHIP FLOCCULATION ADDITION SYSTEM

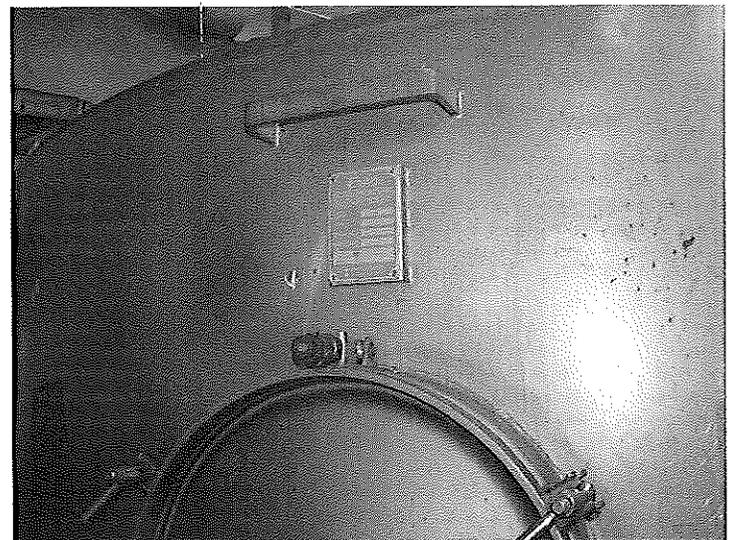
PHOTO #:12 DATE: SEPTEMBER 3, 2011
TAKEN BY: AMY JANKOWIAK FILE No.:P9030028
DESCRIPTION: BLACKWATER VACUUM COLLECTION TANK

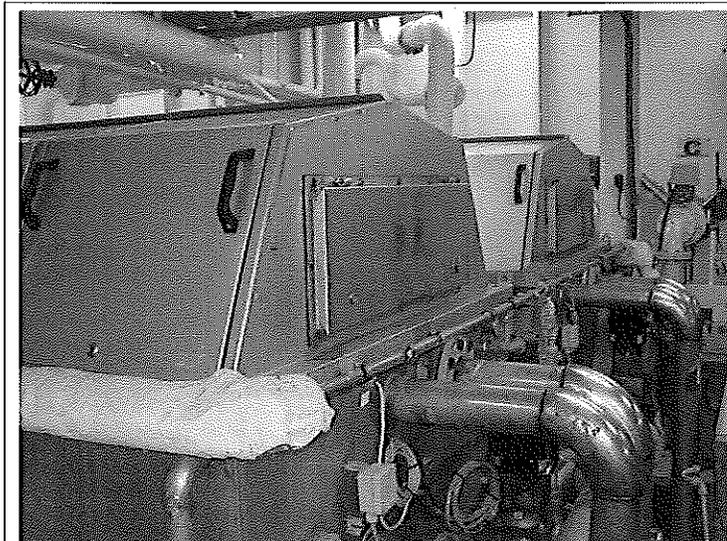
PHOTO #:13 DATE: SEPTEMBER 3, 2011
TAKEN BY: AMY JANKOWIAK FILE No.:P9030029
DESCRIPTION: SCANSHIP POLISHING FILTER

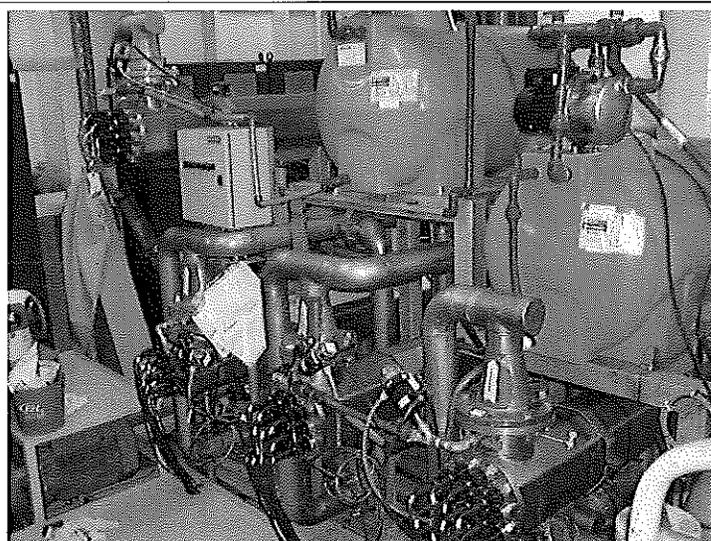
<input checked="" type="checkbox"/> Daily 24-hour Continuous Monitoring for Disinfection Effectiveness	Has disinfection effectiveness monitoring.
<input checked="" type="checkbox"/> Disinfection Effectiveness Monitoring Equipment Functioning Properly	Appears to be functioning properly.
<u>Disinfection Effectiveness Monitoring:</u> UV intensity is monitored for disinfection effectiveness as well as bulb failure.	
<input checked="" type="checkbox"/> Auto Shut Down or Operational Controls to Insure System Shut Down if Disinfection System Upset Occurs	Low intensity will shut down the effluent.
<input checked="" type="checkbox"/> Disinfection System Operated and Maintained Properly	The UV system appeared to be operational and maintained well.
<u>Disinfection System:</u> The UV system consists of 3 separate UV units with 14 bulbs each. An automatic cleaner is used.

PHOTO #:14 DATE: SEPTEMBER 3, 2011
TAKEN BY: AMY JANKOWIAK FILE No.:P9030030
DESCRIPTION: SCANSHIP ULTRAVIOLET LIGHT DISINFECTION SYSTEM (3 UNITS)

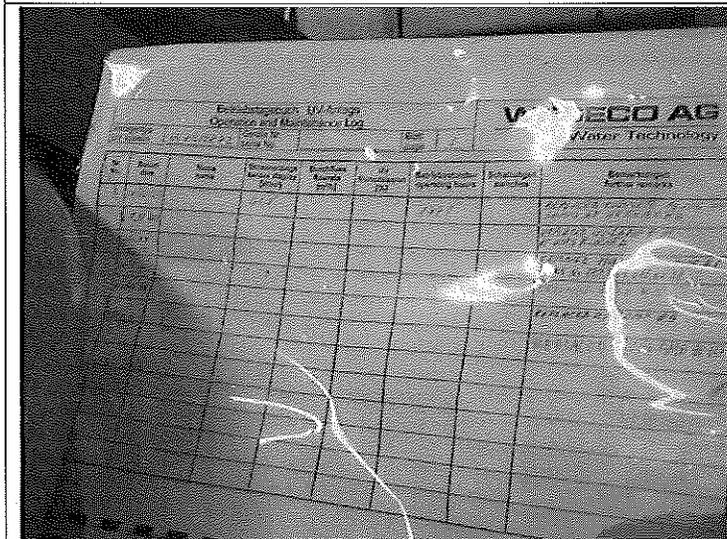
The cruise line uses a system called AMOS for work orders and maintenance. Manufacturer recommendations for maintenance of each piece of equipment is included in the AMOS system which triggers staff when maintenance is required. Scanship also monitors maintenance on the system. Any needed calibrations, cleaning, and other needed maintenance would be included in AMOS. Total suspended solids (TSS) (equivalent to turbidity) (photo #17) is monitored continuously at UV disinfection. If TSS exceed 25 mg/l, the system alarms and staff responds to investigate. At 30 mg/l, the system alarms and switches automatically to hold that discharge. PH is also monitored for adjustments.

PHOTO #:15 DATE: SEPTEMBER 3, 2011
TAKEN BY: AMY JANKOWIAK FILE No.:P9030031
DESCRIPTION: SCANSHIP UV LIGHT MAINTENANCE LOG

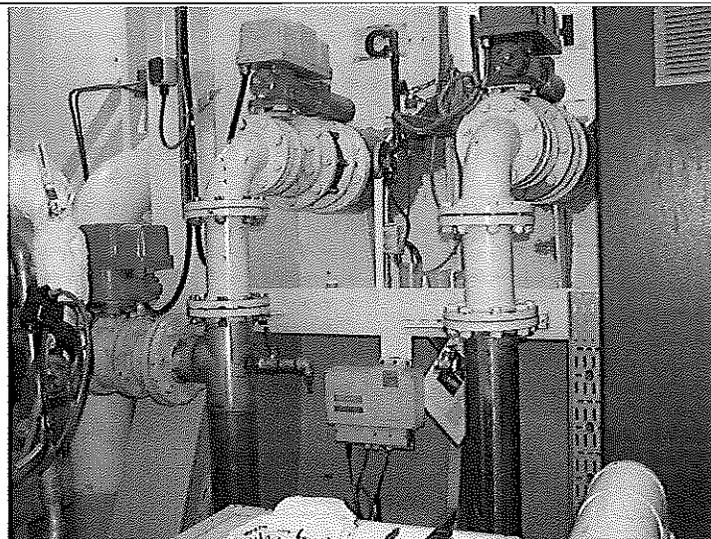
PHOTO #:16 DATE: SEPTEMBER 3, 2011
TAKEN BY: AMY JANKOWIAK FILE No.:P9030032
DESCRIPTION: SCANSHIP EFFLUENT SAMPLING POINT AND DISCHARGE PORT

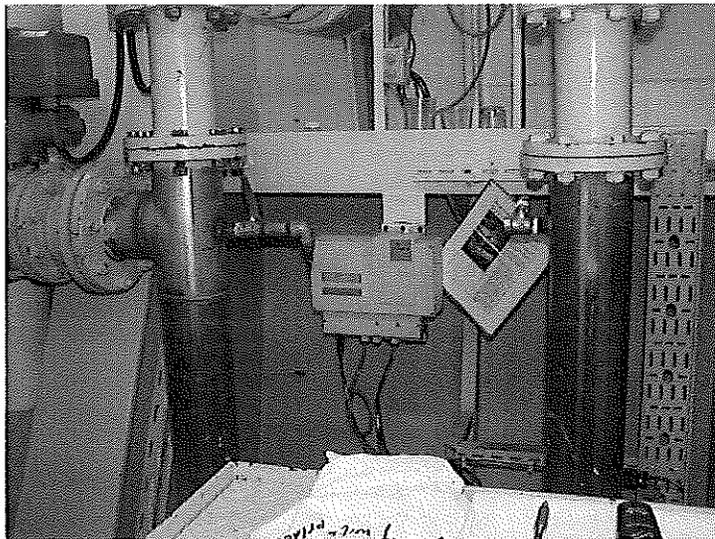
PHOTO #:17 DATE: SEPTEMBER 3, 2011
TAKEN BY: AMY JANKOWIAK FILE No.:P9030033
DESCRIPTION: SCANSHIP TSS METER

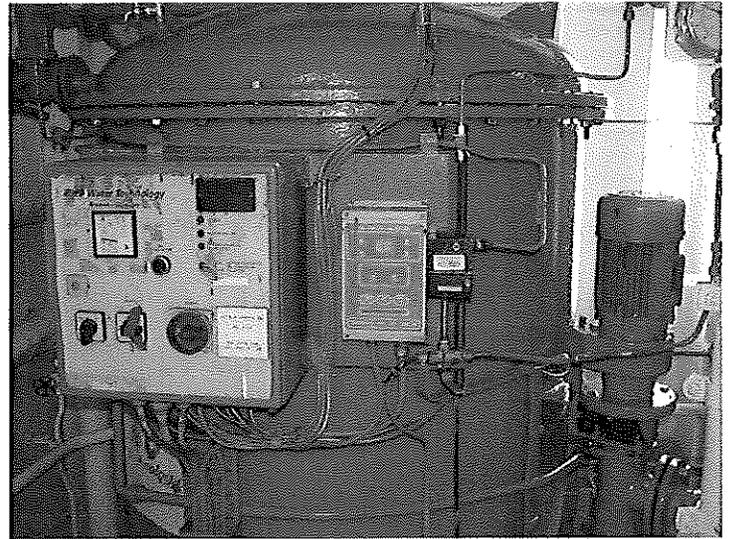
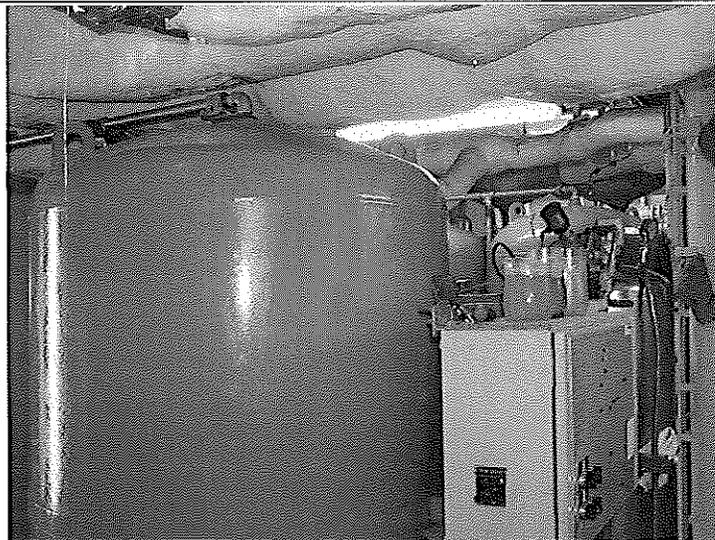
Oily bilge is treated and with a Marin Floc oily water separator system (photos #18 and #19). Discharges (photo #21) occur at less than 15 ppm and outside of MOU waters. A white box (photo #20) is used to prevent discharges of more than 15 ppm. Oily sludge is drummed and offloaded for proper disposal. Oily rags are incinerated.

PHOTO #:18 DATE: SEPTEMBER 3, 2011
TAKEN BY: AMY JANKOWIAK FILE No.:P9030034
DESCRIPTION: MARIN FLOC OILY BILGE OILY WATER SEPARATOR

PHOTO #:19 DATE: SEPTEMBER 3, 2011
TAKEN BY: AMY JANKOWIAK FILE No.:P9030035
DESCRIPTION: MARIN FLOC OILY BILGE OILY WATER SEPARATOR

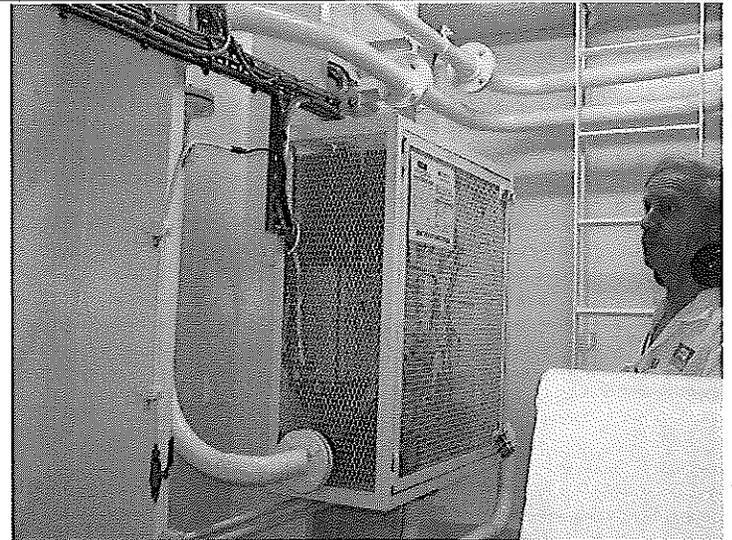
PHOTO #:20 DATE: SEPTEMBER 3, 2011
TAKEN BY: AMY JANKOWIAK FILE No.:P9030036
DESCRIPTION: OILY BILGE WHITE BOX

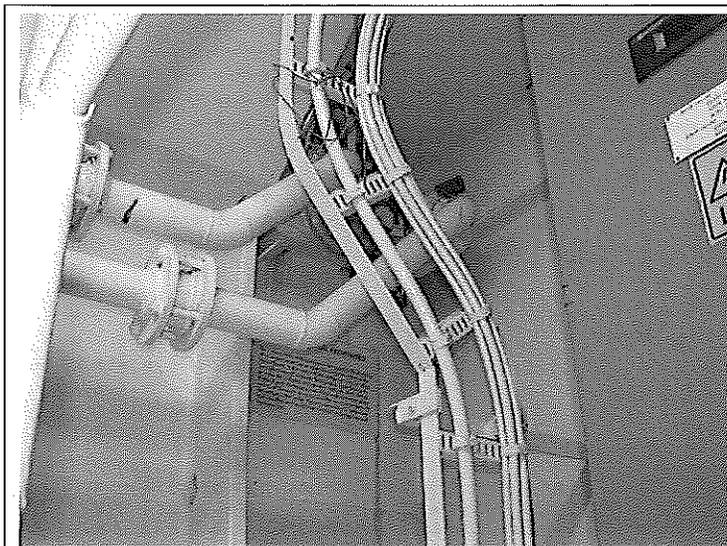
PHOTO #:21 DATE: SEPTEMBER 3, 2011
TAKEN BY: AMY JANKOWIAK FILE No.:P9030037
DESCRIPTION: OILY BILGE DISCHARGE PORT

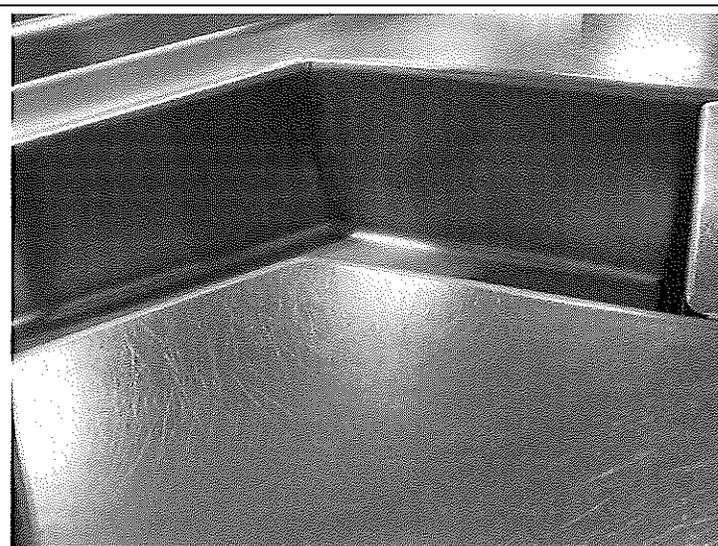
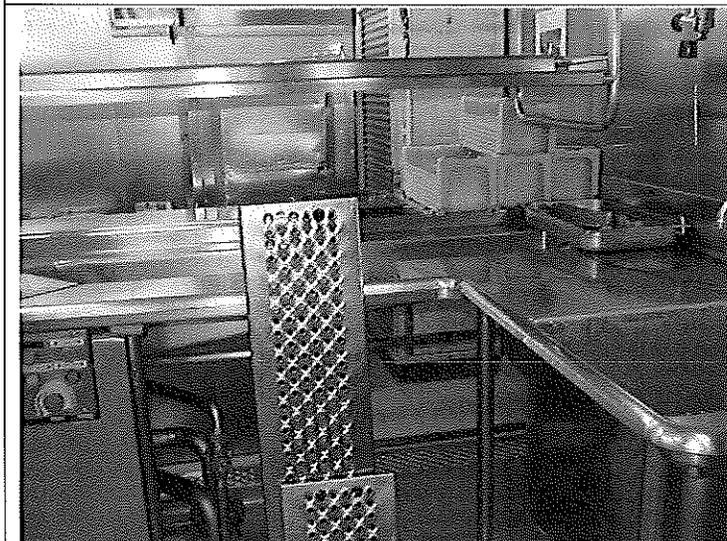
Food waste is sorted (photos #22 and #23) prior to going into the pulpers (photo #25). Solid food waste is discharged outside of MOU waters after pulping (photo #24). Some materials are incinerated. Galley water and pulper water goes to the Scanship system. Used cooking oil goes to the sludge tank.

PHOTO #:22 DATE: SEPTEMBER 3, 2011
TAKEN BY: AMY JANKOWIAK FILE No.:P9030038
DESCRIPTION: GALLEY FOOD TO PULPER

PHOTO #:23 DATE: SEPTEMBER 3, 2011
TAKEN BY: AMY JANKOWIAK FILE No.:P9030039
DESCRIPTION: GALLEY FOOD TO PULPER

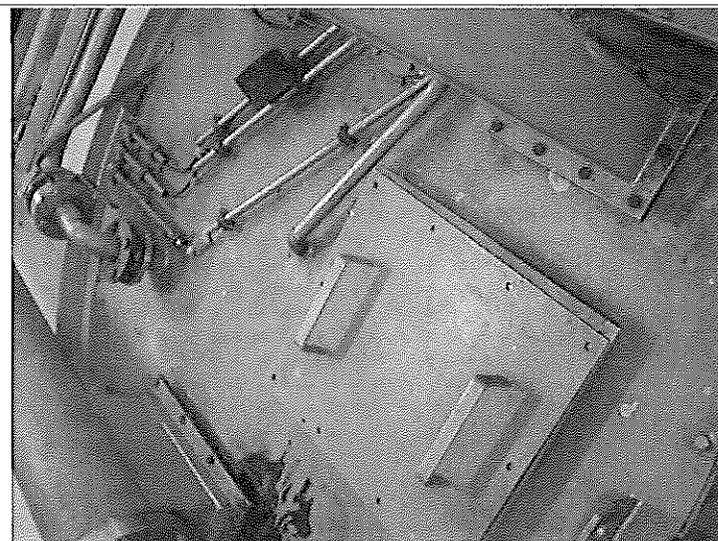
PHOTO #:24 DATE: SEPTEMBER 3, 2011
TAKEN BY: AMY JANKOWIAK FILE No.:P9030040
DESCRIPTION: FOOD WASTE TANK (1 OF 2)

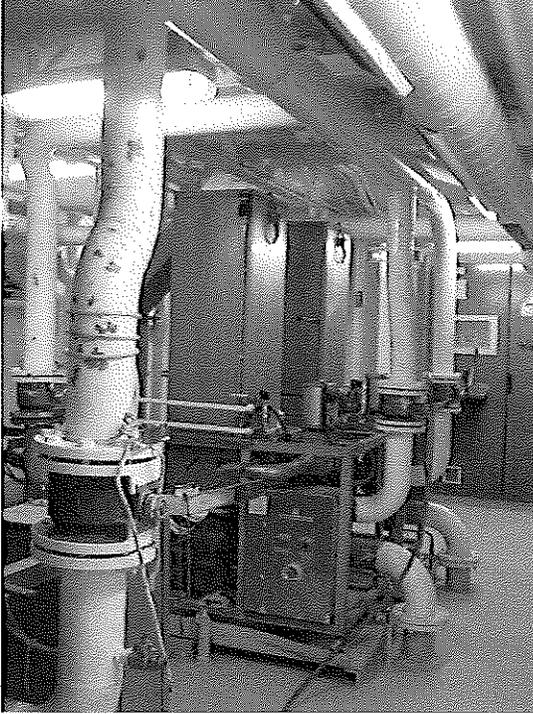
PHOTO #:25 DATE: SEPTEMBER 3, 2011
TAKEN BY: AMY JANKOWIAK FILE NO.:P9030041
DESCRIPTION: FOOD WASTE PULPER
