State of Washington Department of Ecology  
**Cruise Ship Memorandum of Understanding, Cruise Operations in Washington State Inspection Report**

Amy Jankowiak, Washington State Department of Ecology (Ecology) Northwest Regional Office, Water Quality Program (NWRO-WQ), along with Biniam Zelelow, NWRO-WQ conducted the inspection of the Princess Cruises GOLDEN PRINCESS on September 8, 2013. The main contact on board the GOLDEN PRINCESS was Rumen Georgiev, Occupational Safety and Environmental Officer (OSEO) for the GOLDEN PRINCESS. Prior notification of the visit was given on September 4, 2013 for security protocol. The purpose of the inspection was to evaluate compliance with the *Memorandum of Understanding Cruise Operations in Washington State* (MOU), as amended. The GOLDEN PRINCESS is not approved to discharge in MOU waters.

The GOLDEN PRINCESS was placed into service in 2001 and is 951 feet long with a width of 118 feet. The vessel has a approximately 2978 passengers and 1000 crew.

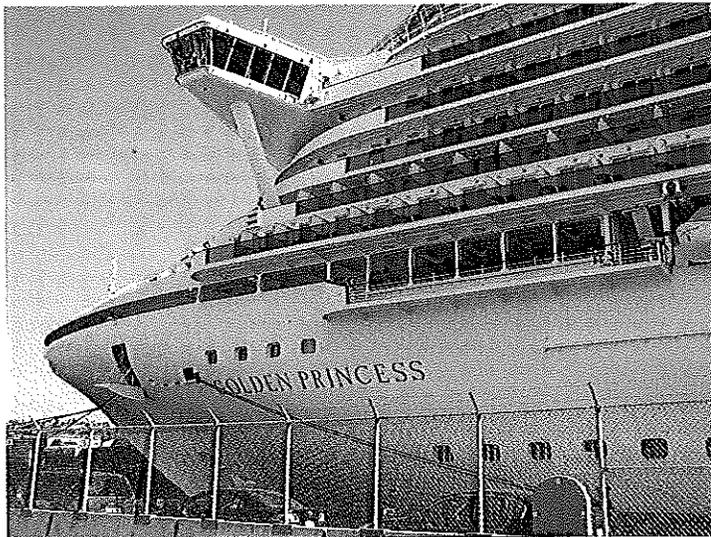
PHOTO #:01 DATE: SEPTEMBER 8, 2013  
TAKEN BY: AMY JANKOWIAK FILE No.: P9080528  
DESCRIPTION: VESSEL

We arrived and boarded the ship (photos #01 and #02) at about 9:20 am and began with introductions and a plan for the day with Rumen Georgiev, OSEO. We discussed various waste streams and discharge protocols. We toured the garbage and recycling areas, hazardous waste storage, and the incinerators. We then reviewed discharge records and protocols in the Engine Control Room (ECR) (photos # 19 and #20) and then viewed the oily water separators, the Hamworthy Membrane Bio-Reactors (MBR) advanced wastewater treatment system (AWTS), the sampling laboratory, the ballast water treatment system and the Sea Chest. We then went over notification and navigation on the Bridge and then finalized with a debriefing and we disembarked the vessel at about 11:54 am.

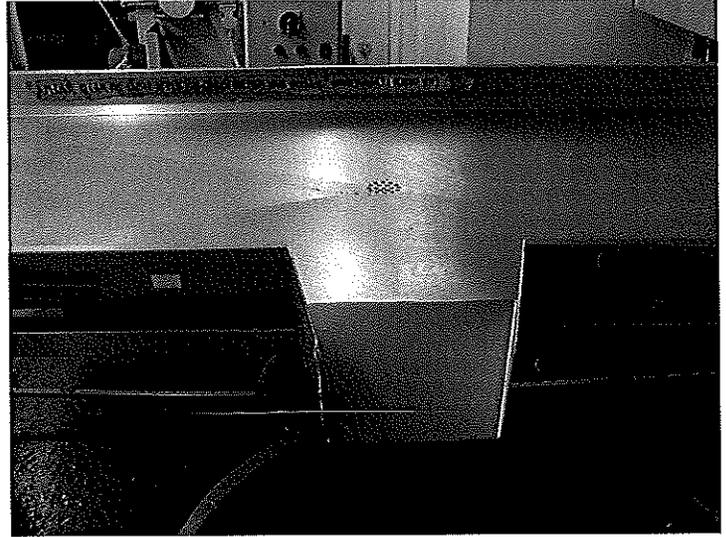
PHOTO #:04 DATE: SEPTEMBER 8, 2013  
TAKEN BY: BINIAM ZELELOW FILE No.: P9080464  
DESCRIPTION: GARBAGE/RECYCLING ROOM - SORTING TABLE

Solid waste (garbage, recyclables, etc) is collected sorted (photos #03, #04, and #14) and either reused, recycled, incinerated (photo #09) or offloaded to shore as appropriate. Materials such as glass (mixed color), metals, plastic (photo #05), aluminum, and some cardboard is recycled. The garbage record book was reviewed and showed consistency with requirements.

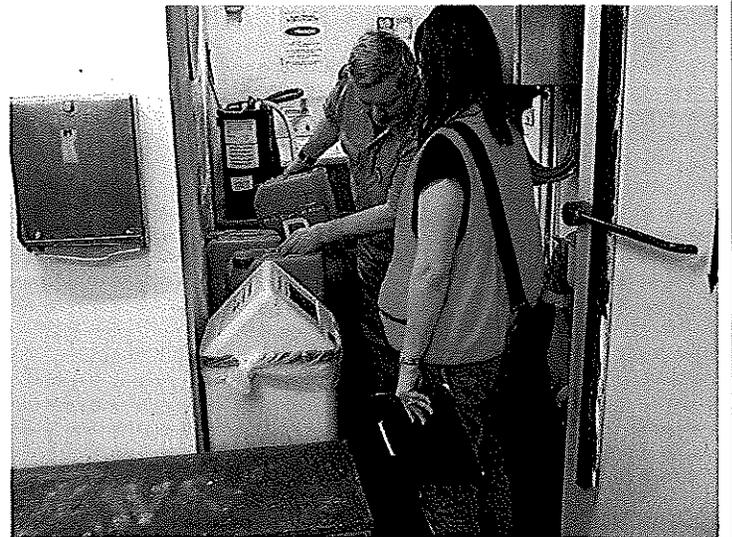
PHOTO #:06 DATE: SEPTEMBER 8, 2013  
TAKEN BY: BINIAM ZELELOW FILE No.: P9080469  
DESCRIPTION: PHOTO WASTE SILVER RECOVERY UNIT (SRU)

PHOTO #:07 DATE: SEPTEMBER 8, 2013  
TAKEN BY: BINIAM ZELELOW FILE No.: P9080470  
DESCRIPTION: PHOTO WASTE SILVER RECOVERY UNIT (SRU)

Any photo waste is collected and sent through a silver recovery system (photos #06 and #07). The treated waste is then incinerated as non-hazardous waste when tests show less than 5 ppm silver. Tests results are logged (photo #08). Used filters (photo #15) go back to the company for recycling. Fluorescent bulbs (photo #13) are offloaded as hazardous waste and not crushed on board. Hazardous waste materials include items such as oily rags, incinerator ash, some aerosols which are punctured with aerosol removal system (photo #12), sharps, used cartridges and filters, and expired chemicals. Hazardous waste is offloaded in Victoria, Canada only on this voyage. Hazardous waste logs were reviewed and appear to be consistent with MOU requirements.

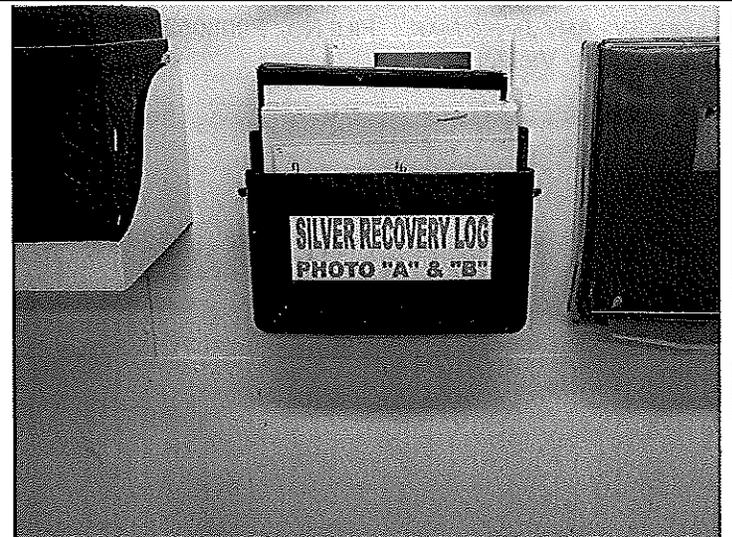
PHOTO #:08 DATE: SEPTEMBER 8, 2013  
TAKEN BY: BINIAM ZELELOW FILE No.: P9080487  
DESCRIPTION: PHOTO WASTE SILVER RECOVERY UNIT (SRU)  
LOG

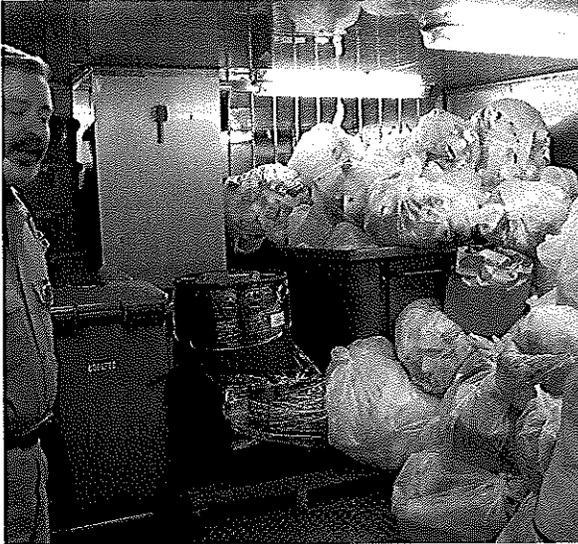
PHOTO #:09 DATE: SEPTEMBER 8, 2013  
TAKEN BY: BINIAM ZELELOW FILE No.: P9080473  
DESCRIPTION: COLD STORAGE – GARBAGE FOR INCINERATION

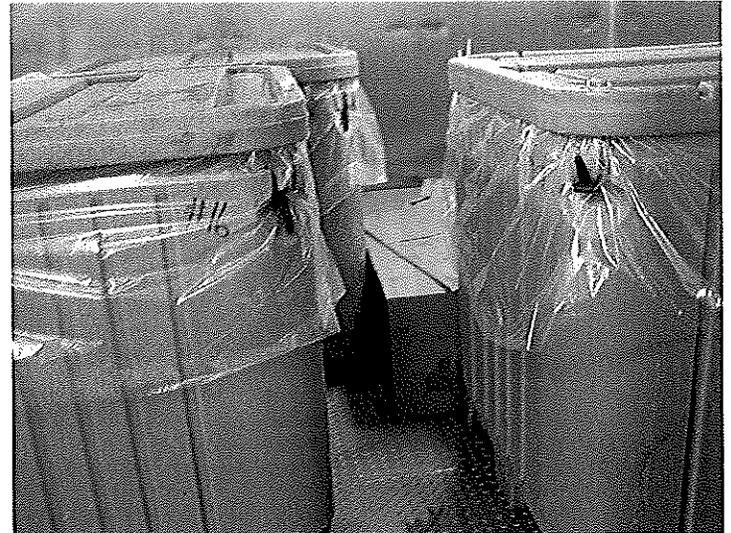
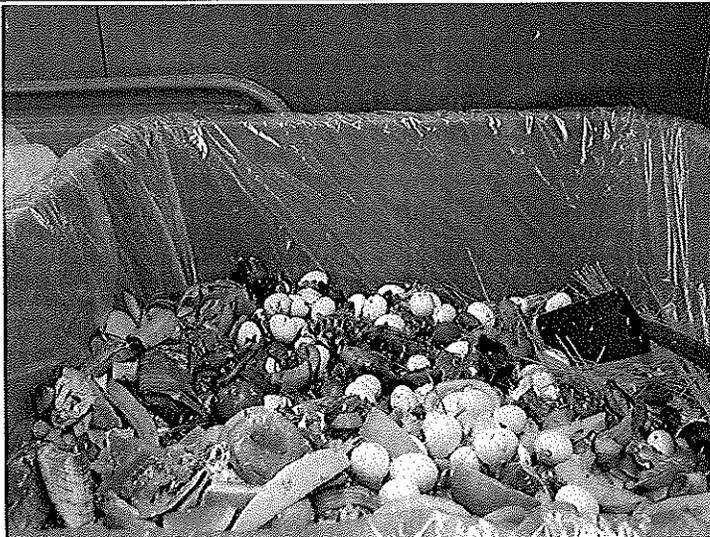
PHOTO #:10 DATE: SEPTEMBER 8, 2013  
TAKEN BY: BINIAM ZELELOW FILE No.: P9080474  
DESCRIPTION: COLD STORAGE – COMPOST BINS

PHOTO #:11 DATE: SEPTEMBER 8, 2013  
TAKEN BY: BINIAM ZELELOW FILE No.: P9080475  
DESCRIPTION: COLD STORAGE – COMPOST BINS

chute is locked and not used. Items such as bones, fish skin and some food items are composted (photos #10 and #11) on board in the cold room. The compost is then sealed and offloaded in Canada for beneficial use. Cooking oil is recycled as biodiesel. Records reviewed were consistent with this protocol. Sorting is periodically checked and monitored to ensure only allowed food waste gets discharged. Galleys use phosphate free and non-toxic detergents and degreasers.

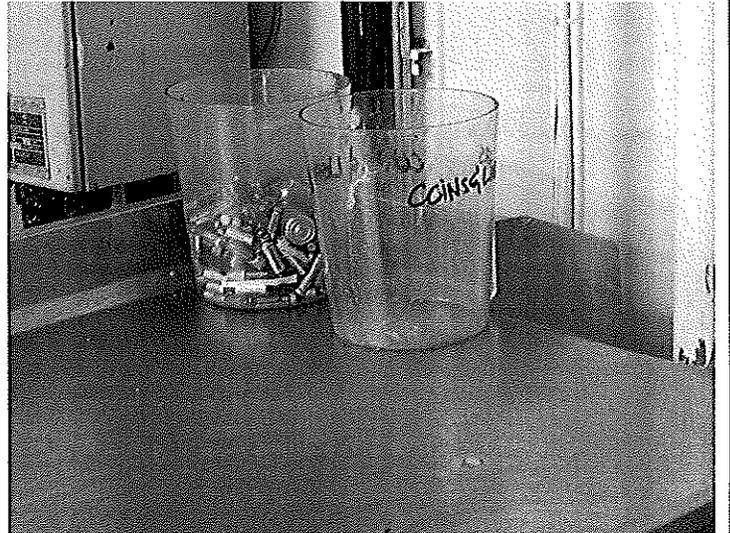
PHOTO #:14 DATE: SEPTEMBER 8, 2013  
TAKEN BY: BINIAM ZELELOW FILE No.: P9080484  
DESCRIPTION: GARBAGE/RECYCLING ROOM – BATTERIES

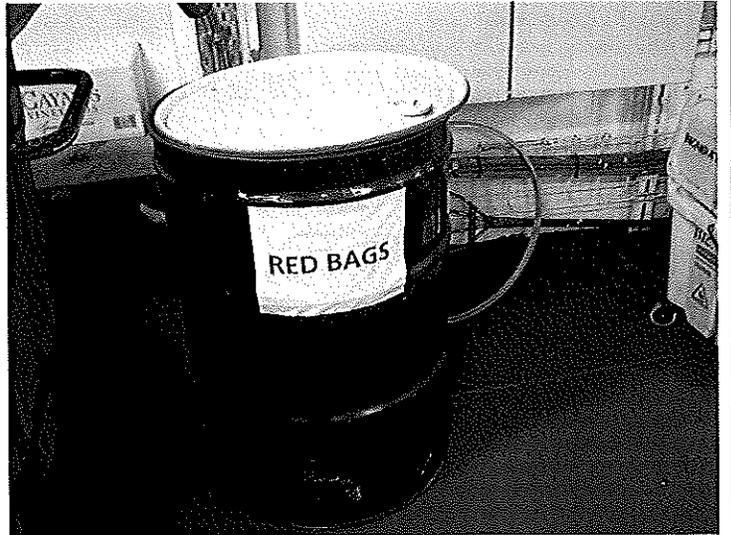
PHOTO #:18 DATE: SEPTEMBER 8, 2013  
TAKEN BY: BINIAM ZELELOW FILE No.: P9080491  
DESCRIPTION: MEDICAL WASTE (RED BAGGED) FOR  
INCINERATION

Unused or outdated pharmaceuticals and narcotics are typically incinerated, although some may be sent back to the manufacturer. There are no drains in the medical facility. Sharps are off-loaded as bio-hazardous waste and red bagged medical waste (photo #18) is incinerated. Oily rags, dry garbage, paper, and some cardboard are incinerated. Some paper, cartons, light plastics and food contaminated materials are incinerated. Incinerators (photos #16 and #17) are only operated once underway and 3-4 miles prior to port they are stopped. No incineration occurs in the OCNMS. Incinerator ash is offloaded as hazardous waste and tested annually to ensure non-metals status. Recent results have passed for non-metals.
