State of Washington Department of Ecology
Cruise Ship Memorandum of Understanding, Cruise Operations in Washington State Inspection Report

Amy Jankowiak, Washington State Department of Ecology (Ecology) Northwest Regional Office, Water Quality Program (NWRO-WQ) conducted the inspection of Holland America Line WESTERDAM on September 15, 2012 along with Jacqui Schultz, NWRO-WQ. The main contact on board the WESTERDAM was David Bass, Safety, Environmental and Health Officer (SEH) for the WESTERDAM. Tina Stotz with the Environmental Management Systems Department of Holland America Line was also there for the inspection. Prior notification of the visit was given on September 12, 2012 for security protocol. The purpose of the inspection was to evaluate compliance with the *Memorandum of Understanding Cruise Operations in Washington State* (MOU), as amended. The WESTERDAM is not approved to discharge wastewater in MOU waters.

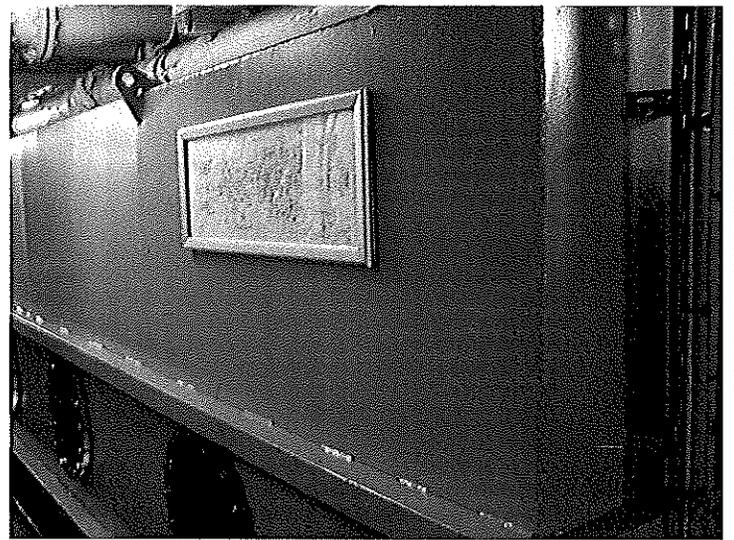
Blackwater and some graywater is collected into tanks (photo #02) and then flow is sent to prefiltration through the SWECO system. Screenings are filtered out and sent to incineration. The SWECO system (photo #03) vibrates out the solids to the solids tank where it combines with solids from the bioreactors and is sent to another tank for holding and discharge outside of MOU related waters. Filtrate from the SWECO is collected to a tank and then sent to the bioreactors.

PHOTO #:02 DATE: SEPTEMBER 15, 2012
TAKEN BY: AMY JANKOWIAK FILE No.: P9150002
DESCRIPTION: AWTS BUFFER TANK

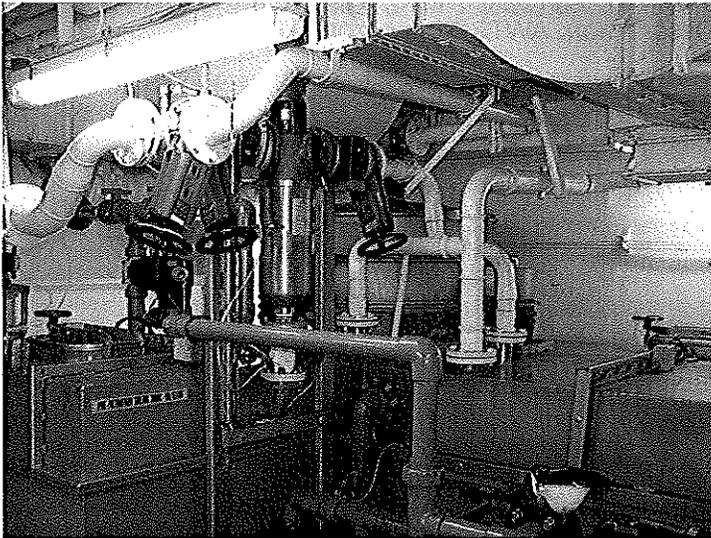
PHOTO #:03 DATE: SEPTEMBER 15, 2012
TAKEN BY: AMY JANKOWIAK FILE No.: P9150003
DESCRIPTION: AWTS SWECO FILTER (BACK CORNER)/SLUDGE
TANK (LEFT)/LIQUID TANK (RIGHT)

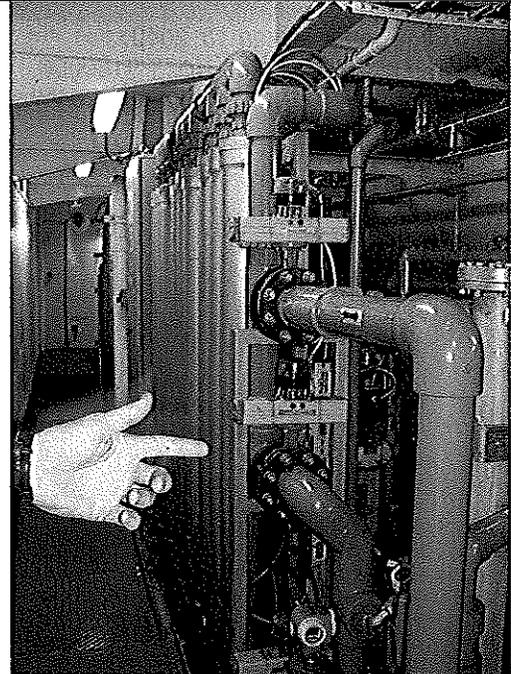
beginning of the bioreactors to enhance activity. A minimal amount of solids are periodically wasted to the solids tanks. Total Suspended Solids (TSS) are monitored continuously at the bioreactors. From the bioreactors, flow goes through the membranes for ultrafiltration (UF) (photo #04). The UF's are cleaned by backwashing with a wash tank (photo #05). Effluent or permeate from the UF's are sent to the permeate tanks (photo #05). Turbidity (photo #07) is also monitored continuously from the permeate tank. All three lines then combine at one ultraviolet light disinfection system (photo #08). The UV system consists of eight lights and a control board (photo #09) has a lighted alarm if any of the bulbs are out. Spare bulbs are available on board. From the UV, the flow can either go straight overboard, or it can go to storage tanks for discharge (photo #11) at an allowed location. A sample point is located at the permeate (photo #10). The Rochem system is currently not discharging in MOU related waters.

PHOTO #:04 SEPTEMBER 15, 2012
TAKEN BY: AMY JANKOWIAK FILE No.: P9150005
DESCRIPTION: AWTS ULTRAFILTERS

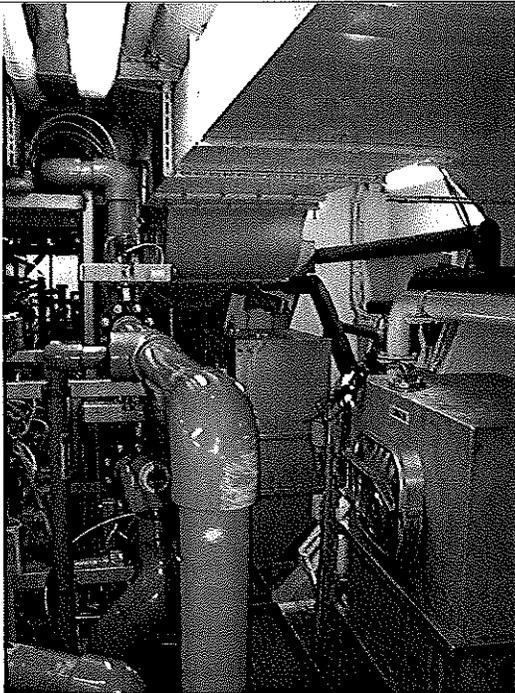
PHOTO #:05 DATE: SEPTEMBER 15, 2012
TAKEN BY: AMY JANKOWIAK FILE No.: P9150006
DESCRIPTION: AWTS PERMEATE TANK (FAR) AND WASH TANK (NEAR)

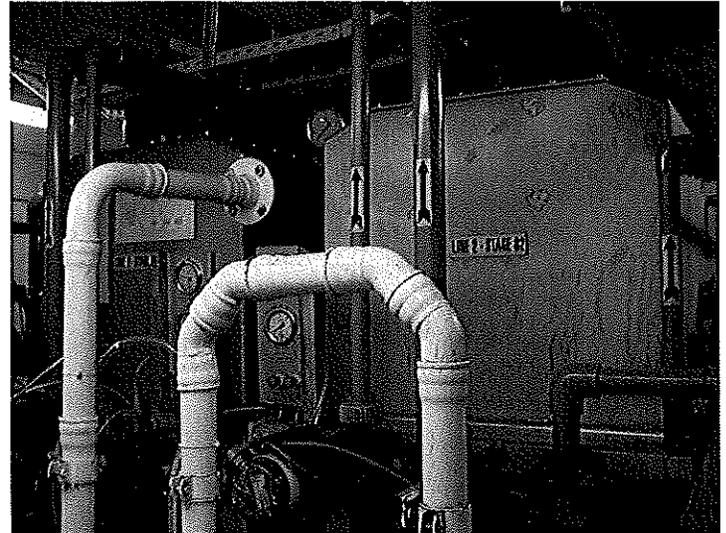
The biological activity takes place in the bioreactors (photo #06). Solids in the bioreactors are returned back to the

PHOTO #:06 DATE: SEPTEMBER 15, 2012
TAKEN BY: AMY JANKOWIAK FILE No.: P9150007
DESCRIPTION: AWTS BIOREACTOR TANKS

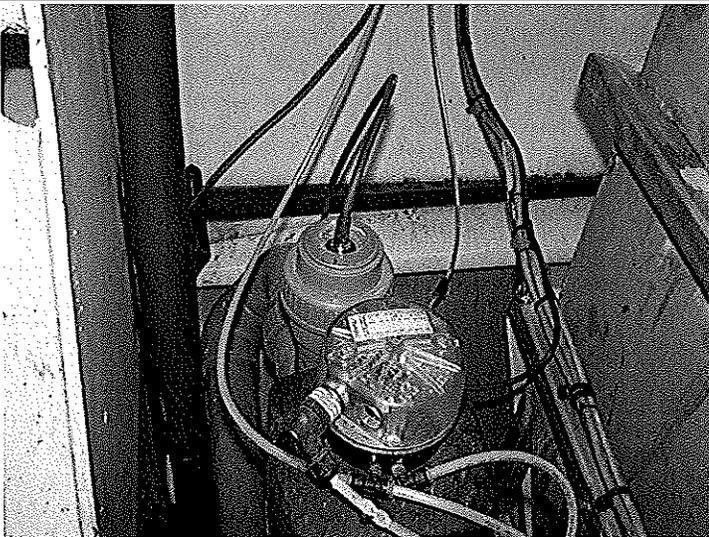
PHOTO #:07 DATE: SEPTEMBER 15, 2012
TAKEN BY: AMY JANKOWIAK FILE No.: P9150008
DESCRIPTION: AWTS TURBIDIMETER FOR PERMEATE TANK

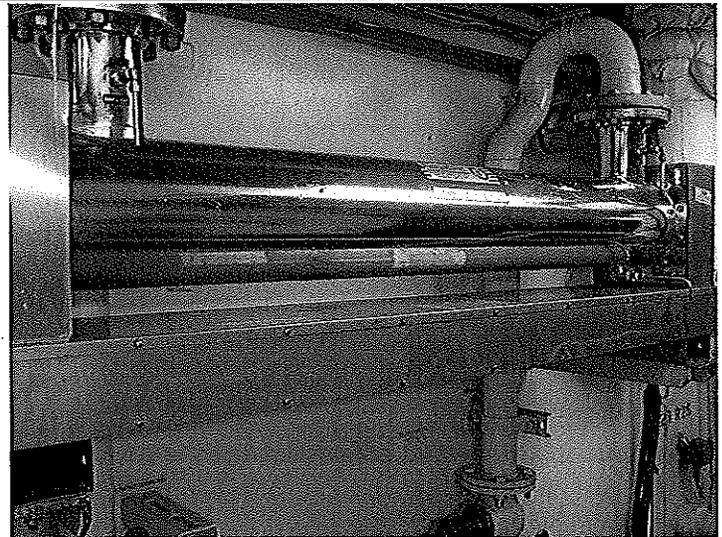
PHOTO #:08 SEPTEMBER 15, 2012
TAKEN BY: AMY JANKOWIAK FILE No.: P9150009
DESCRIPTION: AWTS ULTRAVIOLET DISINFECTION UNIT

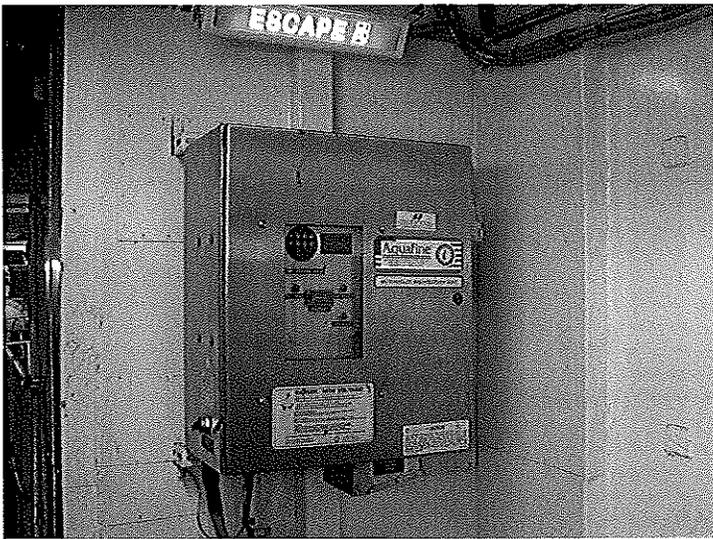
PHOTO #:09 DATE: SEPTEMBER 15, 2012
TAKEN BY: AMY JANKOWIAK FILE No.: P9150010
DESCRIPTION: AWTS UV CONTROL PANEL

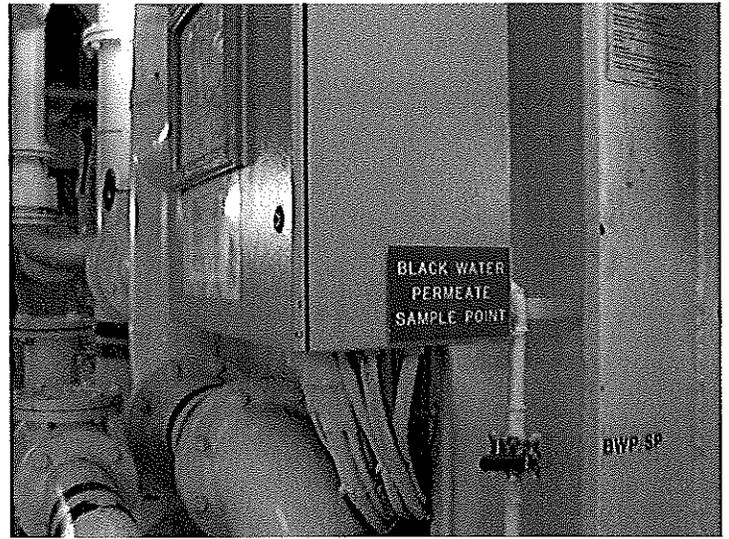
PHOTO #:10 DATE: SEPTEMBER 15, 2012
TAKEN BY: AMY JANKOWIAK FILE No.: P9150012
DESCRIPTION: AWTS BLACKWATER PERMEATE SAMPLE POINT

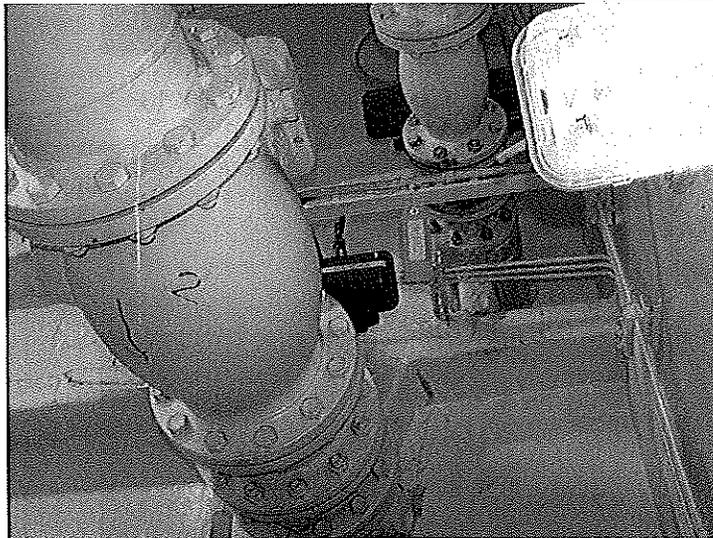
PHOTO #:11 DATE: SEPTEMBER 15, 2012
TAKEN BY: AMY JANKOWIAK FILE No.: P9150013
DESCRIPTION: AWTS DISCHARGE PORT

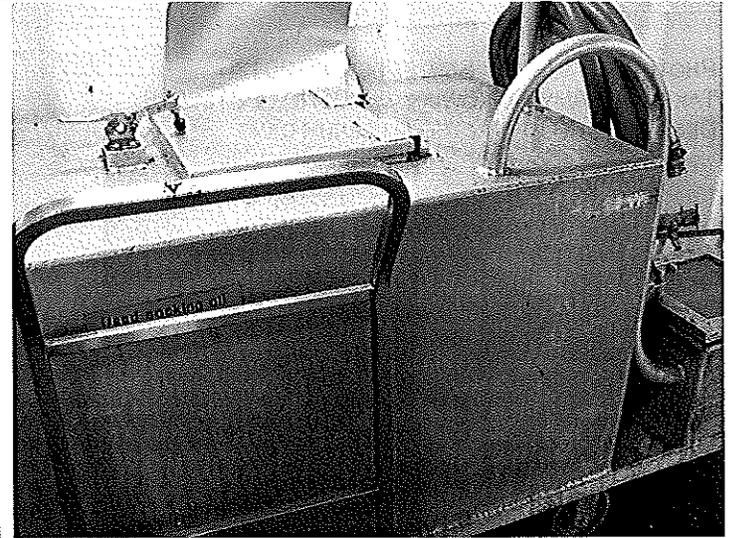
Food waste is collected in various locations, is sorted and then sent through a Somat pulper (photos #19 and #20). Pulped food waste and galley water is discharged outside of MOU related waters. Records reviewed were consistent with this protocol. A food chute (photo #18) is not used anymore. Food waste such as bones, coffee grounds (photo #23) and pineapples which the pulpers can't take are now sent to compost bins (photo #25) which are offloaded in Victoria for composting. Typically three compost bins per week are offloaded. Food waste is sorted in the galley and screened prior to discharge. Galleys use phosphate free and non-toxic detergents and degreasers. Used cooking oil filtered and re-used as fuel (photo #12). Filtered materials go to food waste.

PHOTO #:12 SEPTEMBER 15, 2012
TAKEN BY: AMY JANKOWIAK FILE No.: P9150014
DESCRIPTION: USED COOKING OIL TROLLEY

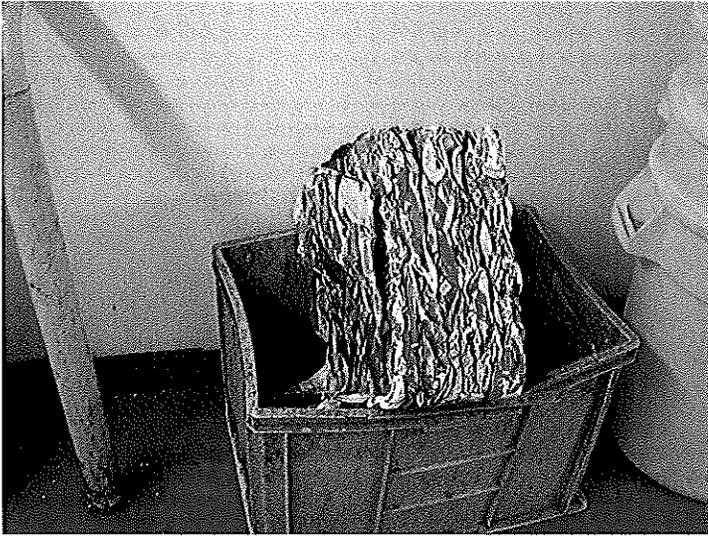
Glass (photo #15), some plastics, scrap metals, aluminum (photo #13), most cardboard (photo #16), batteries, wood pallets, paper and other items are recycled. Staff painted collection bins for batteries for easy identification (photo #26). Many materials are re-used and donated, such as mended books, clothes, and paint. Reduction, reuse and recycling progress is tracked and minimization improvements are constant.

PHOTO #:13 DATE: SEPTEMBER 15, 2012
TAKEN BY: AMY JANKOWIAK FILE No.: P9150015
DESCRIPTION: COMPACTED ALUMINUM CANS

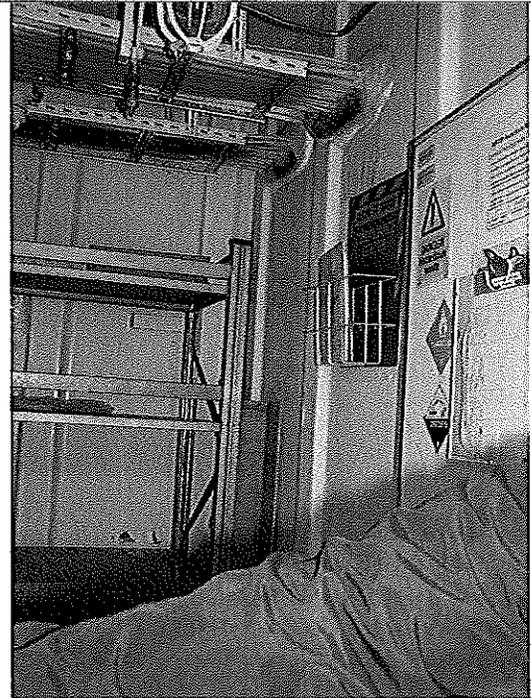
PHOTO #:14 DATE: SEPTEMBER 15, 2012
TAKEN BY: AMY JANKOWIAK FILE No.: P9150018
DESCRIPTION: HAZARDOUS WASTE STORAGE

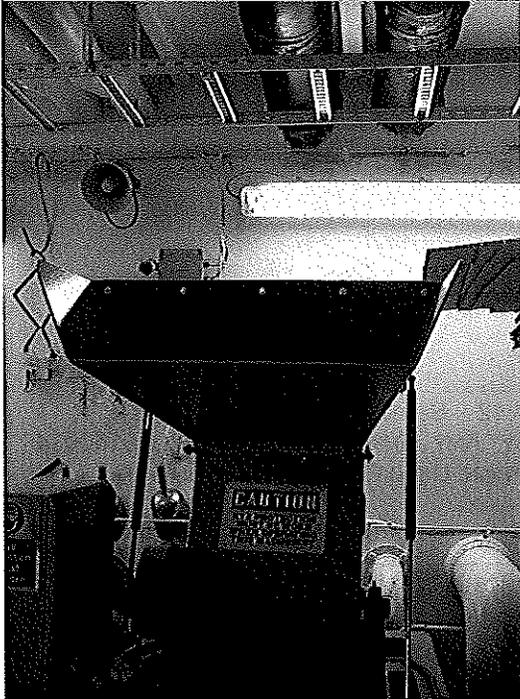
PHOTO #:15 DATE: SEPTEMBER 15, 2012
TAKEN BY: AMY JANKOWIAK FILE No.: P9150020
DESCRIPTION: GLASS CRUSHER

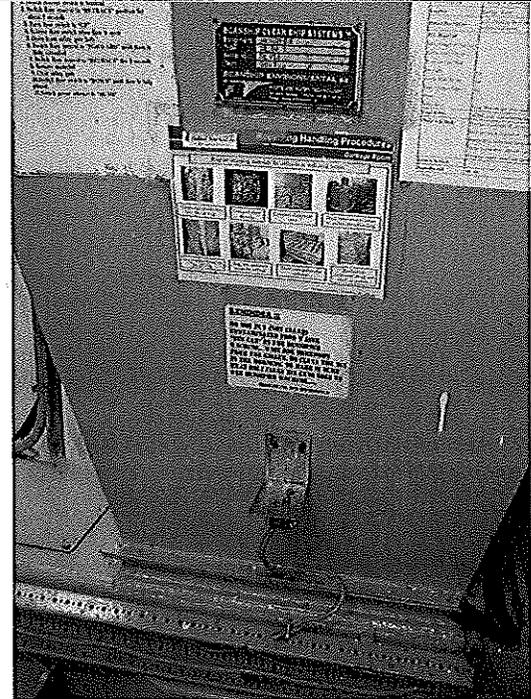
PHOTO #:16 SEPTEMBER 15, 2012
TAKEN BY: AMY JANKOWIAK FILE No.: P9150021
DESCRIPTION: CARDBOARD DENSIFIER

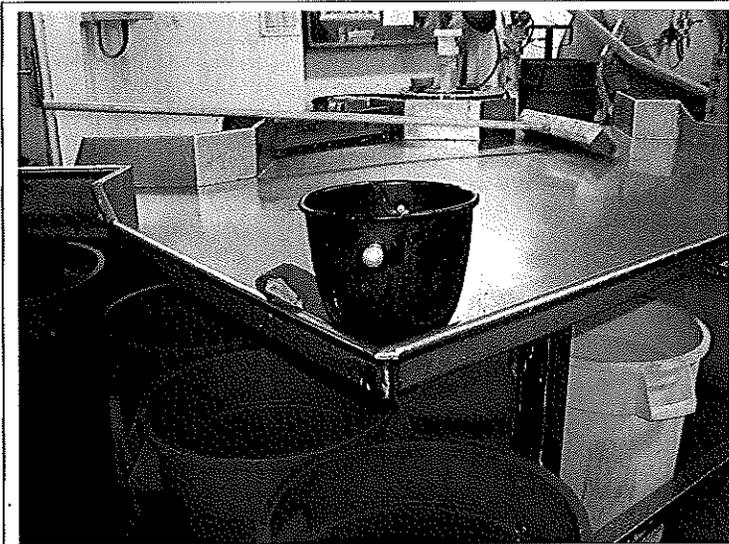
Solid waste (garbage, recyclables, etc) is collected sorted (photo #17) and either reused, recycled, incinerated or offloaded to shore as appropriate. Sorting bins are cleaned out and water is sent to the graywater tanks (photo #22). Staff are trained on sorting and waste material handling (photo #24). The garbage record book was reviewed and showed consistency with requirements.

PHOTO #:17 DATE: SEPTEMBER 15, 2012
TAKEN BY: AMY JANKOWIAK FILE No.: P9150022
DESCRIPTION: GARBAGE/RECYCLING SORTING TABLE

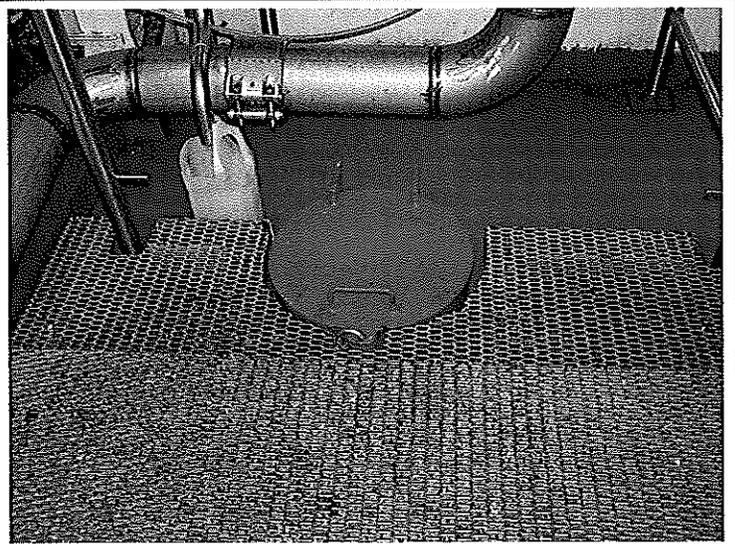
PHOTO #:18 DATE: SEPTEMBER 15, 2012
TAKEN BY: AMY JANKOWIAK FILE No.: P9150023
DESCRIPTION: FOOD WASTE CHUTE

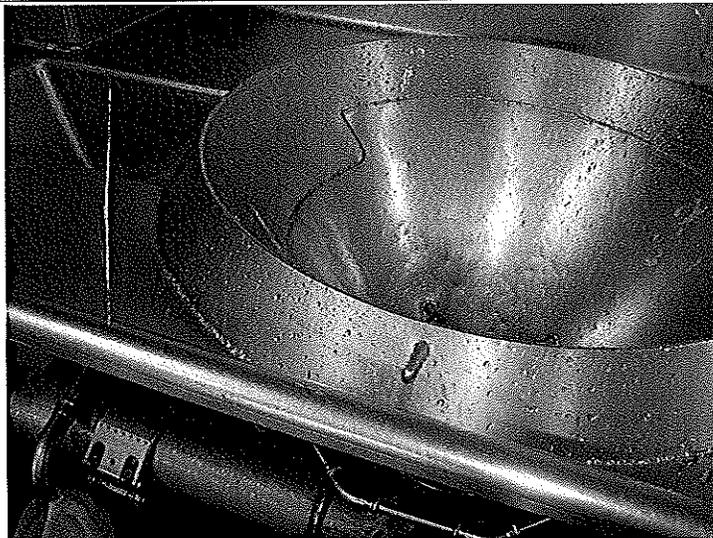
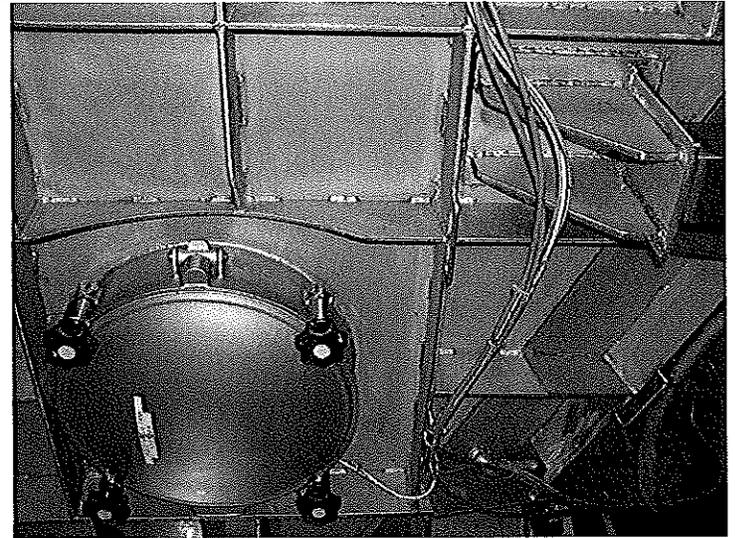
PHOTO #:19 DATE: SEPTEMBER 15, 2012
TAKEN BY: AMY JANKOWIAK FILE No.: P9150024
DESCRIPTION: FOOD WASTE PULPER

PHOTO #:20 SEPTEMBER 15, 2012
TAKEN BY: AMY JANKOWIAK FILE No.: P9150025
DESCRIPTION: FOOD WASTE TANK

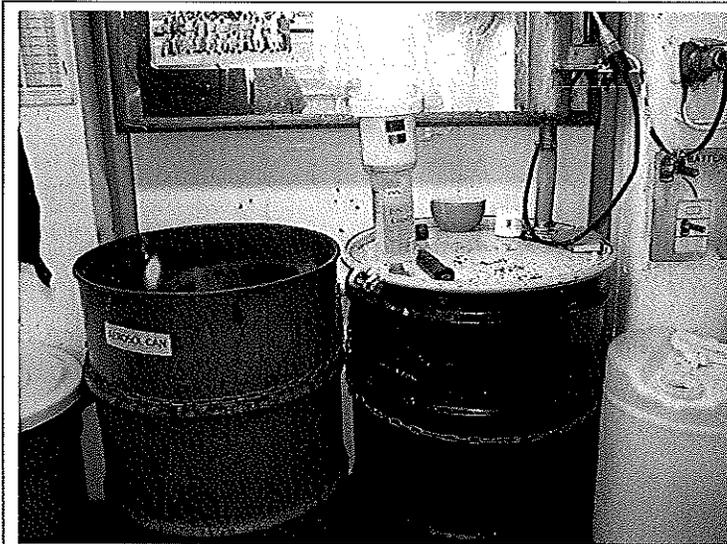
PHOTO #:21 DATE: SEPTEMBER 15, 2012
TAKEN BY: AMY JANKOWIAK FILE No.: P9150026
DESCRIPTION: AEROSOL PUNCTURE SYSTEM

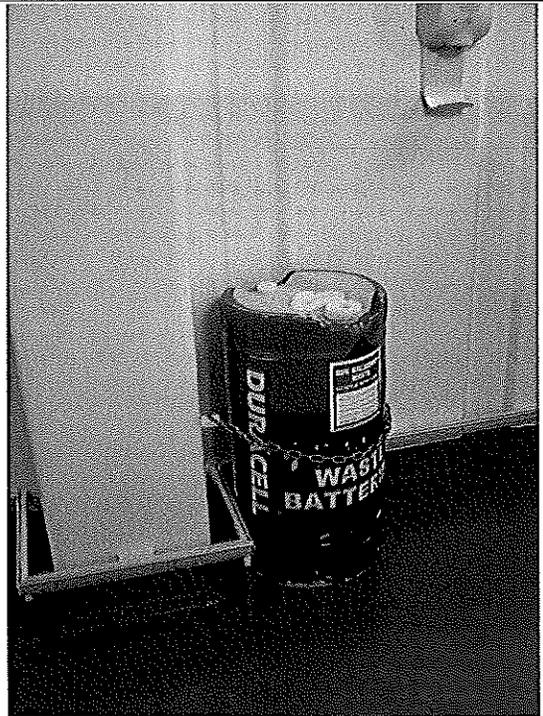
PHOTO #:26 DATE: SEPTEMBER 15, 2012
TAKEN BY: AMY JANKOWIAK FILE No.: P9150032
DESCRIPTION: BATTERY COLLECTION BIN – PAINTED BY STAFF

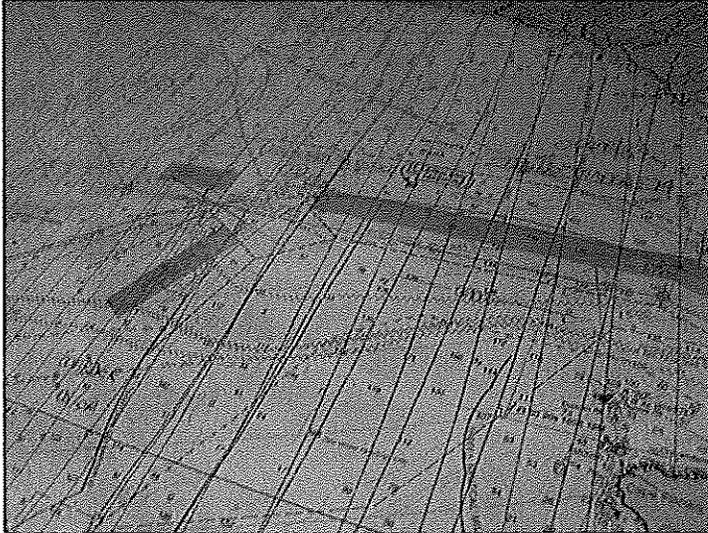
PHOTO #:28 SEPTEMBER 15, 2012
TAKEN BY: AMY JANKOWIAK FILE No.: P9150034
DESCRIPTION: NAVIGATIONAL CHARTS ON BRIDGE

PHOTO #:29 DATE: SEPTEMBER 15, 2012
TAKEN BY: AMY JANKOWIAK FILE No.: P9150035
DESCRIPTION: NAVIGATIONAL CHARTS ON BRIDGE – PORTS
CLOSED LOCATION

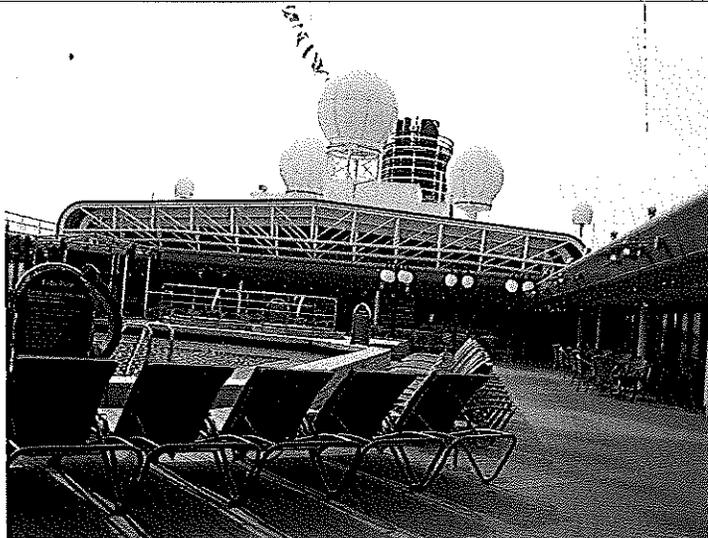
One pool uses salt water and the rest use fresh water and are disinfected with bromine. Pool water (photo #31) is discharged overboard outside of MOU related waters. Spa water is emptied daily to the graywater tanks and are then discharged outside of MOU related waters.

PHOTO #:31 DATE: SEPTEMBER 15, 2012
TAKEN BY: AMY JANKOWIAK FILE No.: P9150040
DESCRIPTION: POOL DECK
