## Whatcom Clean Water Program Quarterly Progress Report January - March 2014

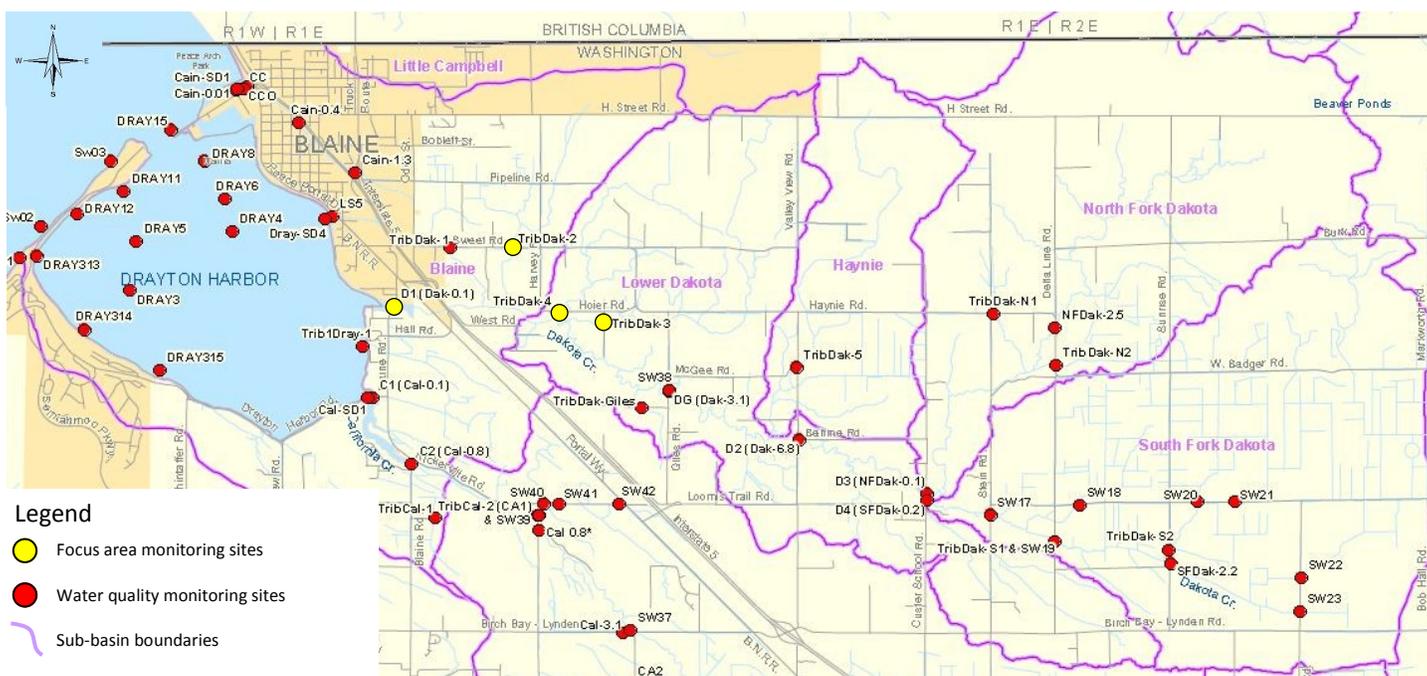
**Figure 7. Water quality monitoring stations - Dakota Creek sub-basin (part of Drayton Harbor watershed)**

In the Drayton Harbor watershed as a whole, Whatcom County Public Works staff collects routine water quality samples on a monthly basis at approximately 30 stations. At eight of those stations, Northwest Indian College (NWIC) staff collects samples a second time each month. Nooksack Indian Tribe Natural Resources staff collects samples twice per month from an additional 26 short-term monitoring sites in the Drayton Harbor watershed. Figure 7 shows water sampling locations.

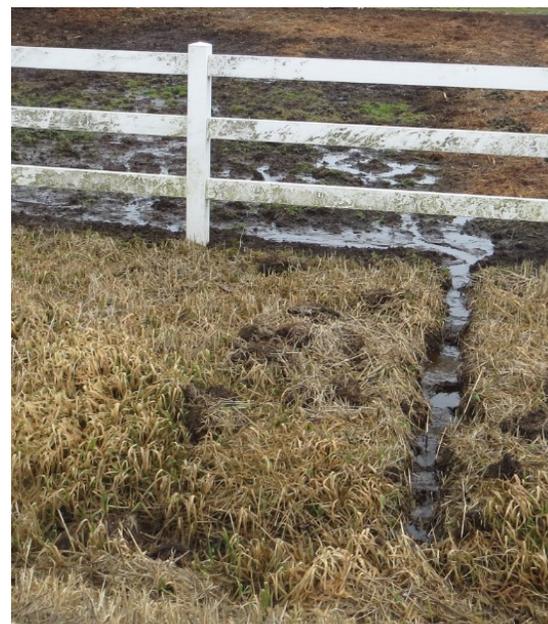
Muddy, manure-contaminated runoff (1) is allowed to flow into a ditch (red arrow) within a livestock confinement area. The confinement area ditch flows to a roadside ditch (2). The fecal coliform density result of a sample taken from the runoff to the roadside ditch at (2) was 78,000 FCU/100mL. The roadside ditch flows to a local Whatcom County creek which flows to a recreational beach and shellfish area.

Example of manure-contaminated runoff from a horse confinement area allowed to flow into a roadside ditch that flows to a local Whatcom County creek.

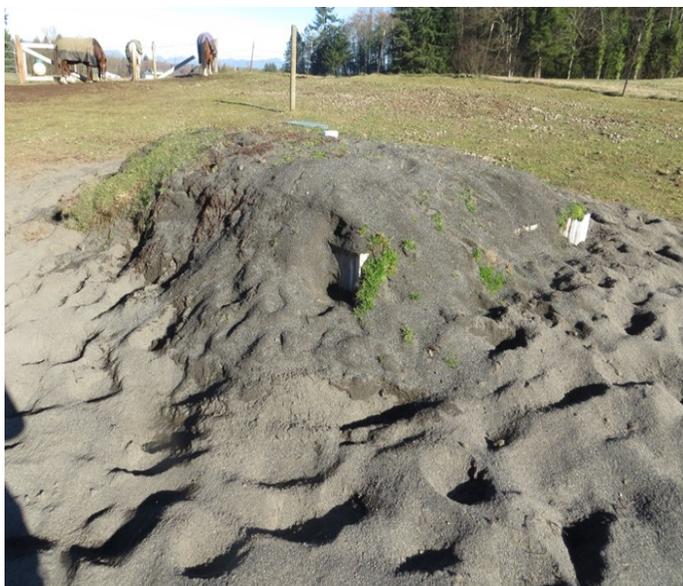
WCHD staff confirmed horses had trampled the drainfield, severely eroding the cover material and exposing the basin where the system discharges sewage effluent. WCHD required that the property owner hire a Glendon Biofilter installer to reconstruct the Glendon pods and that the installer evaluate the OSS and

*Before: A Glendon Biofilter septic system pod trampled by horses. Trampling caused cover material to slough away and expose parts of the basin. Sand wetted with sewage effluent is visible.*

submit a Report of System Status (ROSS) upon completion of the repair. Additionally, WCHD requested that the landowner install livestock exclusion fencing around the Glendon pods and drainfield to prevent future damage.

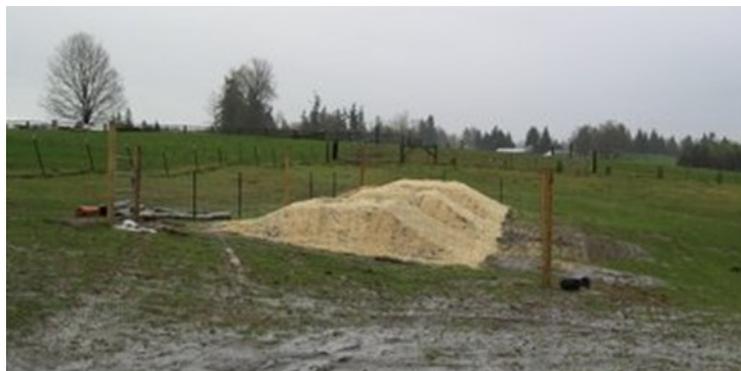
*After: A certified Glendon Biofilter installer reconstructed the pods and conducted a flow test to confirm proper system function. The landowner installed exclusion fencing to prevent future damage to the system from livestock access.*

WCHD staff confirmed completion of repair work to the mounded system in late March, including installation of livestock exclusion fencing.
