PHASE 1 REPORT: HORSE HEAVEN WATER STORAGE APPRAISAL ASSESSMENT

WRIA 31

Prepared for: WRIA 31 Planning and Advisory Committee

Project No. 090045-009-01 • August 15, 2012 Final

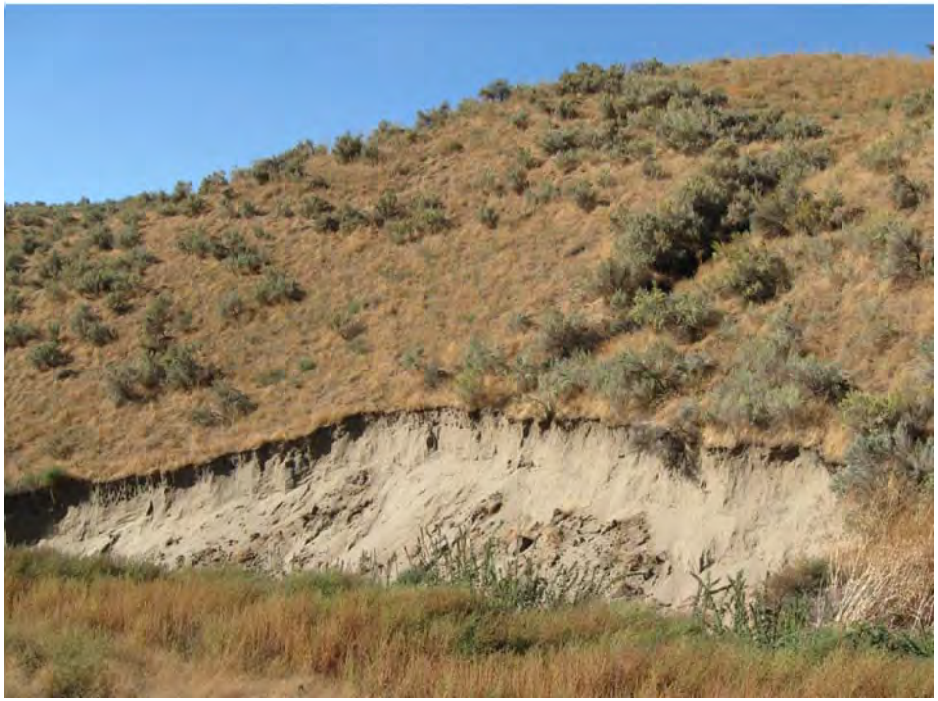
Slope failure caused by erosion along meandering creek.
Similar conditions can occur along reservoir shorelines.

Shallow slope failure triggered by erosion at toe of slope.
Similar failures may occur during reservoir filling and operation.
