Publication No. 76-e31

MEMORANDUM

Subject: East Point Seafoods Effluent and Receiving Water Study

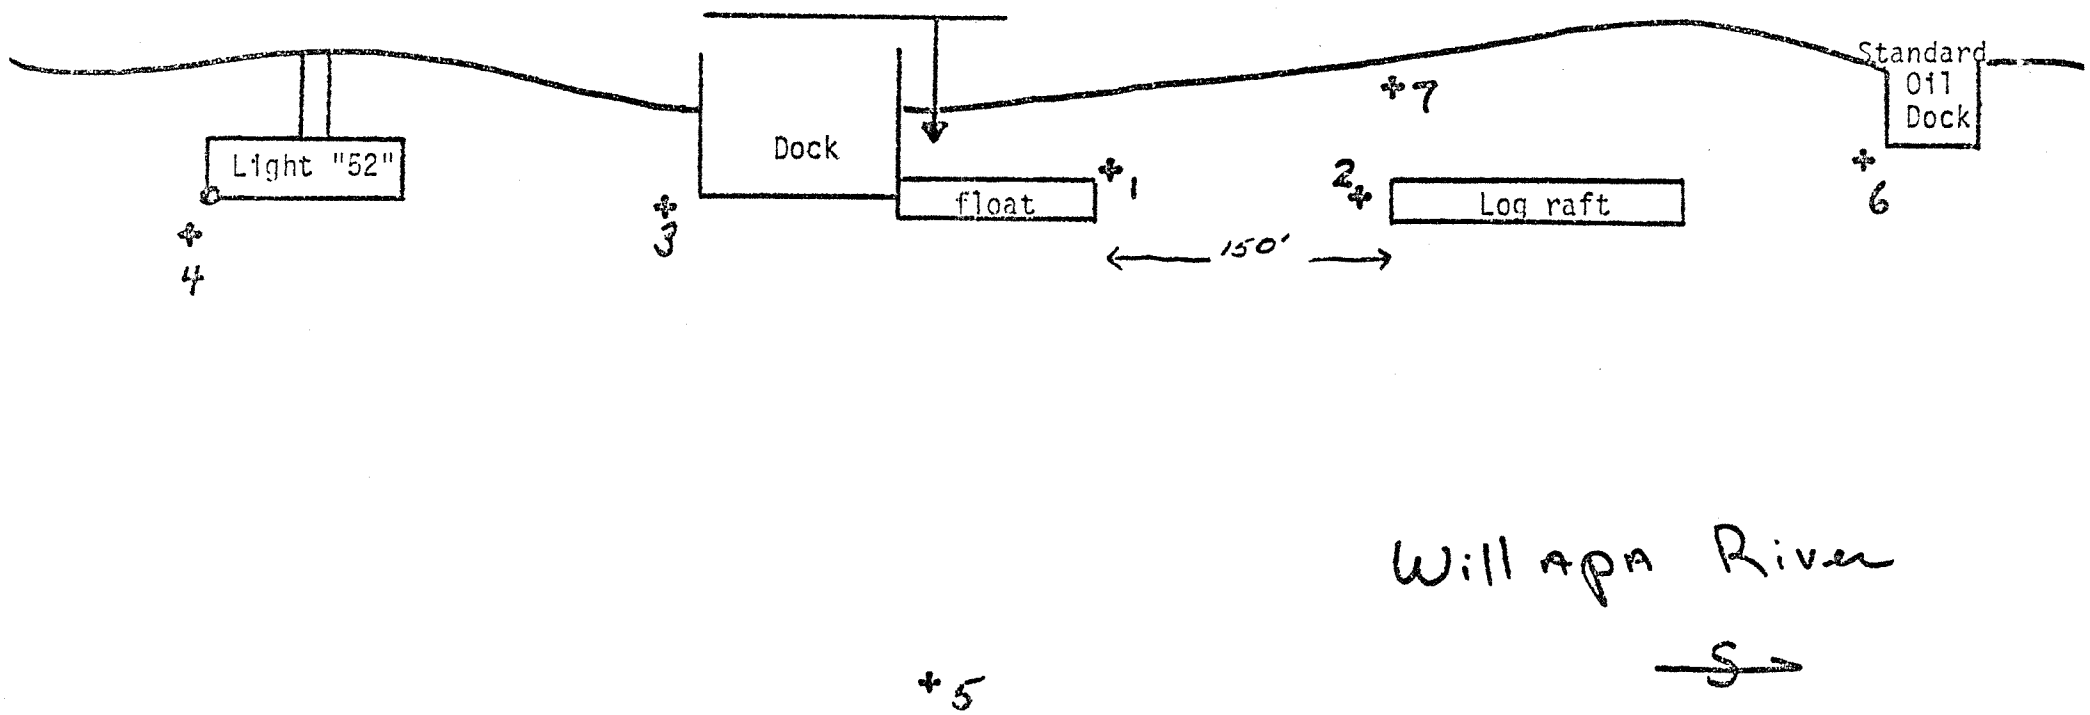
Figure 1

The tidal current during the survey was from Station 4 toward Station 6 (See Figure 1). Stations 4 and 5 can be considered as background control stations. Station 1 was within 50 feet of the effluent discharged onto the beach. Stations 2 and 7 were within the waste plume as the waste plume didn't rapidly dilute and continued directly down current; Station 7 was degraded more than Station 2. Station 6 was the downstream most station.

Background DO levels at Stations 4, 5 and 6 were only slightly below water quality standards. Stations 3, 2, 1 and 7 demonstrated very depressed DO levels ranging from 5.0 to 3.3 mg/l.

Water quality would be improved with repair of the broken waste discharge line and installation of a well designed diffuser.
