Publication No. 79-e11

DEPARTMENT OF ECOLOGY

MEMORANDUM
January 19, 1979
seg 11-2402

Subject: South Bend STP Class II Survey

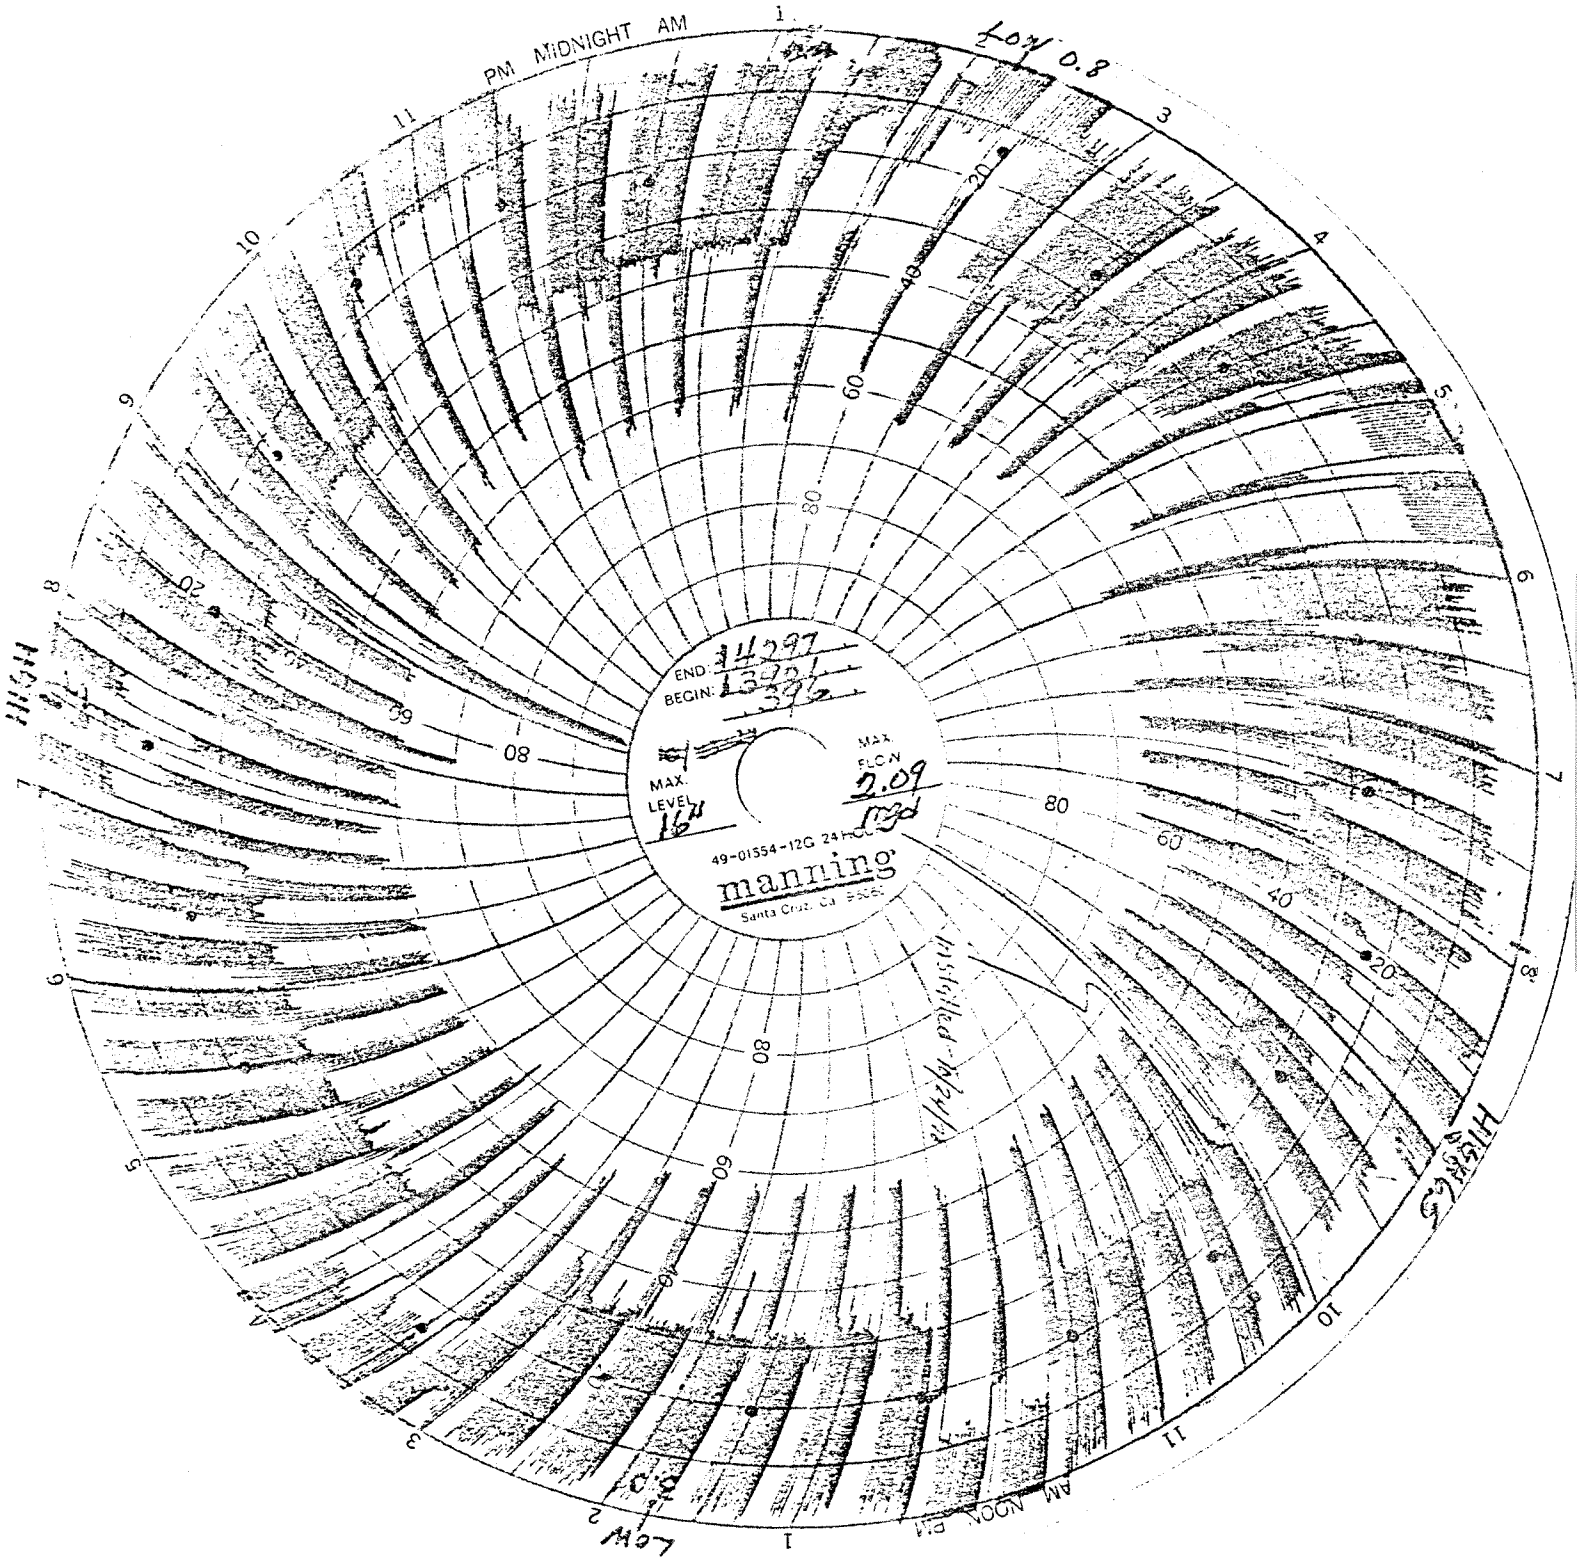
Figure 2

PM MIDNIGHT AM
AM NOON PM
LOW 0.8
HIGH
LOW
END: 14297
BEGIN: 13921
396
MAX. LEVEL 16"
MAX. FLOW 2.09 mgd
49-01554-12G 24 HOUR
manning
Santa Cruz, Ca

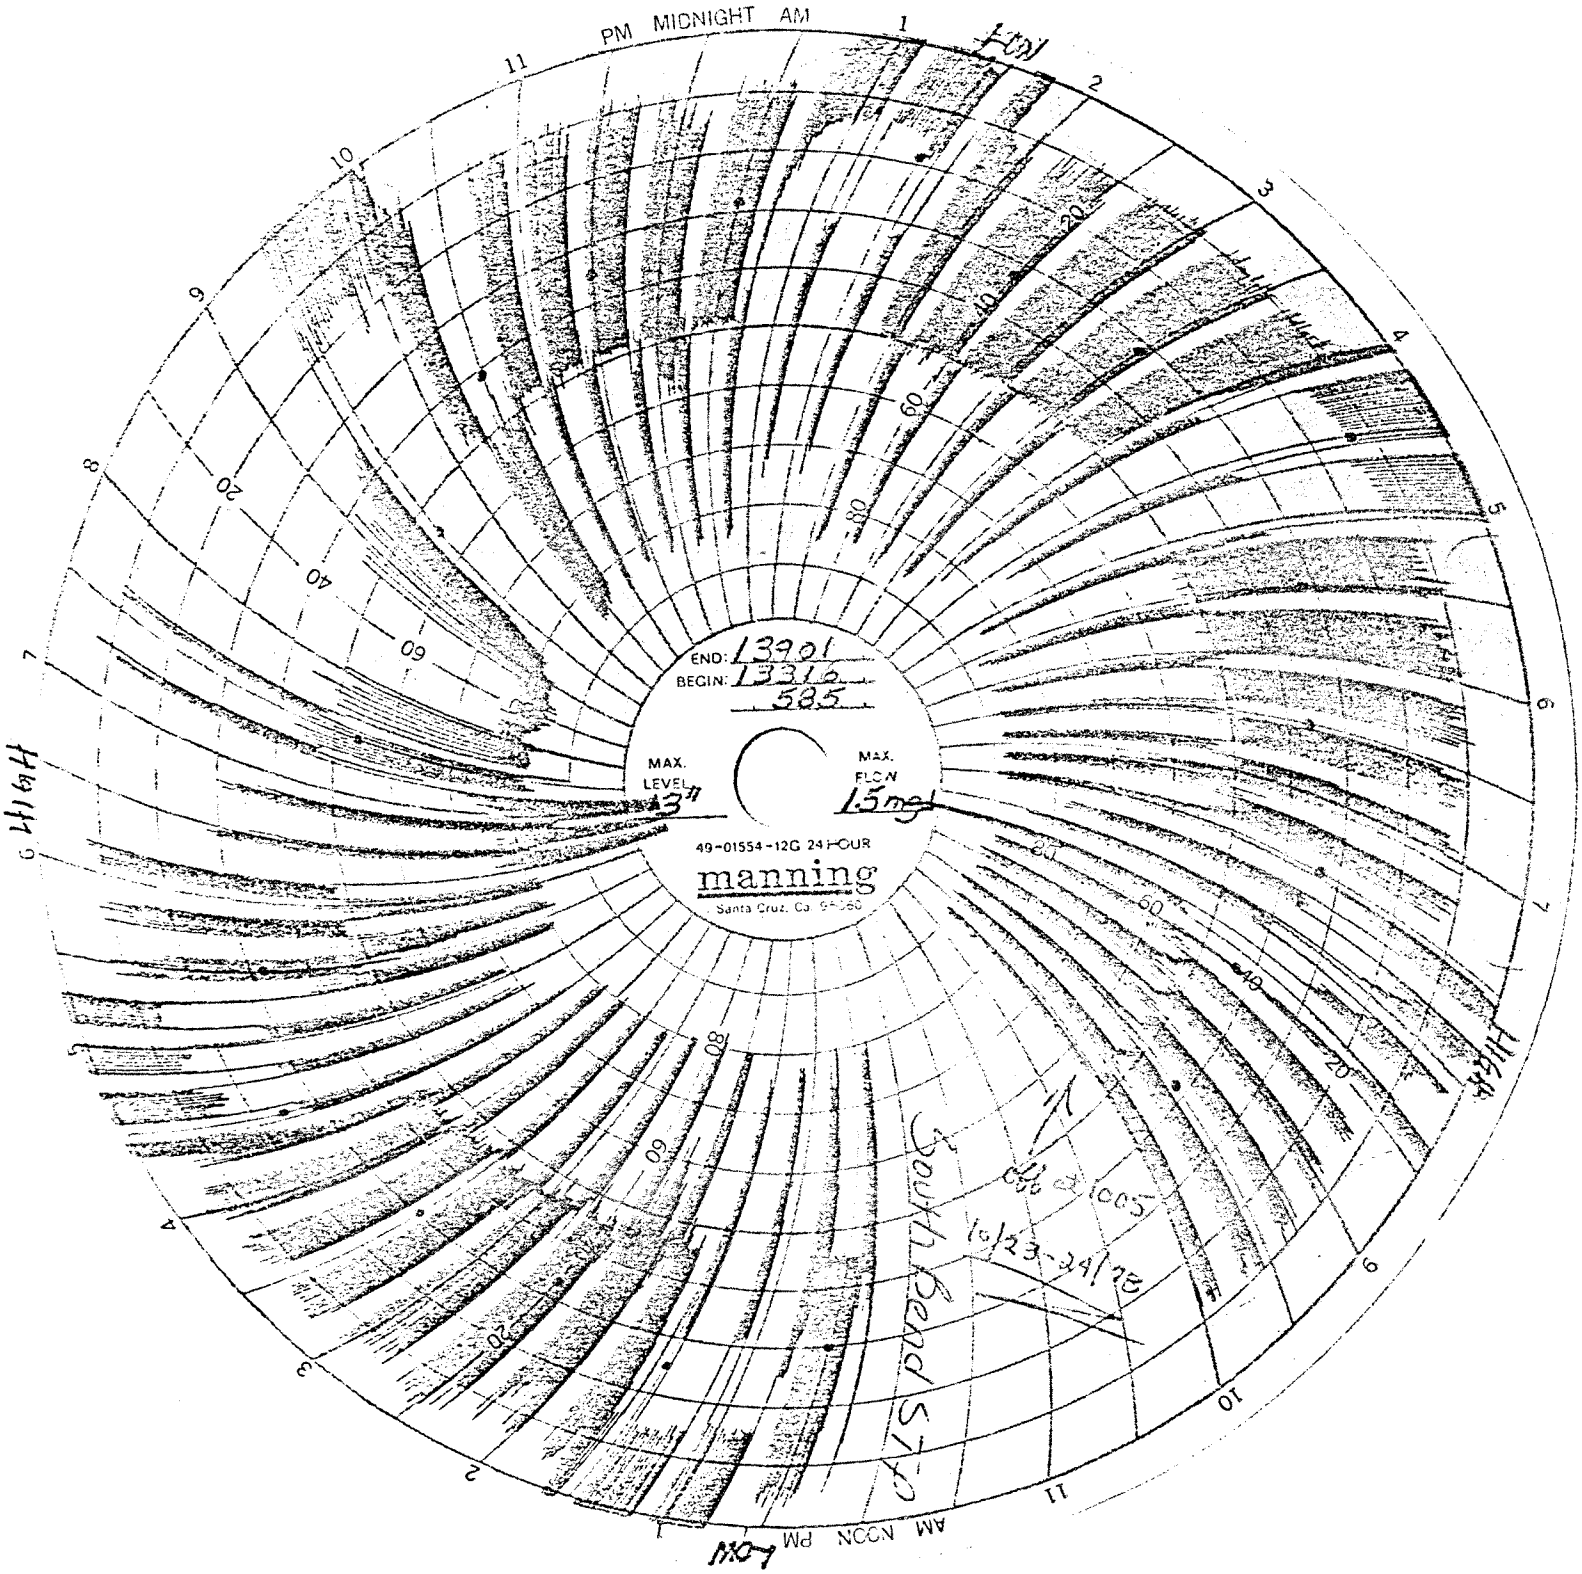
Figure 3

PM MIDNIGHT AM
AM NOON PM
END: 13901
BEGIN: 13316
585
MAX. LEVEL 13"
MAX. FLOW 1.5 mgd
49-01554-12G 24 HOUR
manning
Santa Cruz, Ca.
South Bend STP
10/23-24/78
