Publication No. 83-e12

STATE OF WASHINGTON

MEMORANDUM
August 17, 1983

Subject: Blaine STP Class II Inspection - February 15-16, 1983

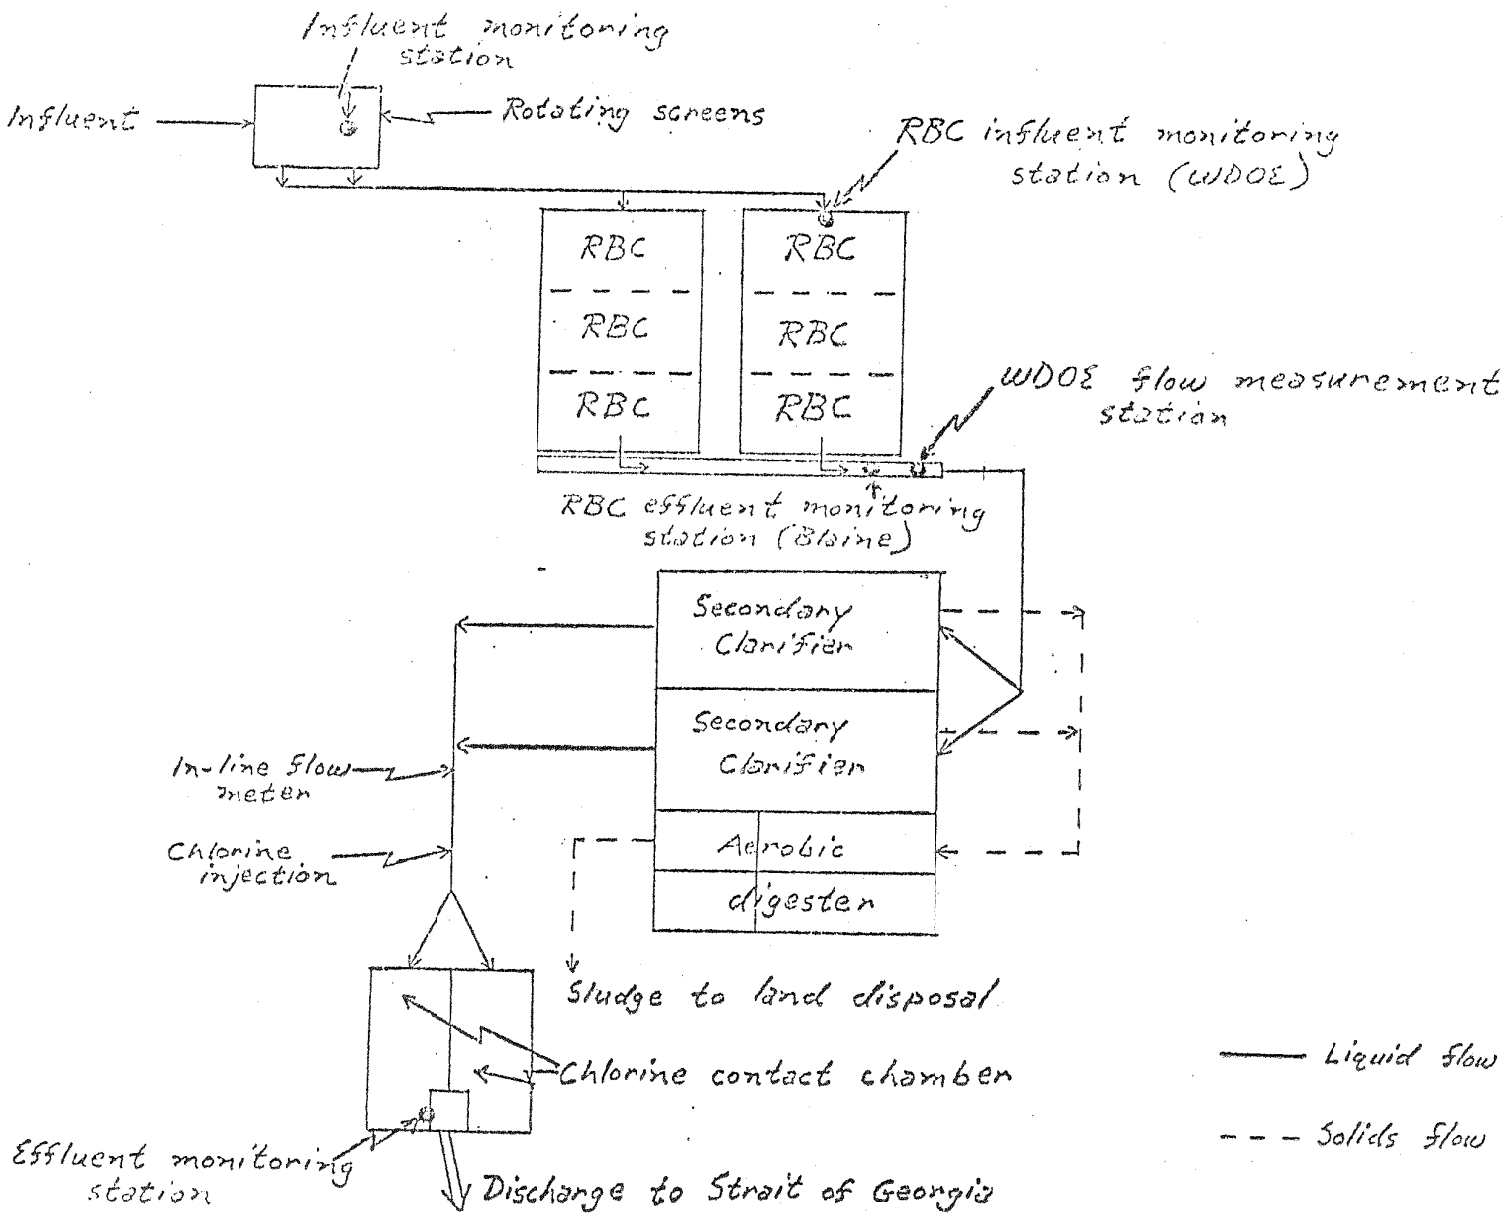
Figure 2. Flow scheme at Blaine STP - Blaine STP Class II Inspection, February 1983.

The Blaine STP is a rotating biological contactor (RBC) type secondary plant (Figures 1 and 2). Plant treatment facilities include rotating screens, air-driven RBC units, secondary clarifiers, and chlorine injection and contact units. Sludge is aerobically digested, then applied to land. Discharge via an outfall to the Strait of Georgia is regulated by National Pollution Discharge Elimination System (NPDES) Permit No. WA-002264-1.

WDOE composite samplers were set up to collect plant influent, RBC basin at the basin inlet, and plant effluent samples (Figure 2). The samplers collected approximately 250 mls of sample every 30 minutes for 24 hours. Blaine STP composite samplers were set to collect plant influent, RBC

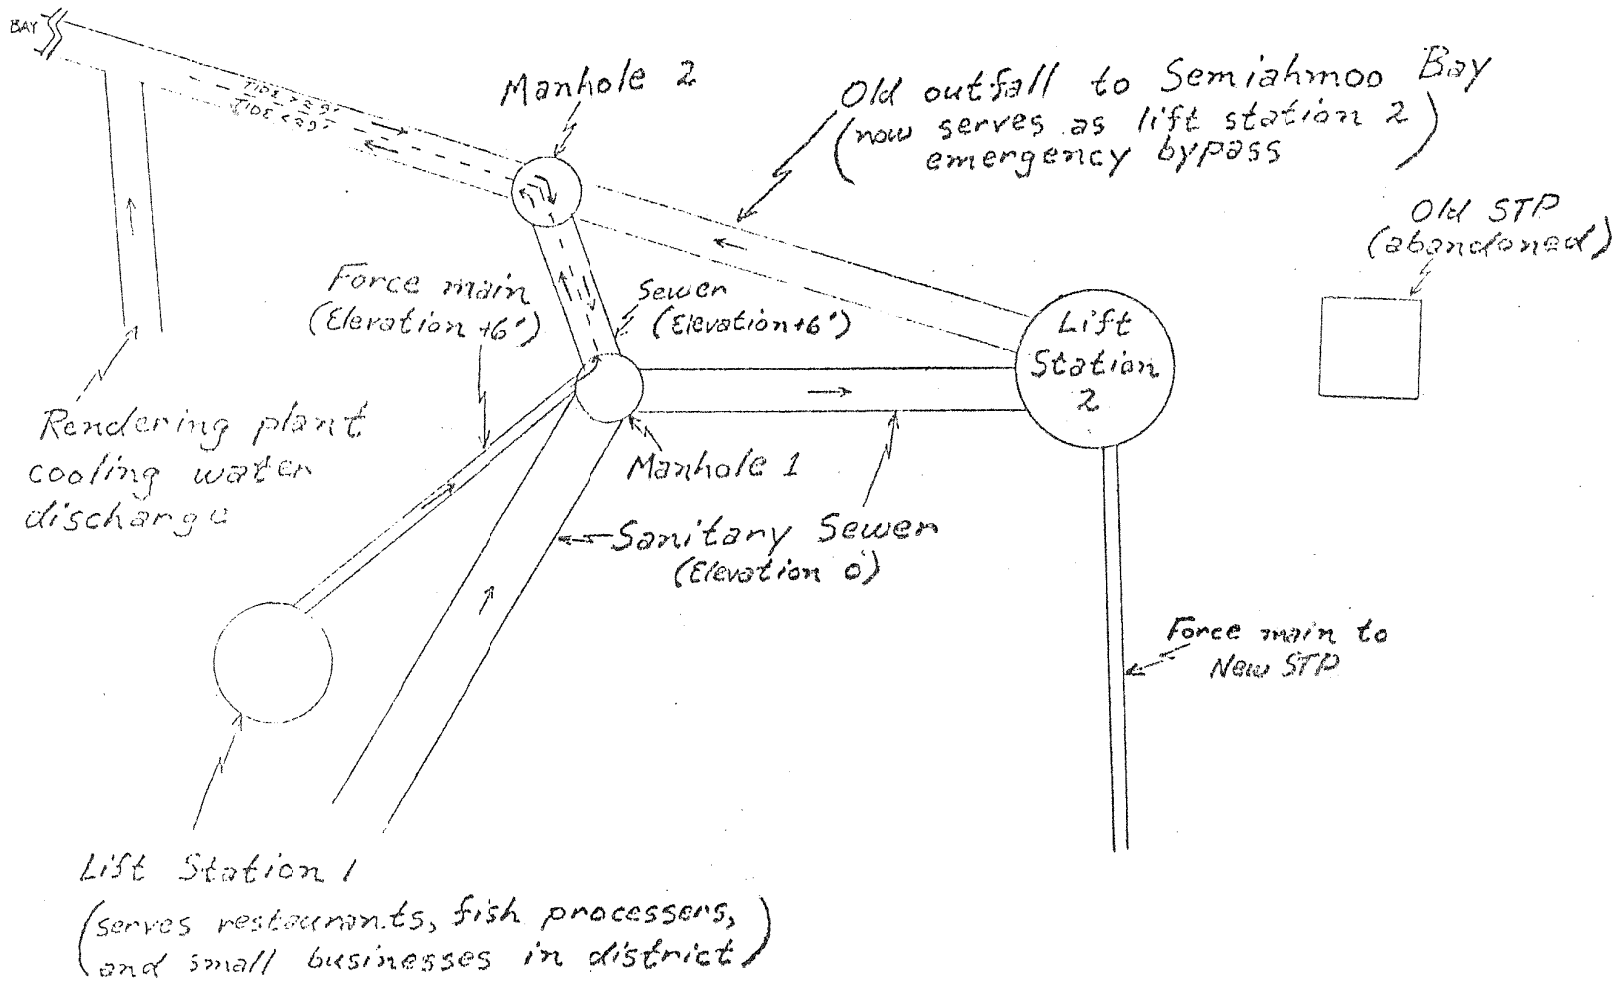
Figure 3. Flow scheme of bypass area - Blaine STP Class II Inspection, February 1983.

In addition to the treatment plant samples, several grab samples were taken at a manhole near the old treatment plant (Figure 3). The manhole sampled (Manhole [MH] 1) is the site where lift station 1, serving the restaurants, fish processors, and small businesses southwest of the lift station, would discharge into the sanitary system. The waste would then be carried to lift station 2 at the site of the old STP from which it is pumped to the new STP for treatment. Last year, plant overloads believed to be caused by high BOD and grease loadings from lift station 1 resulted in a decision to re-route the flow from lift station 1 to the old STP outfall line. (The old STP outfall line presently serves as an emergency bypass for lift station 2). During tides greater than approximately 9 feet, the flow in the old STP outfall is reversed, resulting in lift station 1 flow, cooling water discharge from a fish rendering plant, and marine water entering the sanitary system at MH 1 and being pumped to the new STP. Grab samples of the backflow at MH 1 were collected for field and laboratory analysis.

A portion of the flow to the plant was entering the system as backflow from MH 1 (Figure 3). Grab samples for field and laboratory analysis were taken from the MH 1 backflow when it was spilling into the sanitary sewer system (Tables 1, 4, and 5). Conductivities for the three grab samples collected at MH 1 were 3350, 3700, and 5000. Conductivity data collected by the WDOE ambient monitoring program at the Drayton Harbor entrance channel ranges from 19,200 to 48,000 and has a geometric mean of approximately 34,600. By comparing the Drayton Harbor mean conductivity to the MH 1 backflow conductivities, one could estimate that roughly 10 to 15 percent of the MH 1 backflow is marine water.

The estimated daily load to the STP from the manhole 1 backflow is fairly small, primarily because the estimate was based on the backflow occurring for only four hours daily. The concentrations and hourly loads demonstrate that flow from lift station 1 should be treated rather than bypassed.

Based on the Class II BOD_5, TSS, and fecal coliform values, the waste being bypassed at manhole 1 demonstrates the need for treatment. The exact quality and quantity of waste being bypassed is both unknown and variable. Approximate ranges of flow and waste strength would be useful for management of the waste stream. Lift station 1 is probably the best site to collect the necessary samples and make flow estimates.
