Publication No. 83-e40

STATE OF WASHINGTON
DEPARTMENT OF ECOLOGY
7272 Cleanwater Lane, LU-11 • Olympia, Washington 98504 • (206) 753-2353

MEMORANDUM
December 1, 1983

Subject: Longview Diking District Study

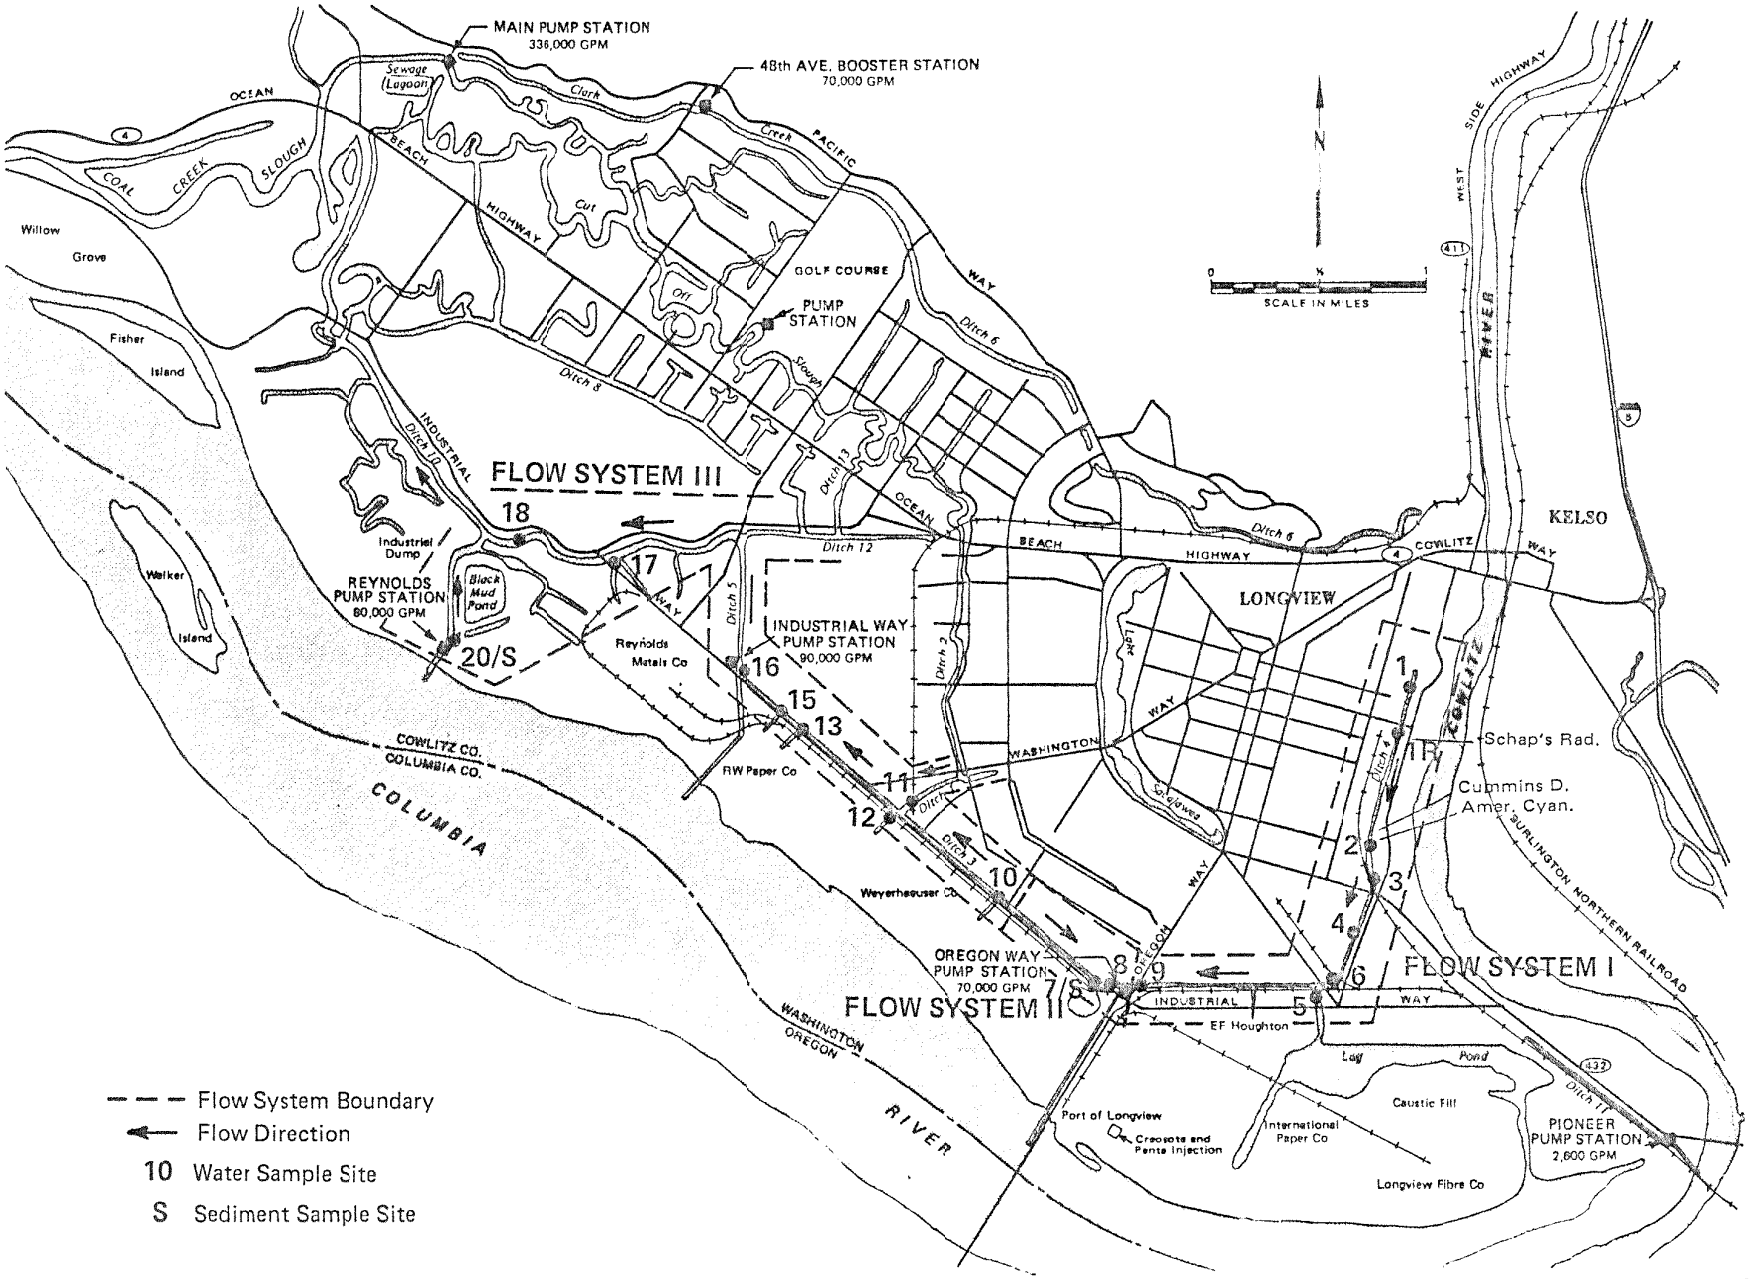
Figure 1. SAMPLING LOCATIONS ON LONGVIEW DITCHES. MAP MODIFIED FROM CONSOLIDATED DIKING IMPROVEMENT DISTRICT NO. 1, 1982.

Cummins Diesel (1153 - 3rd, Figure 1) routes floor wash water to an oil-water separator and then illegally discharges to ditch 4. There were several oily areas on the ditch at this location and several pipes present along the bank. The ditch had just been dredged and oil-laden sediments covered the bank. An inspection of Cummins Diesel was made on January 28, 1983 by Morhous and a sample of the separator discharge collected. Morhous found the separator filled with oil and sludge and advised the operator to have it cleaned as soon as possible. The analytical results of the discharge from the separator for recoverable oil and grease at the time of inspection was >5,000 mg/L. On a second visit on March 21, 1983, Morhous noted the separator still appeared to be losing oil. A sample of the discharge resulted in a concentration of oil and grease of 300 mg/L, which would not be allowed if an NPDES permit were in effect.

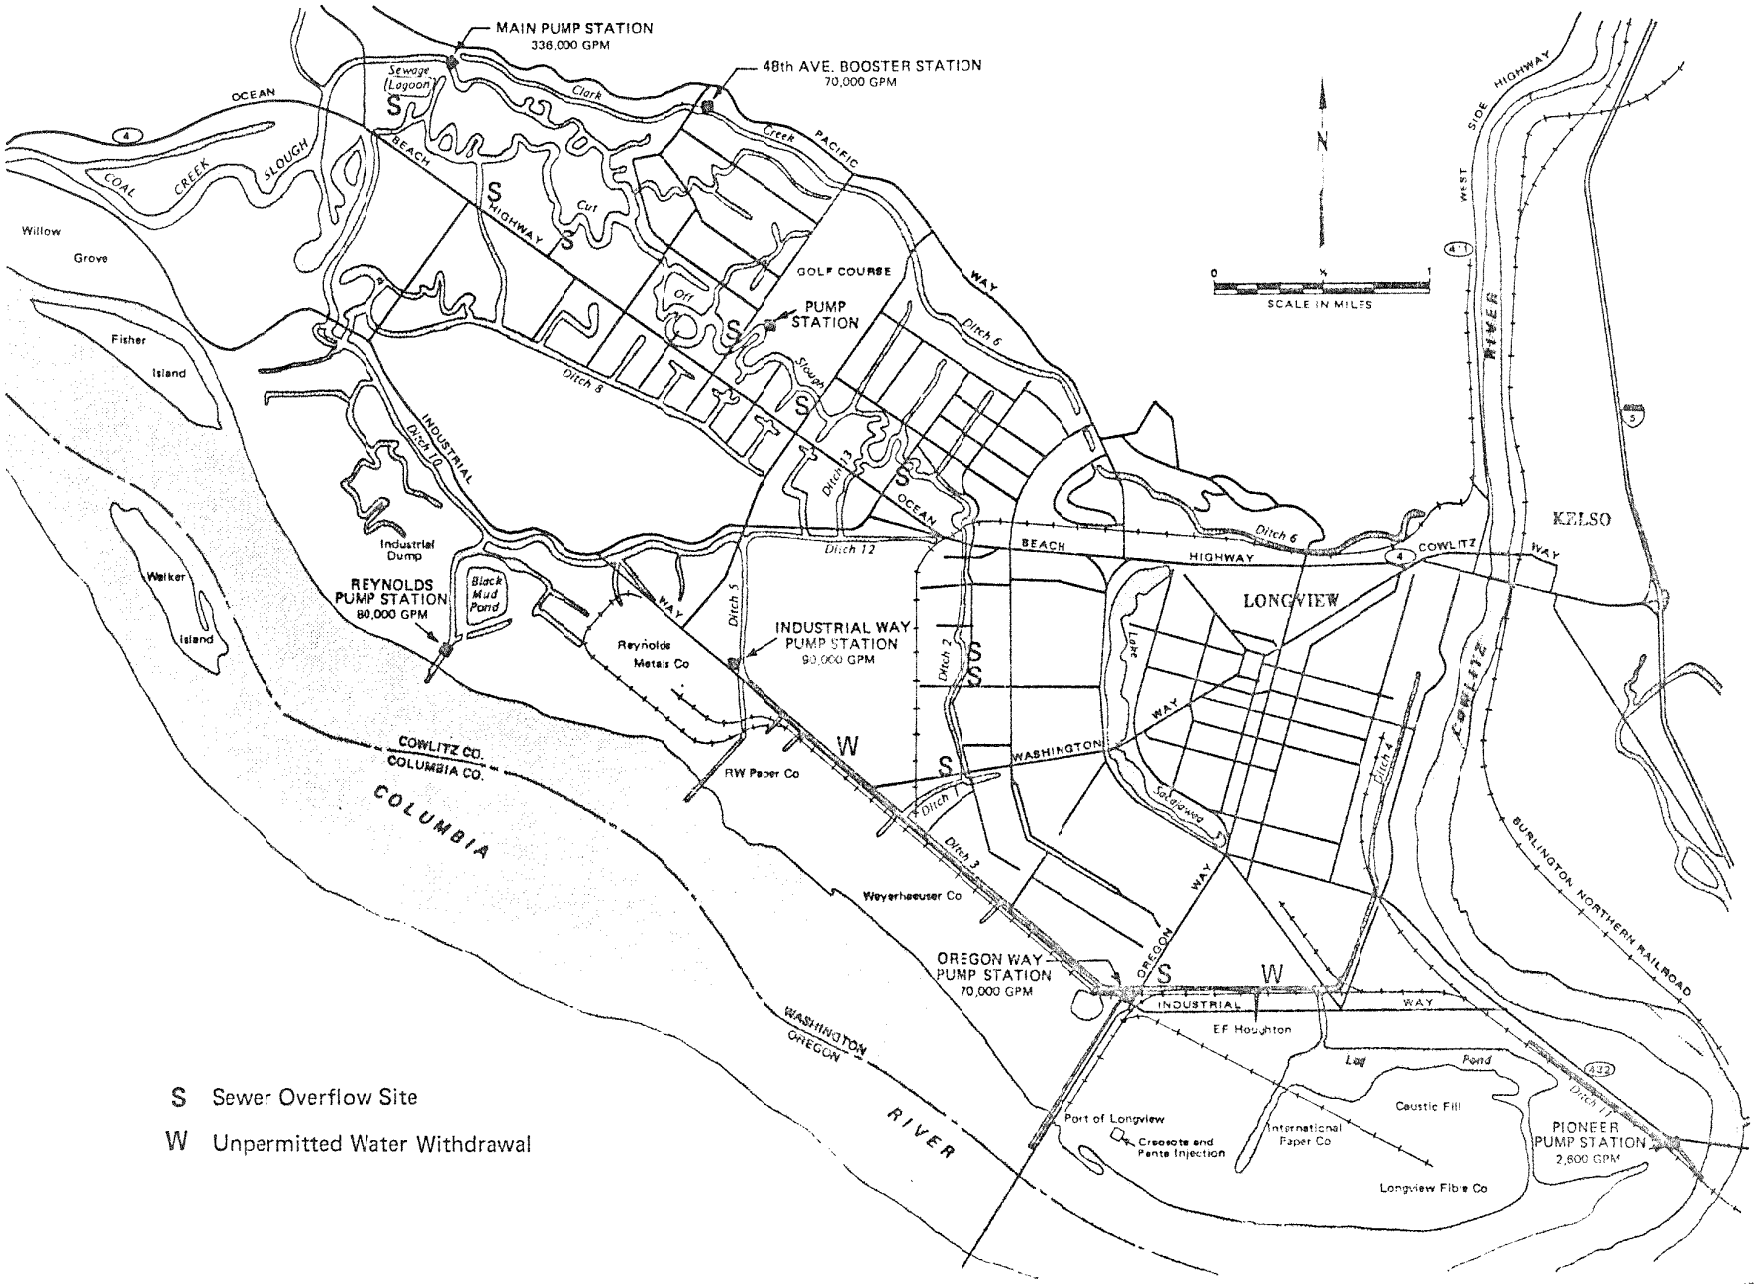
Figure 2. LOCATION OF SANITARY SEWER OVERFLOWS AND UNPERMITTED WATER WITHDRAWALS. MAP MODIFIED FROM CONSOLIDATED DIKING DISTRICT NO. 1, 1982.

Locations of 10 of the 11 sanitary sewer overflow sites are shown in Figure 2 (Zandi, 1983; Edtl, 1983). Bypasses are manually controlled and events recorded in a log maintained by the city engineer (Edtl, 1983). The record for 1982 indicates bypasses occur most frequently to ditches 6 and 7 in the north section of town and in ditch 2 in the central section near Hudson Street. Bypasses occur primarily in the months of heavy precipitation; however, none were recorded during the period of this sampling.

The locations of the sewer bypasses are given in Figure 2. As noted previously, the bypasses generally occur during the winter months and based on recent records, occur most frequently on the north edge of town to ditch 6. The bypasses are caused in part by groundwater infiltration and inflow during the winter months. The infiltration means that the sewage is diluted at the time of bypass and is subsequently diluted by flow in the ditches. Because ditch and bypass quality and quantity have never been simultaneously determined and there were no bypasses occurring at the time of this sampling, a quantification or estimation of impacts was not possible. It may be possible to quantify impacts during future field work; however, a bypass event will not be a prerequisite for sampling.

Sewage discharges typically increase BOD, nutrient, turbidity, and bacterial loading to the receiving water and may increase other constituents depending on the waste stream in a given service area. It is very likely that such bypasses cause or aggravate Class A water quality criteria violations, and from a public health aspect, raw sewage entering totally accessible, open ditches in a residential area is a situation of serious public health concern.
