Publication No. 83-e43

STATE OF WASHINGTON
DEPARTMENT OF ECOLOGY
7272 Cleanwater Lane, LU-11 • Olympia, Washington 98504 • (206) 753-2353

MEMORANDUM
April 5, 1983

Subject: Colfax Class II and Receiving Water Survey

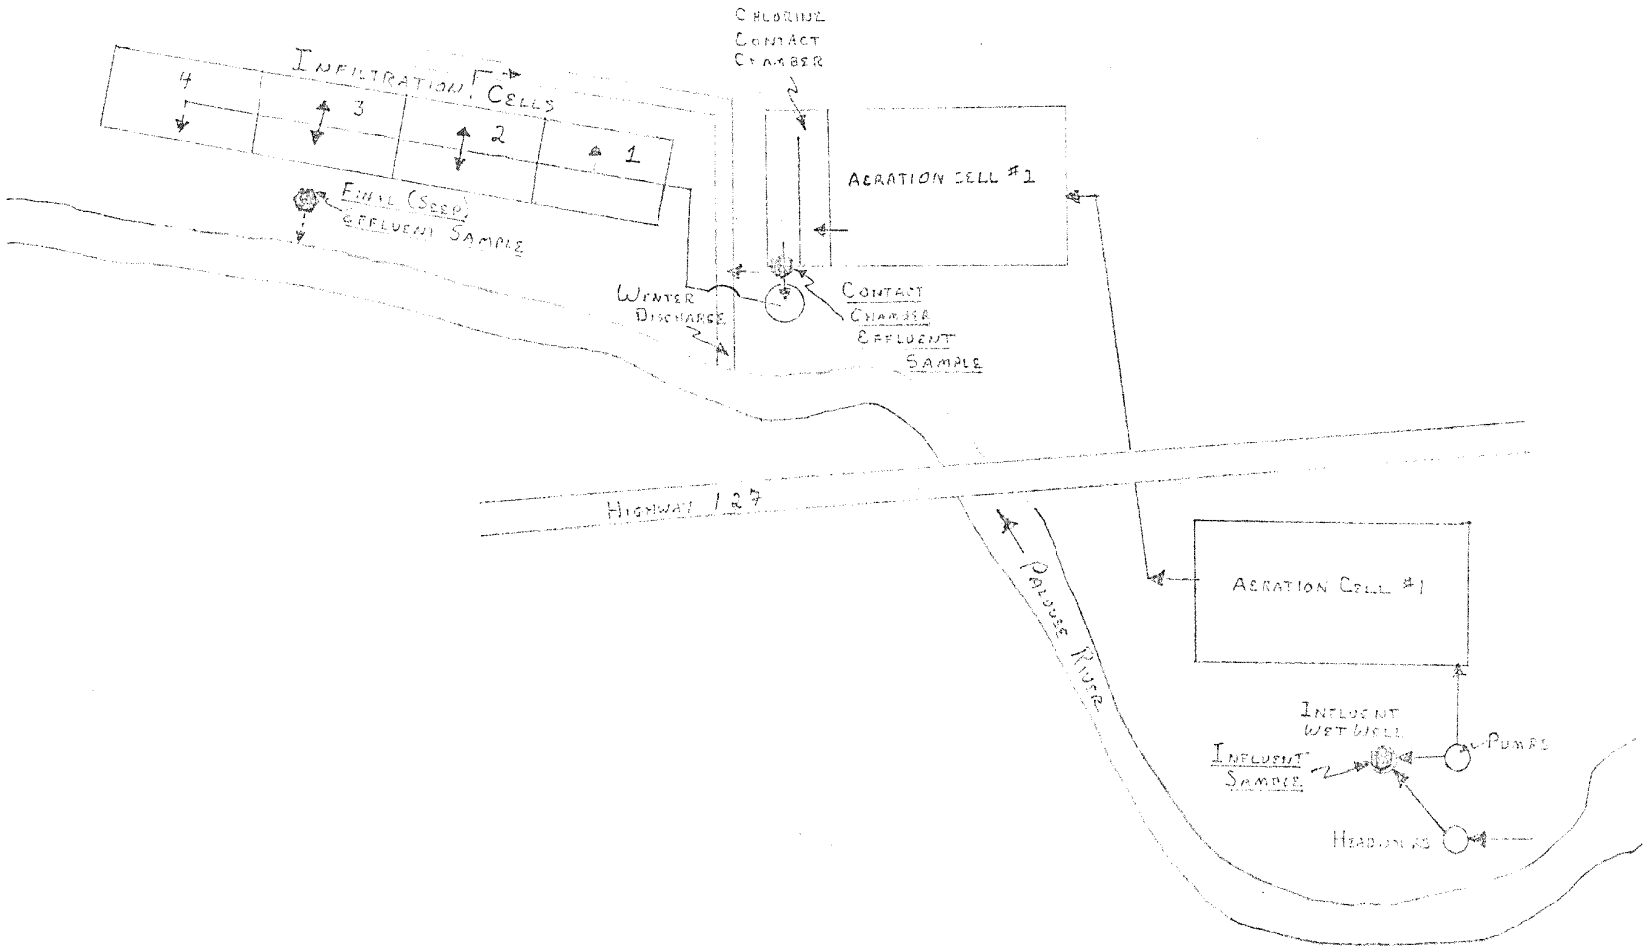
Figure 1. Colfax sewage treatment plant and sample locations.

The flow diagram of the Colfax WTP is illustrated in Figure 1. Incoming sewage is comminuted at the headworks and then pumped from the influent wet well to aeration basin #1. Influent samples are obtained from the wet well. Wastewater then flows to aeration basin #2. The total detention time in basins #1 and #2 is about 25 days. Chlorine is added at the discharge of basin #2. Plant flow is measured at a 90° V-notch weir located at the end of the contact chamber. After passing through the contact chamber, effluent is usually pumped to a series of infiltration beds. During the winter, effluent has been discharged directly to the Palouse River. There are four filtration beds. These are flat-bottomed cells built in, and bermed by, native soils. During the survey, only cells 2 and 3 were being used. Cell 4 was not being used due to inadequate permeability. Cell 1 is excessively permeable and was not being used.

Twenty-four-hour composite samples were obtained at the influent, contact chamber effluent, and a seep below infiltration cell #3 (see Figure 1). In addition, fecal coliform grab samples were obtained at both effluent sampling sites and field tests for three parameters (temperature, pH, and specific conductivity) were conducted twice at each of the three sample sites. Total chlorine residual was measured concurrently with fecal coliform sampling. Table 1 contains specific information regarding times, dates, locations, and analyses pertinent to each of these samples.

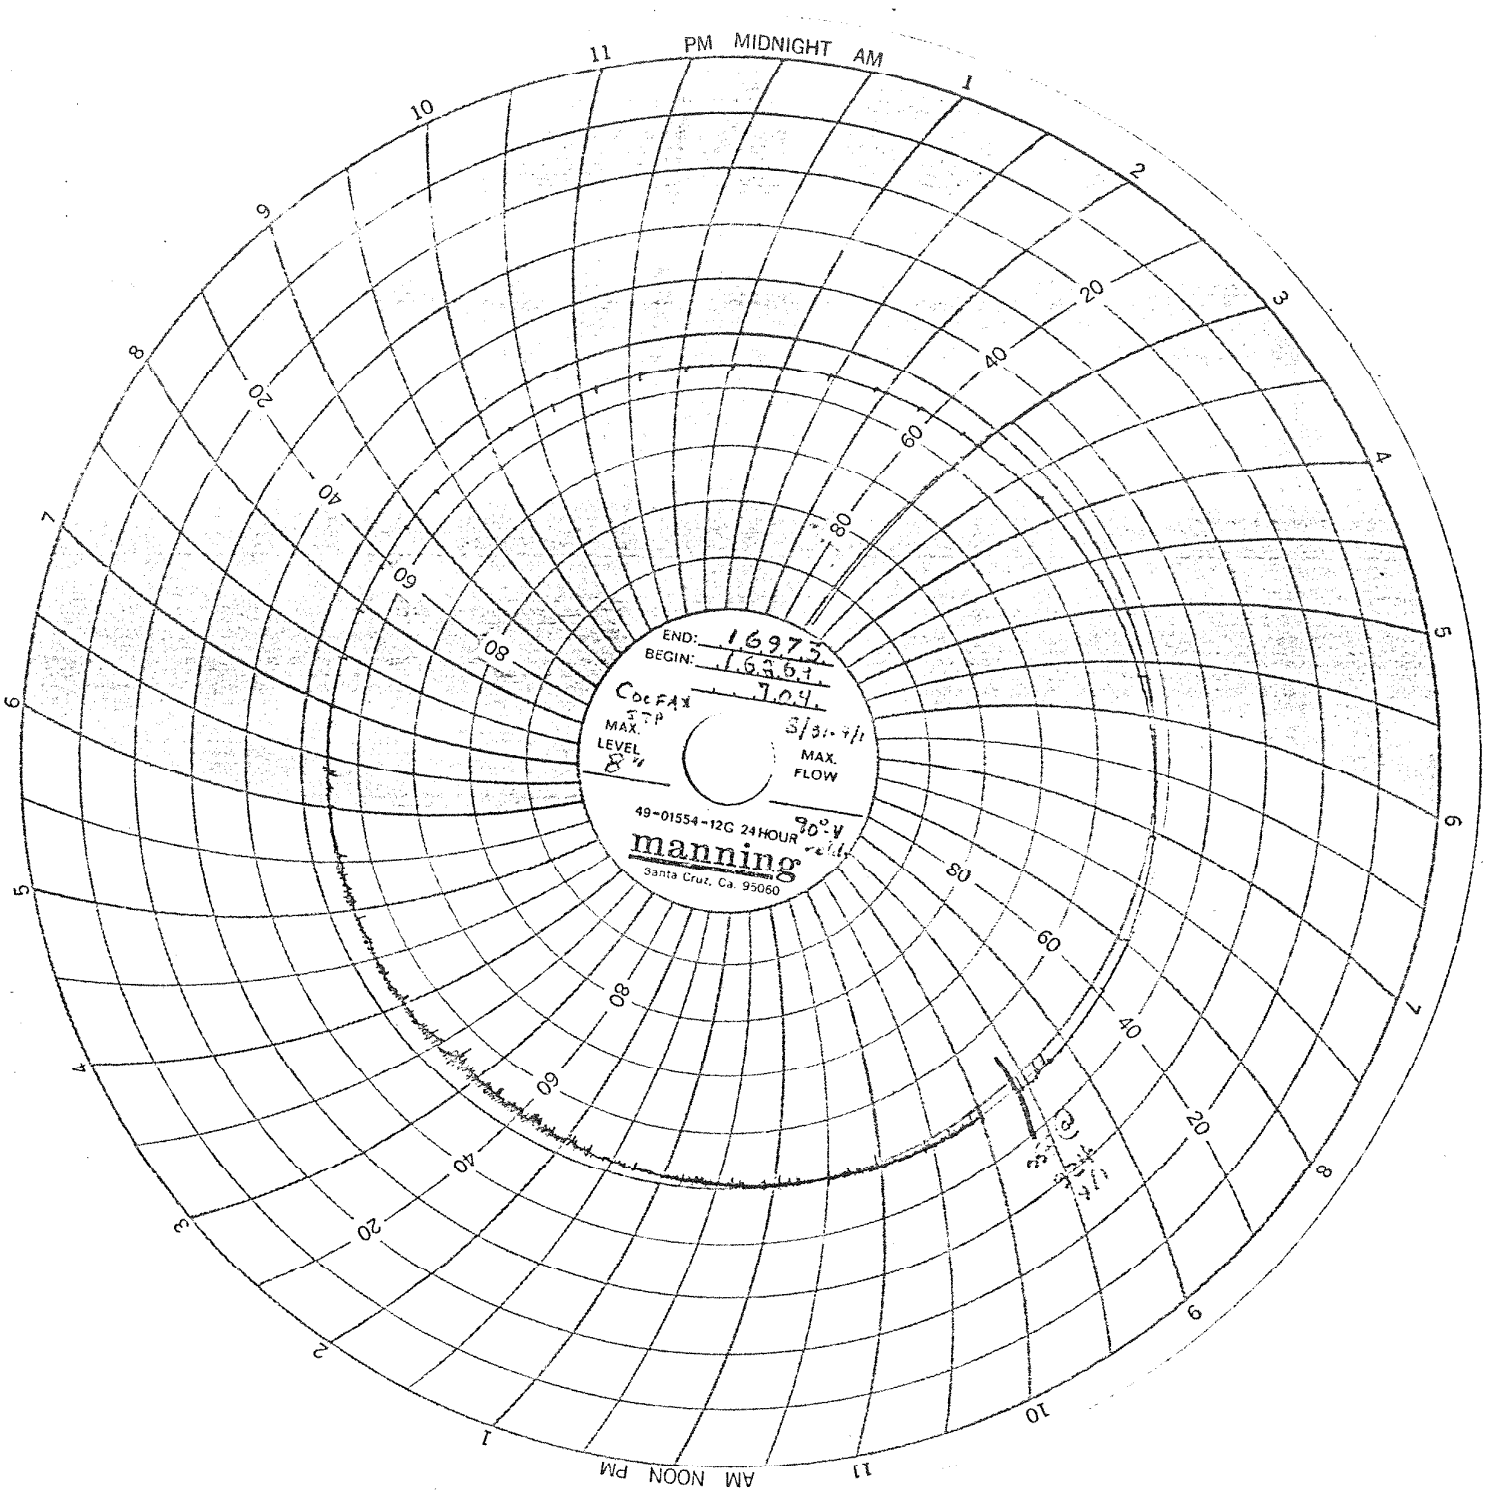
Figure 2. 24-hour flow chart.

the contact chamber outfall. This was being used to determine plant flows. A Manning "Dipper" flow recorder was also installed behind the weir to record flows during the 24-hour sampling period. The flow trace for the sampling period is shown in Figure 2.

Total flow recorded by the plant's Leopold-Stevens meter and WDOE's Manning "Dipper" flow meter were very similar (.295 vs. .294 MGD, respectively). This indicates that the plant's meter is well calibrated and that flows are reported accurately on the discharge monitoring reports (DMRs).

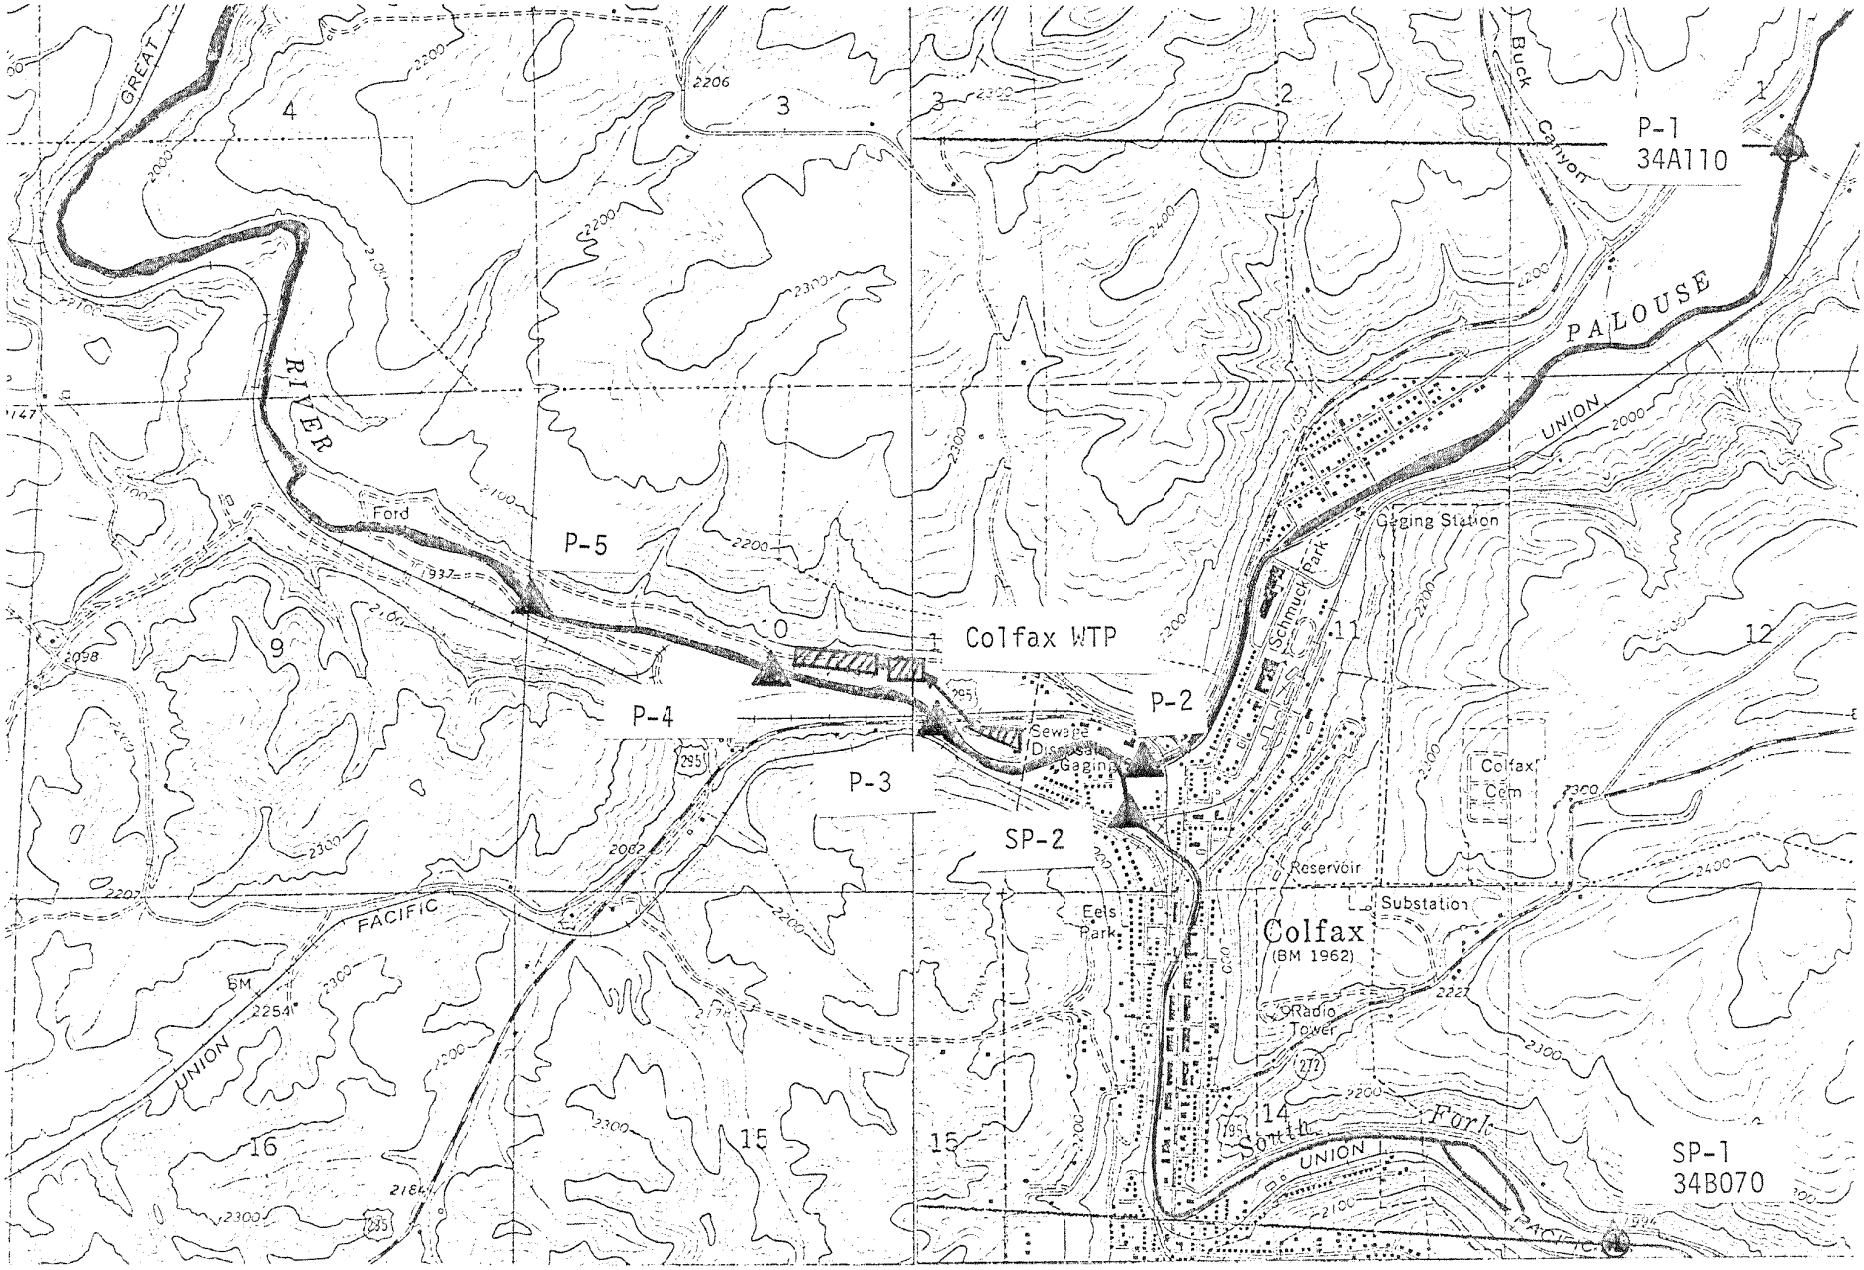
Figure 3. Study area and station locations.

This study was conducted primarily to assess the impact of treated wastewaters discharged from the Colfax WTP on water quality in the Palouse River. In addition, sampling sites on the SFPR and Palouse River were chosen to provide information on other possible impacts on surface water quality near Colfax. The study area is shown in Figure 3.

Seven sites on the SFPR and Palouse River were sampled. Station numbers, names, and river mile locations are given in Table 6A; Figure 3 displays the locations of the sampling sites. Stations SP-1 and P-1 correspond to historical ambient monitoring stations 34B090 and 35A110, respectively.

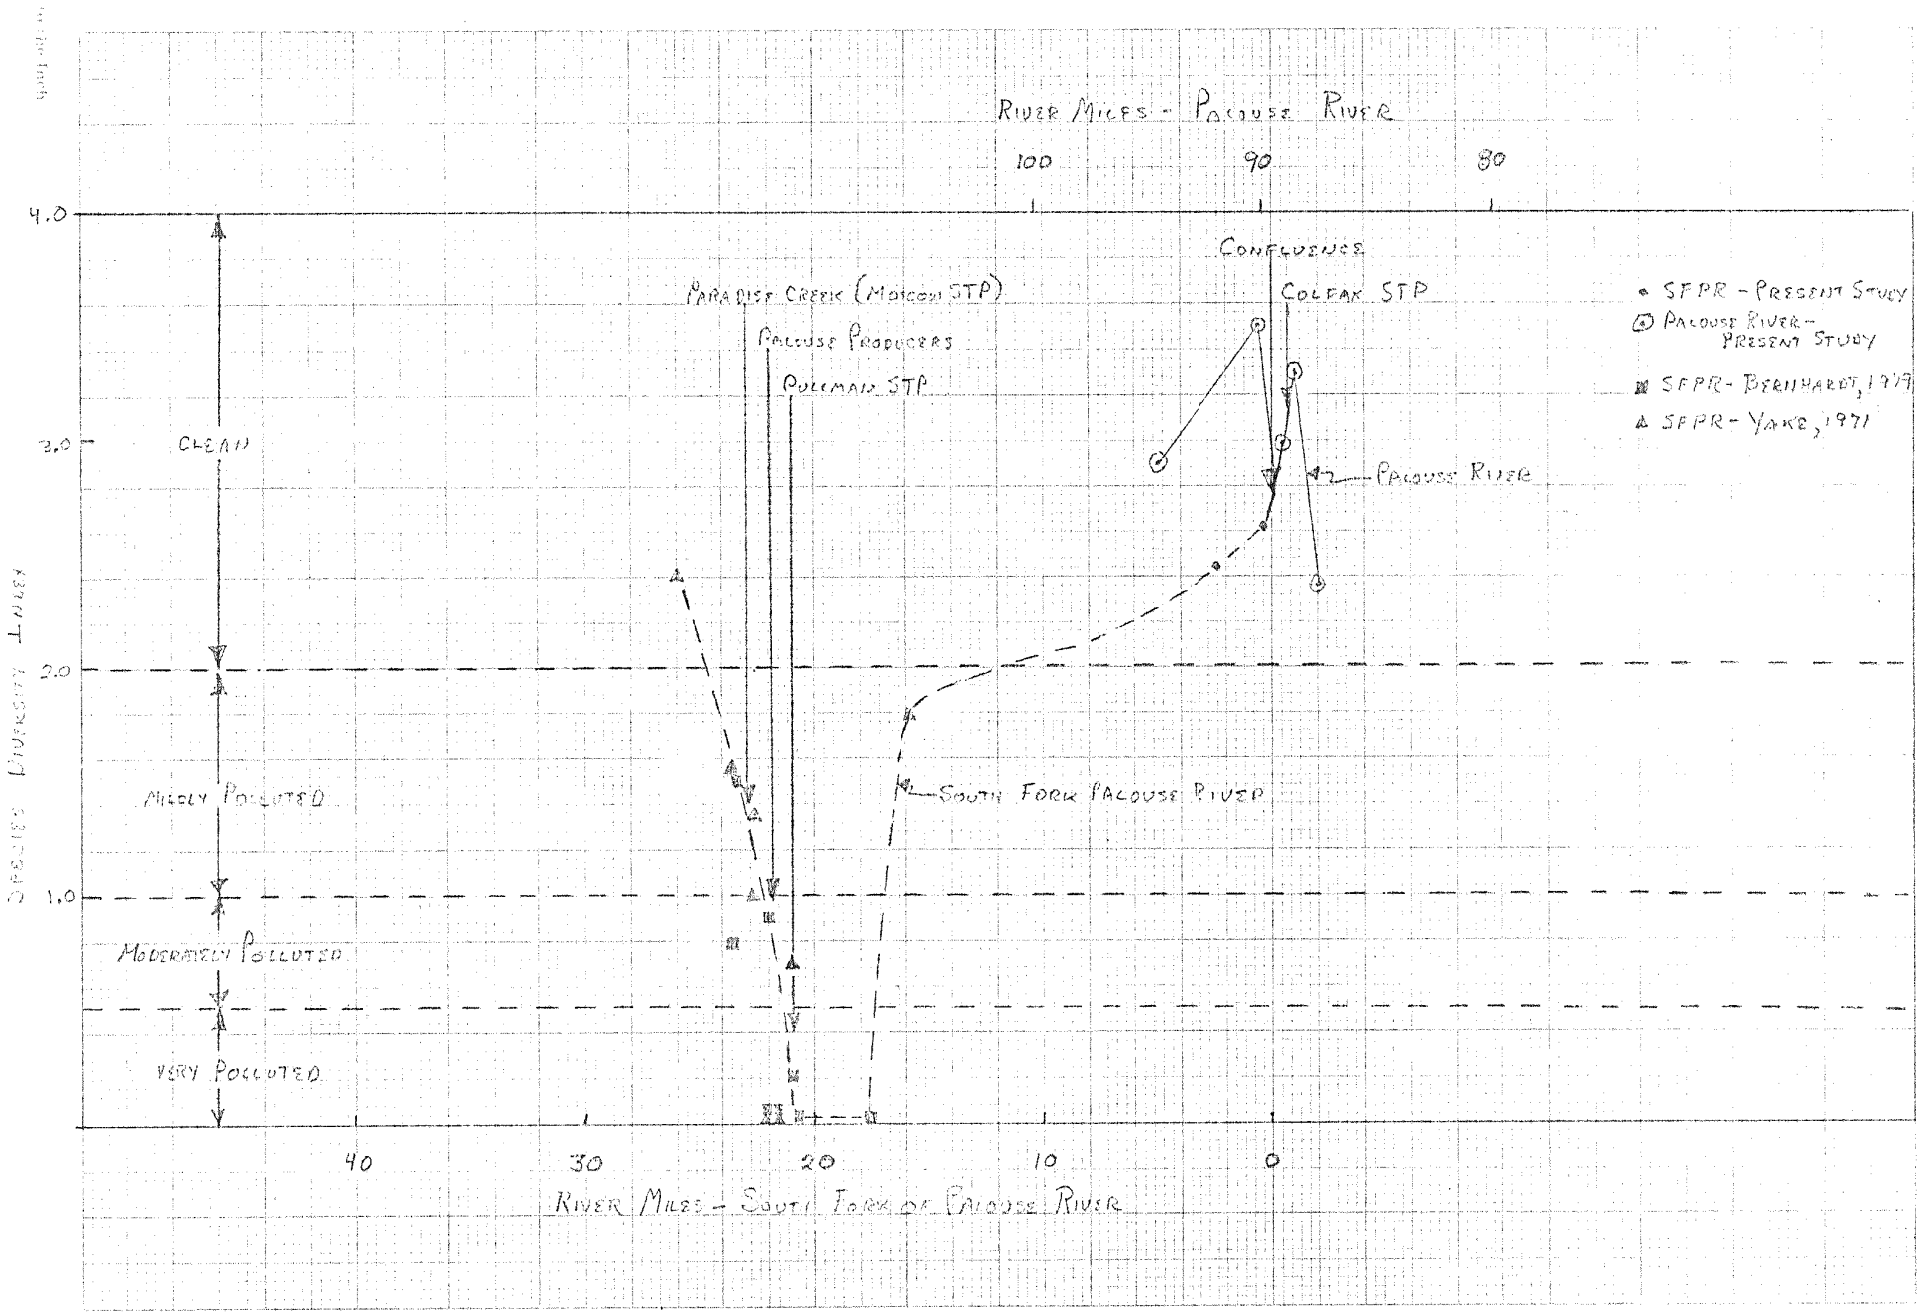
Figure 4. Species diversity: South Fork Palouse and Palouse Rivers.

Figure 4 presents diversity data from benthic invertebrate studies conducted on the SFPR and Palouse River between 1970 and present. Although there were some differences in collection techniques, a

clear pattern emerges. Diversities measured in the lower SFPR and Palouse River near Colfax are substantially higher than those in the upper SFPR. The worst conditions have been measured in the SFPR between downtown Pullman and Albion with Palouse Producers and the Pullman WTP being the most likely major causes. The SFPR appears to have recovered by the time it reaches Colfax and diversities in the Palouse River above and below its confluence with the SFPR and the Colfax WTP indicate generally good water quality.
