DEPARTMENT OF ECOLOGY

January 27, 1986

Subject: Tamoshan Wastewater Treatment Plant Limited Class II Inspection, June 17-18, 1985

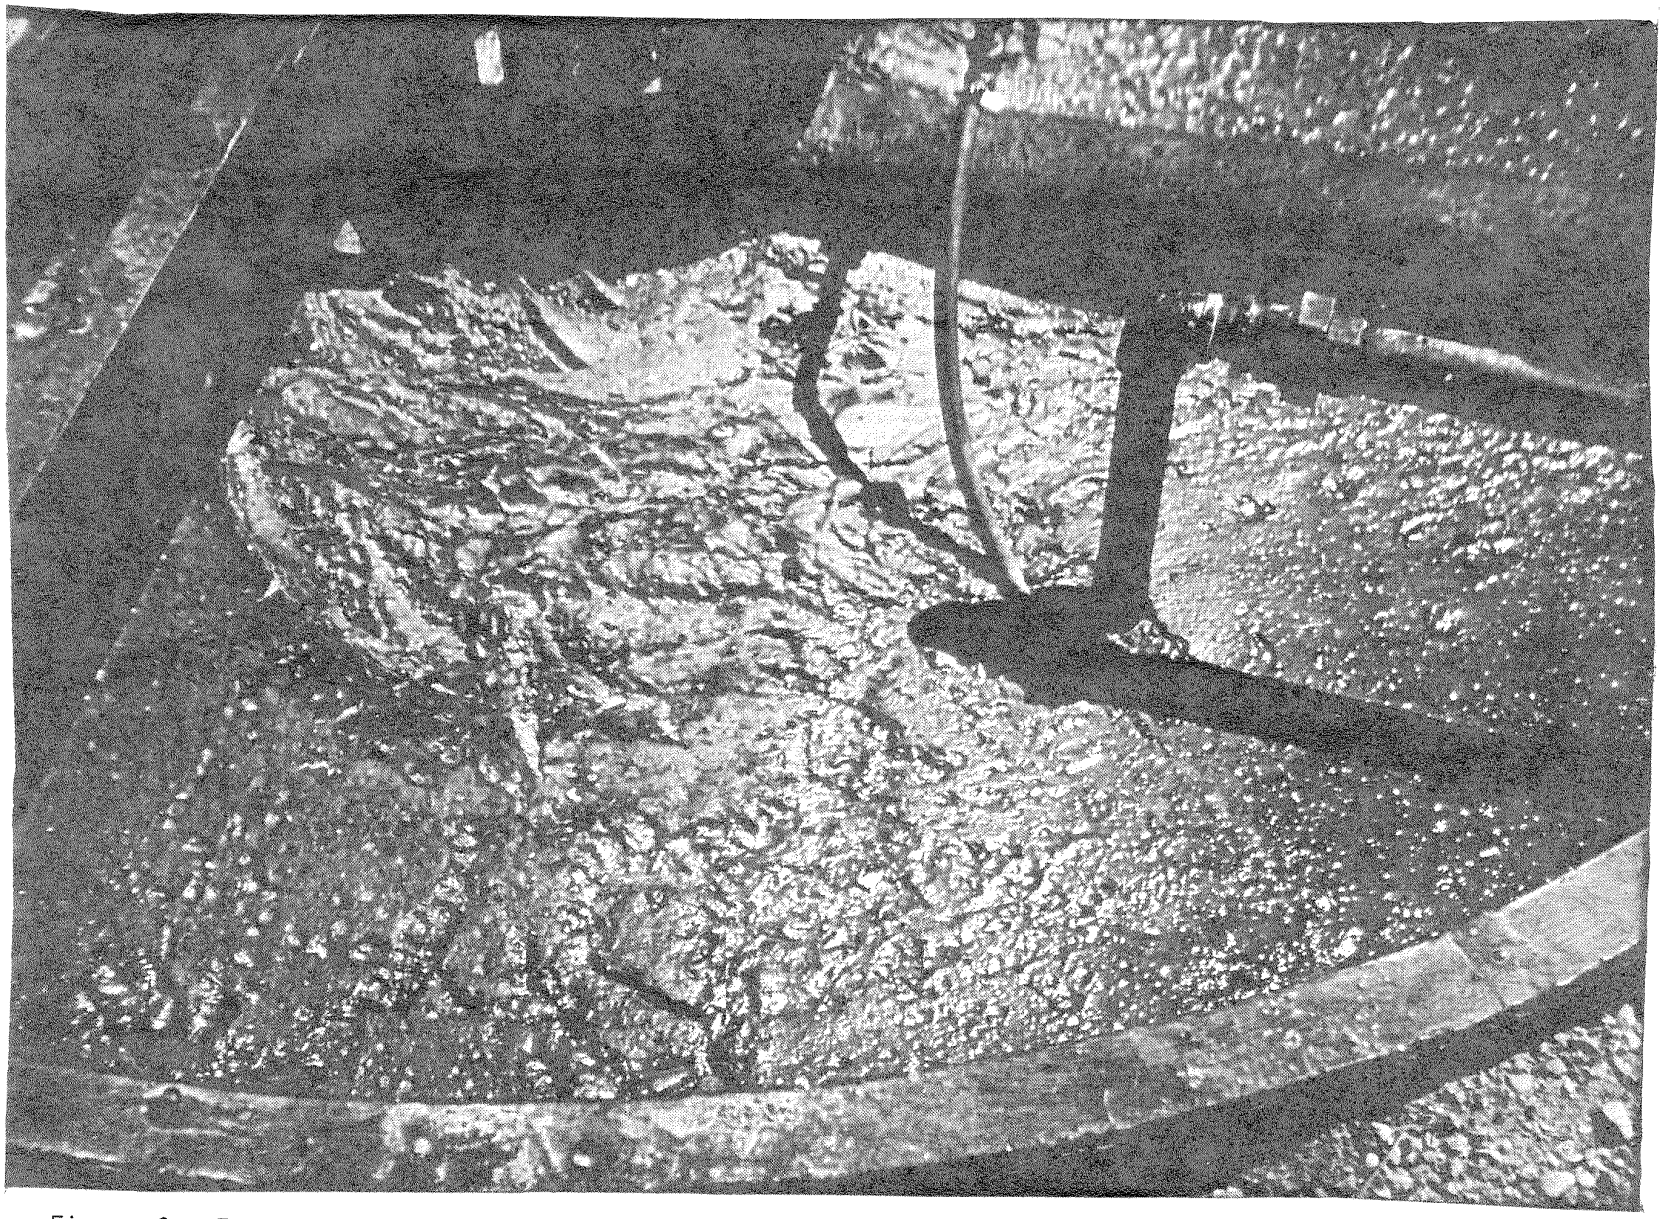
The clarifier appeared to be operating well with the modified launder weir. If solids loss becomes a problem in the future, the flow pattern should be checked to ensure the modification continues to work. Sludge depth in the clarifier was seven feet (41 percent of total depth), which is considered too high. Also, excessive foam was observed in the clarifier (Figure 3). A possible cause is filamentous growth which often occurs when sludge is held too long. Sludge is now wasted once per week. It is recommended that the sludge-wasting rate be increased to reduce sludge age in the aeration basins. This also will reduce sludge depth in the clarifier.

Figure 3. Tamoshan WTP secondary clarifier. Note dark, leathery foam on surface, indicative of old sludge.

2. Plant physical capacity appears to be more than adequate. The operator should investigate the possibility of using one aeration basin. This should reduce sludge age and could help resolve the foaming problem in the clarifier.
