DAISHOWA PULP AND PAPER MILL CLASS II INSPECTION
PORT ANGELES, WASHINGTON
NOVEMBER 14-16, 1988

by
Pat Hallinan

Washington Department of Ecology
Environmental Investigations and Laboratory Services
Compliance Monitoring Section
Olympia, Washington 98504

December 1989

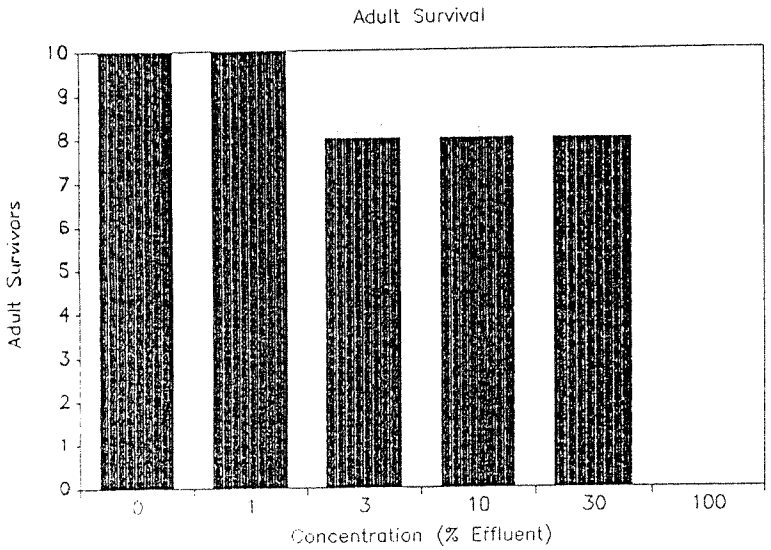
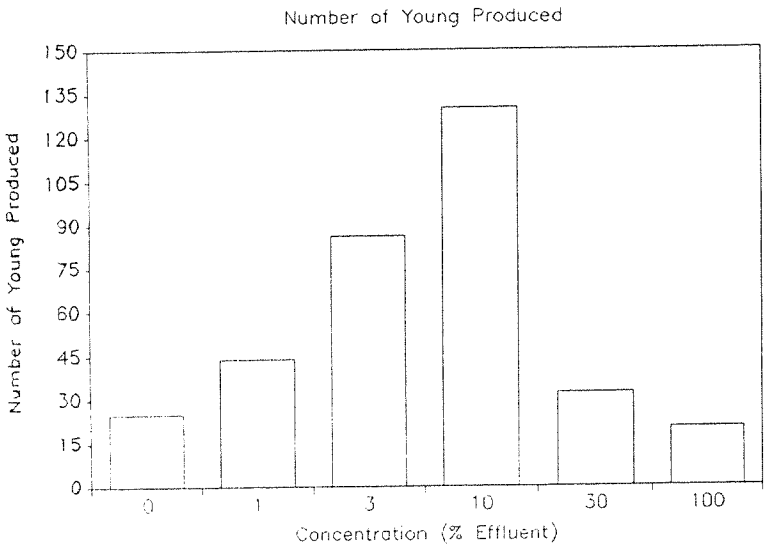
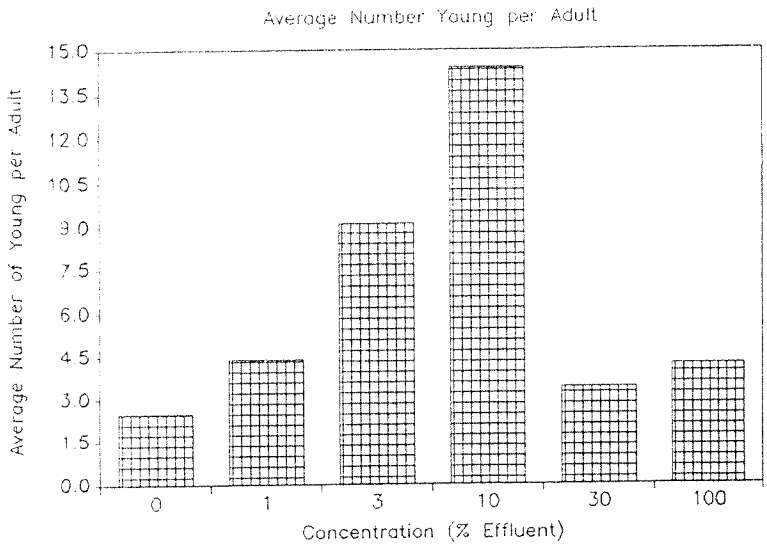
Figure 2. Graphical Presentation of Daphnia magna Bioassay Results - Daishowa, 11/88. (From Stinson, 1989)

A graphical presentation of both survival and reproduction for the *Daphnia* bioassay is shown in Figure 2. Mortality was observed in this bioassay, with a LC_{50} (lethal effluent concentration to 50 percent of the test organisms) of 48 percent. Reproduction increased compared to the control at lower effluent concentrations, then decreased at higher concentrations. This response pattern is typical when the effluent offers enhanced nutrition to the organism: Reproduction rates increase until the sample toxicity overwhelms the nutritional benefits (Stinson, 1989).
