SUBJECT: Texaco Incorporated's Anacortes Refinery

A Class II inspection was conducted at Texaco Incorporated's Anacortes refinery on June 20-22, 1988. The inspection was requested by Kimberly Anderson of Ecology's Industrial Section and conducted by Carlos E. Ruiz and Don Reif of Ecology's Environmental Investigations, Compliance Monitoring Section (CMS). Assisting was Kim Anderson, Ecology environmental engineer, and Texaco's Ken Brown, supervisor; Roland Borey, aquatic toxicologist; and Roland Garbs, laboratory manager.

Figure 1. Treatment process schematic with sampling locations: Texaco Class II inspection- June 20-22, 1988.

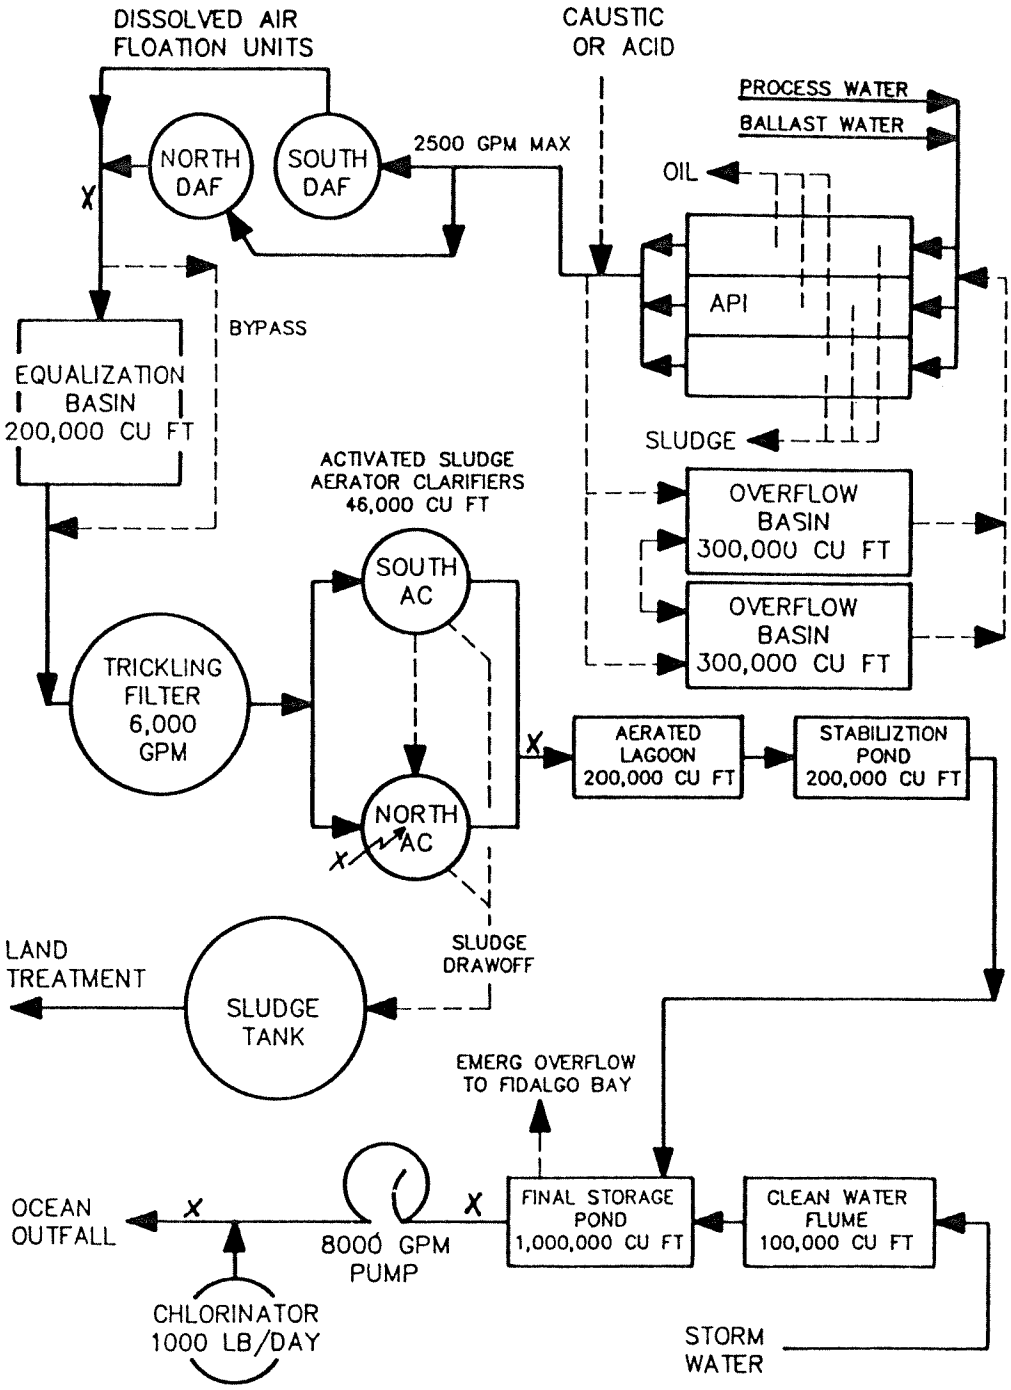
system capacity is 1.9 MGD for process wastewater plus up to 1.7 MGD for ballast water, sanitary wastewater, and stormwater, for a total of 3.6 MGD. Process and ballast waters undergo the full wastewater treatment process while stormwater generally enters the system prior to the final storage pond. Alternately, stormwater can be routed through the API's if desired. Sanitary wastewater is combined with the industrial waste stream and treated in the system described below. A schematic of the WTP is shown in Figure 1.
