US ECOLOGY (USE) REMEDIAL INVESTIGATION STATUS

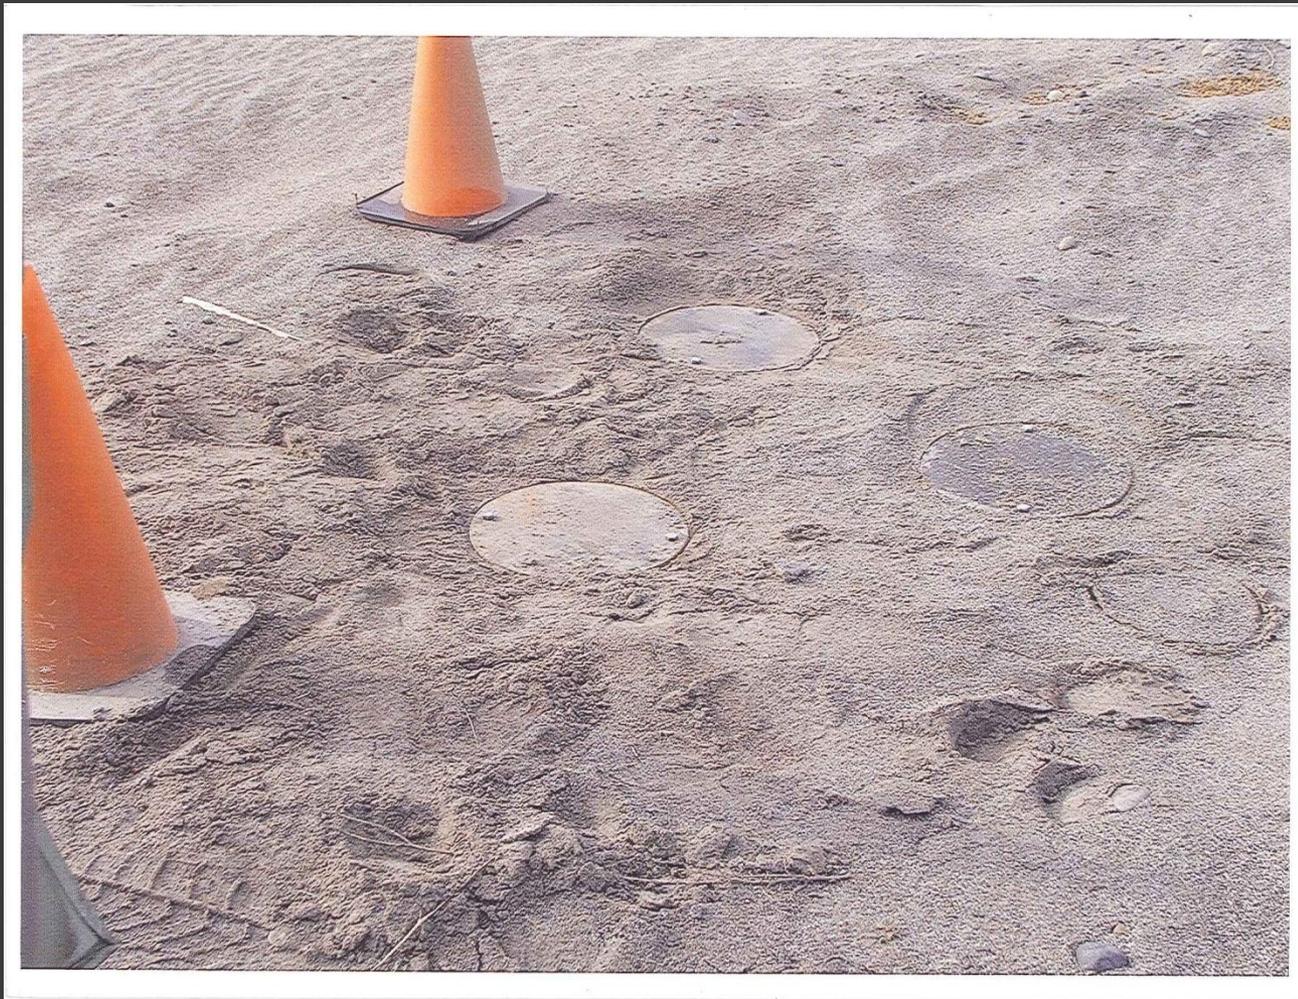
Vadose Nested Wells

- Thirty vadose zone soil-gas monitoring wells
- Installed upon completion of soil sample collection
- Three vadose zone wells installed approximately two feet apart

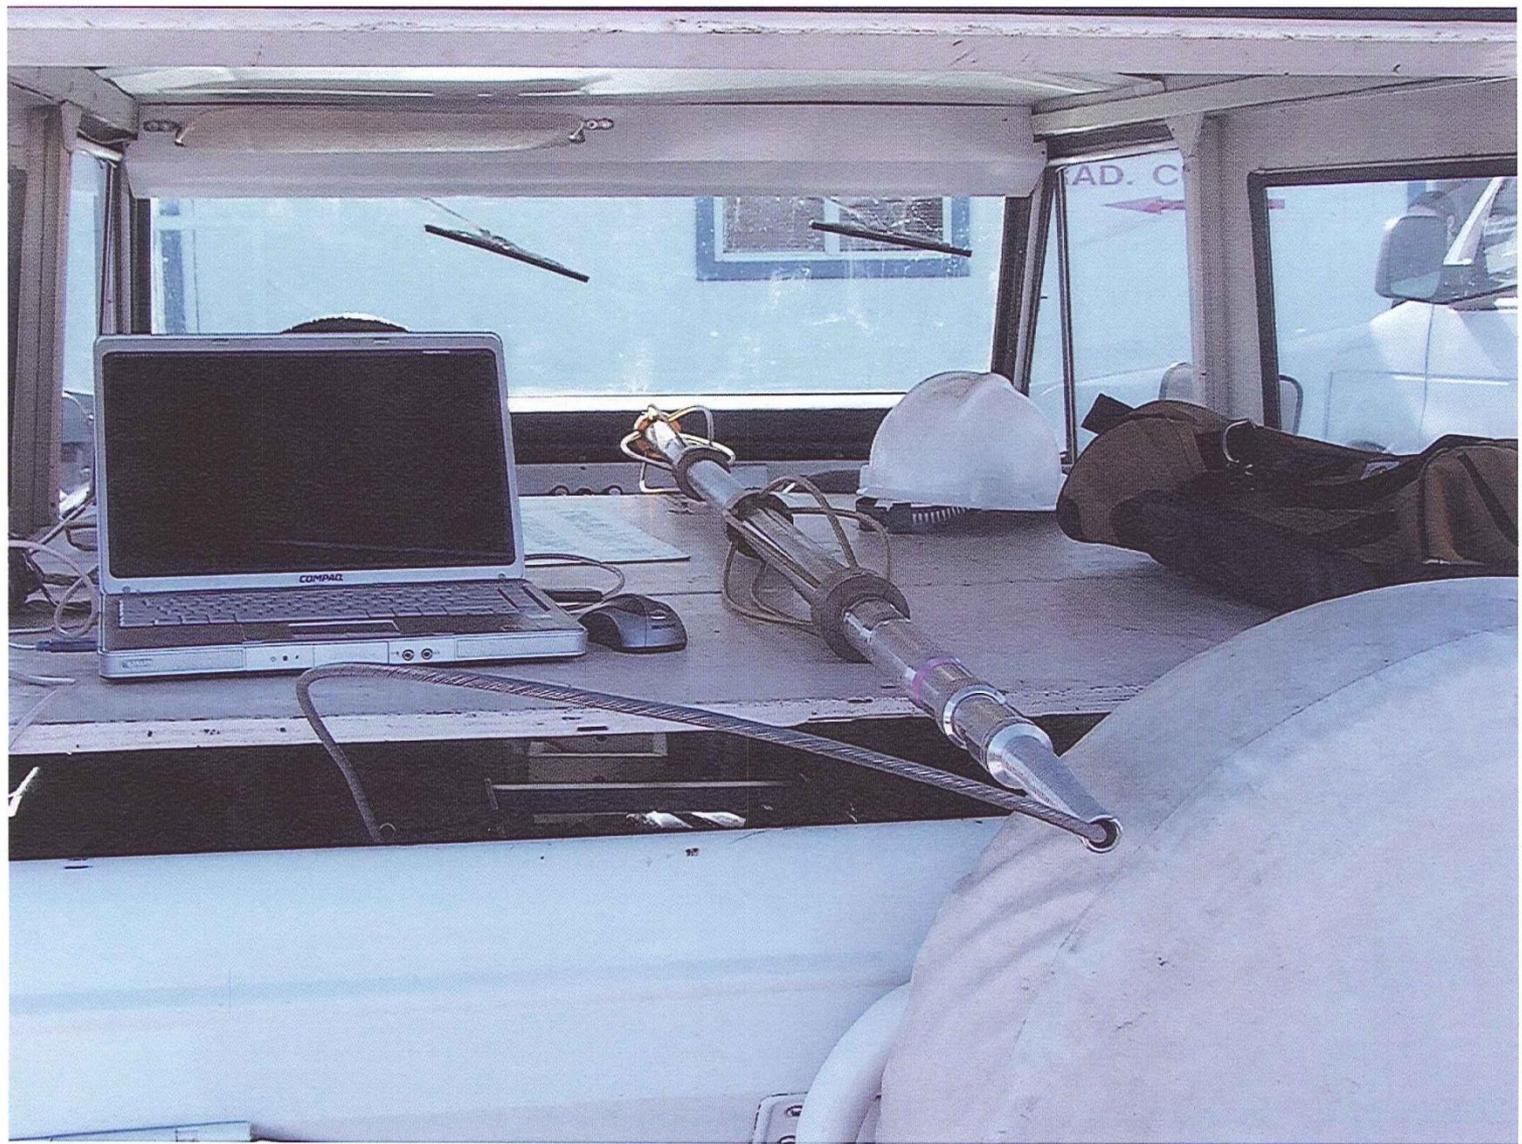
Gyro Survey Equipment

- ① Assay deviations in vertical boreholes
- ① Concurrently performed with borehole camera survey
- ① 7 monitoring wells deviated from vertical 0.009 m to 0.083 m
