Re: Ecology Assessment Report for Field Monitoring Activities of the waste material near Riser 83 of the 241-AY-102 Double Shell Tank (DST)

## ASSESSMENT REPORT

### Field Monitoring Activities

Project: 241-AY-102 Field Monitoring, Riser 83 Video

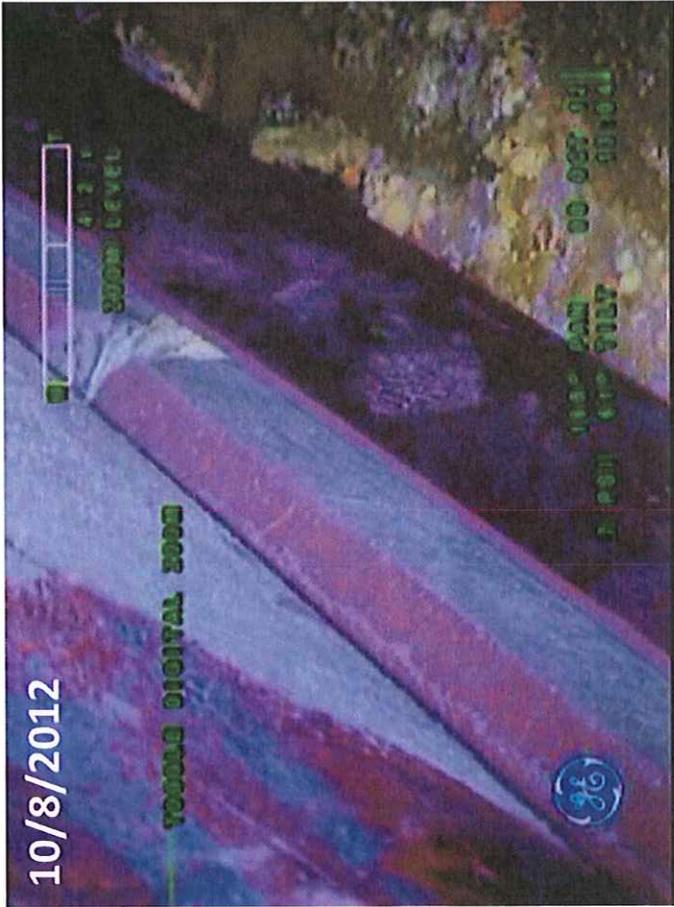
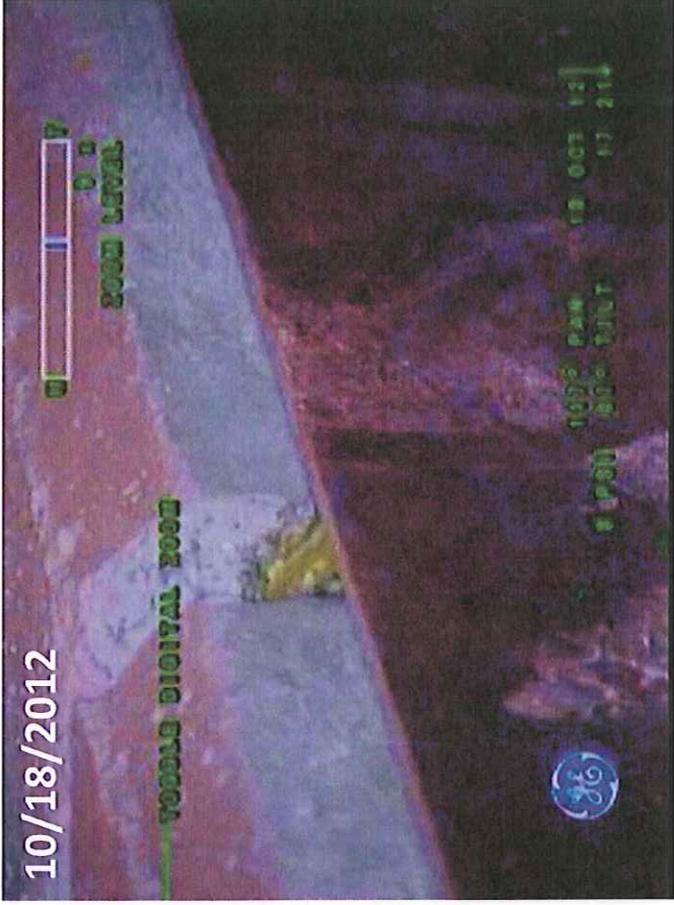
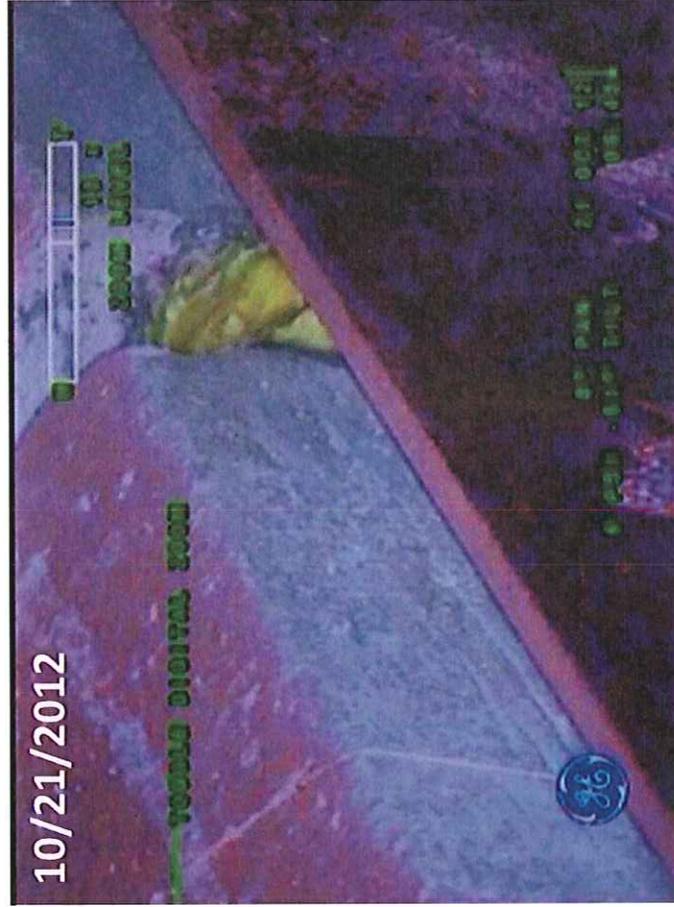
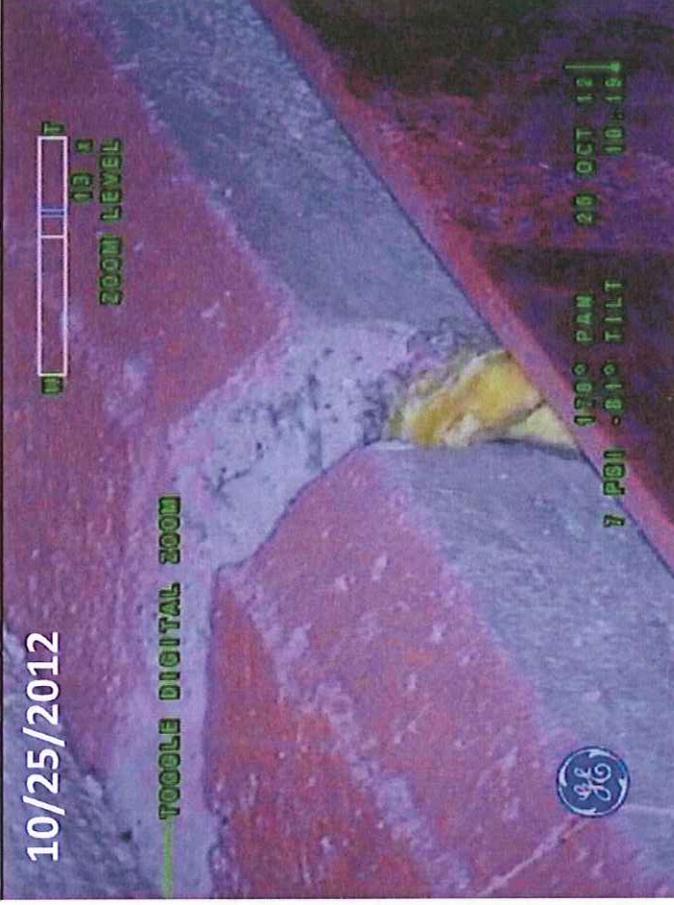
- All witnessing the inspection noted that the color of the waste appeared to be changing. The dark green was changing to a lighter green in some locations. The lighter green was becoming a dark yellow. The darker yellow was changing to a lighter yellow. The lighter yellow was turning to a white color along the waste perimeter. This indicates that the waste material may be drying, most likely due to the ventilation.

- The camera viewed the waste in respect to the different in-annular space "landmarks" including the black dot or rock, two white pebbles and ventilation slots. It was noted by all witnessing the video that the size of the area of the waste material did not appear to have grown as compared to the amount of waste material viewed during the visual inspection conducted on 10/18/12.

- All witnessing the video noted that the quantity and potential cascade of waste through a ventilation slot had either shrunk in size or receded. It looked more like the photos from visual inspections taken on 10/1/12 than those collected during the 10/18/12 effort.

- Ecology noted that there did not appear to be any visual damage indicators such as staining, cracking, pitting, etc. of the 6 inch wide carbon steel refractory ring, annulus floor, primary tank liner, or the refractory/concrete material where the waste was in direct contact with the tank structures. ORP noted that preliminary analytical results of the waste material indicated the presence of corrosion prohibiting constituents such as nitrite and hydroxides. ORP is actively seeking chemistry control/stabilization of the waste material present within the annulus.
