STATE OF WASHINGTON
DEPARTMENT OF ECOLOGY

MEMORANDUM

SUBJECT: Failure Assessment of French Slough Impoundment; SN07-0651

This memorandum summarizes opinions and judgments of the DSO as to the cause of the April 2010 failure of the 30-million gallon Waste Storage Pond operated by the Bartelheimers near Snohomish, Washington.

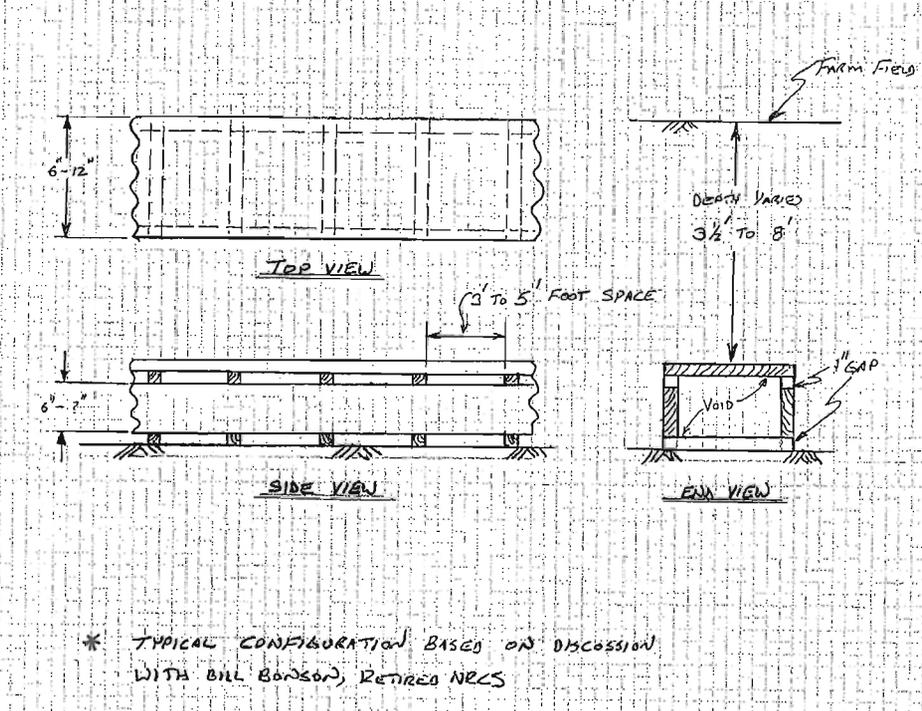
Figure A3

Figure provided by Larry Johnson State Conservation Engineer NRCS. He provided the following comments:

The depth of these types of structure varies ranging from 3.5 feet to 8 feet. The depth is dependent on the distance the drained farm field is to the outlet. Fields that are low and wet and constructing the drain sometimes required passing through areas that are not low. In order to maintain a free draining system and to maintain a positive drainage grade the excavation depth through dry areas was typically greater.

French Slough
Typical Detail Buried Drain
System Scheme from Period
JML April 2010

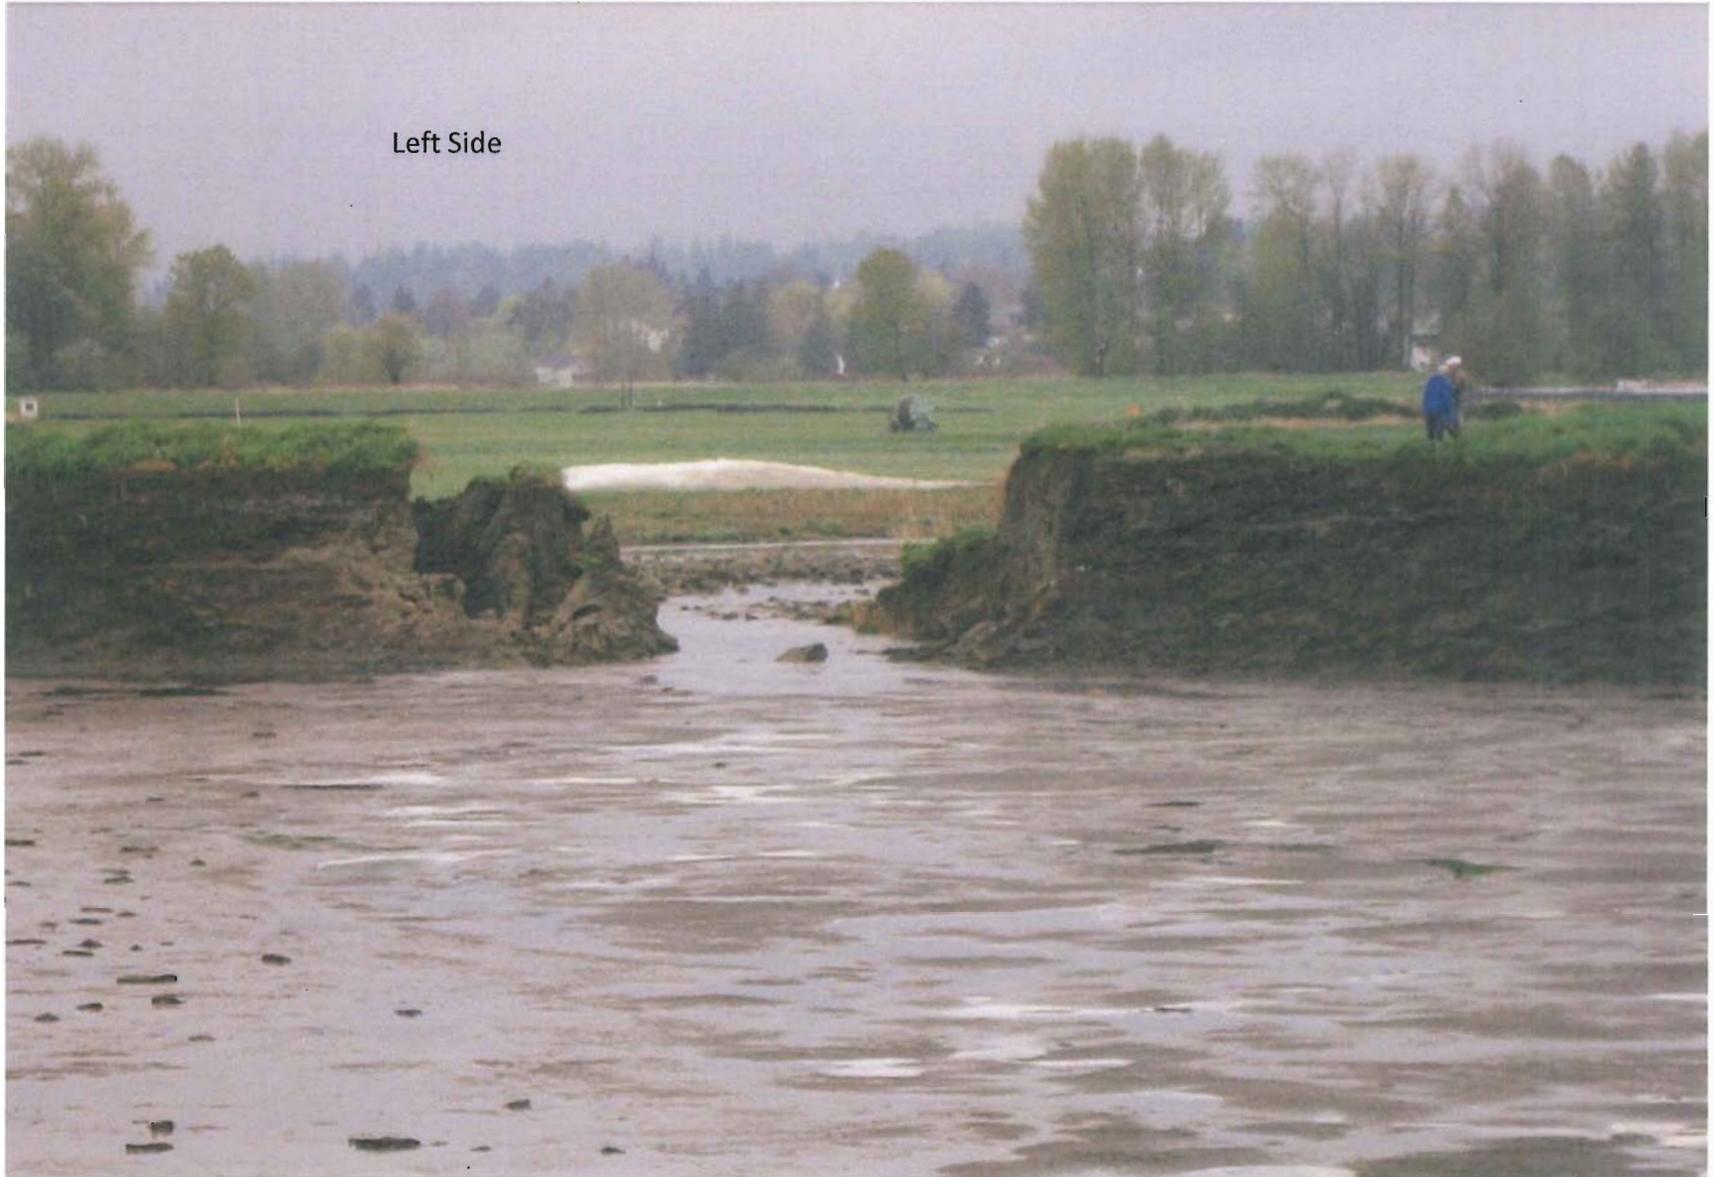
Left Side

View Out Breach

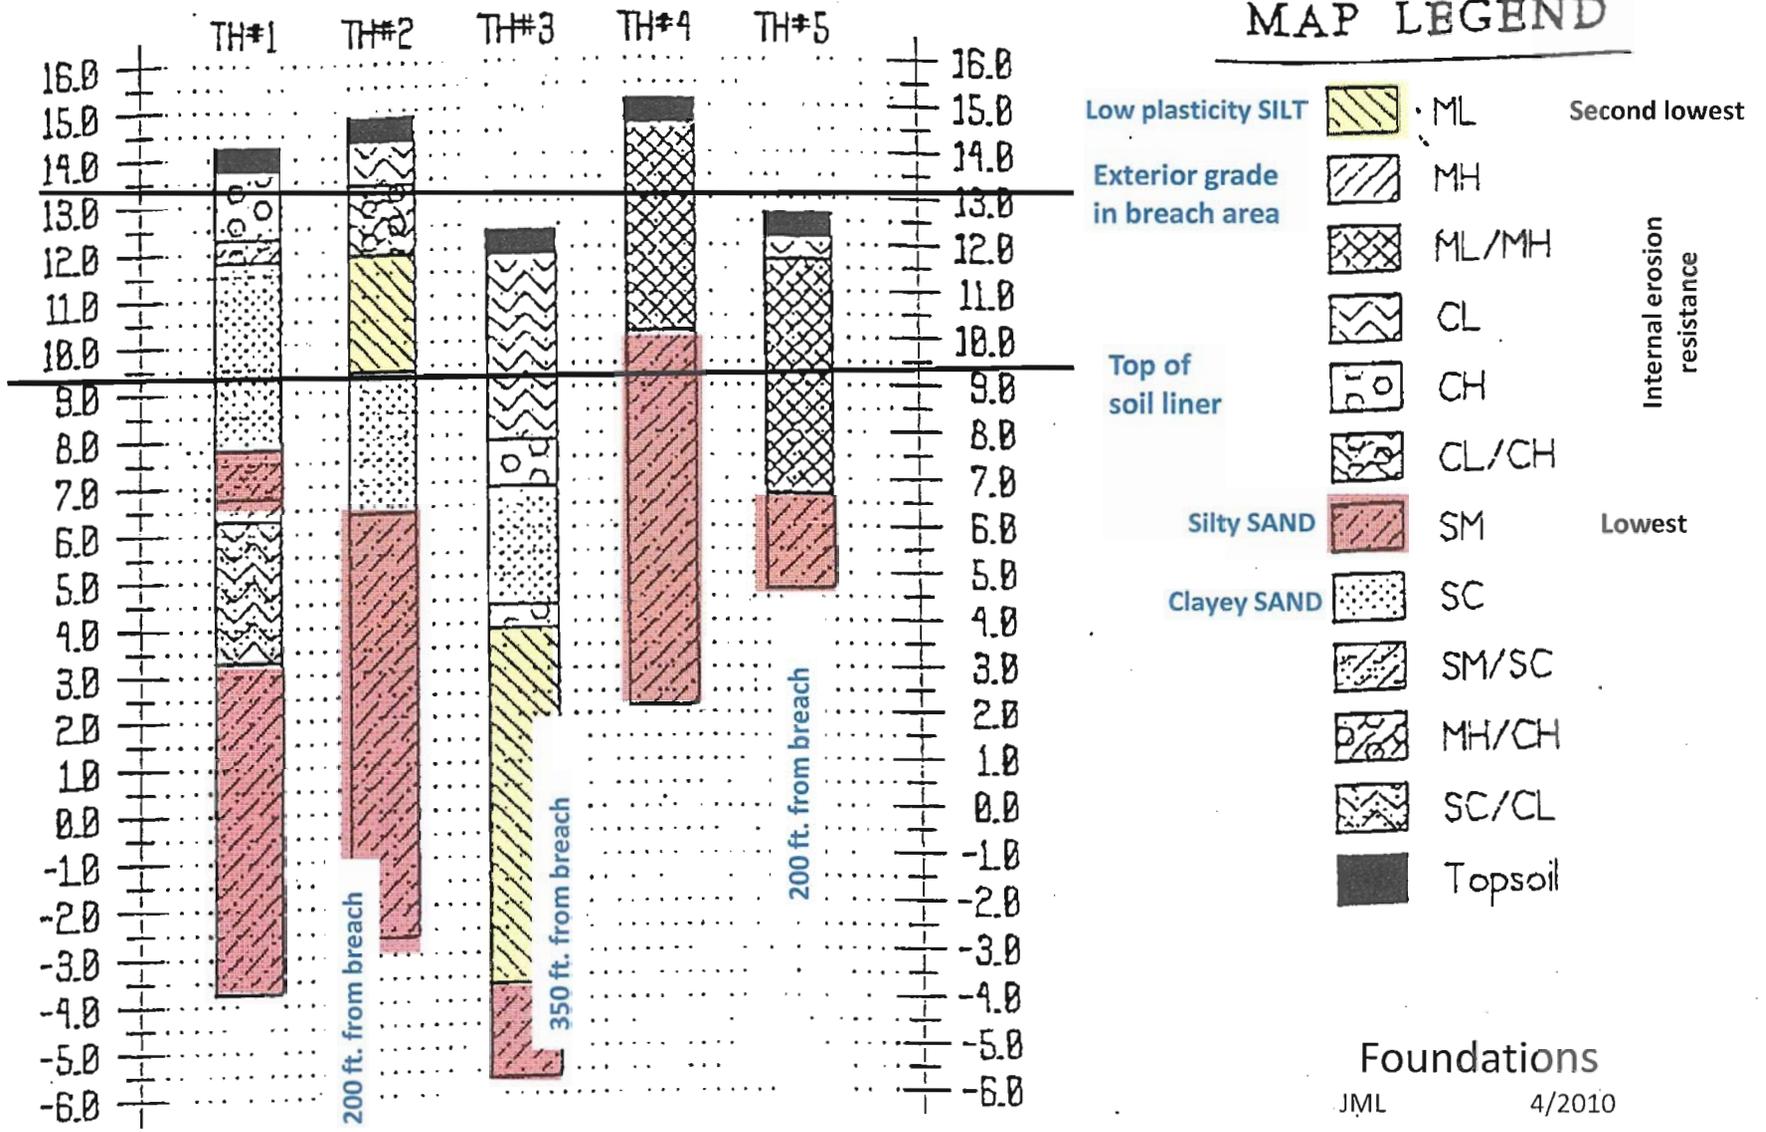
Figure A9

SOIL LOGS

Source: Plan Sheet 4 As-built Plans, NRCS, dated 9/18/1997 with highlights & notes added by LaVassar

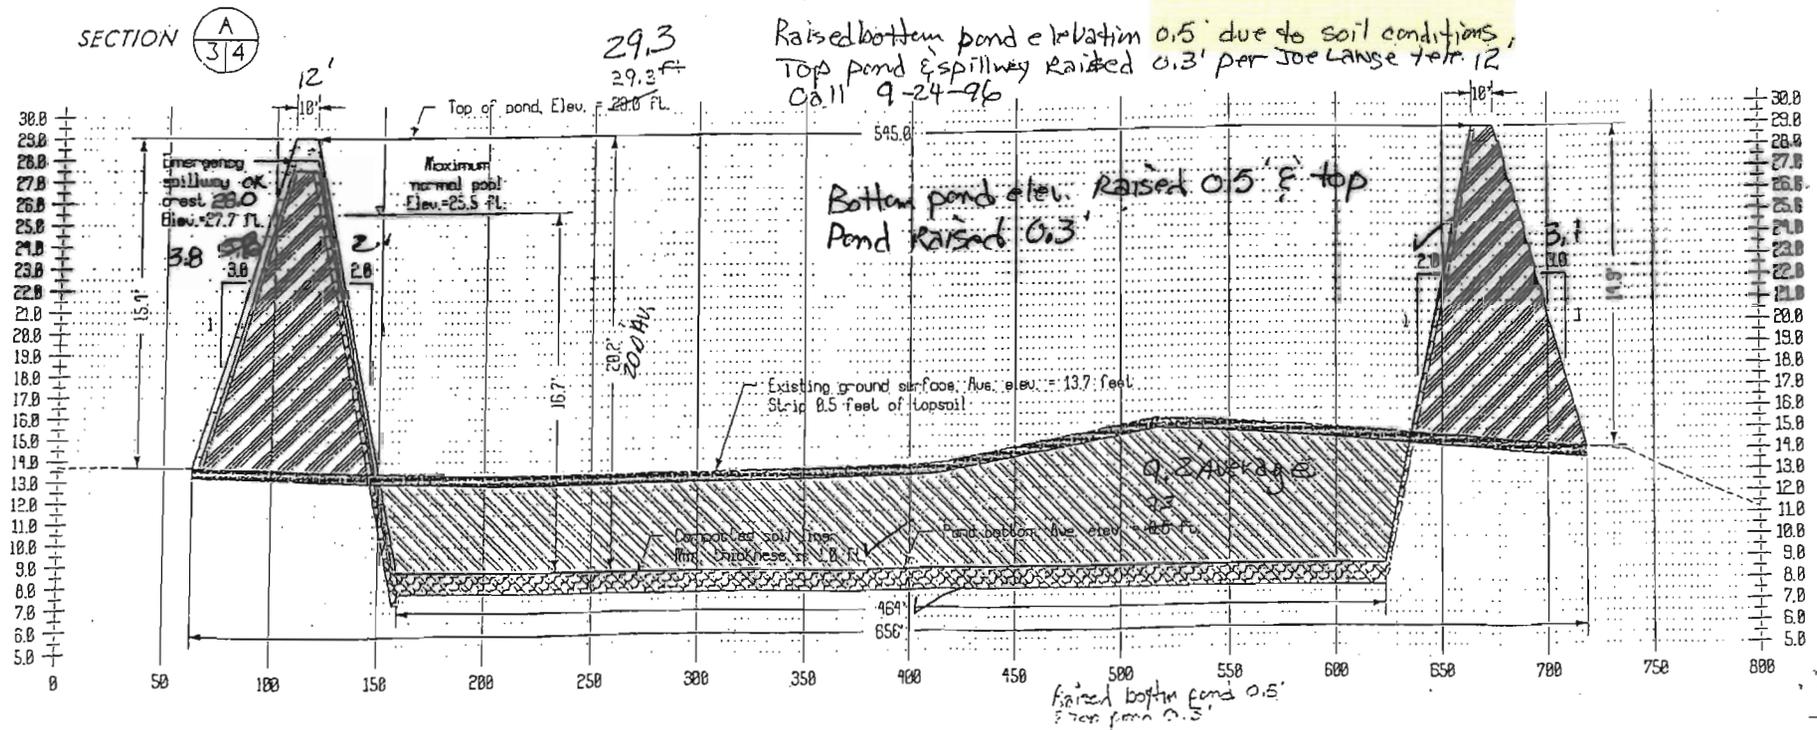
Source: As-built Plans NRCS Sheet 3 Section A.

Questions & Observations:

- 1) A hand written note states the pond bottom was raised "0.5' due to soil conditions". Ideally, the construction record identifies what soil conditions prompted that change.
- 2) The compacted soil liner is shown extending up the 2H on 1V interior pond sideslopes. Compacting this facing zone would have been a challenge. We can come up with schemes to do it, but they involve variously overbuilding the zone, bringing it up coincidentally with the adjacent section of the fill, yo-yoing a roller up the slope, or using a compactive plate hung off a backhoe boom. Again, ideally the construction records describe what was actually done.
