Re: Washington State Department of Ecology (Ecology) Assessment Report for Field Monitoring Activities conducted November 12, 2012 of the waste material near Riser 83 of the 241-AY-102 Double Shell Tank (DST)

ASSESSMENT REPORT

Project: 241-AY-102 Field Monitoring, Riser 83 Video

Location: 241-AY-102, 200 East Area, Hanford

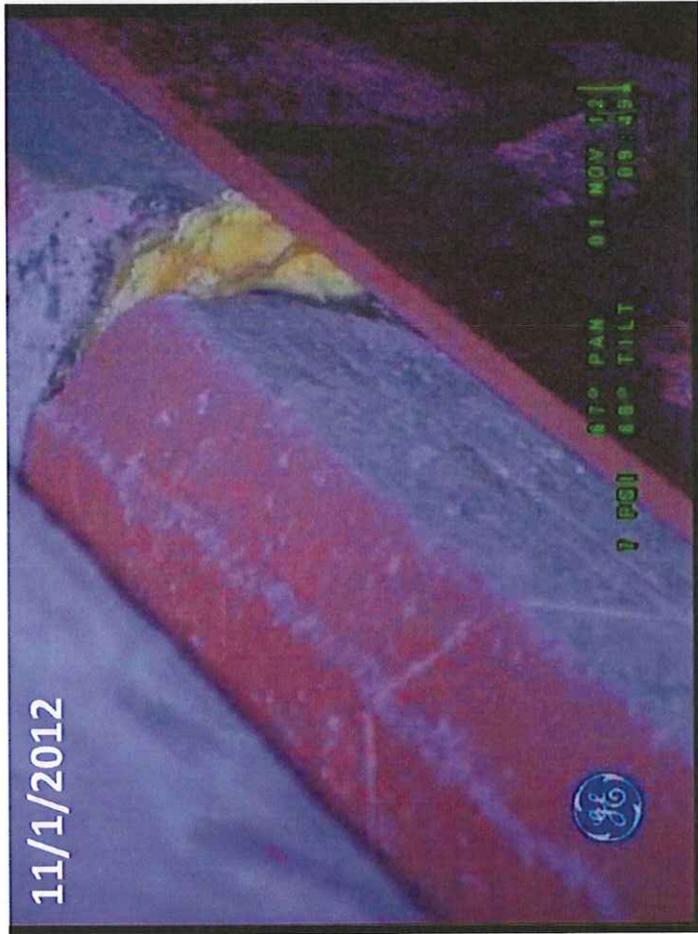
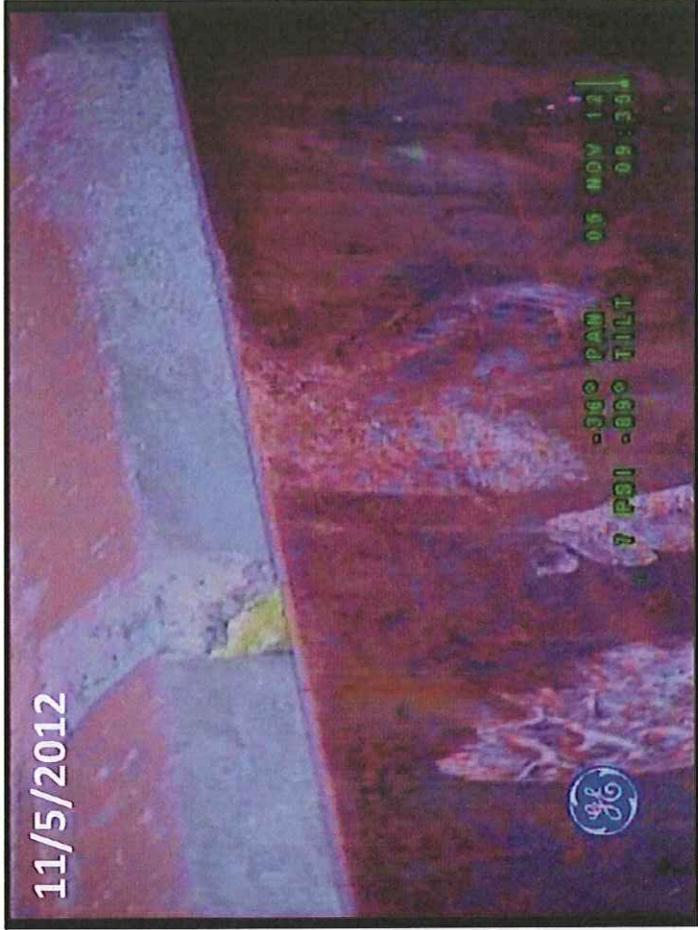
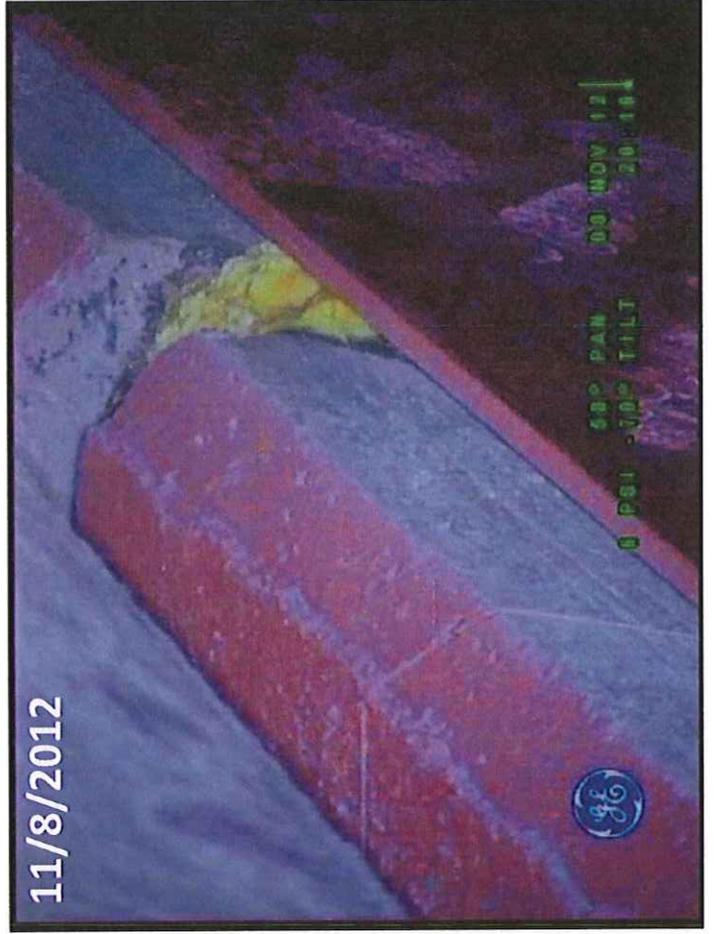
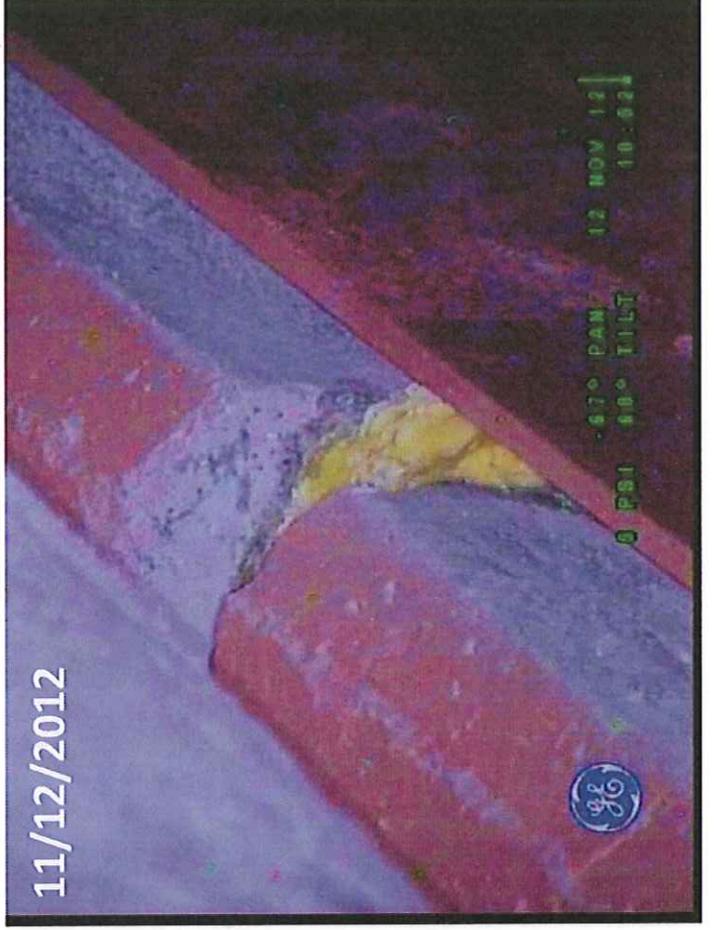
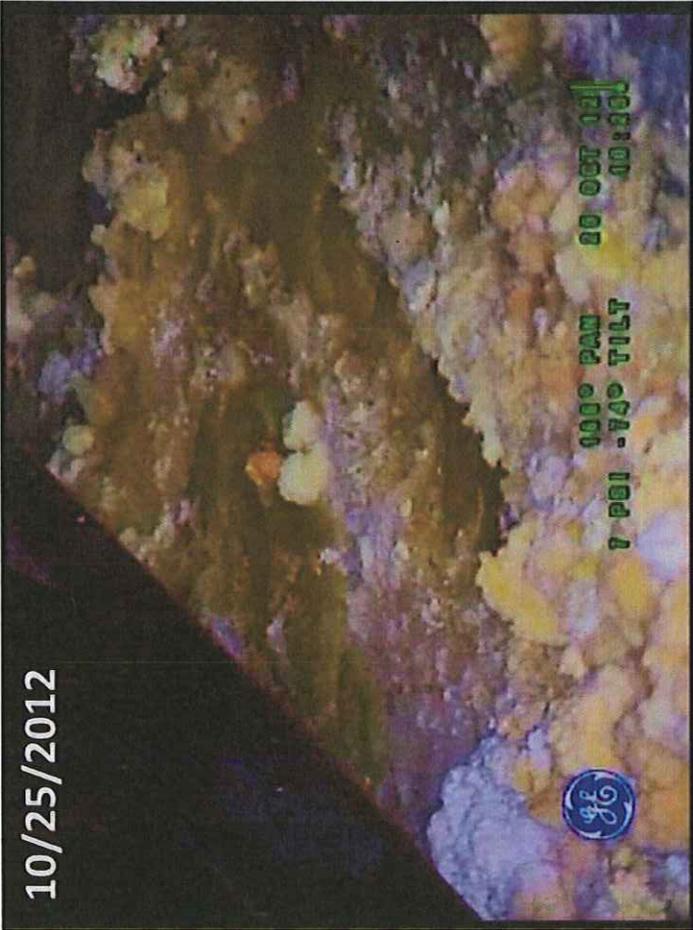
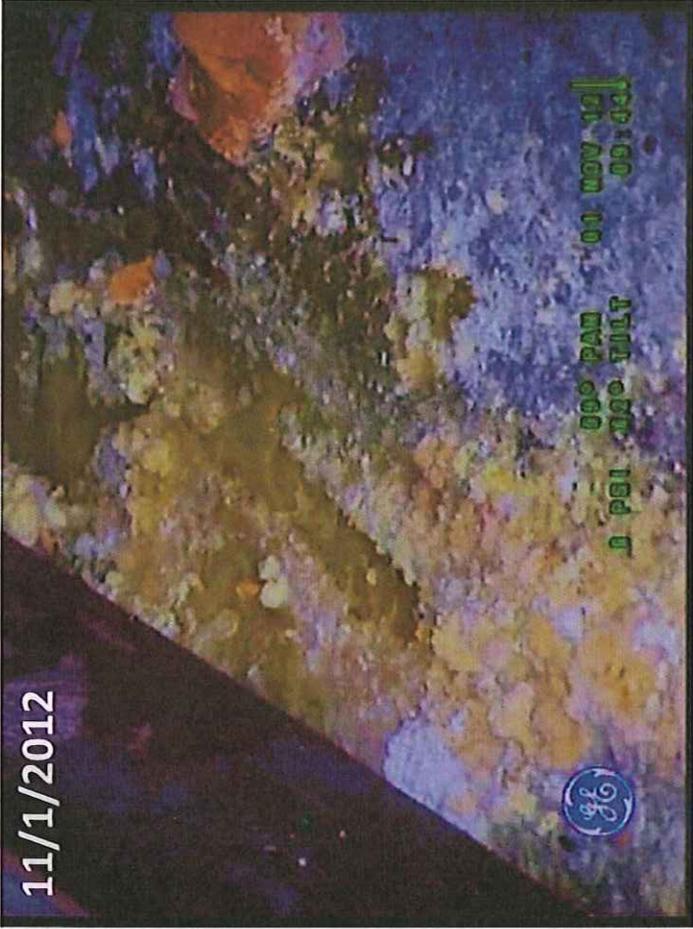
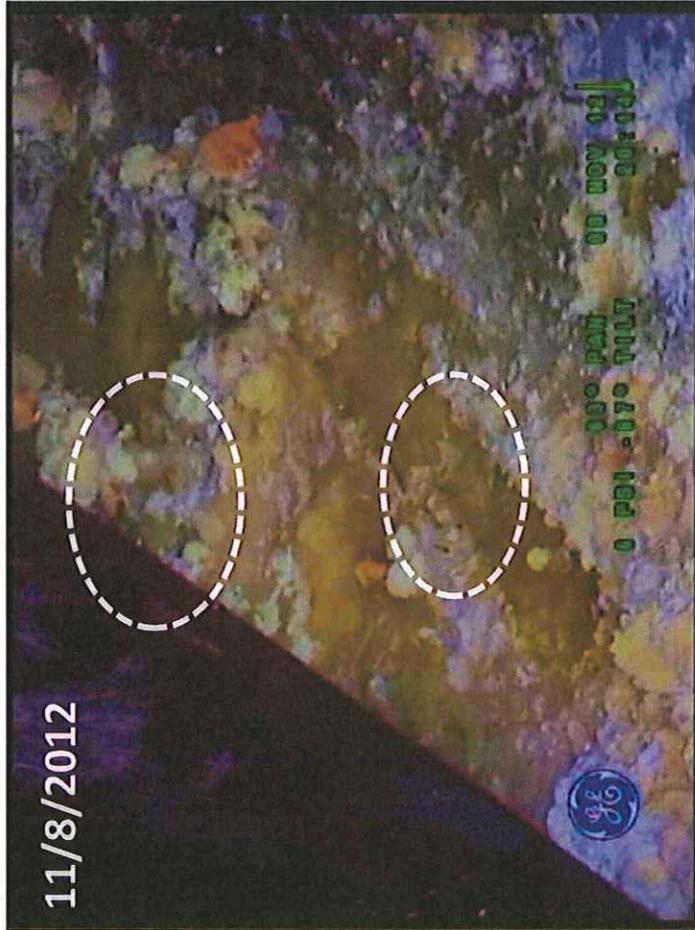
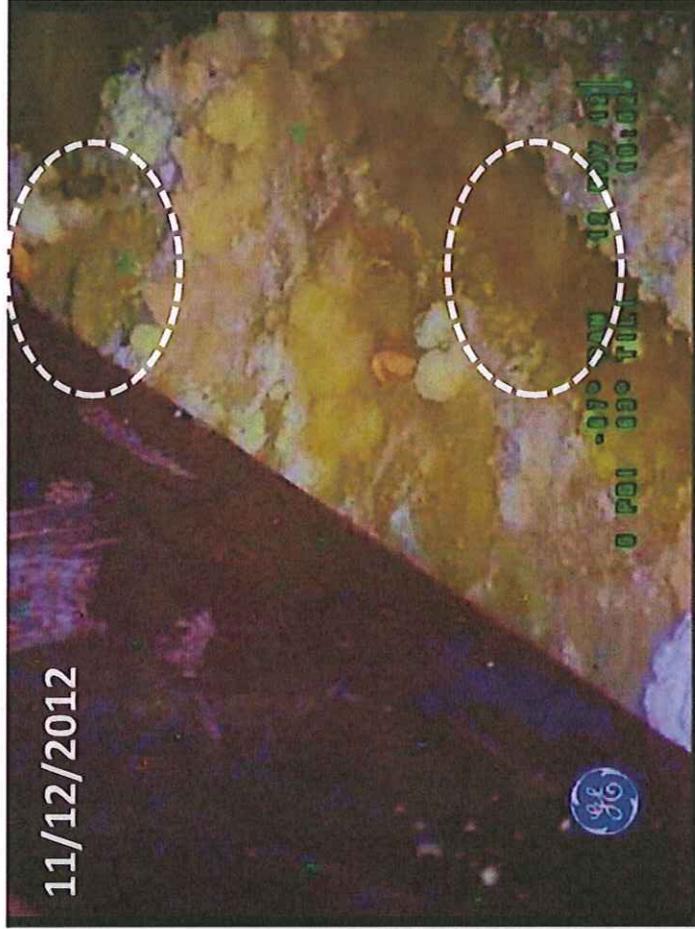
- The extent of the area of the waste material with respect to the annulus “landmarks” (orange foam pieces, black pebble, the ventilation slot, etc.) appeared to slightly grow as compared to the amount of material viewed during the visual inspection conducted 10/18/12 and 10/25/12.

- The moisture streaks on either side of the waste within the ventilation slot near Riser 83 once again appeared to be wet, indicating that the slow leak is still present and has not “self-healed”.

- The waste is in direct contact with tank components. During this inspection Ecology staff could not determine if the 6-inch wide carbon steel refractory ring, annulus floor, primary tank liner, or the refractory/concrete material showed staining, cracking, pitting, etc., at those specific locations, as a result of the direct contact. The lack of visual assessment is due to the increased crystal growth, especially in the lower two-thirds of the leak area within the annulus space near Riser 83.

- Ecology could not visually distinguish if any visual damage indicators such as staining, cracking, pitting, etc. of the 6 inch wide carbon steel refractory ring, annulus floor, primary tank liner, or the refractory/concrete material where the waste was in direct contact with the tank structures. This lack of visual assessment is due to the increased growth of crystals, especially in the lower 2/3rds of the leak area and increased amount of deposition of mineralization around the perimeter of the leak area within the annulus. It is unknown at this time what influence the waste will have that is contacting the annulus floor and refractory/concrete pedestal.
