Professional Engineer's Statement
Everett Smelter Cleanup
March 17, 2003

Everett Smelter Site

2002 Cleanup

Details of Cleanup Activities

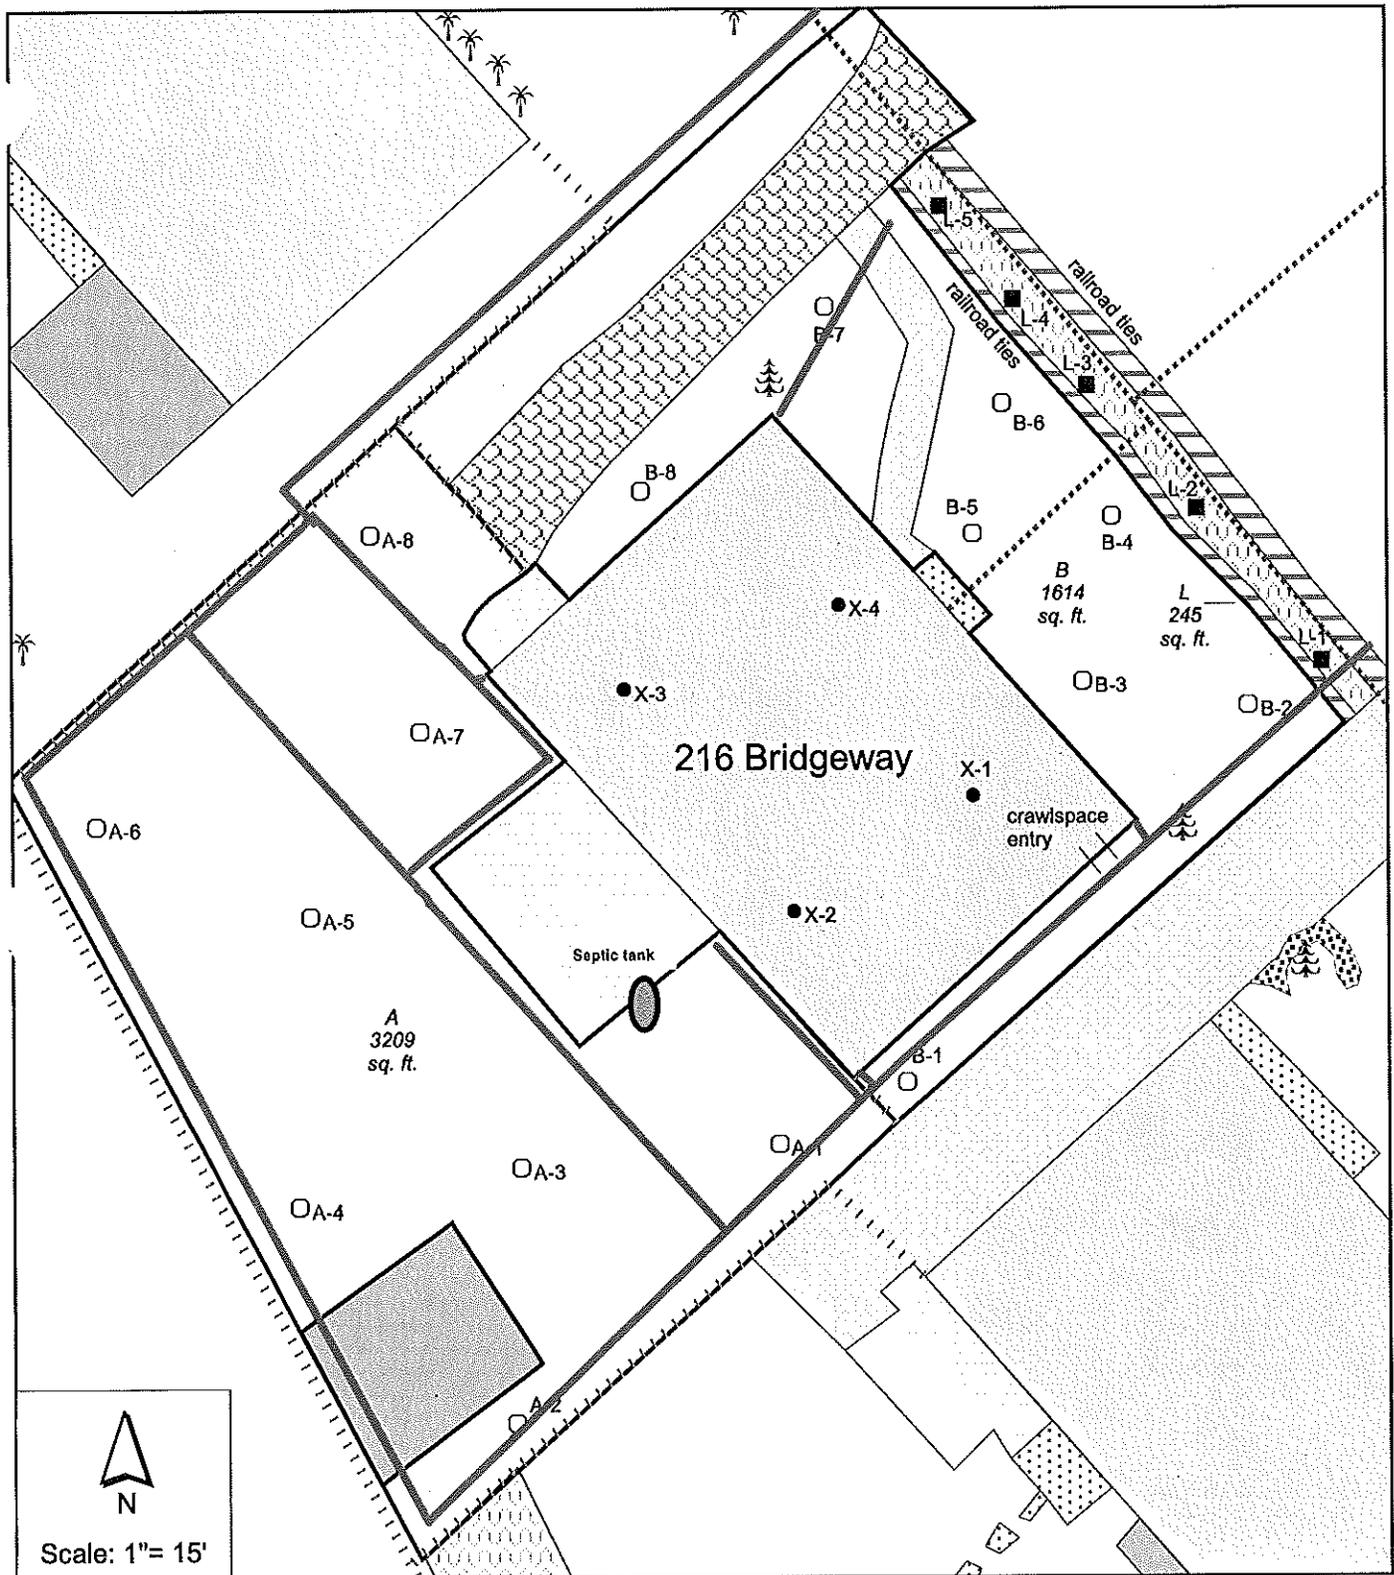
For the purposes of sampling to determine the depth to which excavation would be required, this property was divided into two Decision Units, A and B, as shown on the attached map. The following is a summary of the work done to remediate the property within each of the decision units.

Scale: 1" = 15'

Attachments: A. Site Map
B. Graphs of Arsenic Concentration vs. Depth
C. Explanation of graphs
