Publication No. 85-e27

DEPARTMENT OF ECOLOGY

MEMORANDUM

Subject: Completion Report on WQIS Project 4 for the Commencement Bay Nearshore/Tideflats Remedial Investigation: Sources of Sediment Contamination in Sitcum Waterway, With Emphasis on Ores Unloaded at Terminal 7

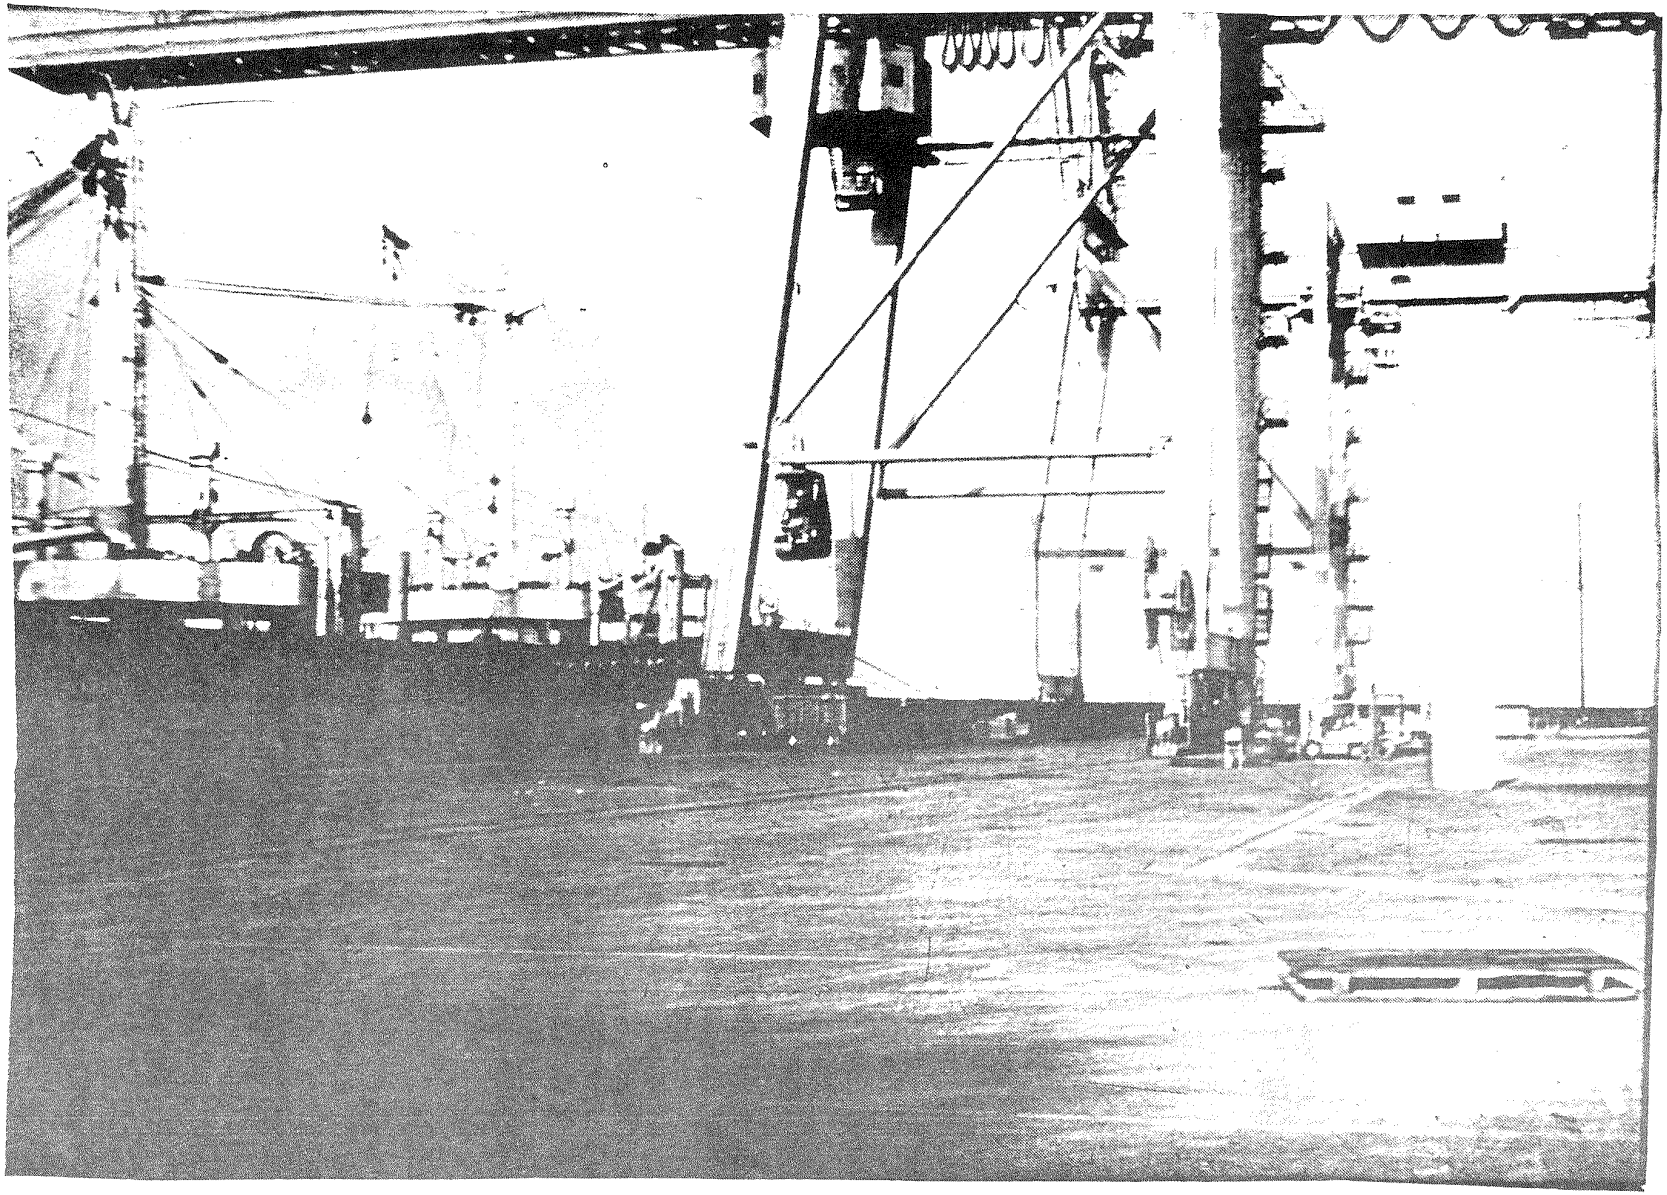
Most of the alumina brought into Terminal 7 is transferred by clamshell bucket to a conveyor system which carries the alumina directly to two storage domes. The domes, which were constructed in 1966 and 1968, have a combined capacity of 136,000 metric tons. Alumina is shipped out via containerized rail cars from Terminal 7. Other types of ores are also unloaded by clamshell bucket, but are transferred directly to open rail cars for inland distribution (Figure 3).

Figure 3. Ore unloading facilities at Terminal 7, Sitcum Waterway, March 27, 1984.

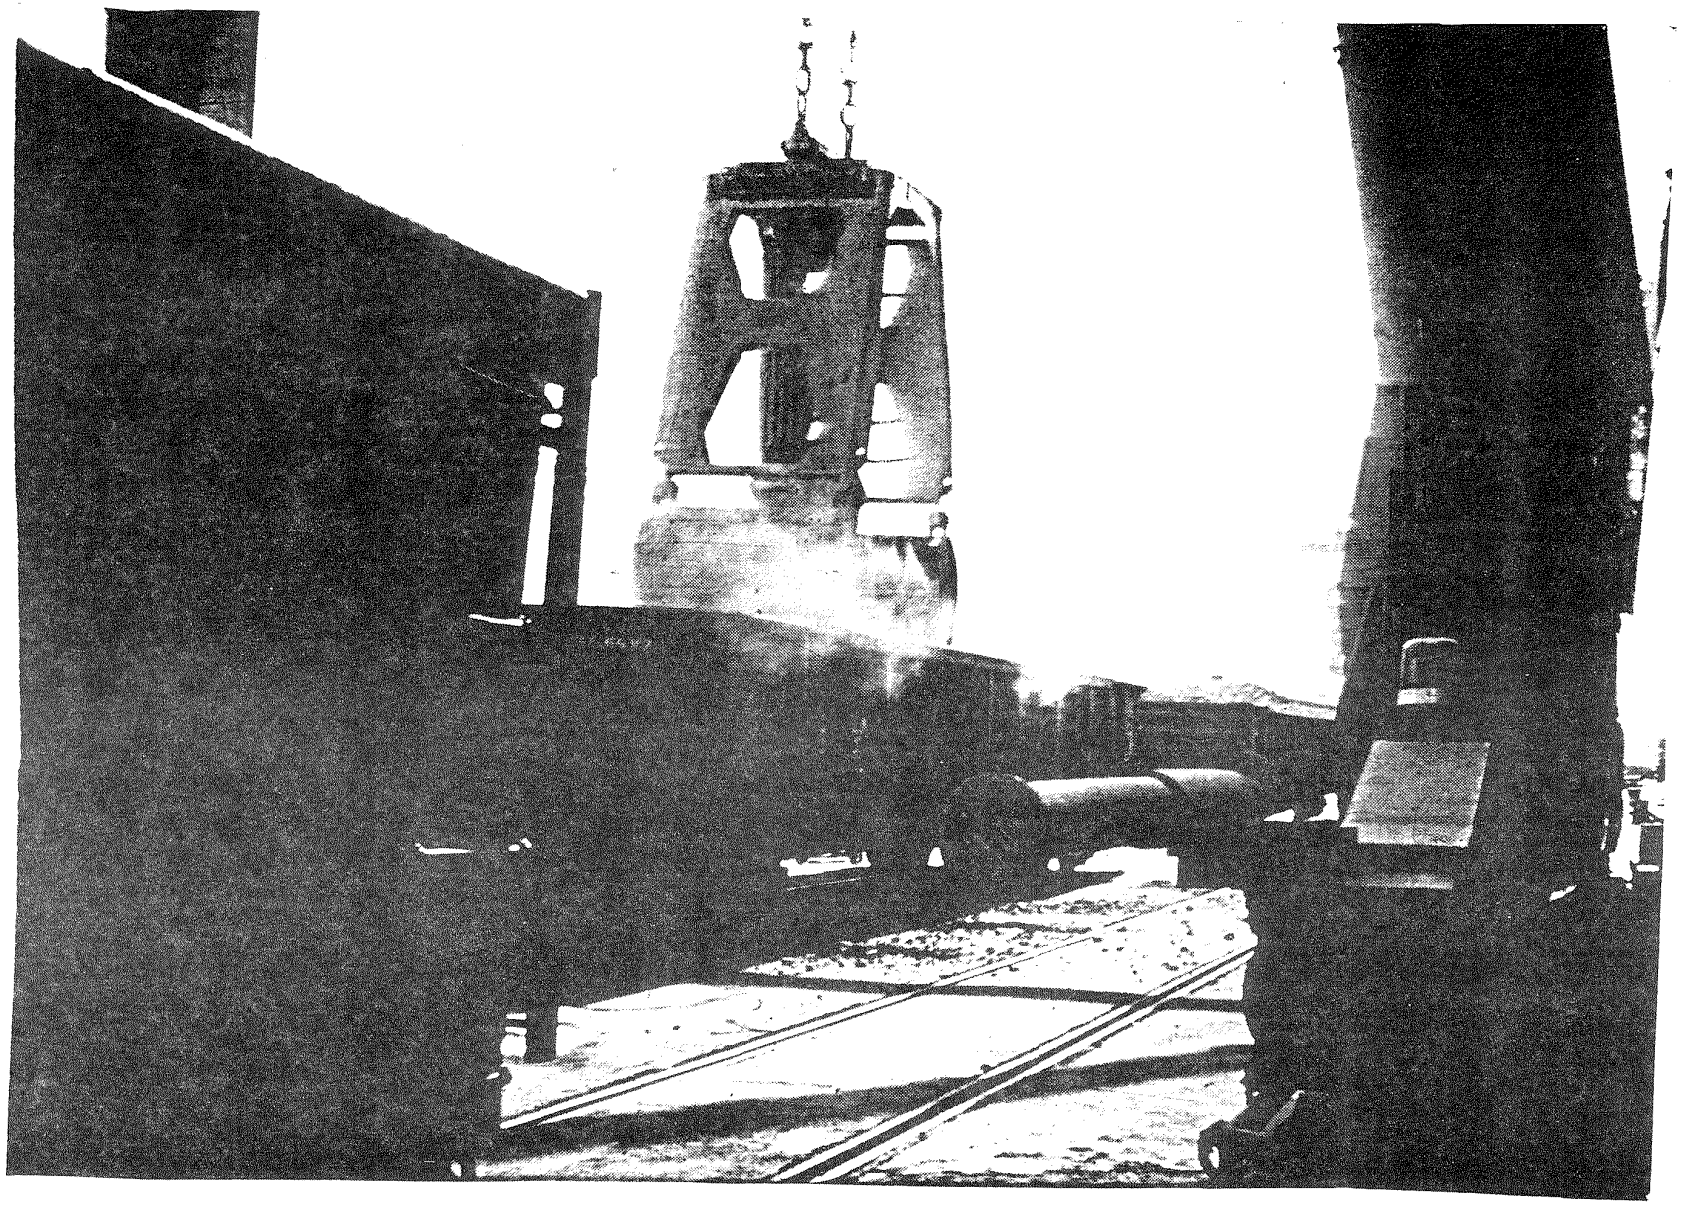
In the process of unloading alumina and ore, spillage occurs on the dock area (Figure 4). WDOE Southwest Regional Office (SWRO) records indicate that it has been the Port of Tacoma's standard practice to sweep up what material can be recovered and wash the remainder into Sitcum Waterway. WDOE also has received requests from the Port to allow discharge of cargo hold washwater directly into the waterway rather than the normal practice of discharge at sea.

Figure 4. Ore spillage during unloading at Terminal 7, Sitcum Waterway, March 27, 1984.

1. The WDOE SWRO should pursue control of the major metals sources (i.e., ore spillage from Terminal 7 and discharge from the North Corner drain) to Sitcum Waterway identified during the present survey.
