PORT TOWNSEND PAPER COMPANY
CLASS II INSPECTION

by
Don Reif

Washington State Department of Ecology
Environmental Investigations and Laboratory Services Program
Compliance Monitoring Section
Olympia, Washington 98504-6811

November 1988

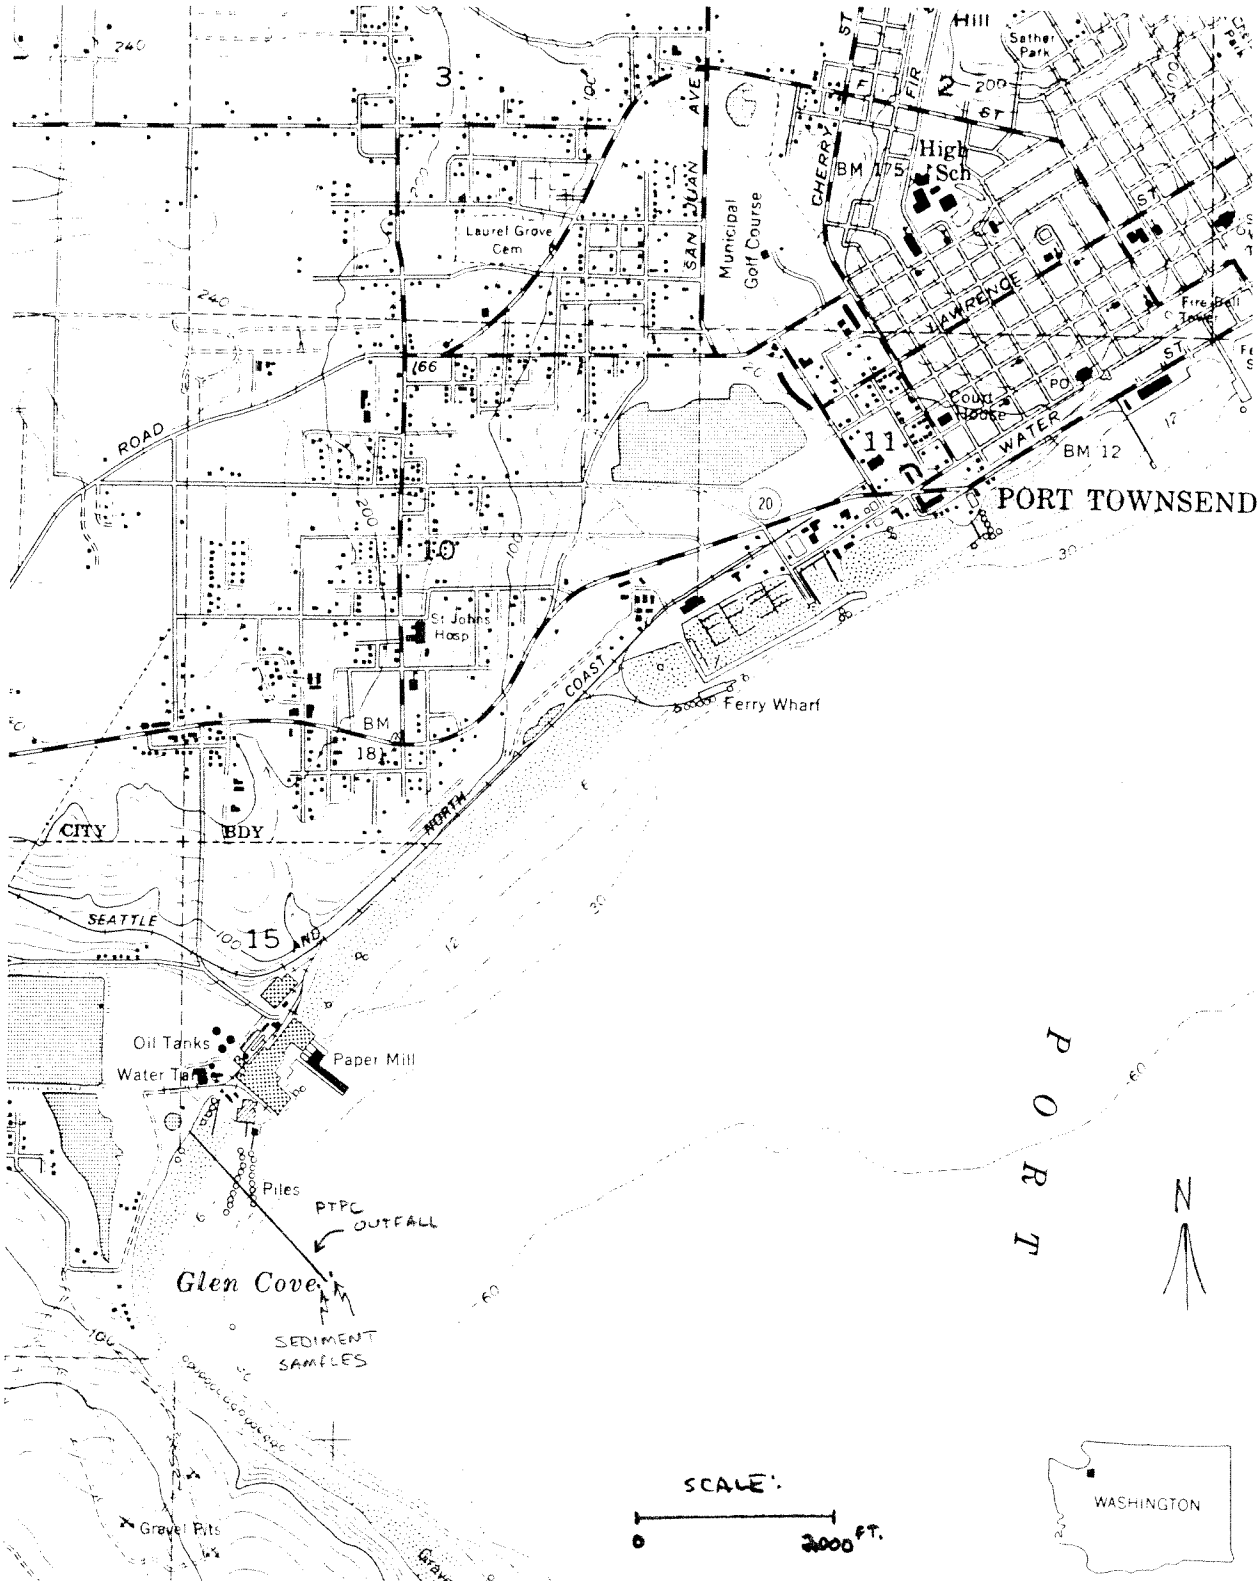
FIGURE 1. PTPC site with outfall and sediment sample locations.

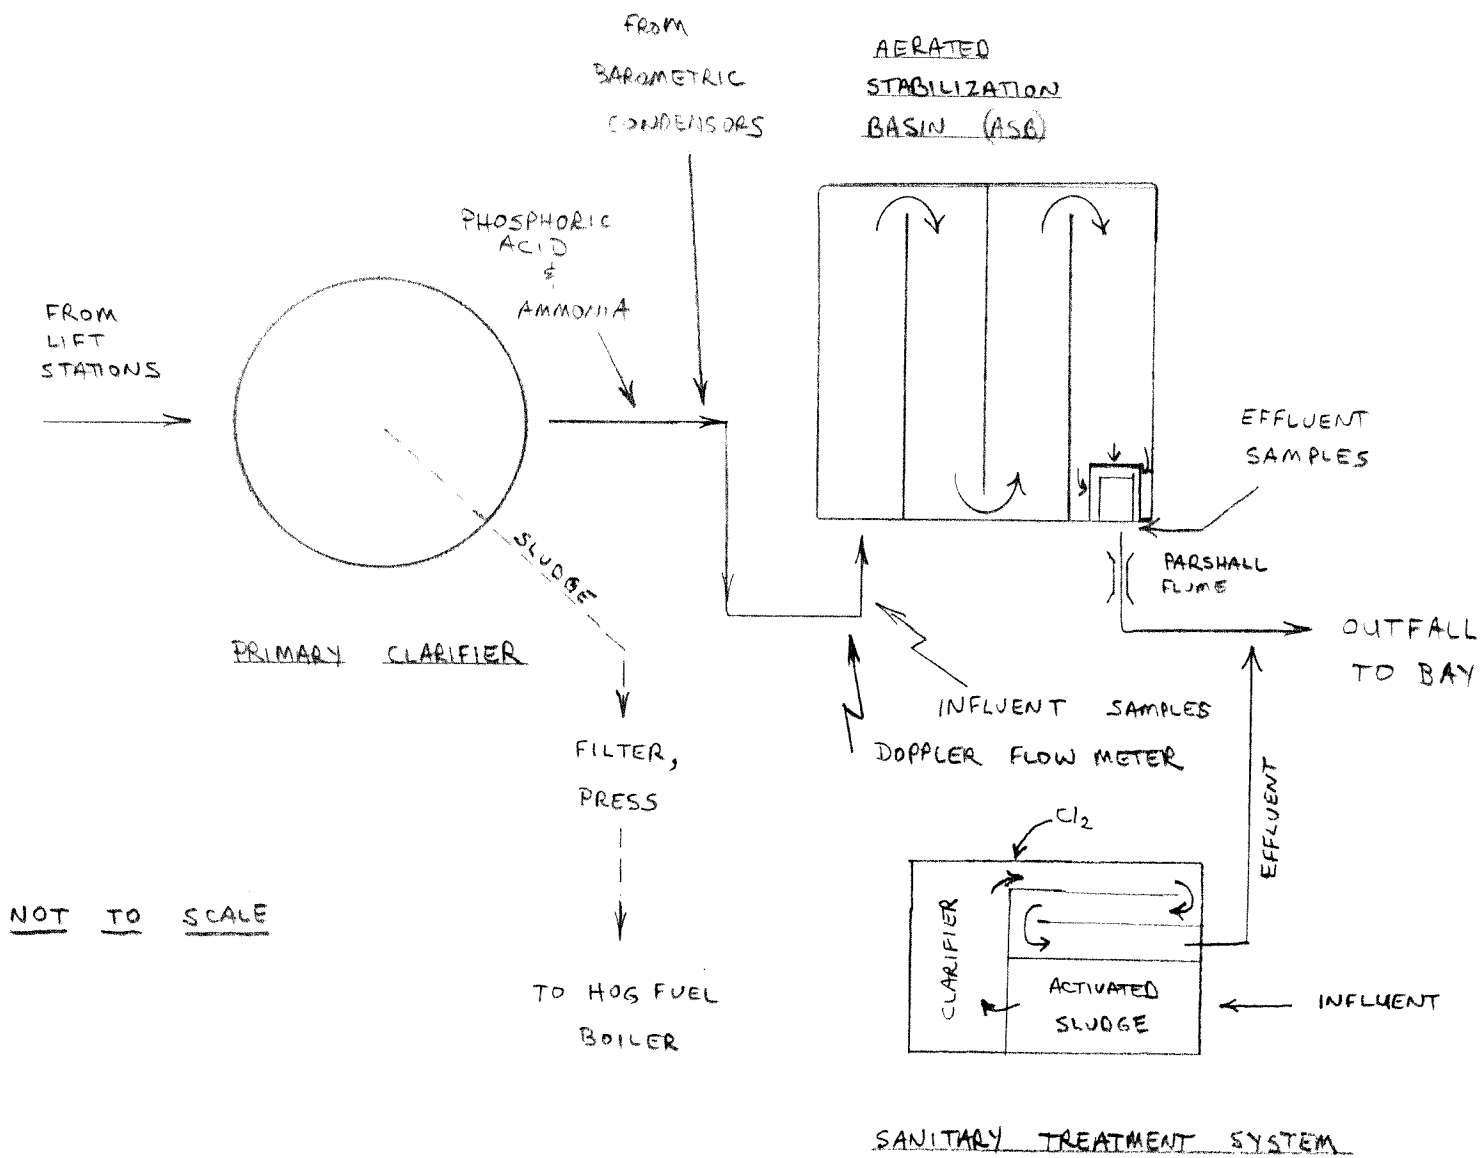
FIGURE 2. Process and sanitary treatment systems schematic: PTPC Class II Inspection; Dec. 1-2, 1987.
