**Professional Engineer's Statement  
Everett Smelter Cleanup, 2000-2001**

# Washington Department of Ecology Everett Smelter Site 2000-2001 Cleanup

## Details of Cleanup Activities

Address:  
230 Skyline Drive  
Everett, WA 98201

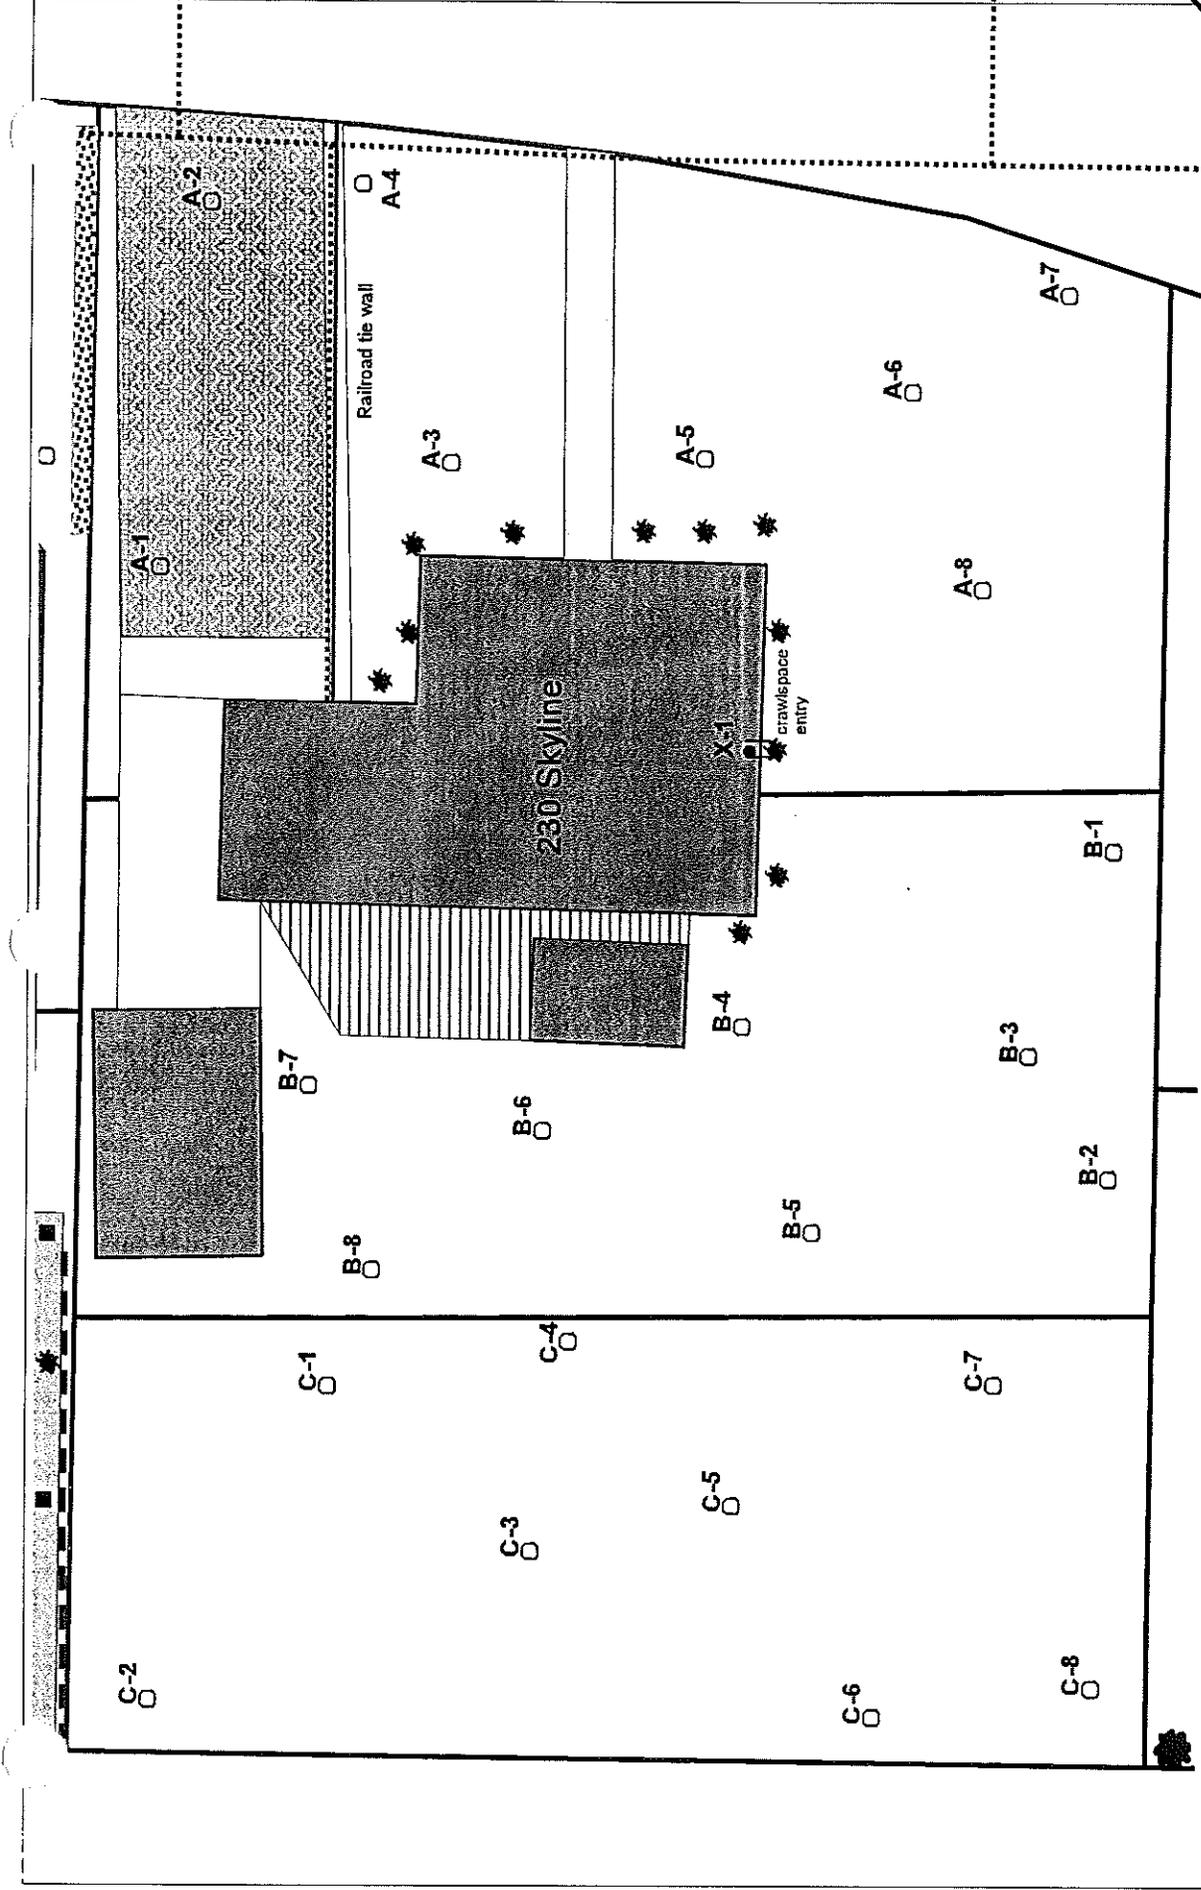
# 230 Skyline

This property was divided by Ecology into three Decision Units, A, B, and C, as shown on the attached map, for purposes of pre-cleanup sampling and decision-making regarding the depth to which excavation was required. The following is a summary of the work done in the remediation of the property within each of the decision units.

Everett Smelter Homesite Cleanup
