**Professional Engineer's Statement
Everett Smelter Cleanup, 2000-2001**

Washington Department of Ecology Everett Smelter Site 2000-2001 Cleanup

Details of Cleanup Activities

Address:
316 Skyline Drive
Everett, WA 98201

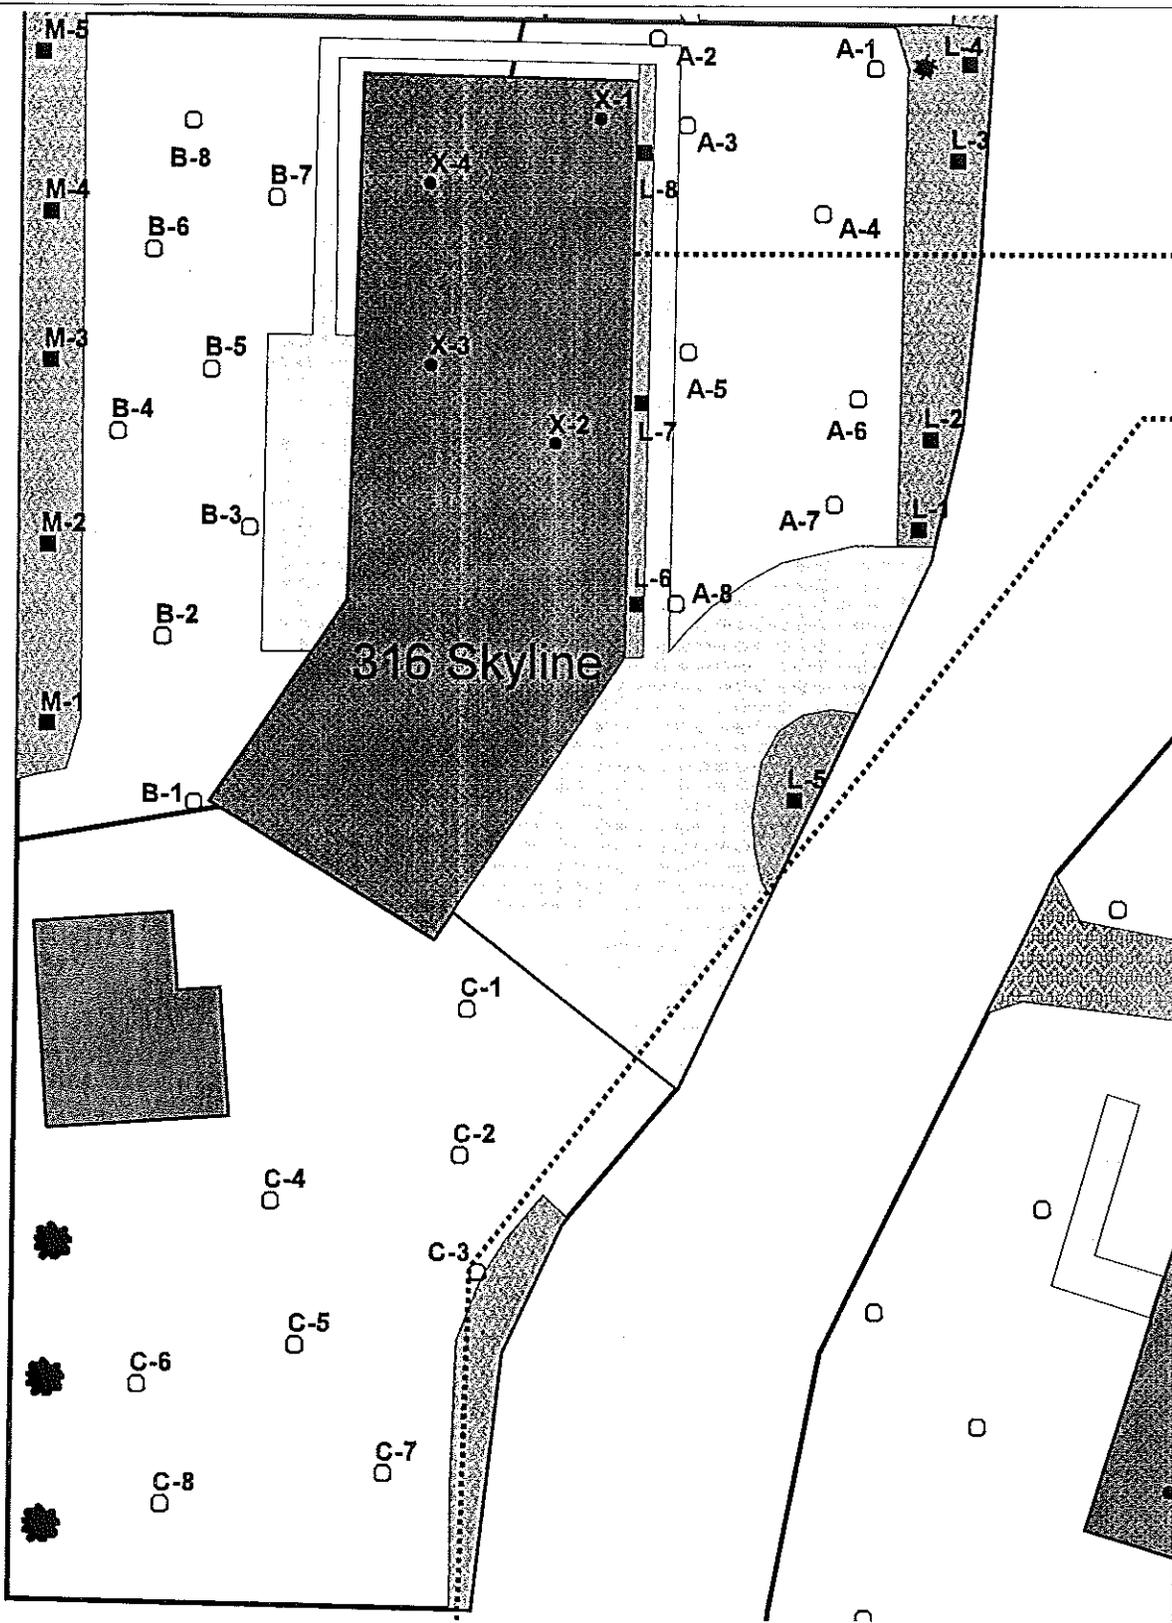
316 Skyline

Everett Smelter Homesite Cleanup

This property was divided by Ecology into three Decision Units, A, B, and C, as shown on the attached map, for purposes of pre-cleanup sampling and decision-making regarding the depth to which excavation was required. The following is a summary of the work done in the remediation of the property within each of the decision units.
