Stanwood Class II Inspection - September 8-9, 1992

by
Marc Heffner

Washington State Department of Ecology
Environmental Investigations and Laboratory Services Program
Toxics, Compliance and Ground Water Investigations Section
Olympia, Washington 98504-7710

September 1993

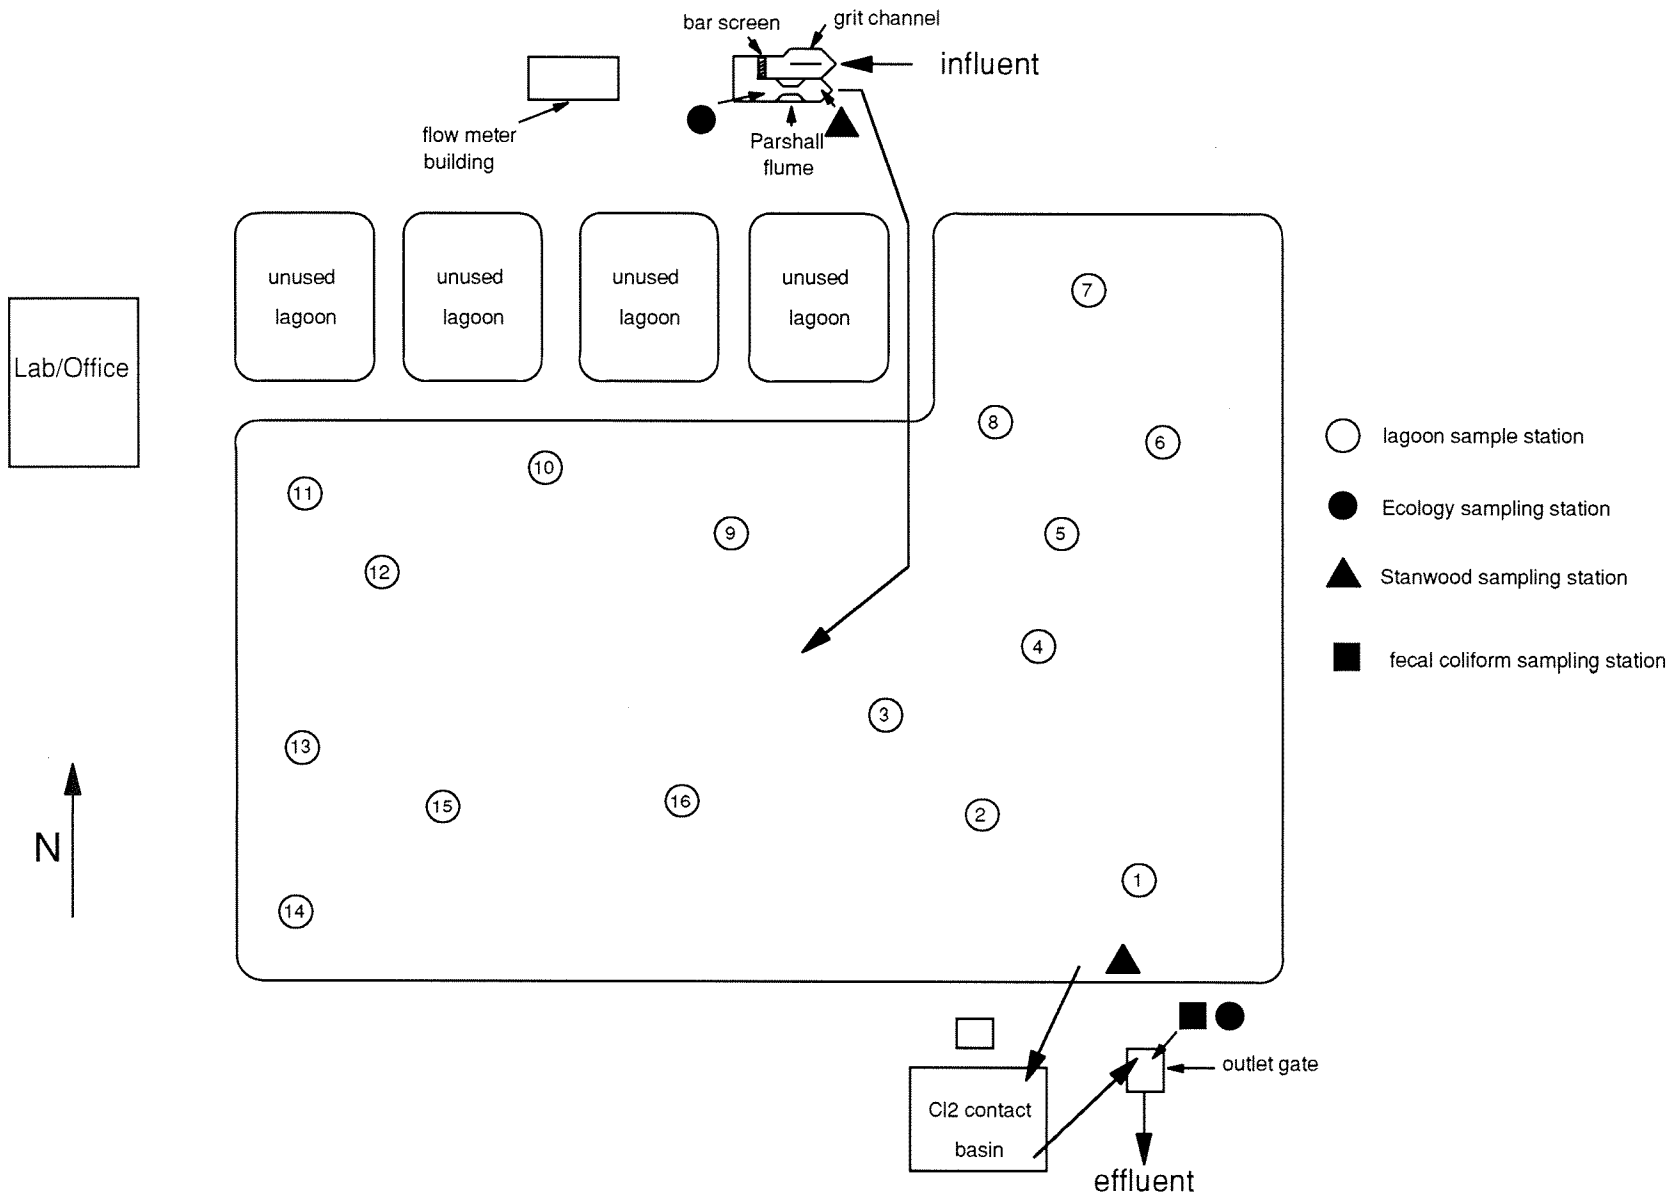
Figure 1 - Flow Scheme - Stanwood, September 1992.

Stanwood operates a secondary wastewater treatment system. The system consists of headworks, a stabilization pond (lagoon), and chlorination facilities (Figure 1). Wastewater discharge to the Stillaguamish River is regulated by NPDES Permit No. WA-002029-0. The permit expired on September 14, 1987, but is still in force pending a new permit.

The Stanwood facility treats wastewater flows from Stanwood plus septage. Influent flow passes through the headworks consisting of a grit channel, bar screen, and Parshall flume (Figure 1). Septage also enters the system at the headworks. Wastewater is then routed to the 36-acre lagoon. Four small lagoons are also available, but were not being used. The four lagoons had been out of service for some time. The lagoon effluent is chlorinated and routed through a chlorine contact chamber. The chlorine contact chamber was unusual. It had numerous small compartments with gates in between allowing various routing and detention time options. At the time of the inspection, few of the gates worked and only one routing option was available. The treated wastewater then passed through an outlet gate and was discharged into the Stillaguamish River.

The lagoon system operates as a continuously discharging facility during the wet season and an intermittently discharging facility during the dry season. Hydraulics allow the plant to discharge only during low and moderately high tides. For roughly the first hour of a discharge cycle, flow consists of the water held in the chlorine contact basin since the last discharge cycle. The water had been previously chlorinated, but has no chlorine residual at the time of discharge.

After the receiving water study and Class II Inspection were completed, the lagoons were scheduled to be drawn down to allow repair of the chlorine contact chamber gate system.
