**Professional Engineer's Statement  
Everett Smelter Cleanup, 2000-2001**

# Washington Department of Ecology Everett Smelter Site 2000-2001 Cleanup

## Details of Cleanup Activities

Address:  
415 Legion Drive  
Everett, WA 98201

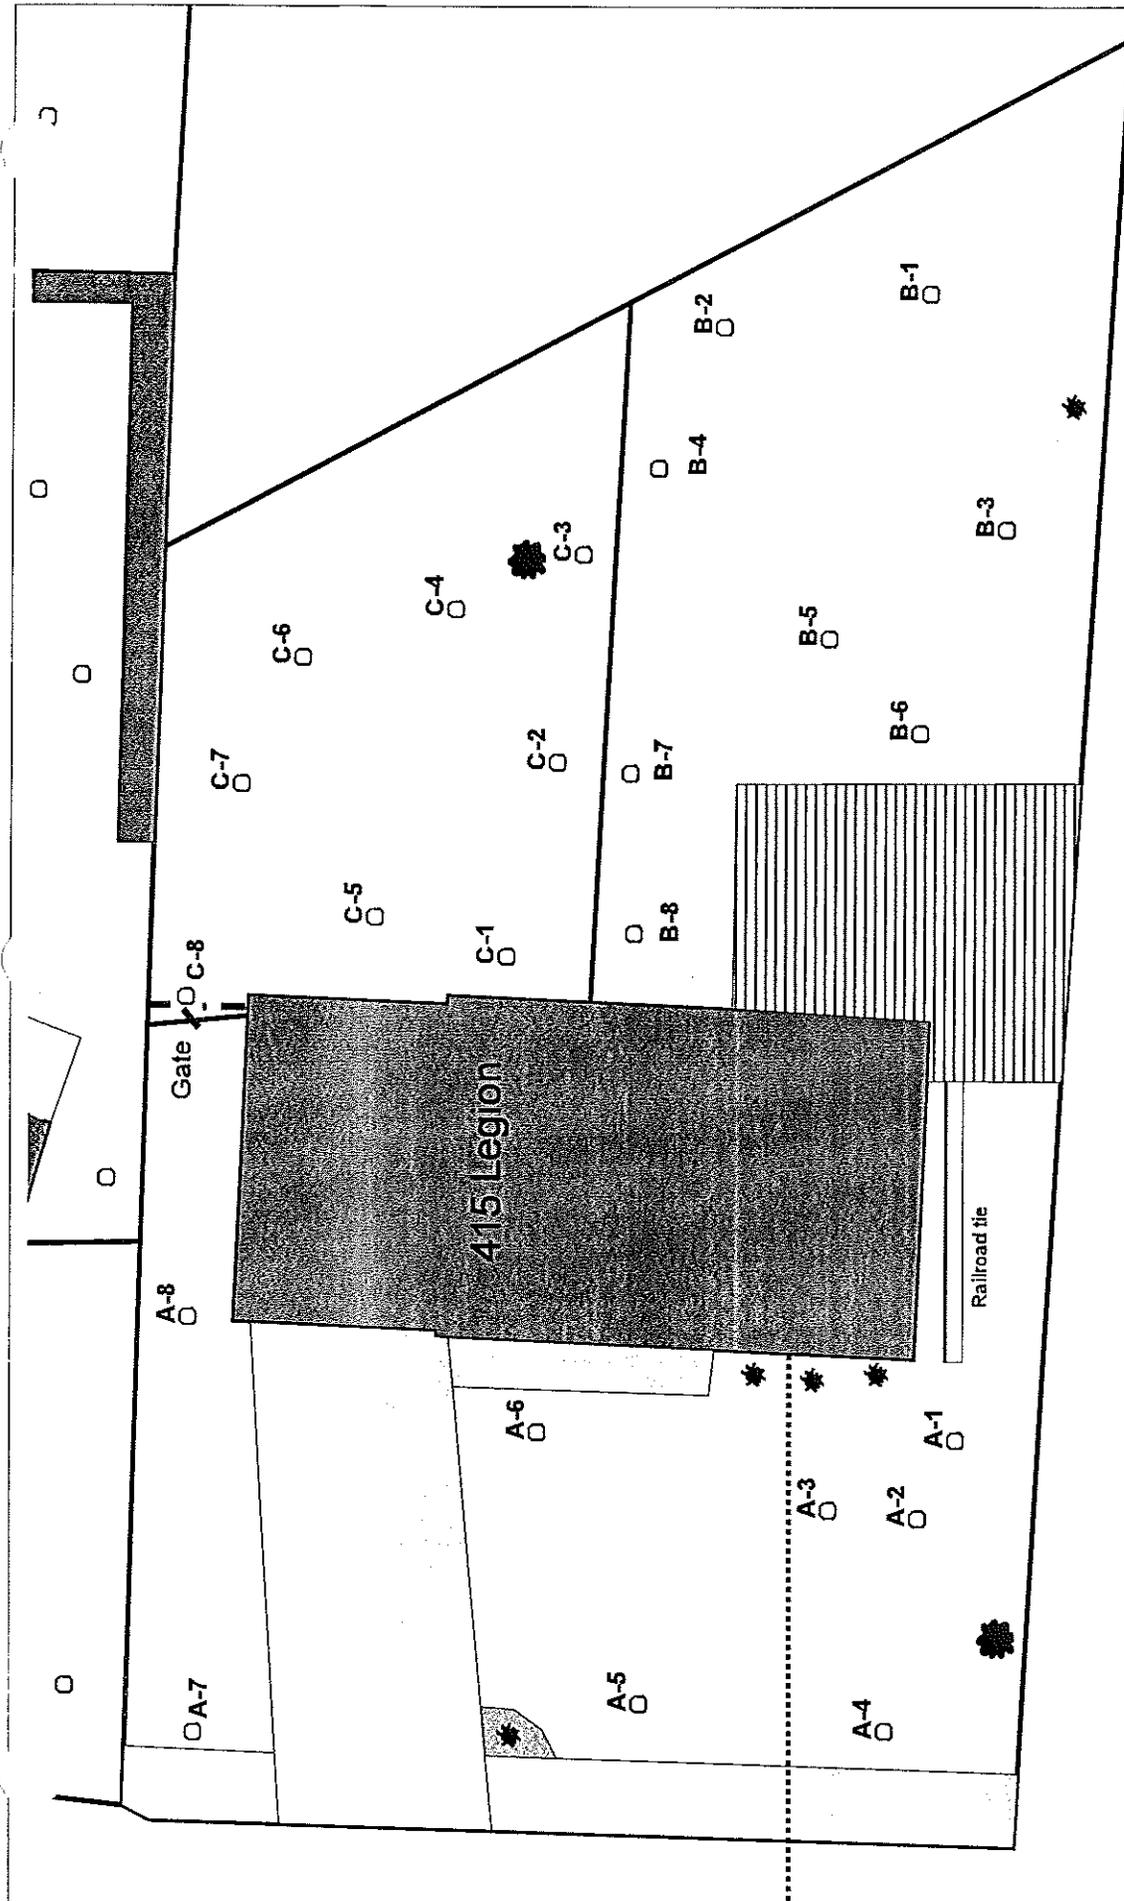
**415 Legion**  
 Everett Smelter Homesite Cleanup  
 Source: Snohomish Health District

This property was divided by Ecology into three Decision Units, A, B, and C, as shown on the attached map, for purposes of pre-cleanup sampling and decision-making regarding the depth to which excavation was required. The following is a summary of the work done in the remediation of the property within each of the decision units.

○ DU Samples
