MEMORANDUM

February 14, 1978

Re: Impact of International Paper Company's wood products mill effluent on the receiving waters of the Upper Chelatchie Creek Drainages

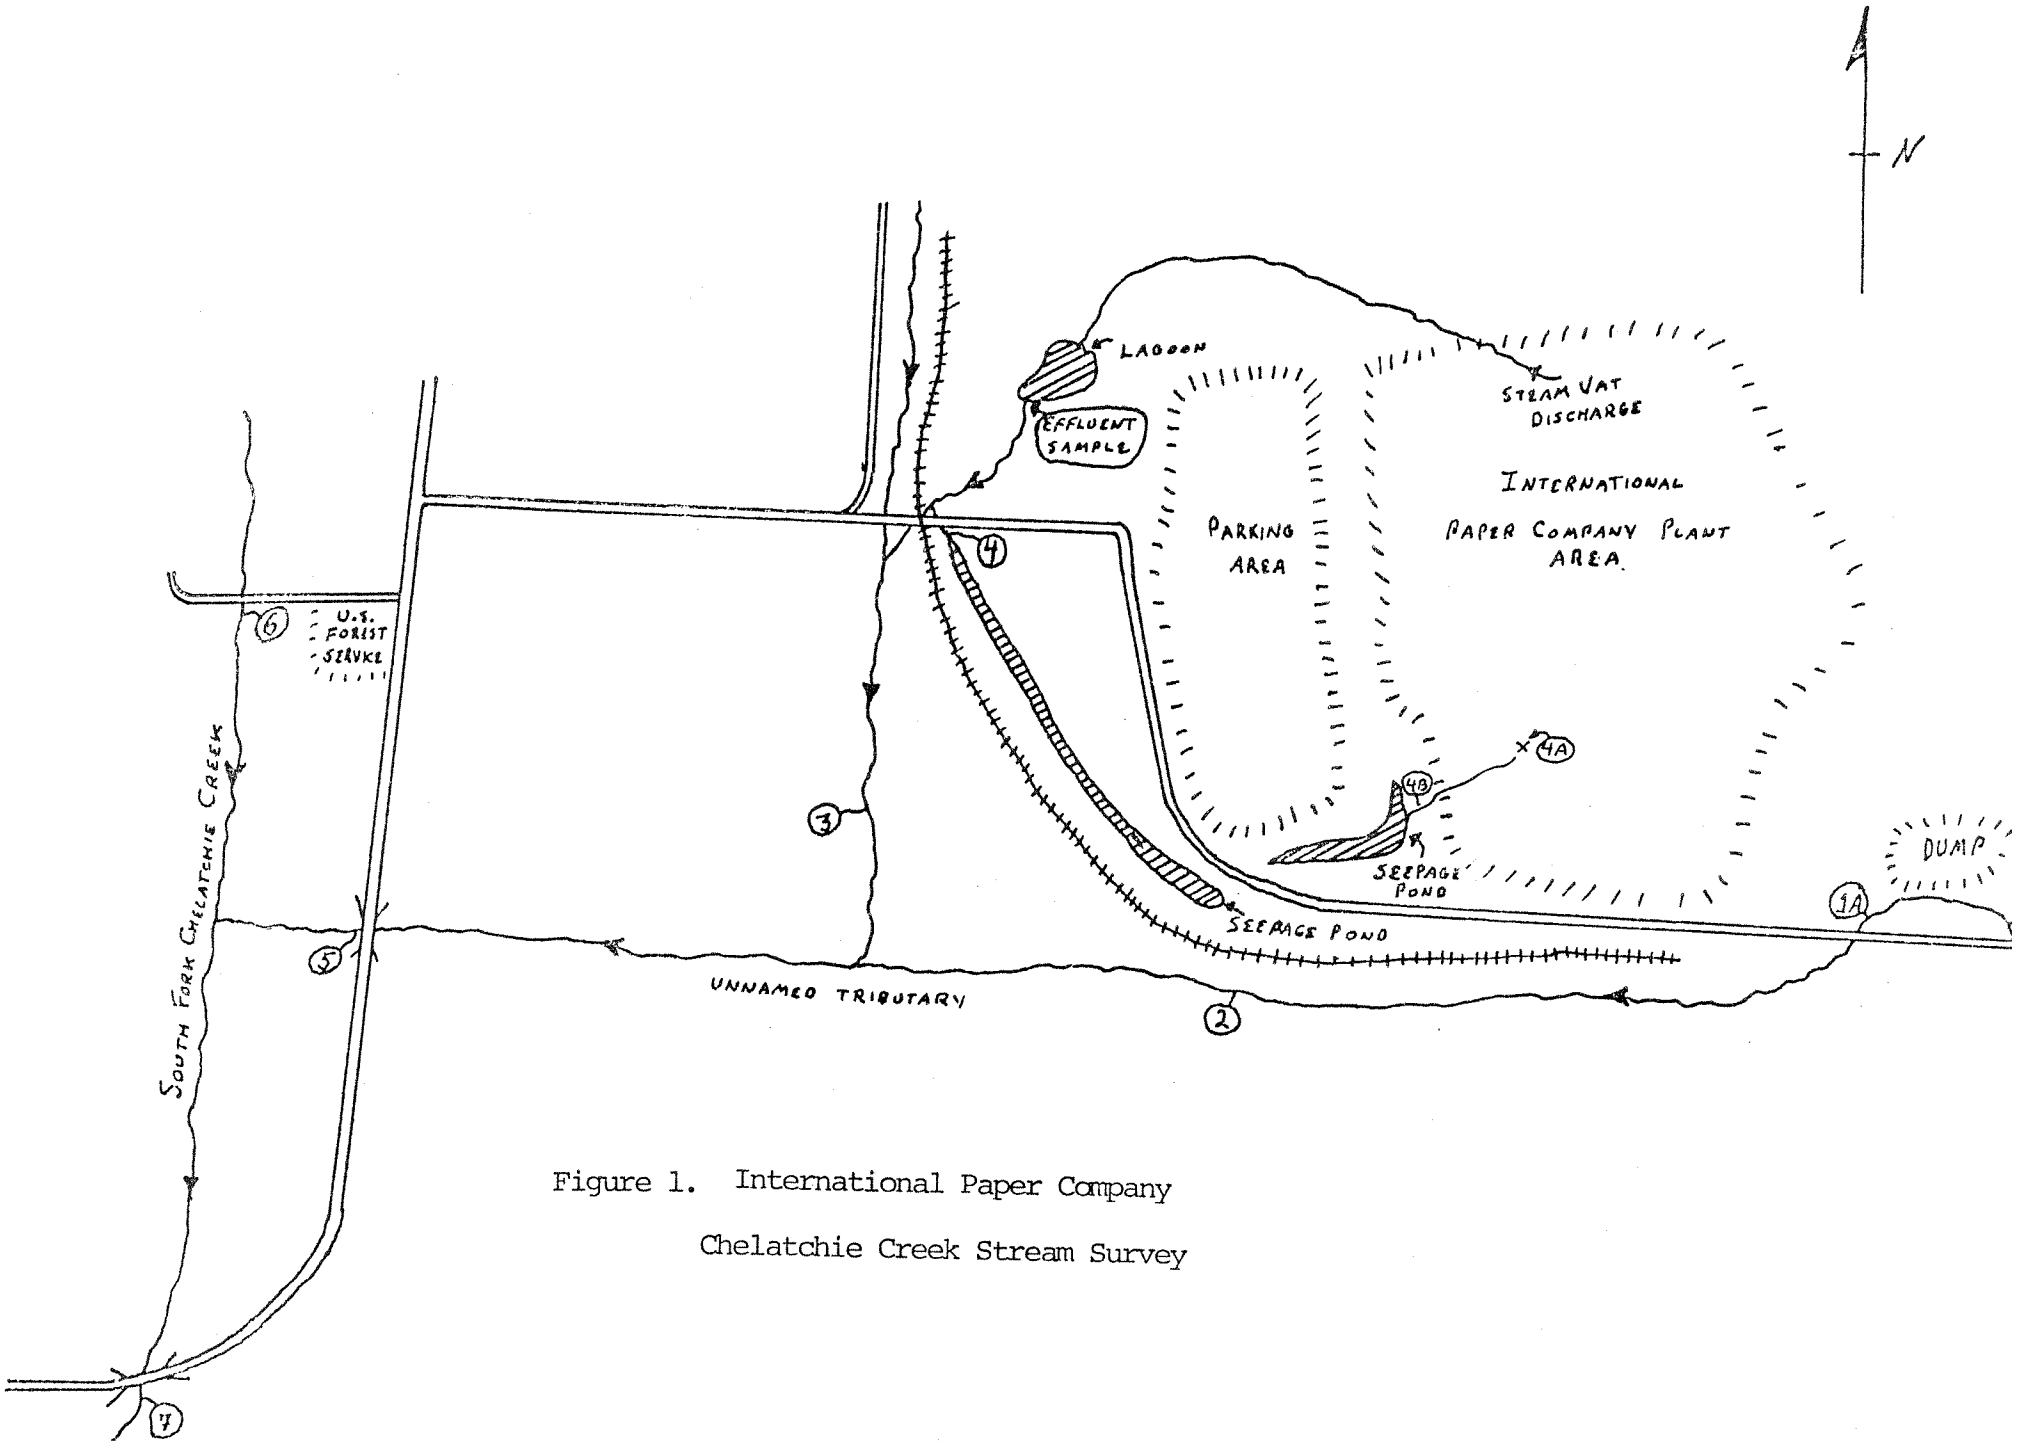
Figure 1. International Paper Company

Figure 1 depicts the study area and locates sampling points. Tables 1, 2 and 3 report the results of field and laboratory analyses of samples taken at each of the sampling locations. Care should be exercised in interpreting the nutrient data as nutrient samples were inadvertantly discarded and nutrient analyses were performed on samples which were neither acidified nor continually iced. The daily loadings of major parameters at each of the stations are summarized in Table 4. The mass balances, based on these loadings, are presented in Table 5 and give some indication of the precision of technique. The results of analyses performed on the mill's portion of the composite sample are reported in Table 6. Sampling times are summarized in Table 7.

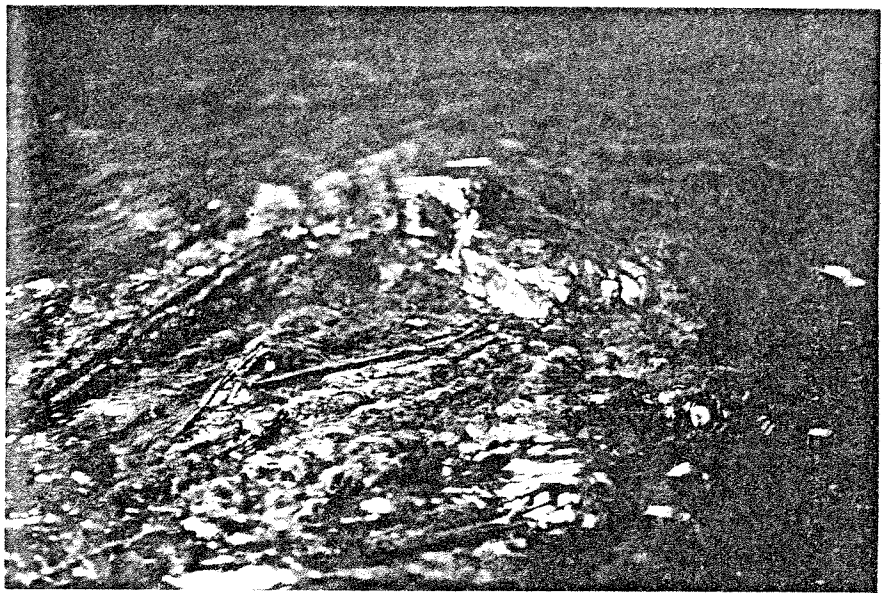
Figure 2. Sphaerotolis-like growths at station #7

Figure 2 is a photograph of Sphaerotolis-like growths at station #7. Similar growths were noted on many of the invertebrates collected at this site. Although a relatively diverse community of benthic invertebrates was collected at this station, Sphaerotolis-like growths have a deleterious effect on fish propogation (Hynes, 1960). Discharge of low nutrient organic wastes (i.e. silage effluent, pulp mill effluent, wood-waste effluent, etc.) has often been implicated in the growth of sewage fungus (Sphaerotolis), (Hynes, 1960; Funk, 1977, personal communication).

Organic loadings are probably responsible for substantial Sphaerotolis-like growths at points below the lagoon discharge. These growths, along with deposition of solids, are potentially deleterious to fish propogation and certainly have an adverse aesthetic impact on the stream.
